Summary Background Document for New Capital Hydropower Improvement Project

Project Title: Lower Monumental Powerhouse Bridge Crane Wheel and Drive System Upgrade

Dam and Reservoir Project: Lower Monumental

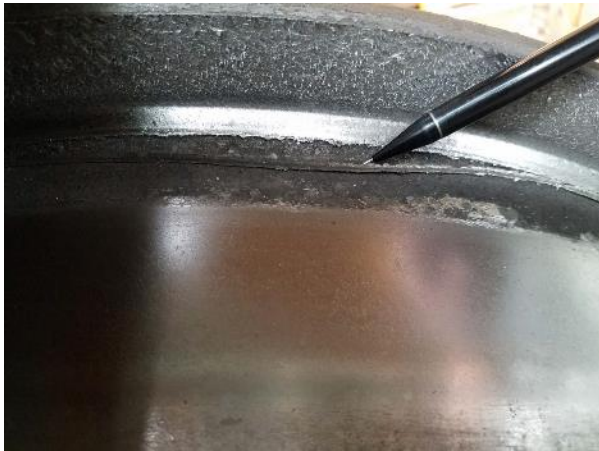
Photo 1: Wheel 6 Flange Wear – Bulk Material “Sheared” Off from Wheel

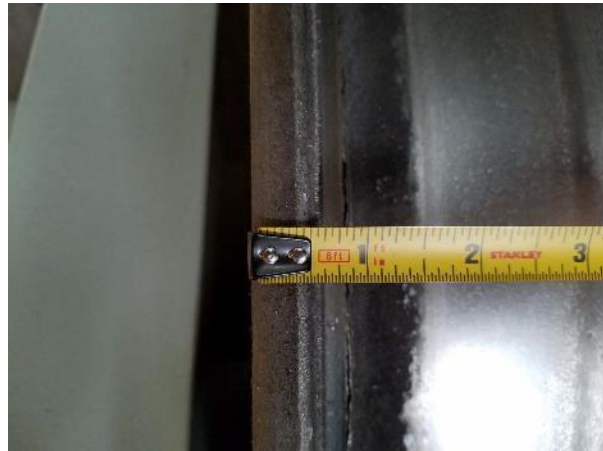
Photo 2: Wheel 6 Flange Visual Inspection (70% of Original Thickness)

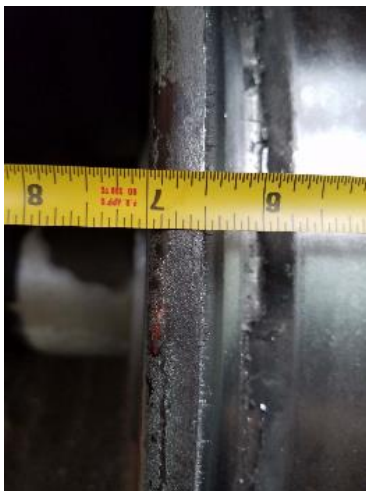
According to the measurements and using the current wear rate, approximately 40% (8 of 20) of the idler wheels are projected to reach 50% of their original flange thicknesses in the next 5 years. The worst worn idler wheels are 3, 4, 5, 20 and 21 which are projected to reach 50% in December 2019.

Overall, the average remaining thickness left on the downstream idler wheel flanges (wheels 1, 3 through 10, and 12) is 78%, with the thinnest flange thickness at 63% of its original thickness (wheel 3). The average remaining thickness left on the upstream idler wheel flanges (wheels 13, 15 to 22, and 24) is 76%, with the thinnest flange thickness at 67% of its original thickness (wheel 20).

Photo 3: Wheel 3 Flange Visual Inspection Thinnest (63% of Original Thickness)

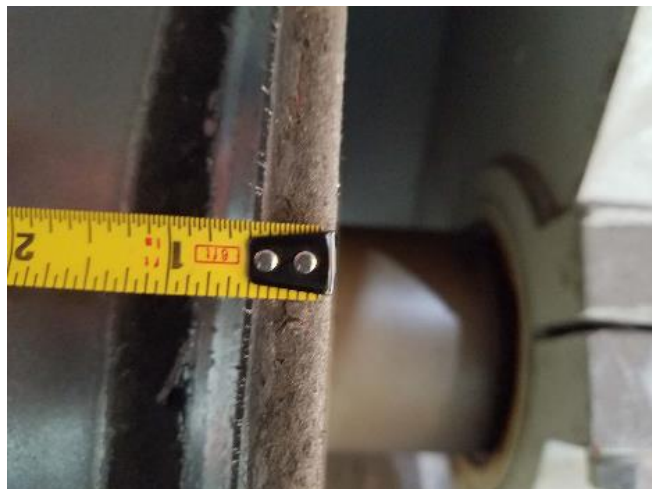
Photo 4: Wheel 4 Flange Visual Inspection (66% of Original Thickness)

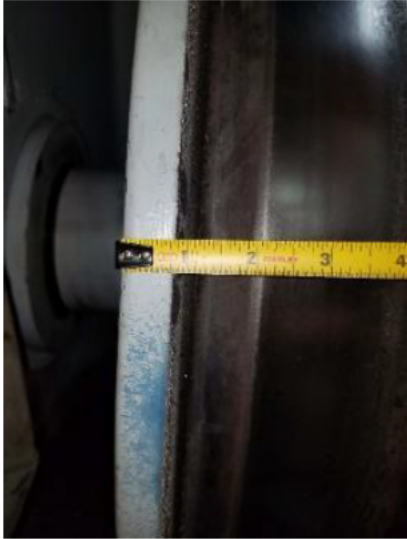
Photo 5: Wheel 1 Flange Visual Inspection (97% of Original Thickness)

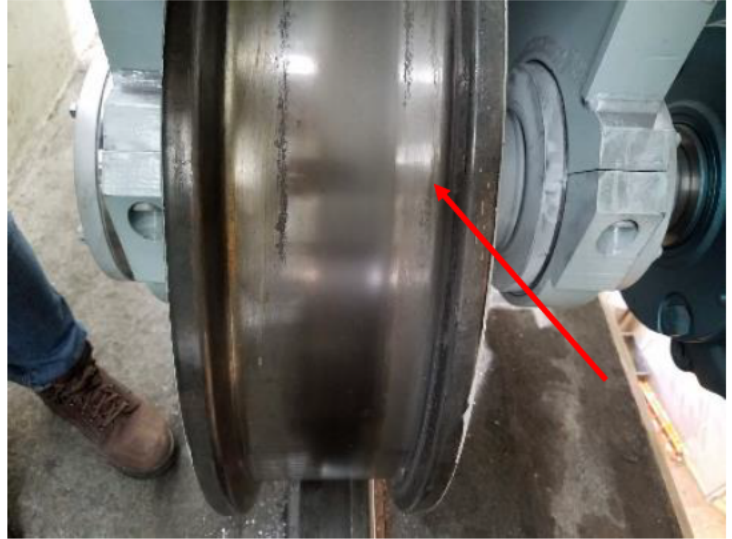
Photo 6: Wheel 2 Flange Visual Inspection (No Signs of Wear)

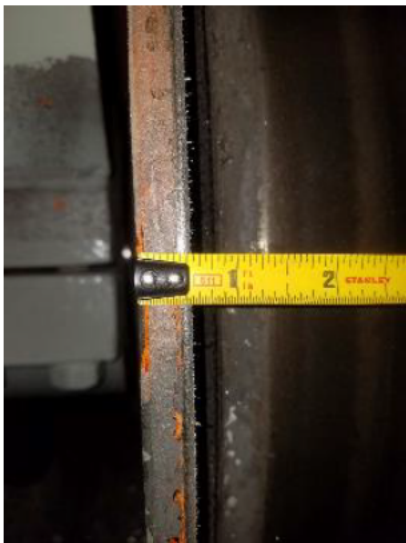
Photo 7: Wheel 20 Flange Visual Inspection (67% of Original Thickness)

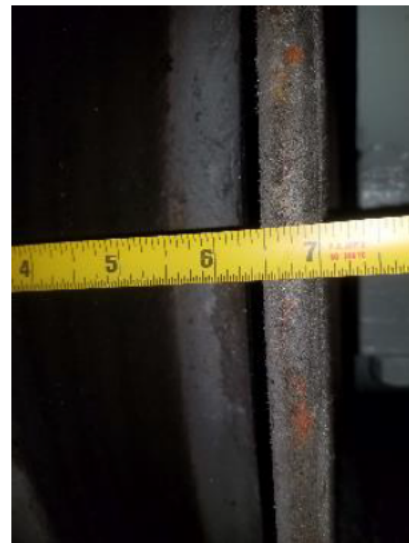
Photo 8: Wheel 21 Flange Visual Inspection (68% of Original Thickness)

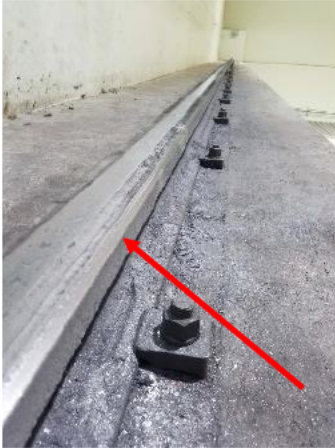
Photo 9: Downstream rail filleting and metal dust generated from the wheel and rail contact.

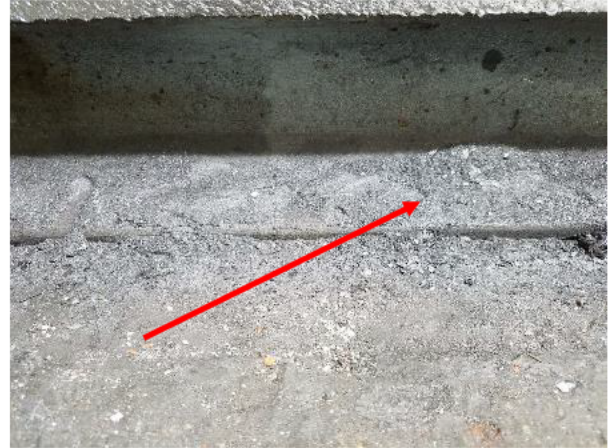
Photo 10: Metal dust generated from the wheel and rail contact during crane movement.
