Detroit Dam Electrical Failure and Fire

*Some Protective System
Lessons Learned – NW
Hydro Operators Regional
Forum May 22, 2008*

**US Army Corps
of Engineers.**

Detroit Dam

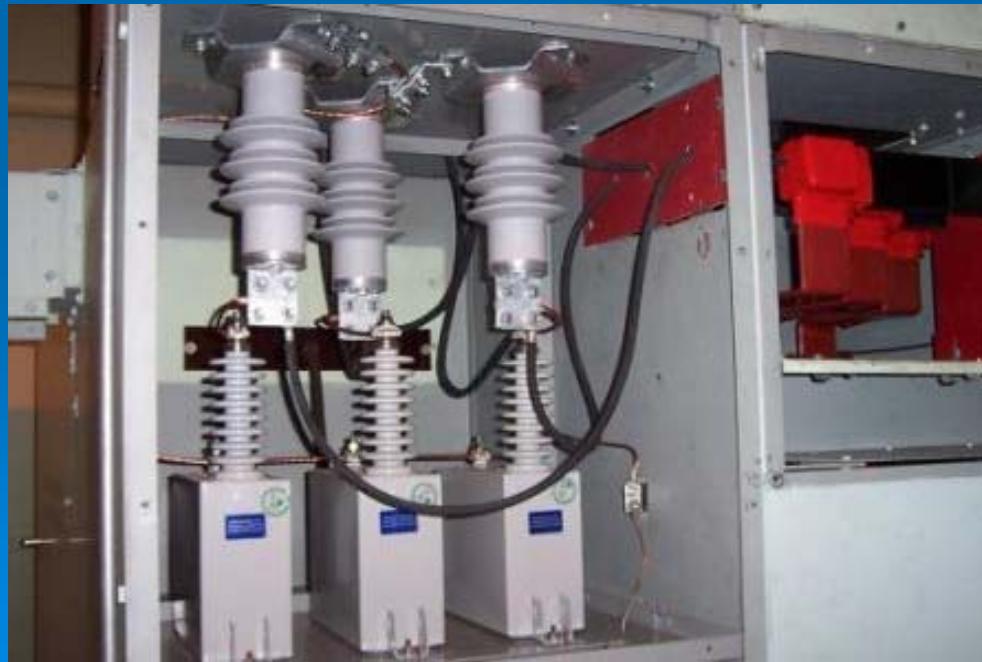
Detroit Fire Immediate Cause Under-rated Surge Arresters 2004

- A contract modification added arresters to temporarily protect several old transformers that would not be replaced until the next phase.
- 12.7kV MCOV proposed and approved.
- 10.2kV MCOV installed (10 sec @13.8kV).

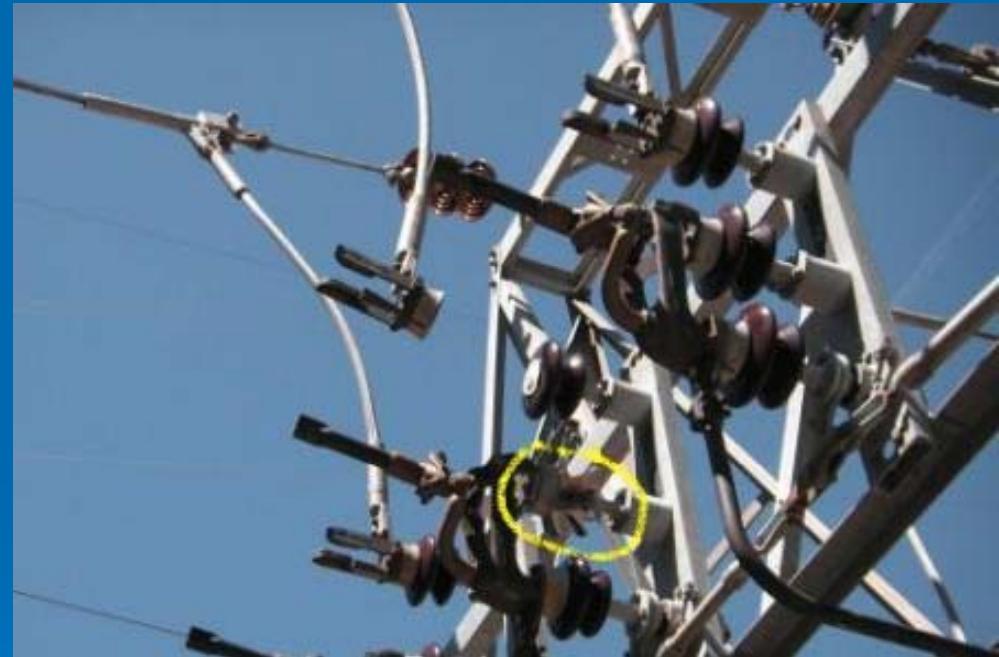
18 June Event Sequence

- Ground fault comes in hard.
- Big Cliff unit trips as designed.
- XJ2, XJ3, XJ5 trip as designed.
- Lights go out.
- Operator gets help.
- Lighting restored.

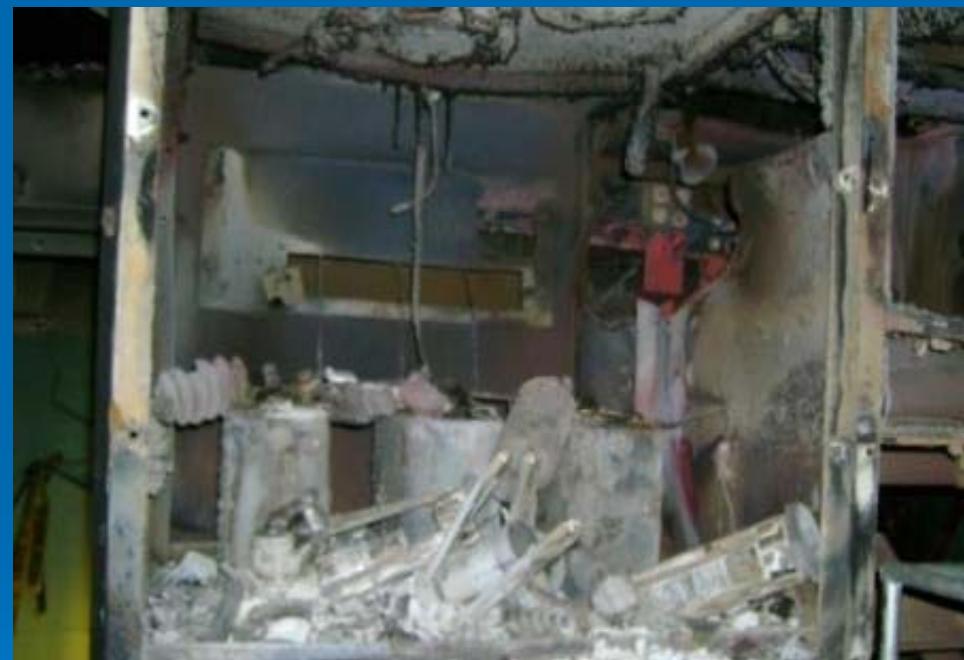
Start of Fire

- Operator re-closed the circuit breaker energizing the firmly faulted bus.
- 13.8kV ground fault still there.
- Surge Arresters see high voltage.
- Surge Arresters burn.
- Reactor limits fault current
- No relay action since operator did not restart the tripped generator

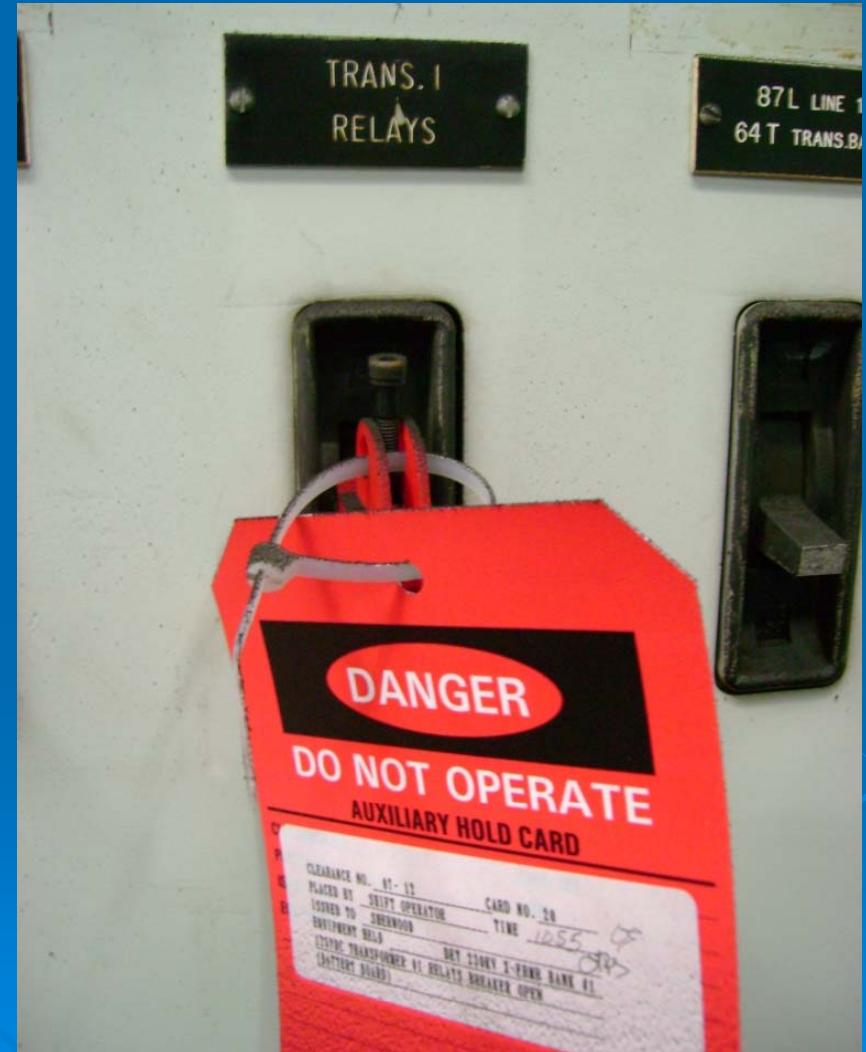
Relay Power Tagged Out, May 07

- Fire burns into XJ5 activating other protective devices – but:
 - A clearance had been taken for the purpose of performing some work on T1 before U1 was returned to service
 - This unknowingly disabled the secondary protective system trip
 - No line lock out relay function.

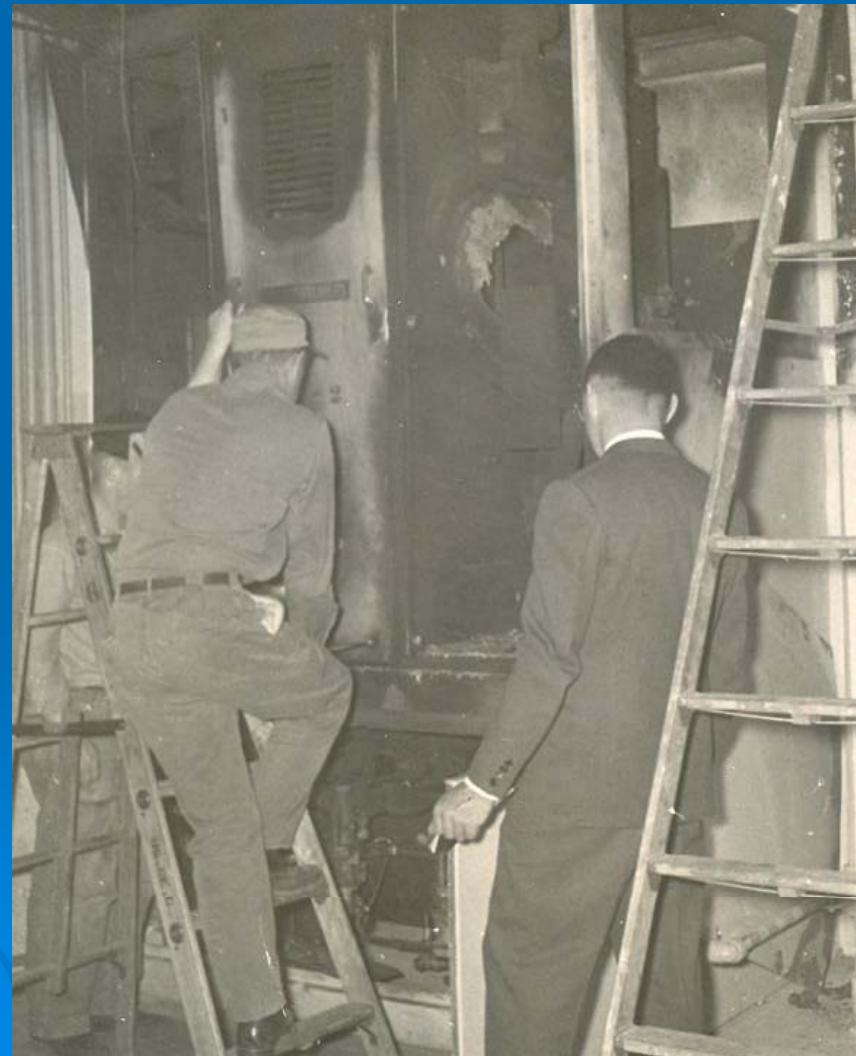
Original Design – 1950's

- Unrealized plans for second yard breaker.
- Yard breaker only tripped by T1 pilot wires or 86L1
- T2 pilot wires do nothing.
- 86L2 must trip 86L1 to trip yard Breaker
- Compromise at the time based on best practices, costs, assumptions.

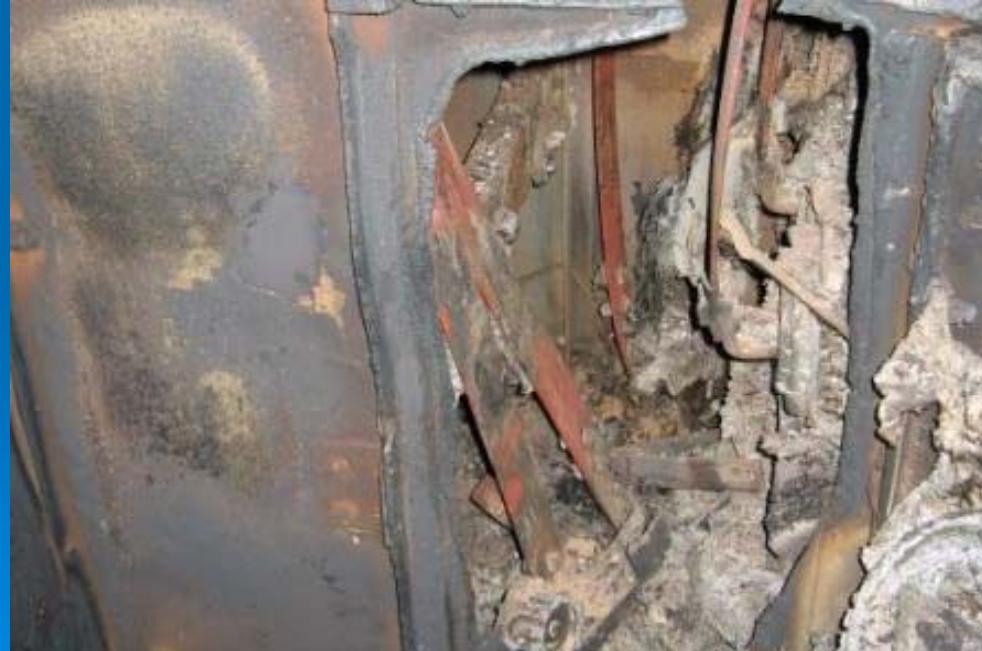
Fire Propagation

- XJ5 Burns
- Still No Relay Action

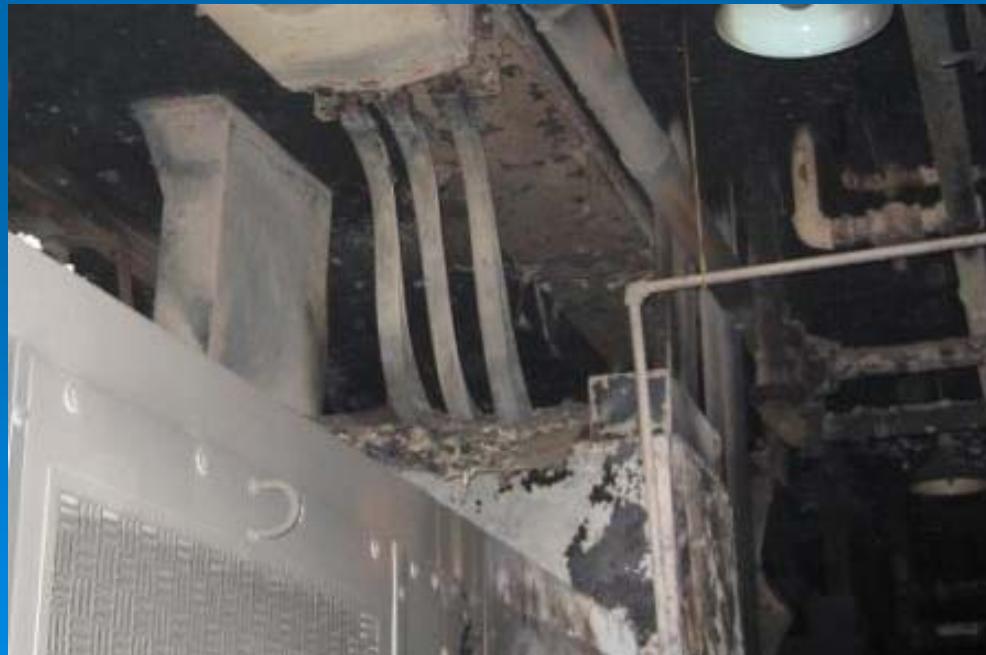
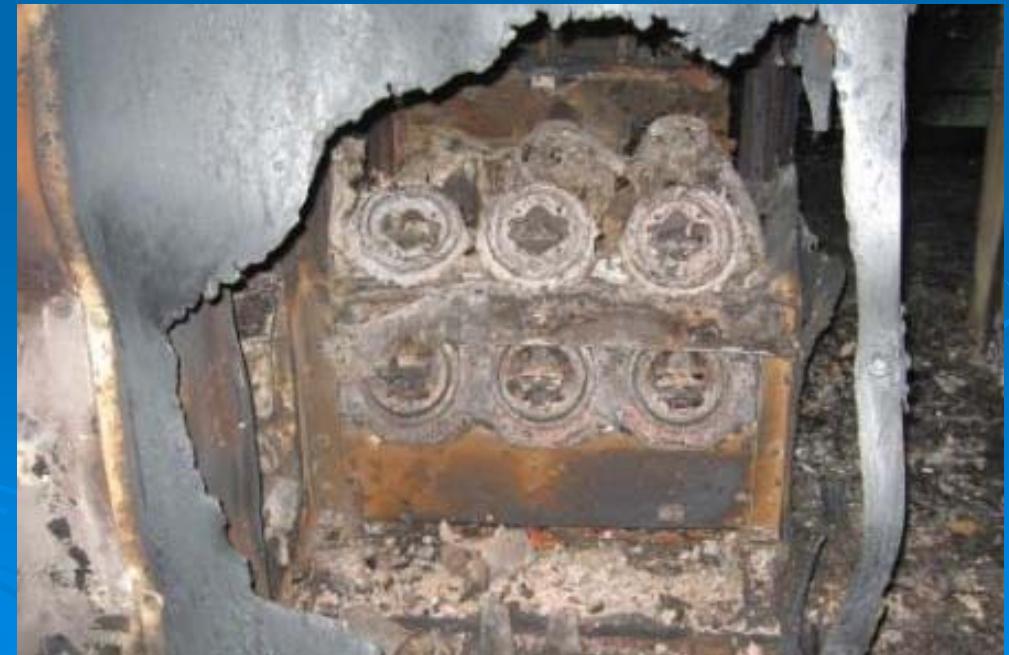
Fire Propagation

- XJ9 Burns
- Still No Relay Action

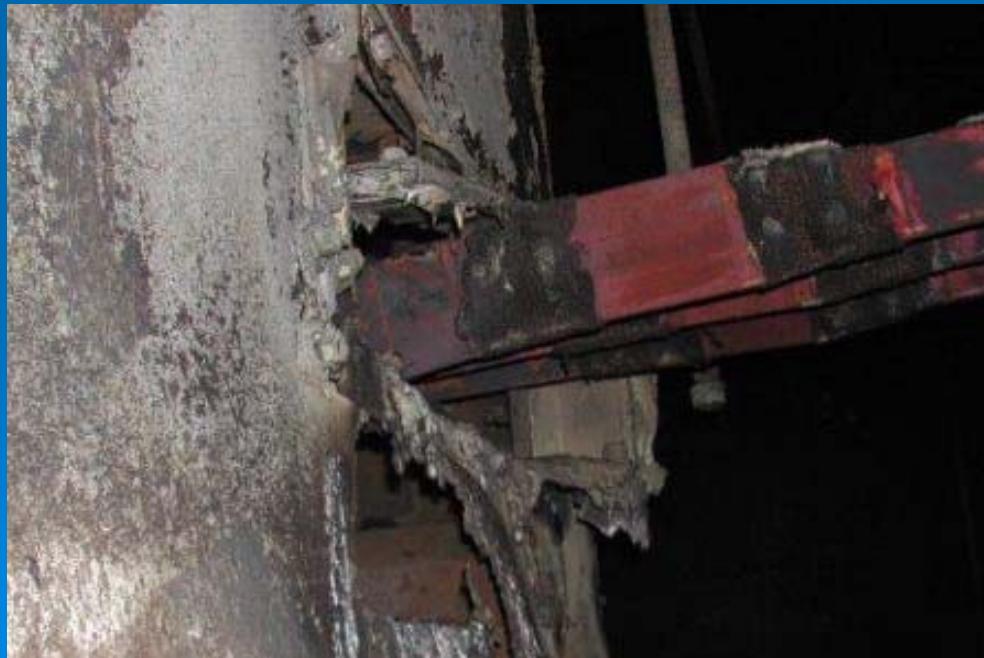
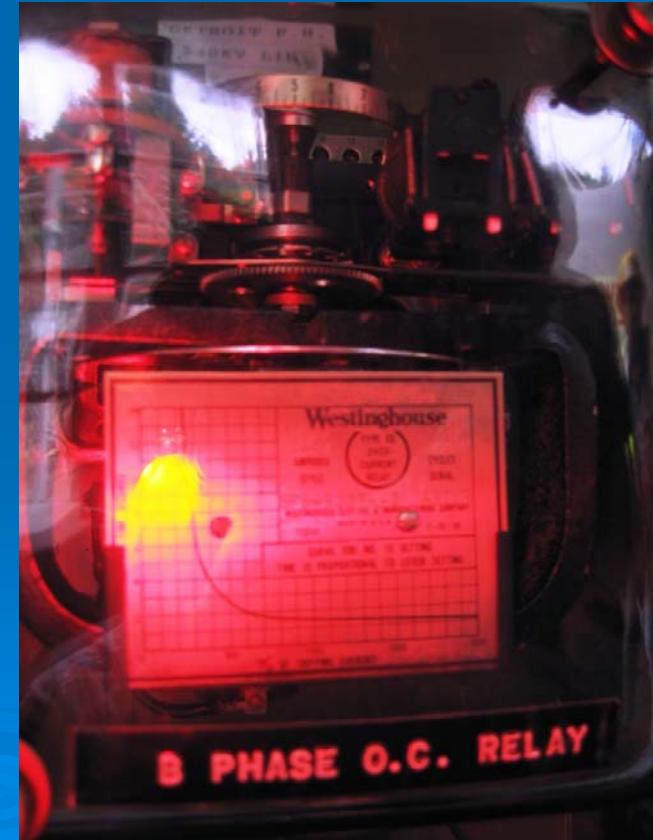
Energy Source Removed

- Bus burns to current limiting reactor.
- Current increases
- BPA over-current relay trips.

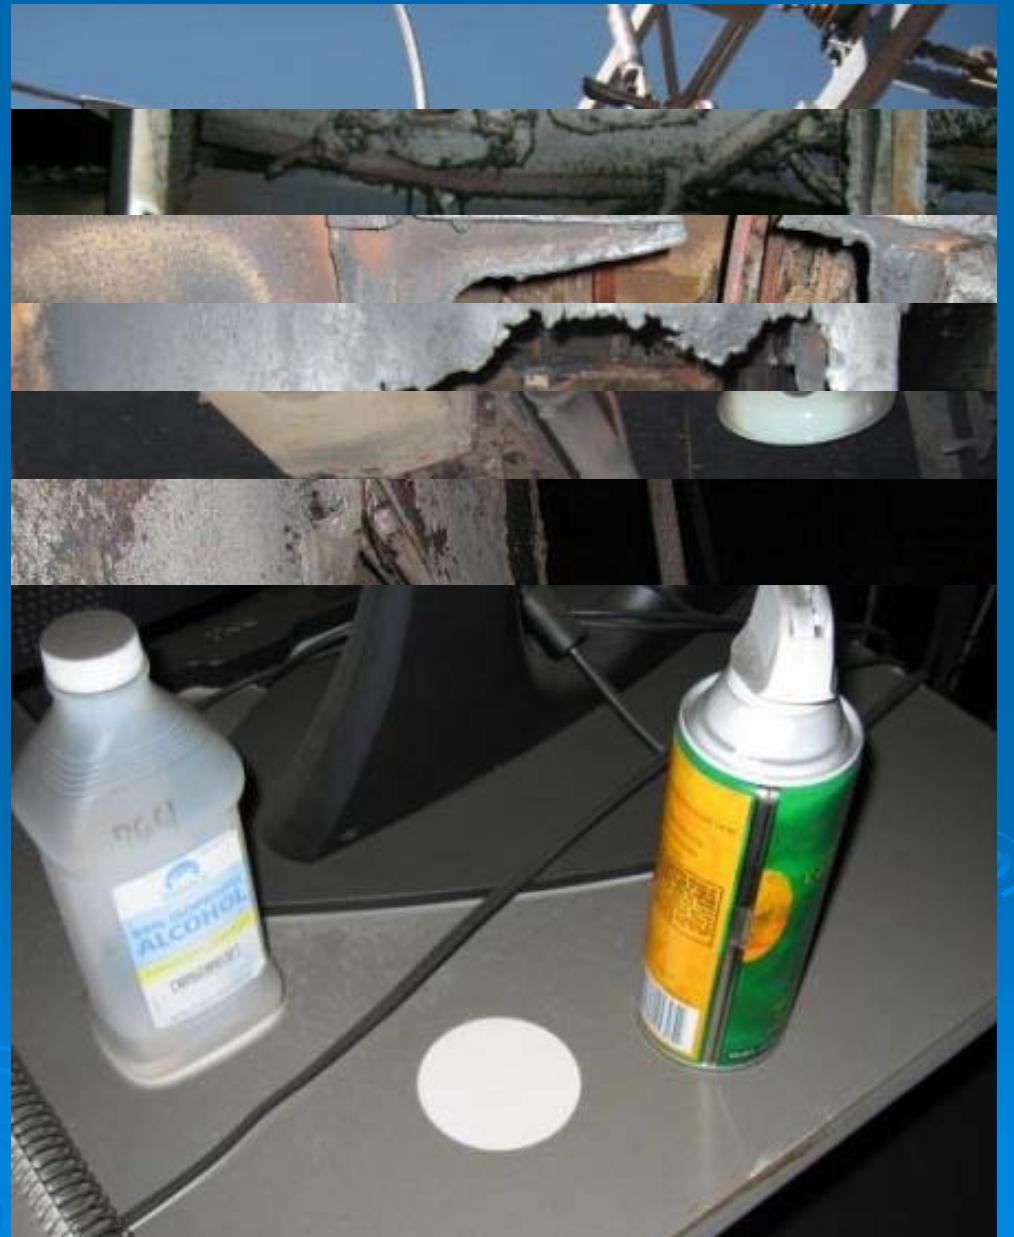
Failure Events: Summary

- BPA ground fault
- New under-rated surge arresters burn
- 2 circuit breakers burn
- BCL bus melted
- Fault bypasses reactor
- Substation breaker clears the fault
- Soot and smoke everywhere

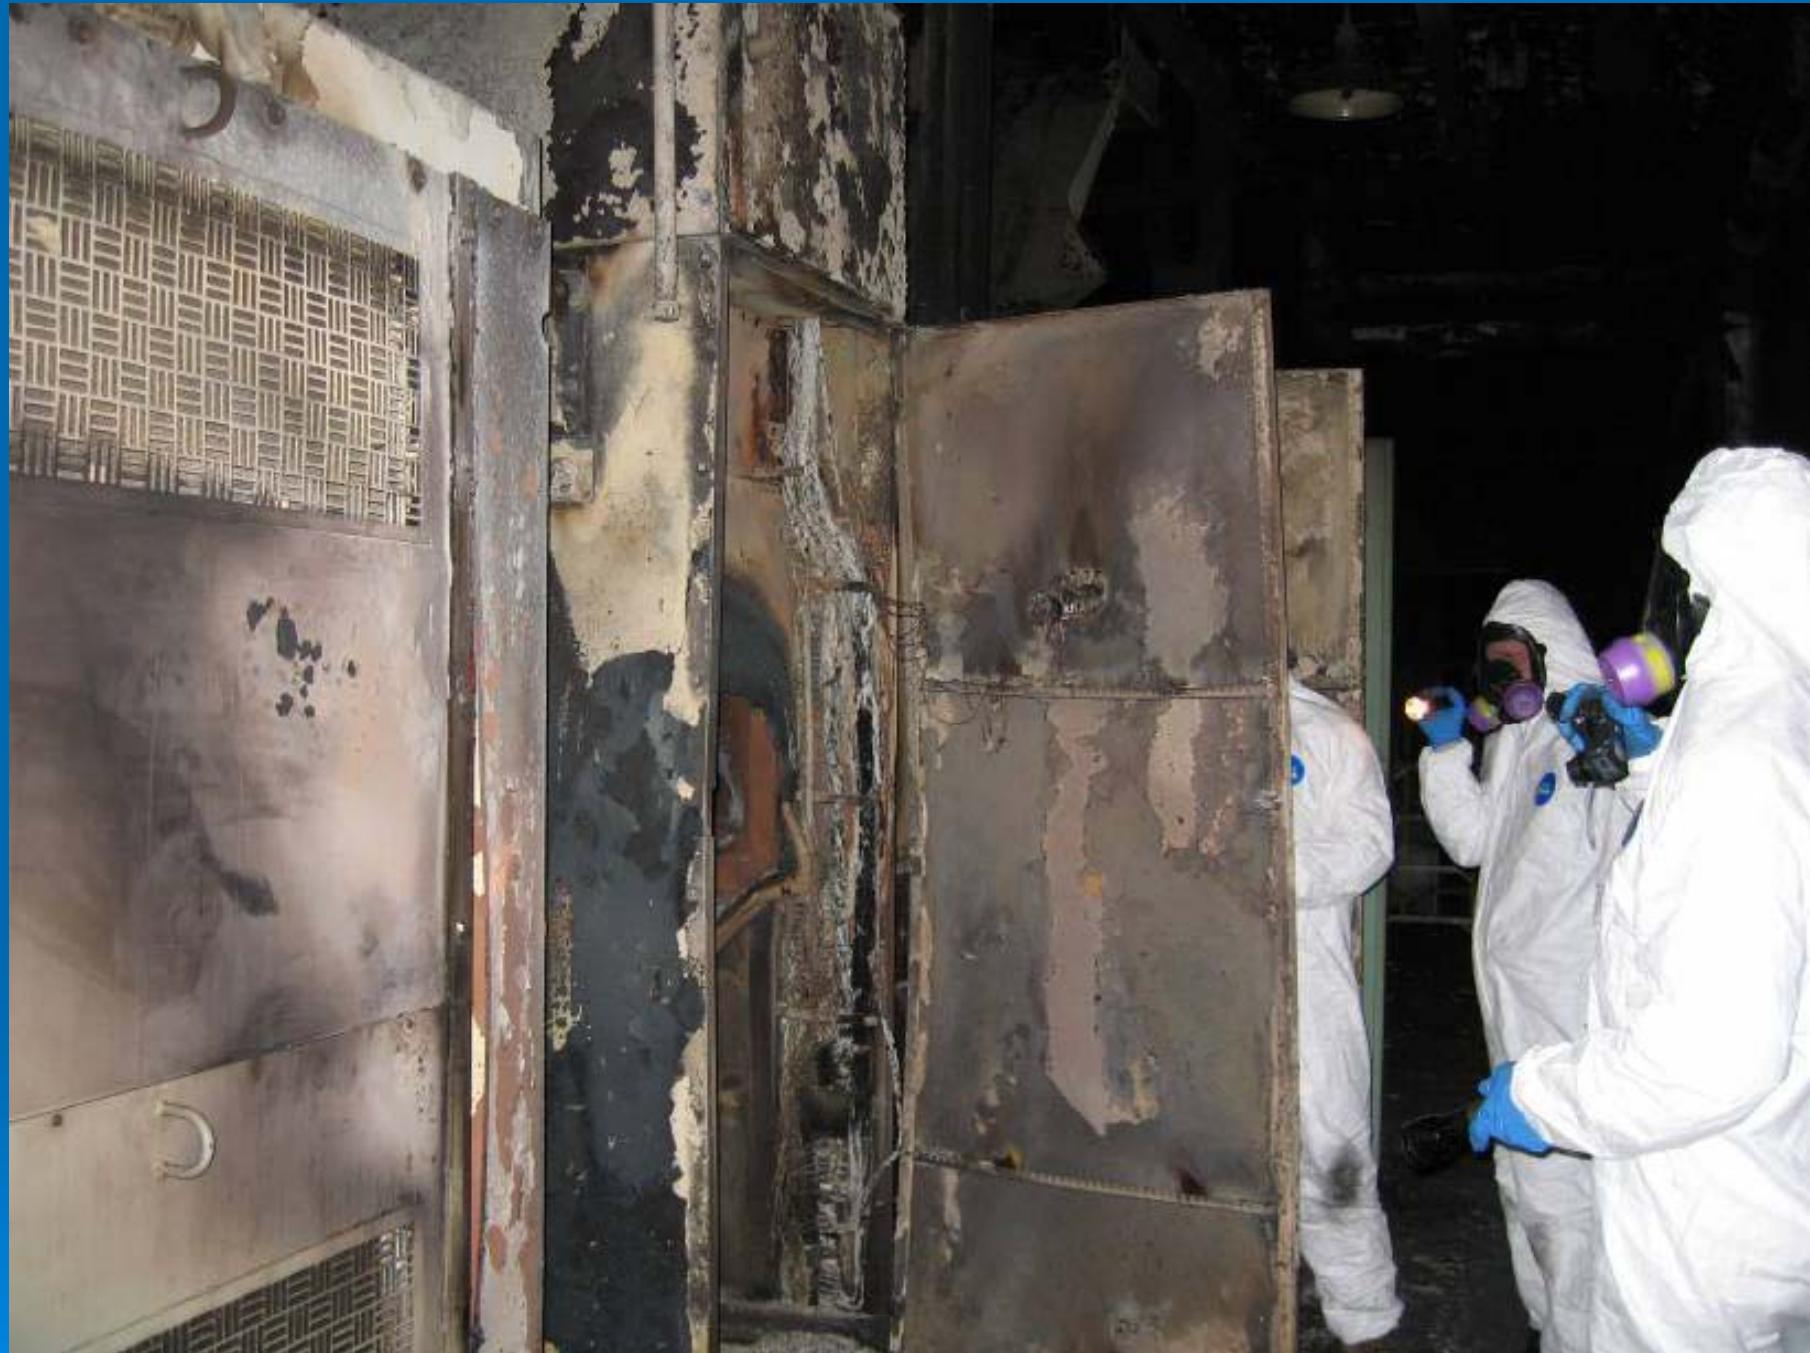
Damage Assessment

- XJ5, XJ9 circuit breakers
- Surge arresters & capacitors
- Metering PTs, CTs
- Switchgear enclosures
- Portions of the isolated phase bus work
- Soot everywhere (environmental clean up \$2+M)
- Current estimate - \$6.5m
