COUNCIL

WESTERN SYSTEMS COORDINATING

System Identifiers .....	1
I.	EXECUTIVE SUMMARY AND INTRODUCTION.....	2
	The Western Interconnection and Western Systems Coordinating Council.....	2
	July 2, 1996 System Disturbance .....	3
	Protective Actions to Stabilize the System .....	4
	Formation of Electrical Islands .....	6
	July 3, 1996 System Disturbance .....	7
	Preliminary Findings .....	8
	Overview and Primary Conclusions.....	9
II.	CONCLUSIONS AND RECOMMENDATIONS .....	11
III.	CONDITIONS PRIOR TO THE DISTURBANCE .....	26
	Predisturbance Conditions .....	26
	Abnormal System Conditions .....	26
	Transmission Out of Service Prior to Outage .....	29
	Other Equipment Out of Service .....	30
	Voltages at Key Substations Prior to Outage .....	31
IV.	DETAILED DESCRIPTION.....	37
	Summary of Load Loss within Islands .....	43
	Restoration .....	45
	July 3 Disturbance.....	51

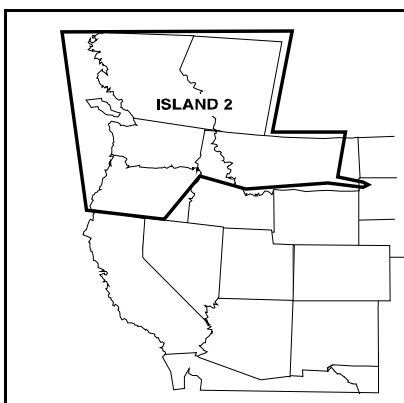
As a power swing started through northern Nevada toward southern Idaho, the voltage dropped rapidly on the north 345 kV tie. About 168 MW of northern Nevada load was lost during the transient low voltage (believed to be the result of motor contactors dropping out, etc.).

In northern Wyoming, the Yellowtail-Rimrock 161-kV and the Yellowtail-Billings and Yellowtail-Crossover 230-kV lines were tripped by out-of-step relay action between 1425:07.207 to about 1425:07.395, separating Wyoming from Montana.

The above line trips caused the formation of two islands. One island contained Montana, Washington,

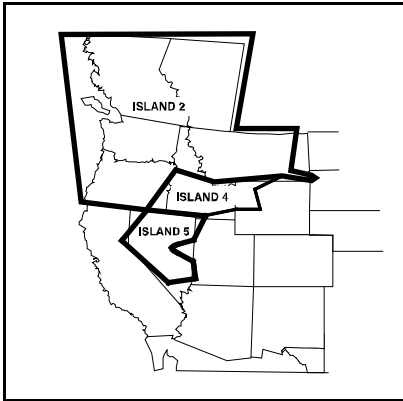
Both Idaho and Nevada were still tied to the southern island through Sierra's ties to California via the weak California-Summit 120-kV, North Truckee-Summit 120-kV and Truckee-Summit 60-kV ties. At approximately 1425:08.300 the 120-kV ties were tripped by out-of-step relays. The 60-kV tie also tripped. At 1425:09.255, the Humboldt-Midpoint 345-kV line relayed at Midpoint on instability. An additional 55 MW of transmission dependent load was tripped as part of Sierra's remedial action scheme for loss of the Humboldt-Midpoint line.

On loss of the Humboldt-Midpoint line, the Idaho (Island 4) and northern Nevada (Island 5) islands were formed, leaving the Western Interconnection separated into four islands. After islanding, the northern Nevada island was in an over-frequency condition.

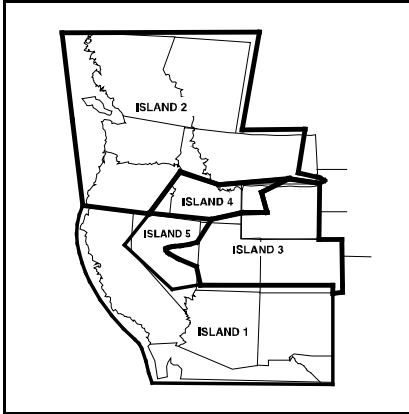
Rocky Mountain area tried to flow to Arizona/California where they were still deficient. This caused an out-of-step separation across the TOT 2 Path, (Utah/Colorado, Arizona/New Mexico/Nevada interface). This out-of-step swing (at 1425:11) tripped the Waterflow-Hesperus, Pinto-Four Corners, and Red Butte-Harry Allen 345-kV lines, the Lost Canyon-Curecanti and Sigurd-Glen Canyon 230-kV lines, and the Durango-Glade Tap 115-kV line. Sierra Pacific's 55-kV ties to Southern California Edison Company tripped on low voltage due to the out-of-step swing.

The foregoing actions completed the formation of two more islands — the Utah, Colorado, Wyoming, western South Dakota, western Nebraska island (Island 3), and the California, Baja California, southern Nevada, Arizona, New Mexico, El Paso island (Island 1). At this time formation of all five islands was complete.
