## Department of Energy

FREEDOM OF INFORMATION ACT/PRIVACY PROGRAM

In reply refer to: FOIA #BPA-2024-02248-F

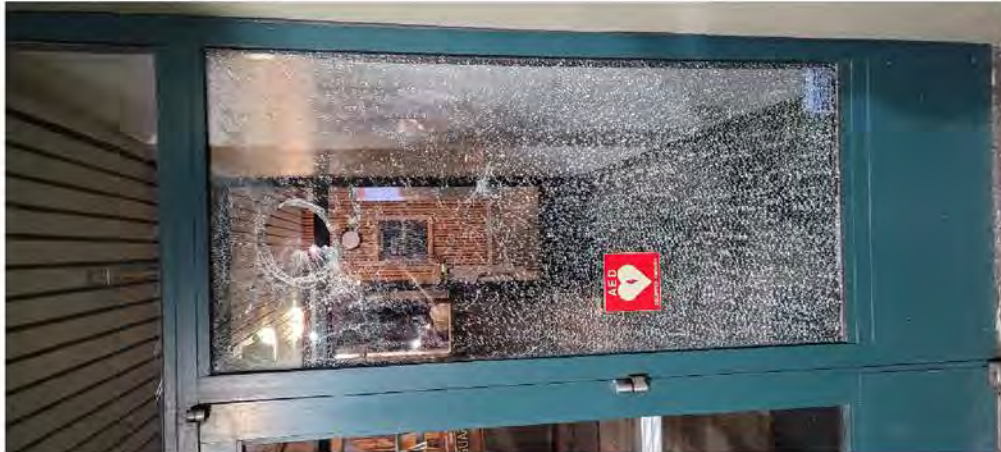
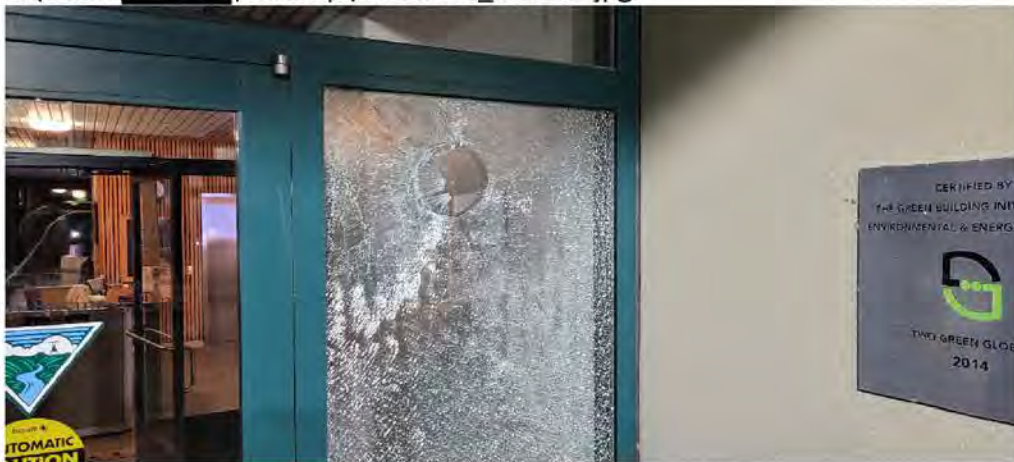
I then dispatched S/O (b)(6) to CSB to investigate the situation and Supervisor (b)(6) went with him. At approximately 1814 hours Supervisor (b)(6) and S/O (b)(6) arrived at CSB and radioed that the glass had been broken. I then called CRESA and relayed what had happened and the description of the person that caused the damage. At approximately 1819 I informed (b)(6) of OSCO. On call facilities was contacted along with the Inter-Con Contract Manager. AMS then received a call from Officer (b)(6) of Vancouver Police and gathered more information about the incident and gave me the case number for the incident. (b)(6) of facilities arrived at 1852 and was requested by (b)(6) to board up the window for security purposes.

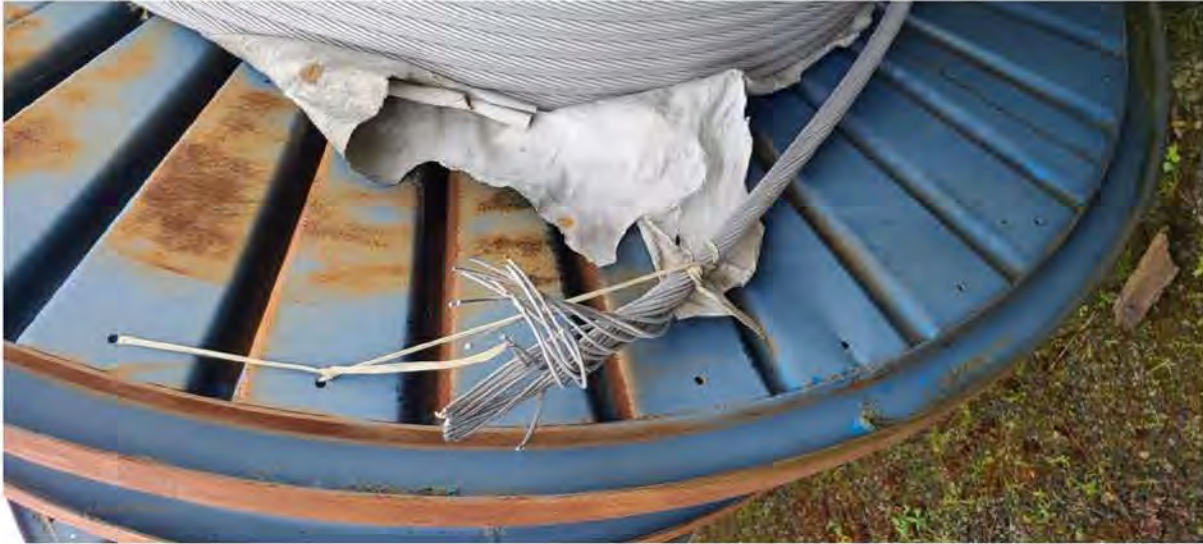
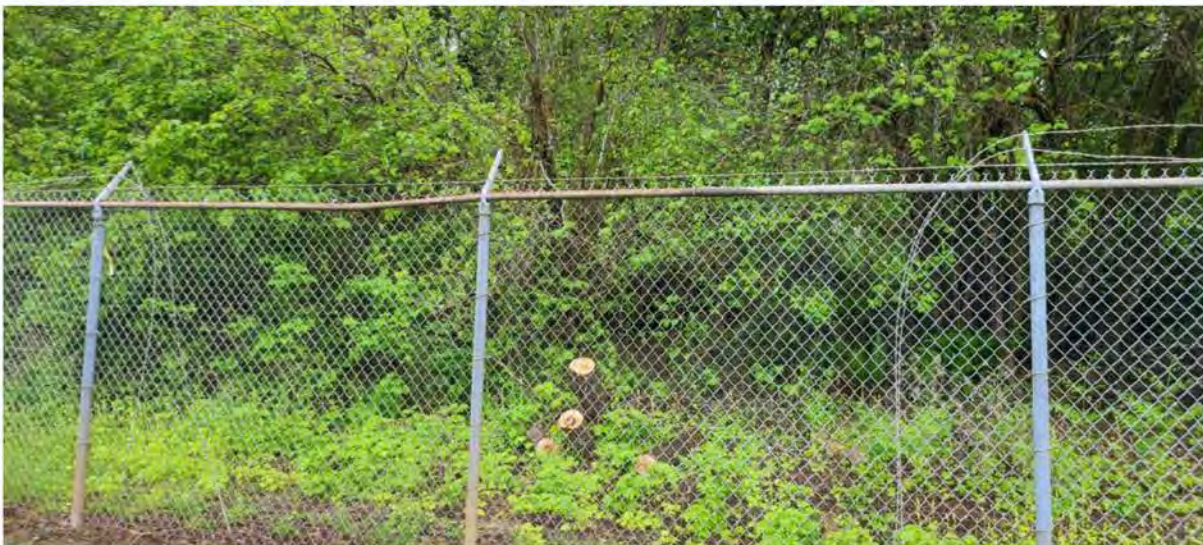
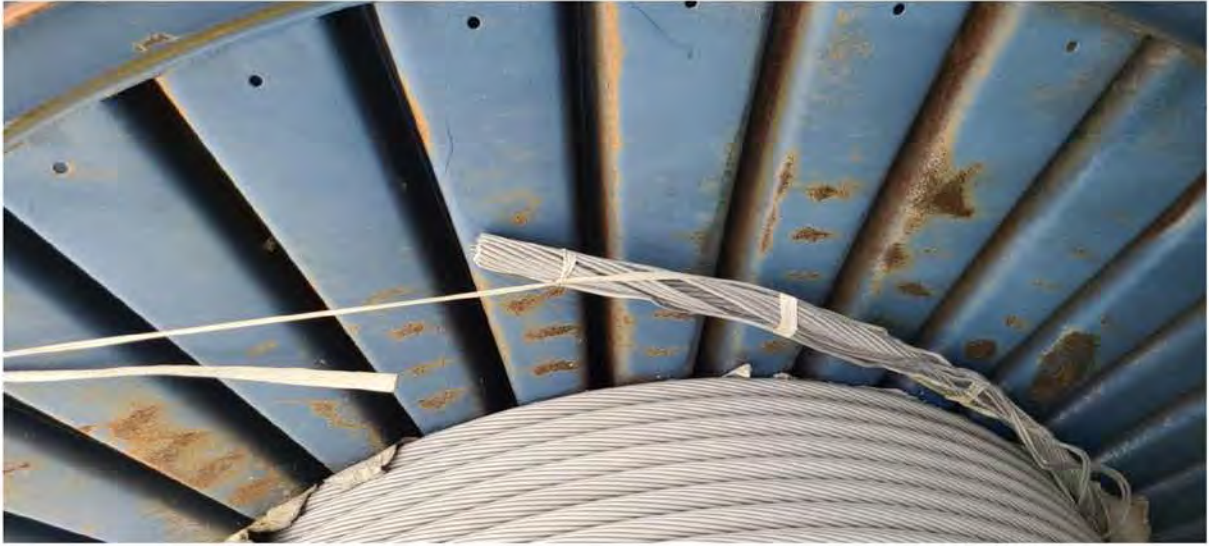
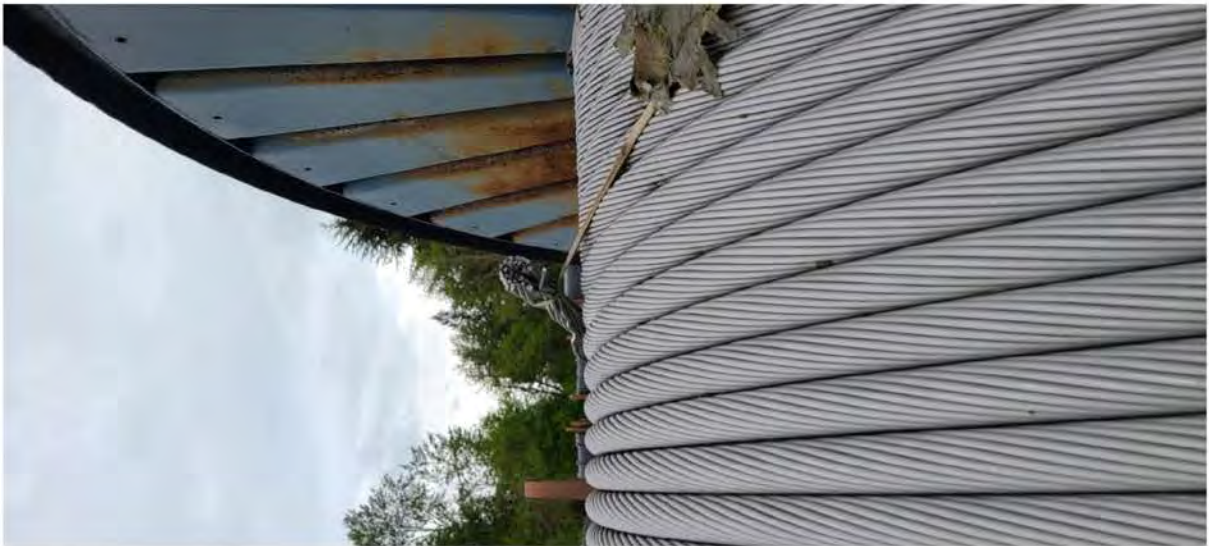
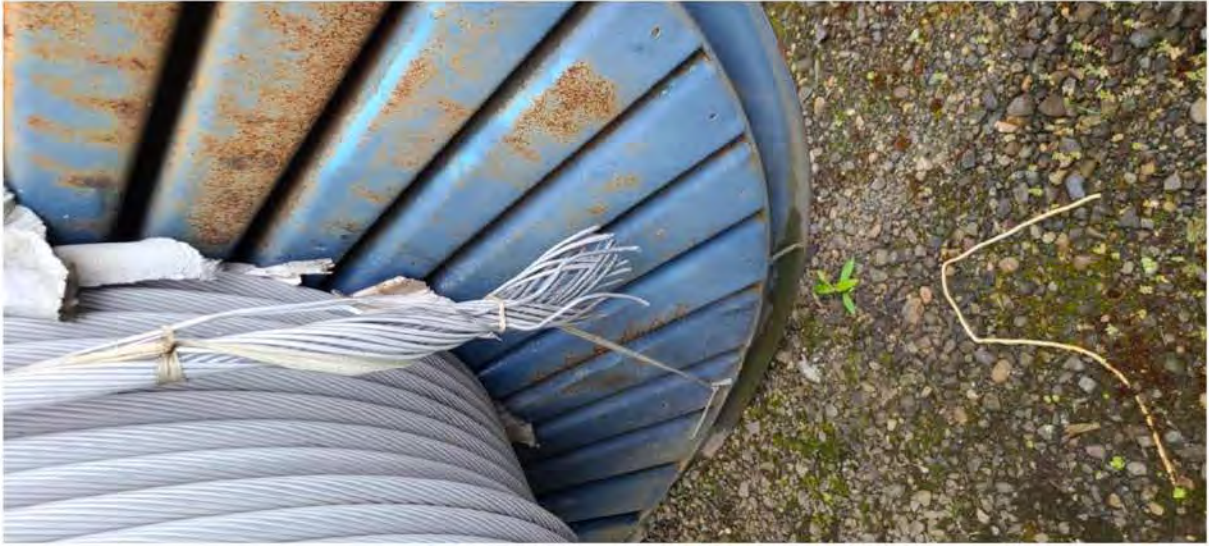
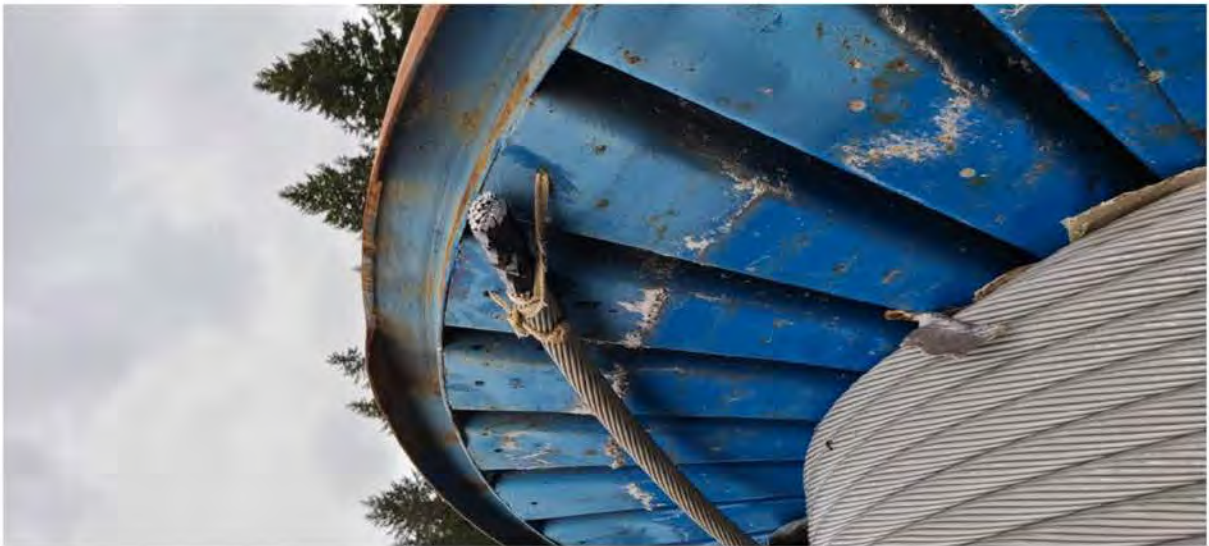
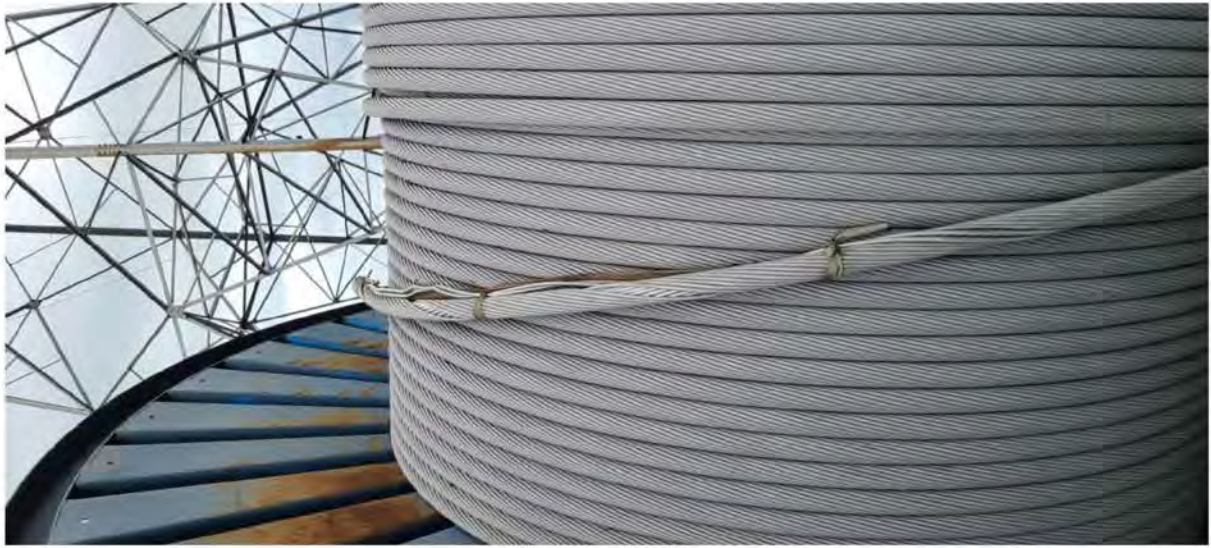
25<sup>th</sup>, 2022. I then dispatched Patrol Officer (b)(6) to the location to meet with the employees and gather additional information. I emailed the Security Incident Report and Property Loss Report forms to the employees to be completed. I went on BPA eGIS LiveMap and found the cut in the fence is approximately 15 feet south of Power Tower MCNY-ROSS-1 Tower Mile 175, Tower Structure 6.

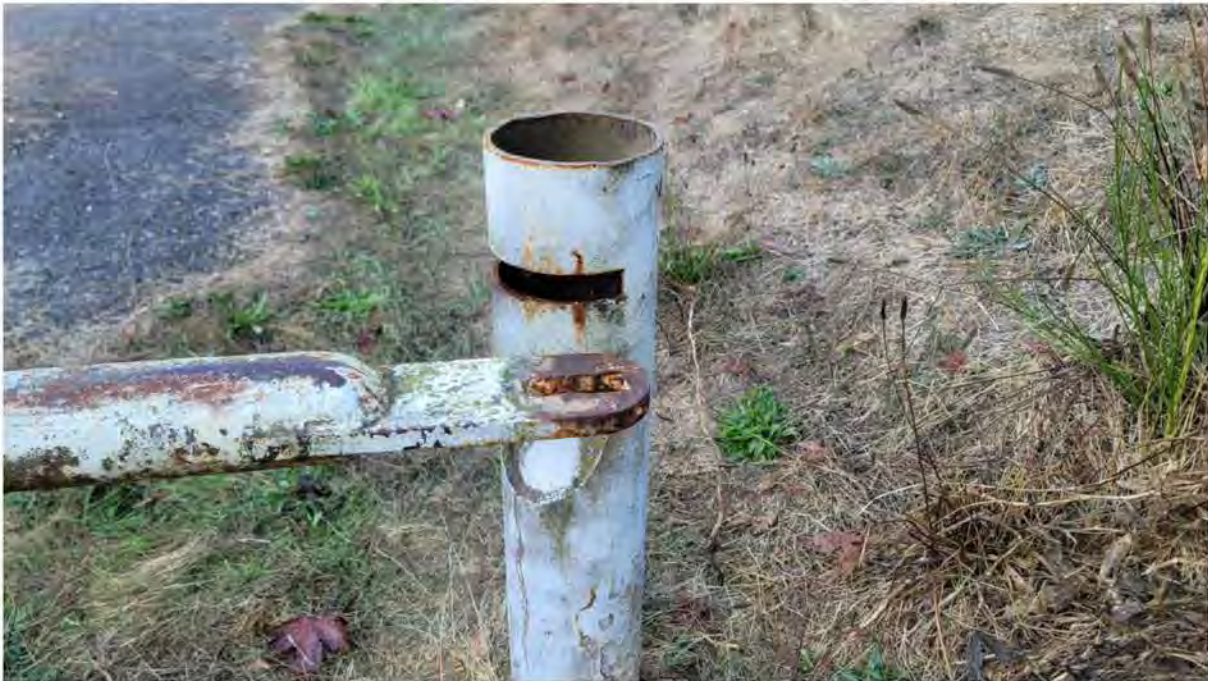
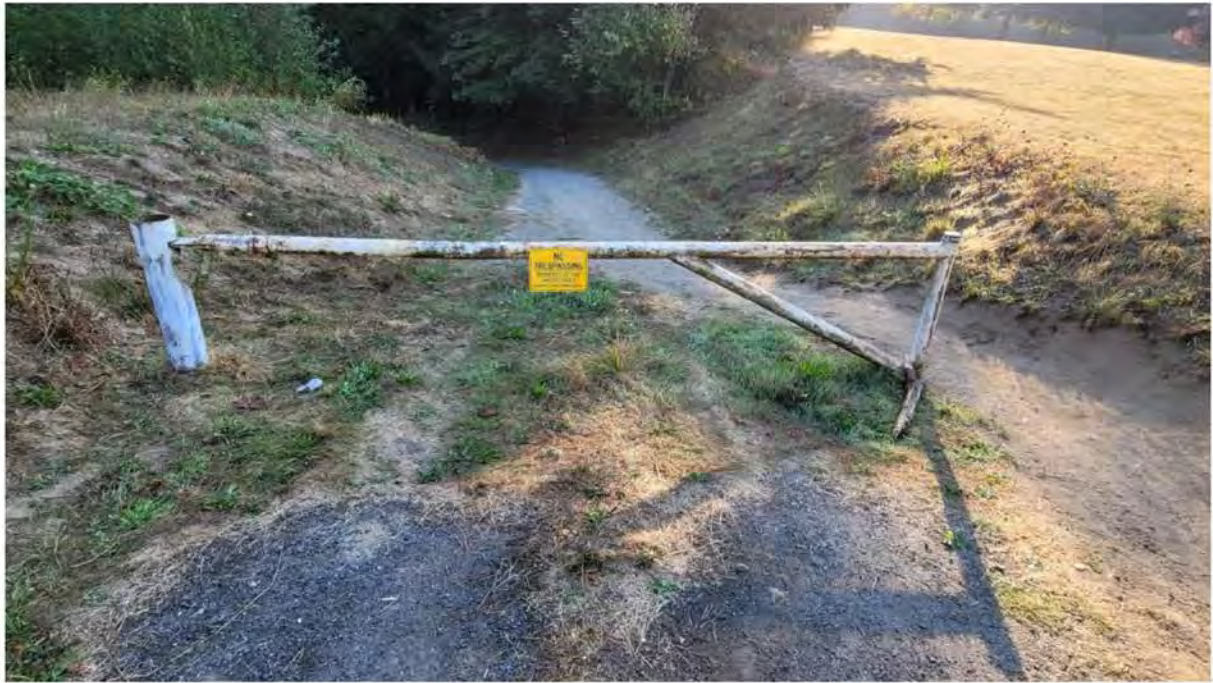
☐ Alarm ☐ Auto Accident ☐ Client Comp. ☐ Emergency ☐ Fire ☐ Injury ☐ Open Door  
☐ Open Safe/File ☒ Prop. Damage ☐ Safety Hazard ☐ Susp. Person(s) ☐ Theft ☐ Trespasser(s) ☐ Vehicle  
☐ Water Leak ☐ Other Explain: **Damage & Removal of Locks & Signs on Vehicle Access Gate to Cold Creek**

(b)(6) notified OSCO Physical Security Specialist (b)(6). Lt. (b)(6) responded to the location and reported two signs that were on the gate were removed as well. I called and notified CRESA non-emergency Dispatch at 0914 hours. I received a call back from (b)(6) of VPD at 1015 hours. She took my report and said the case # was 2022-25856.

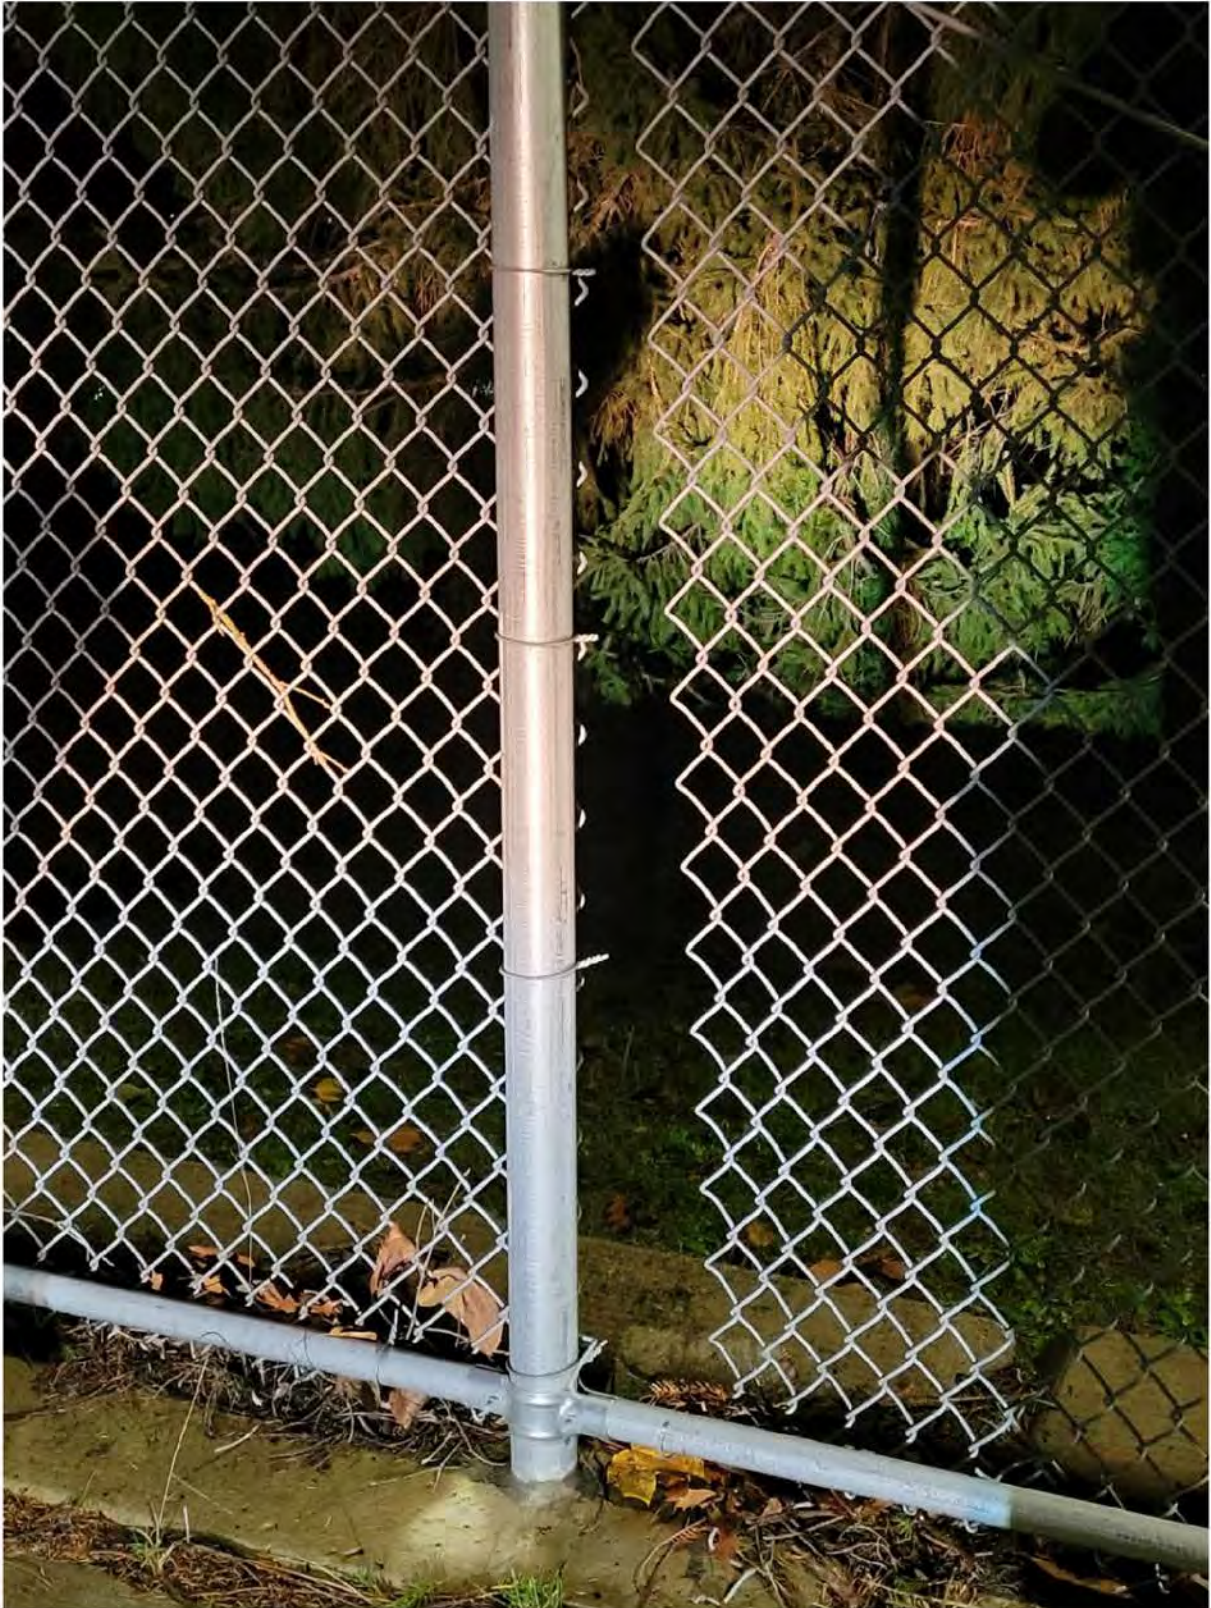
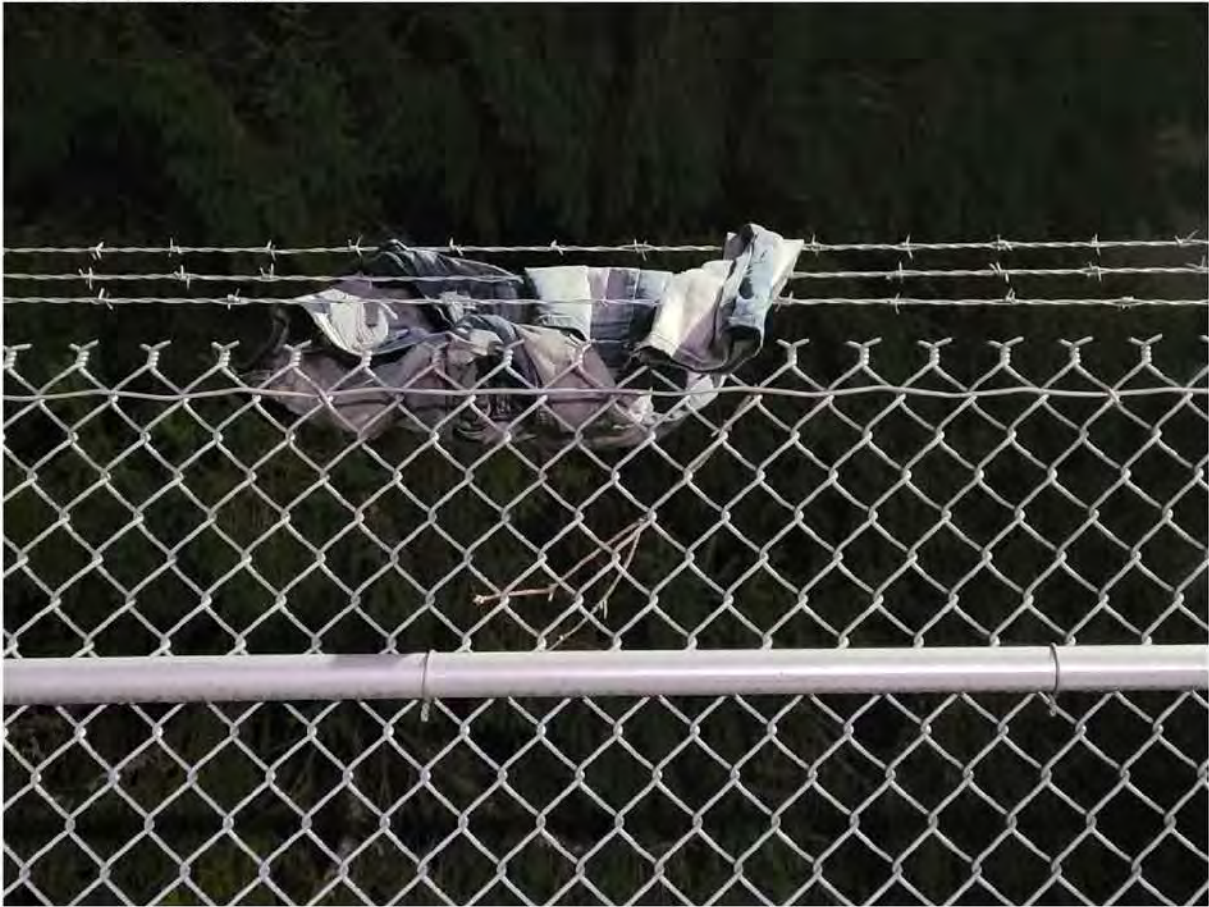
☐ Alarm      ☐ Auto Accident    ☐ Client Comp.    ☐ Emergency    ☐ Fire      ☐ Injury      ☐  
 Open Door  
☐ Open Safe/File      ☒ Prop. Damage      ☐ Safety Hazard    ☐ Susp. Person(s)    ☐ Theft      ☐  
 Trespasser(s)    ☐ Vehicle  
☐ Water Leak    ☐ Other      Explain: **Hole cut in the fence line**

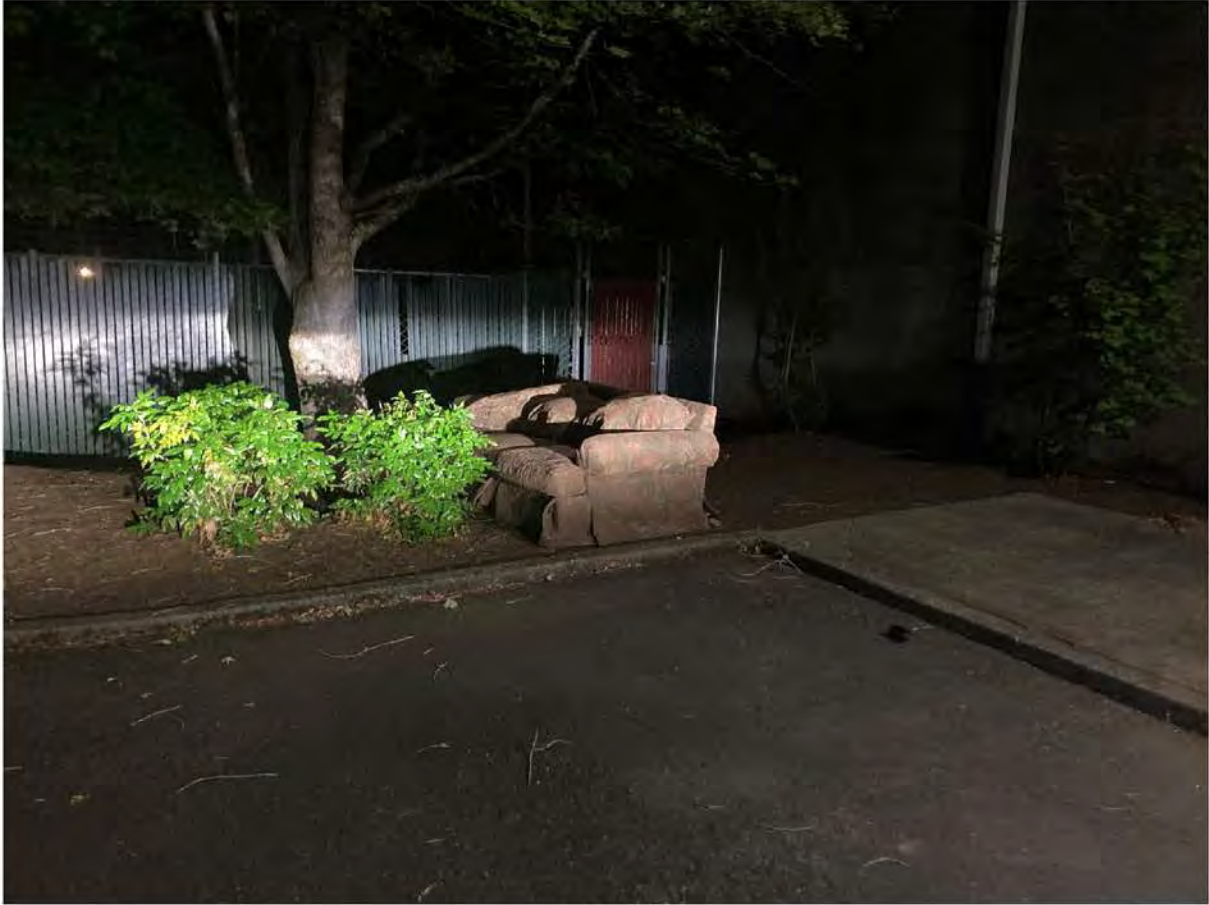
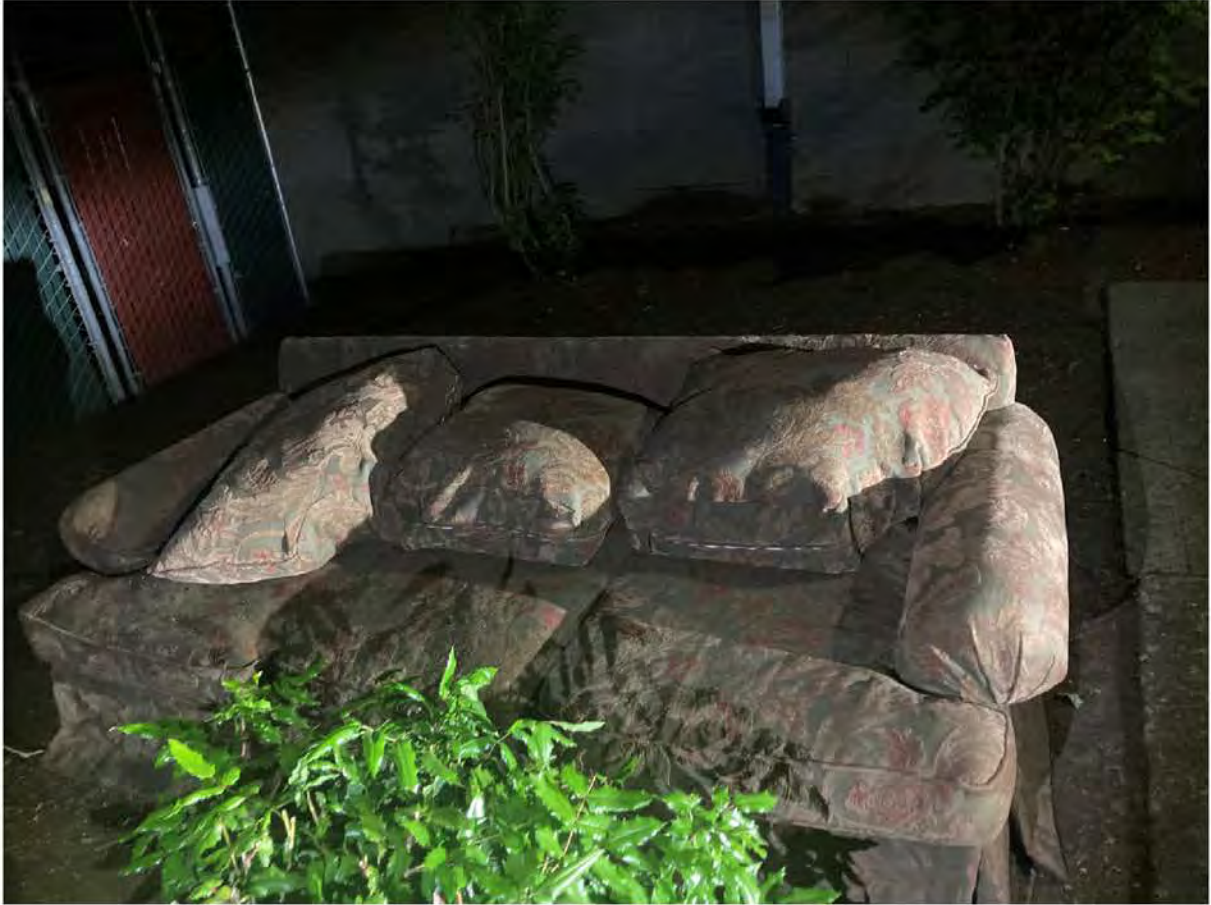
A discarded couch was found in the Credit Union parking lot. No persons were in the area.

After reviewing the VASS, it was found that a silver Minivan driven by a male subject had dumped the couch at 1324 hours on 06 June 2023. Footage and pictures of the couch were uploaded to the ProForce Drive.

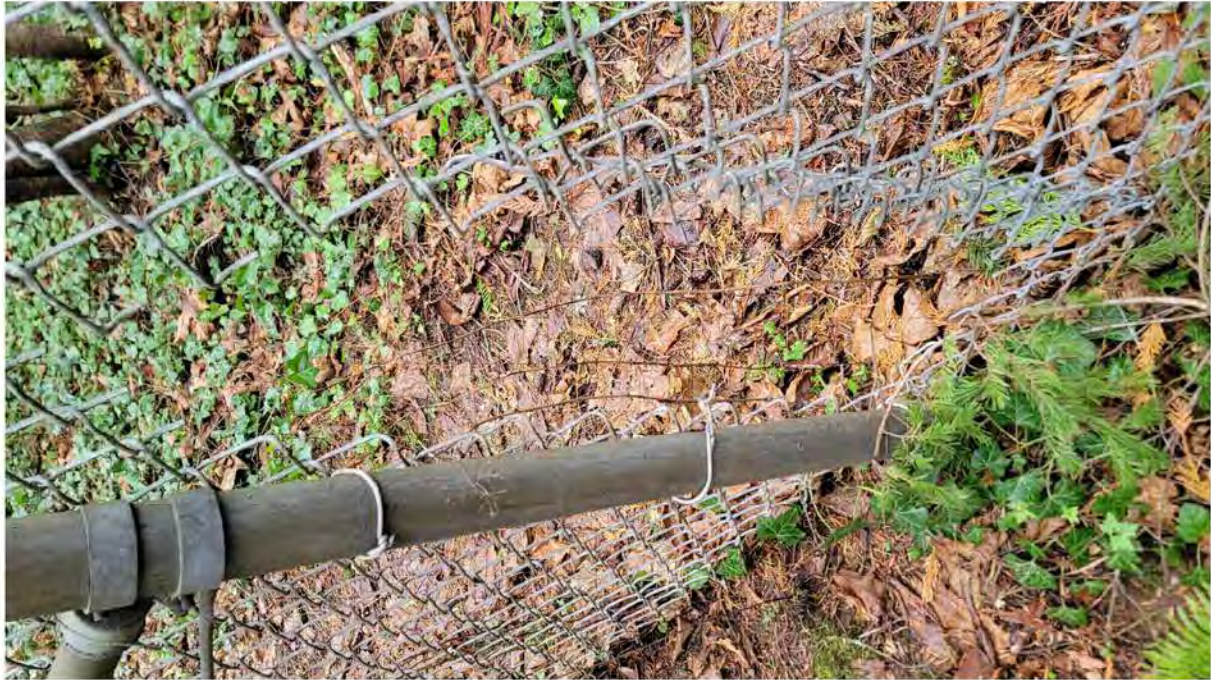
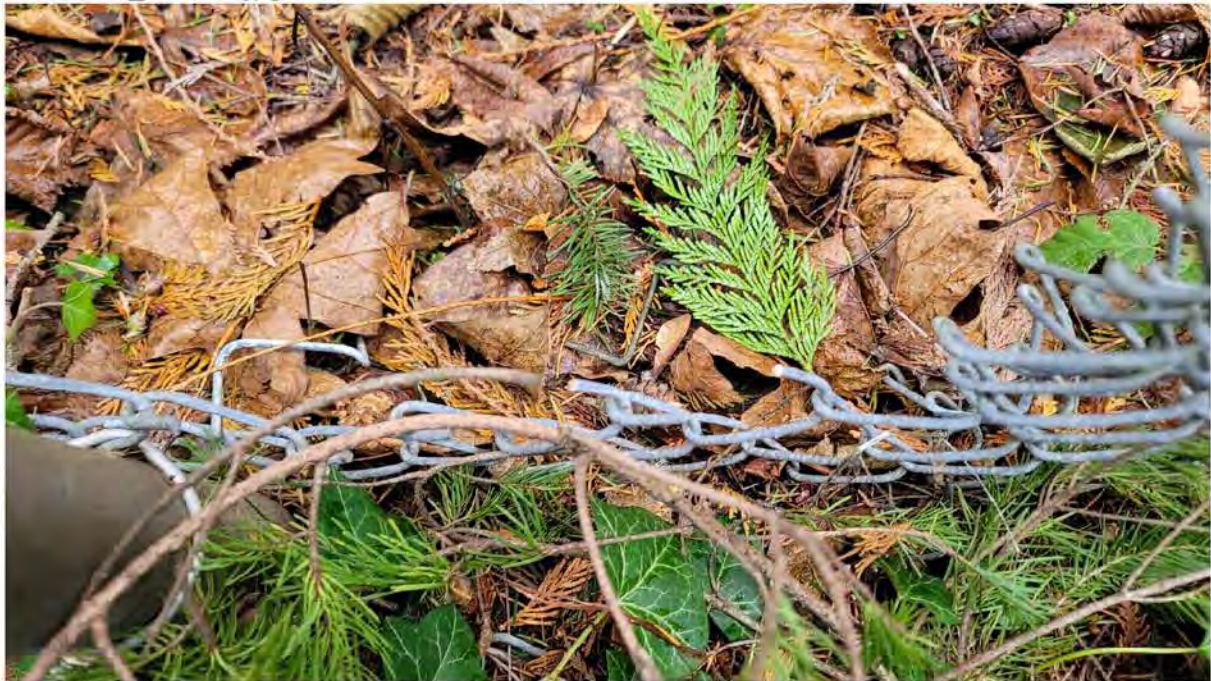
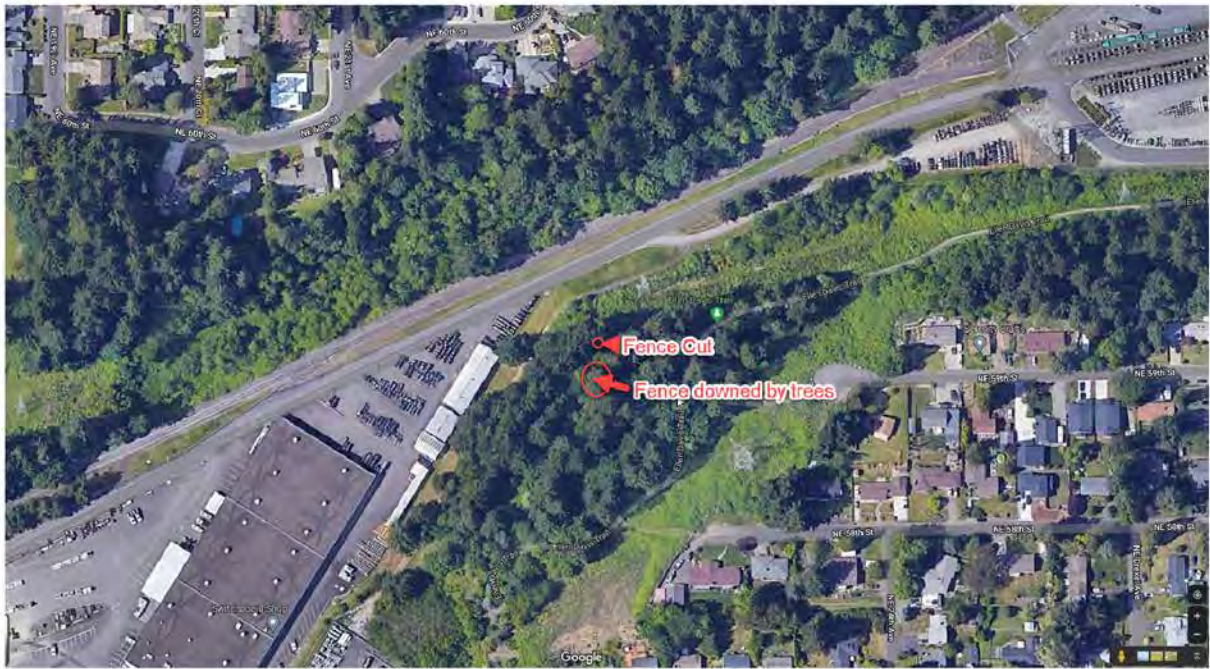
On Thursday, January 5th, 2023 I, Security Lieutenant (Lt.), (b)(6) was on duty as the Ross Security Supervisor at Bonneville Power Administration's Ross Complex, located at 5411 NE Hwy 99, Vancouver, WA 98663. At approximately 1005 hours, I received a call from BPA Employee (b)(6) who indicated that he had been contacted by someone walking their dog and the message was relayed that there was a section of fence down near the Ross Investment Recovery Building (IRC). After receiving the call, I drove around the outside of the Ross Complex in that area, but was unable to find any fence damage. I then drove on the interior of the Ross Complex, along the southern fence line. I then hiked up the hill, above the wire spools, east of the Ross Warehouse. I found a section of fence, approximately 500 feet east of the Ross Warehouse where some large tree branches had taken out about 10 feet of fence. After notifying Facilities of the damage, there was an additional section of fence, approximately 30 feet north that was found to be damaged. This section, which had a vertical cut approximately 4 feet high looked like it had been intentionally cut. When the cut was found, there was about a 6 inch horizontal gap running along the 4 foot vertical length. The way the chain link fencing was cut, it was able to be slid open to increase the horizontal gap to approximately 18 inches. BPA Facilities Operations Specialist, (b)(6) as well as representatives from JLL were onsite when I departed the area at approximately 1050 hours and indicated that both sections of fence would be repaired as soon as possible. Pictures have been included for reference.

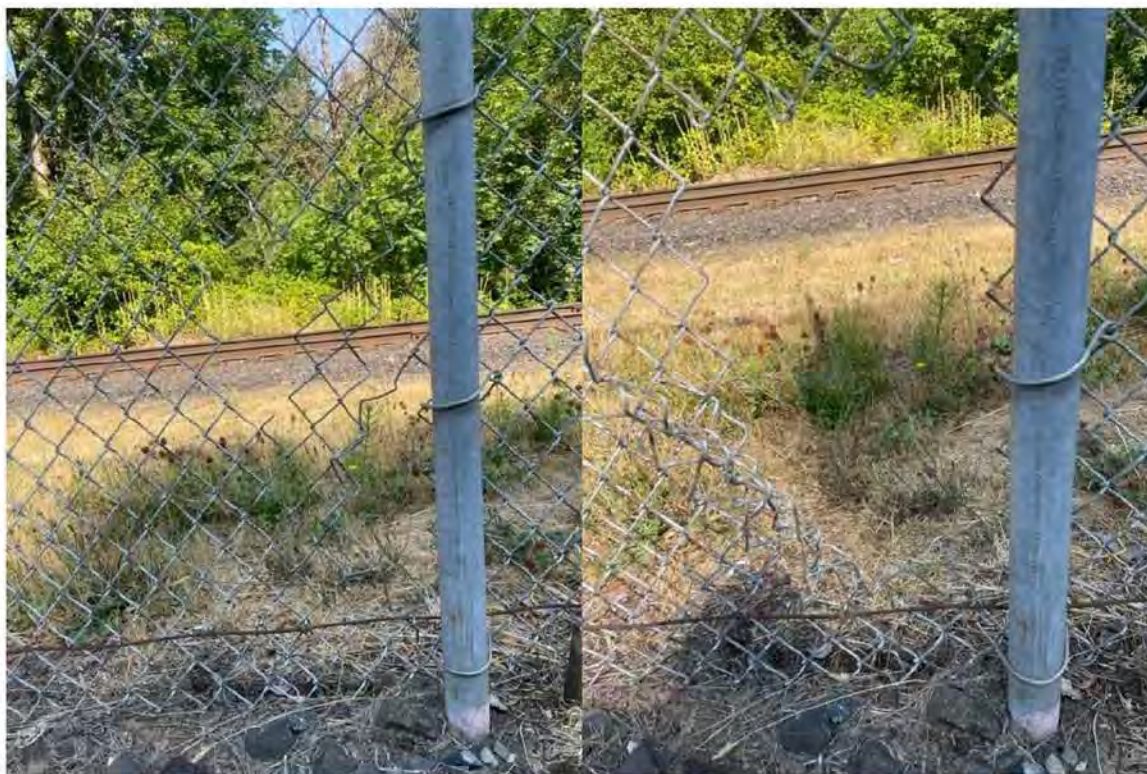
At approximately 1118 hours while on patrol, I was driving east on Ross Canyon Road, inspecting the fence line as I went when I noticed a hole in the fence. The hole was located in the north fence, northeast of the warehouse and directly across from the spools of wire. I immediately stopped and went to inspect it. I notified Lt (b)(6) at 1119hrs. The hole was partially closed as if somebody had tried to restitch the chain link together to hide the hole. Lt. (b)(6) arrived at the location at 1123, and we inspected the surrounding area and fence-line, as well as the wire spools. Nothing else appeared to be tampered with and there was no sign of theft from the spools. After photographing the hole, I returned to the AMS to end my shift. Lt. (b)(6) advised that the hole was chained shut and that PSDO (b)(6) was notified.

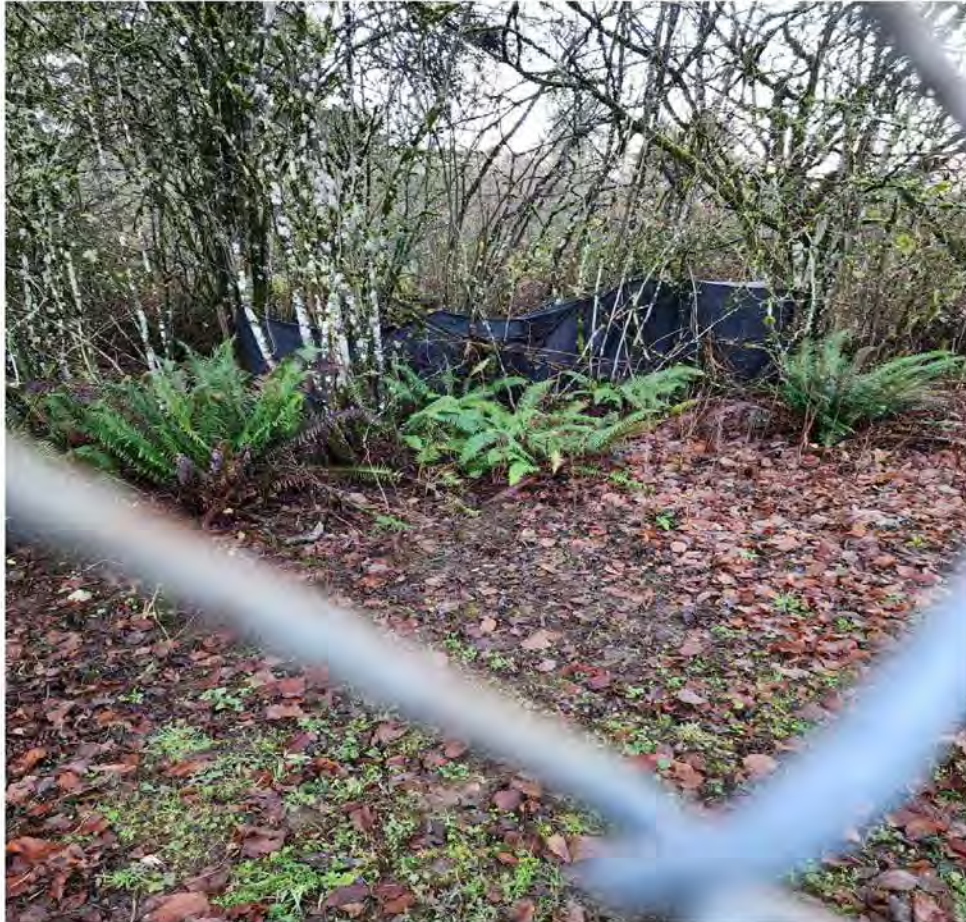
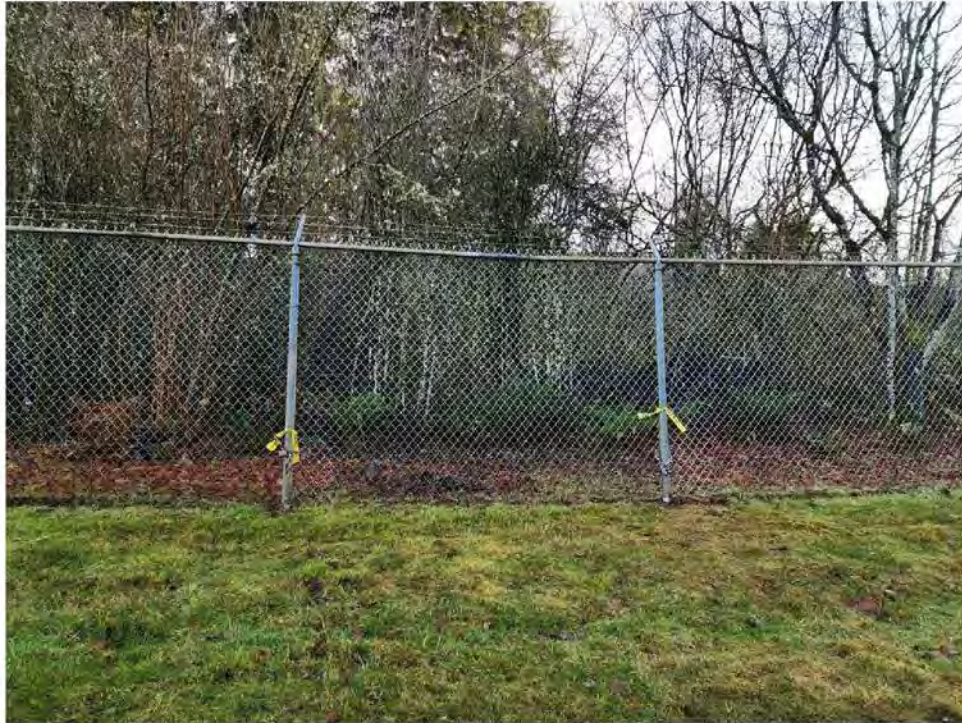
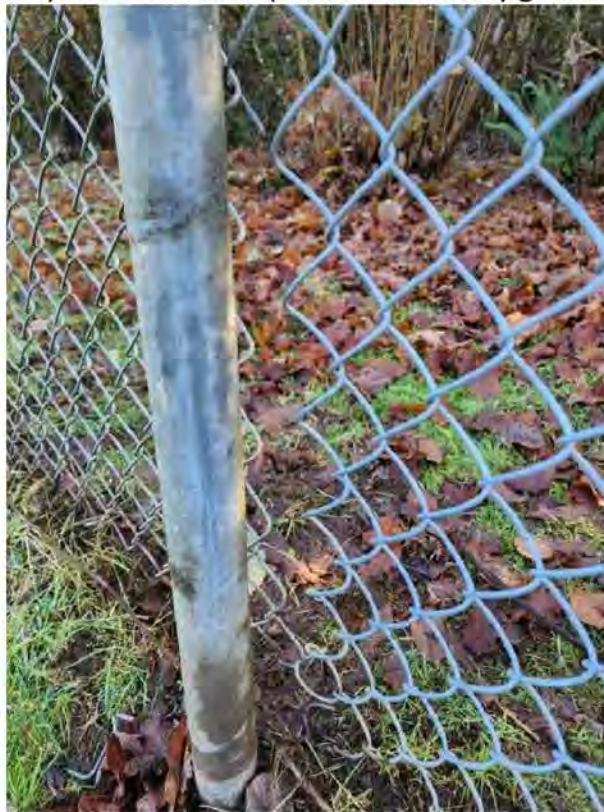
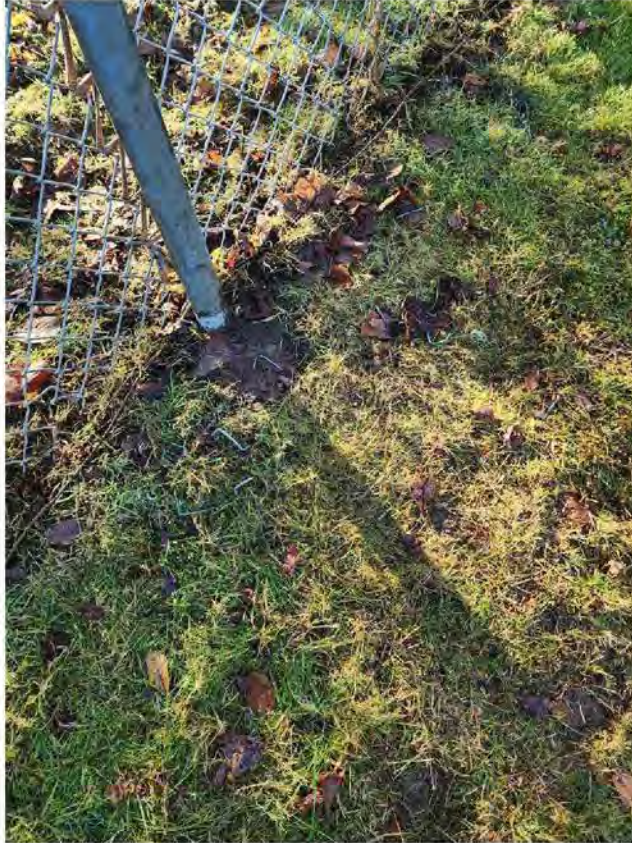
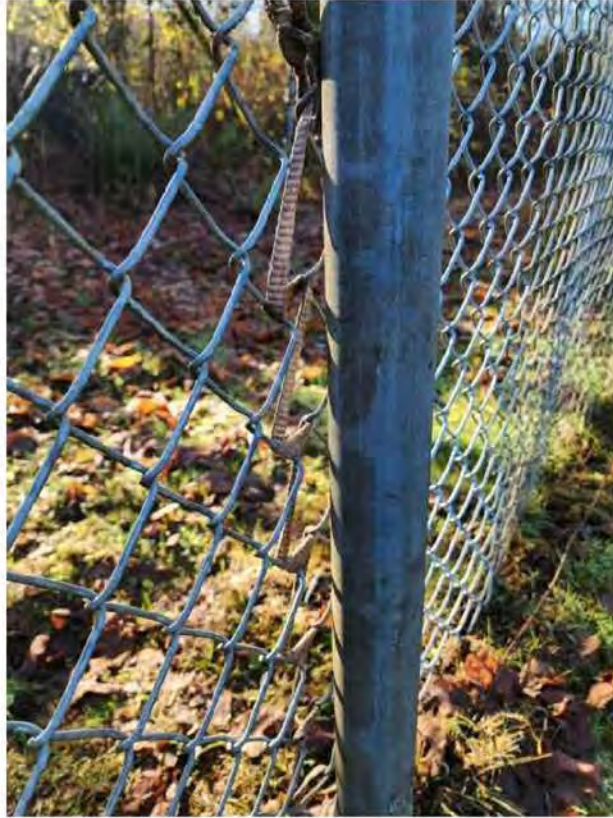
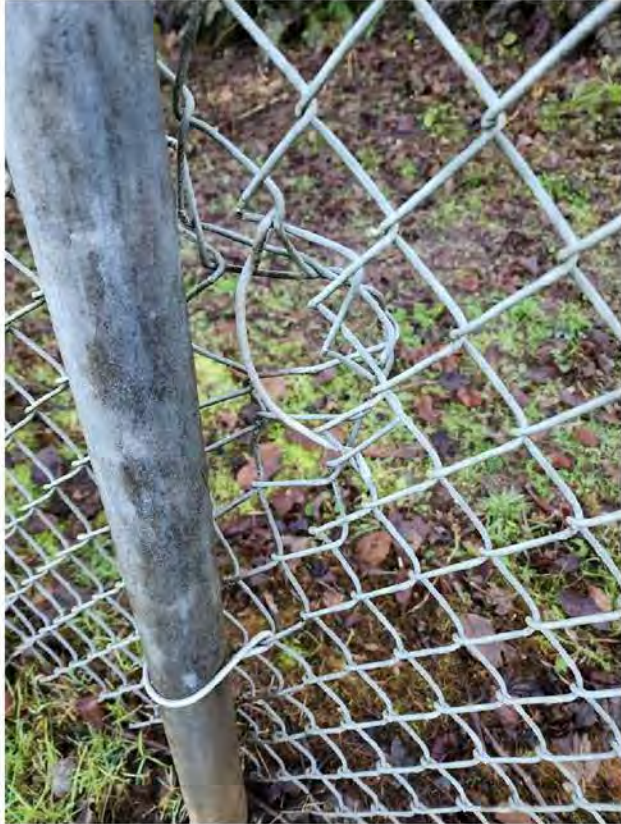
call from BPA employee (b)(6) He reported 2 cuts in the fence line that is Southwest of Gate 27. (b)(6) said there is a homeless camp near the fence line. I notified S/O (b)(6) and he responded to the location. I called and notified (b)(6) of JLL Facilities. I called the JLL emergency hotline and was given work order # BPA-Z-61000898. At approximately 1327 hours, S/O (b)(6) reported the holes were chained up and he was clear of the area.

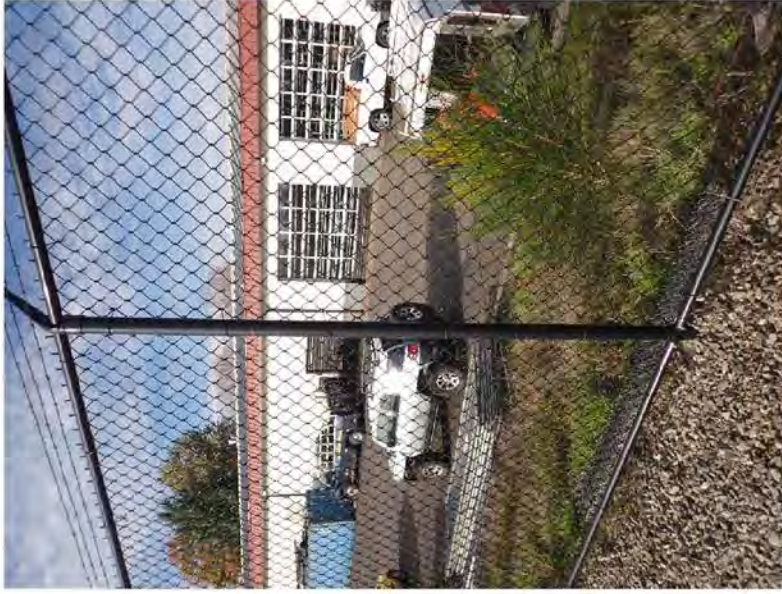
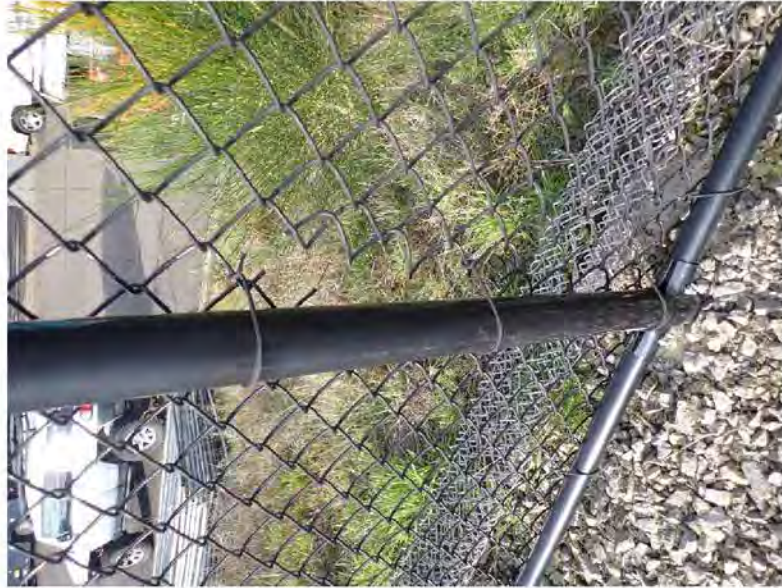
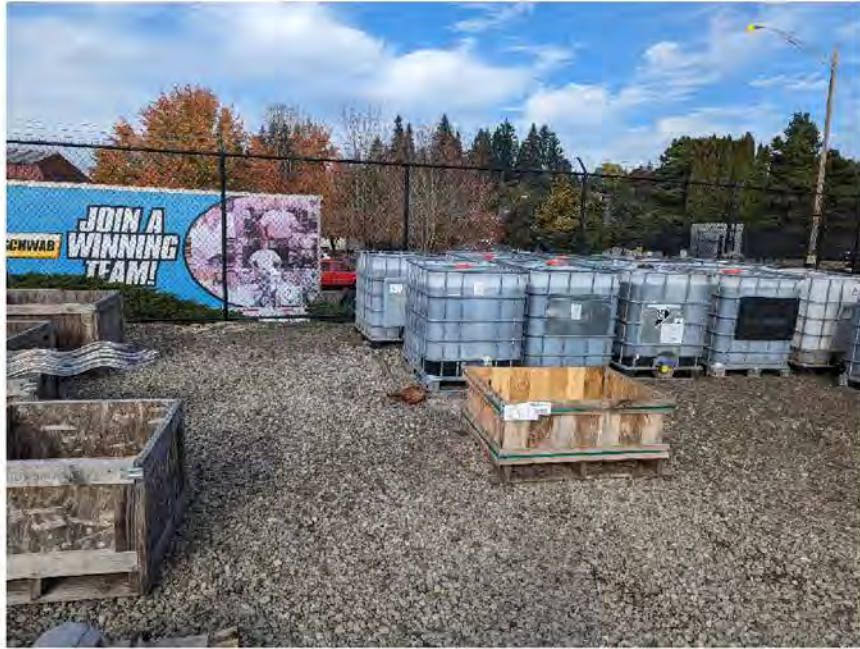
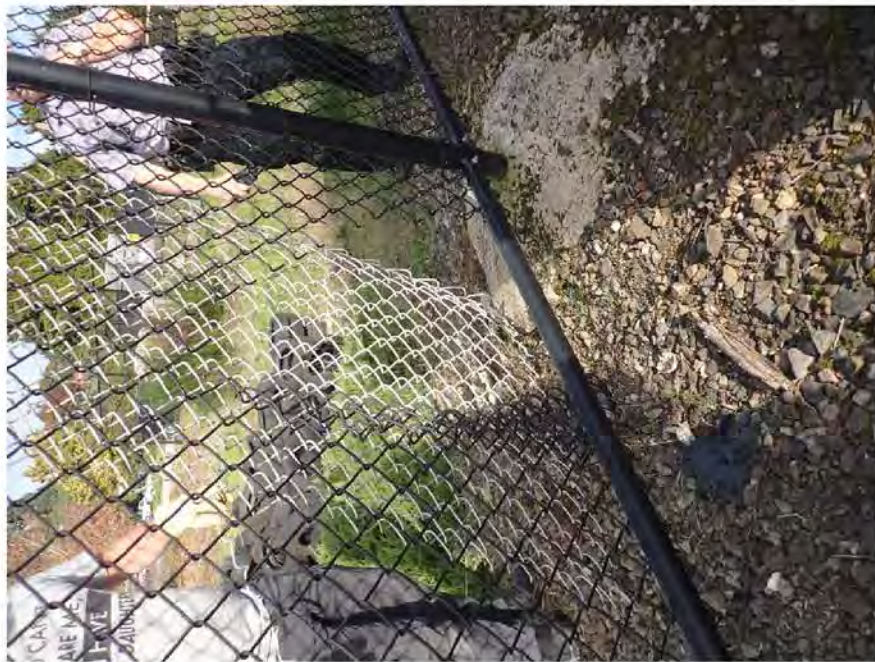
While performing a patrol of the area I observed a smaller hole cut just to the west of the larger one, but much smaller in size. I continued to patrol NW storage and didn't find any other signs of damage to the fence or BPA property. I proceeded to take photos of the damage and then departed the area.
