## Department of Energy

FREEDOM OF INFORMATION ACT/PRIVACY PROGRAM

In reply refer to: FOIA #BPA-2024-02248-F

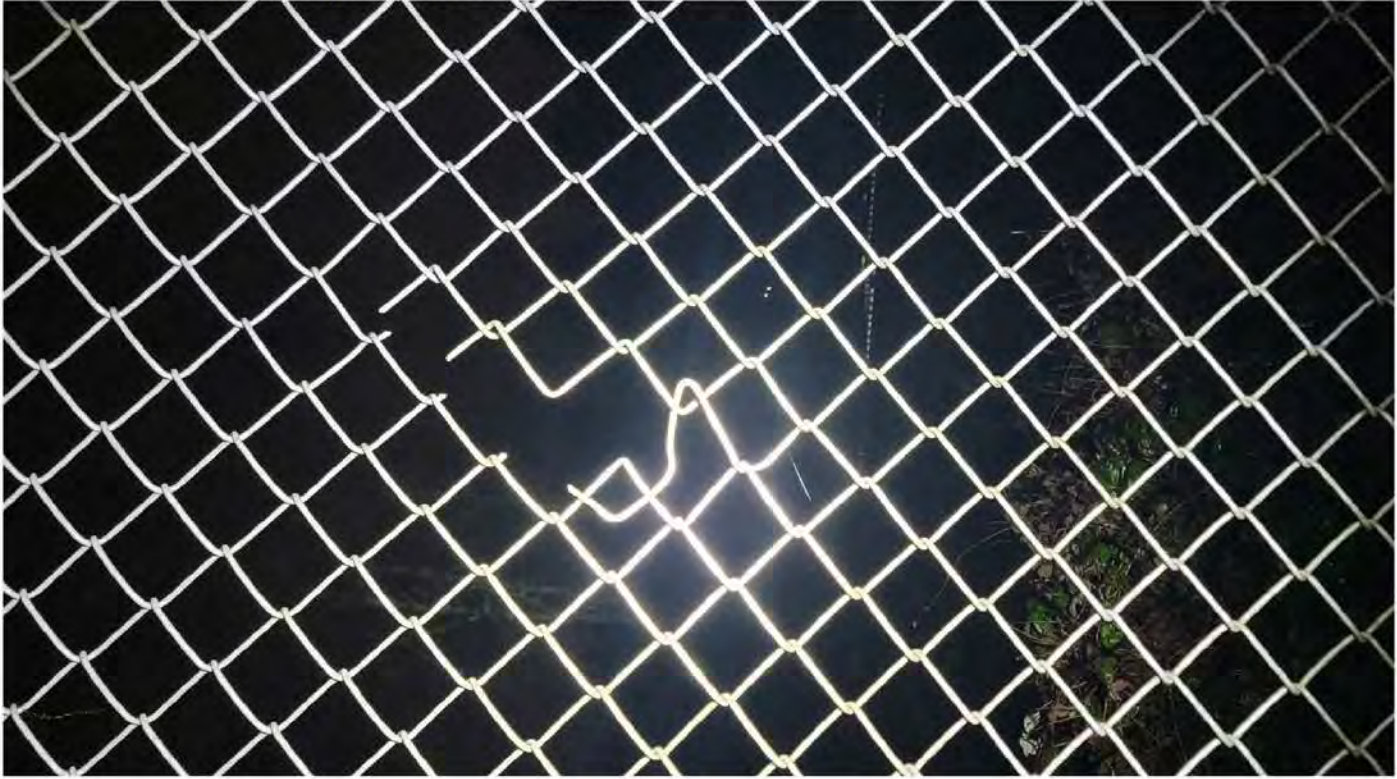
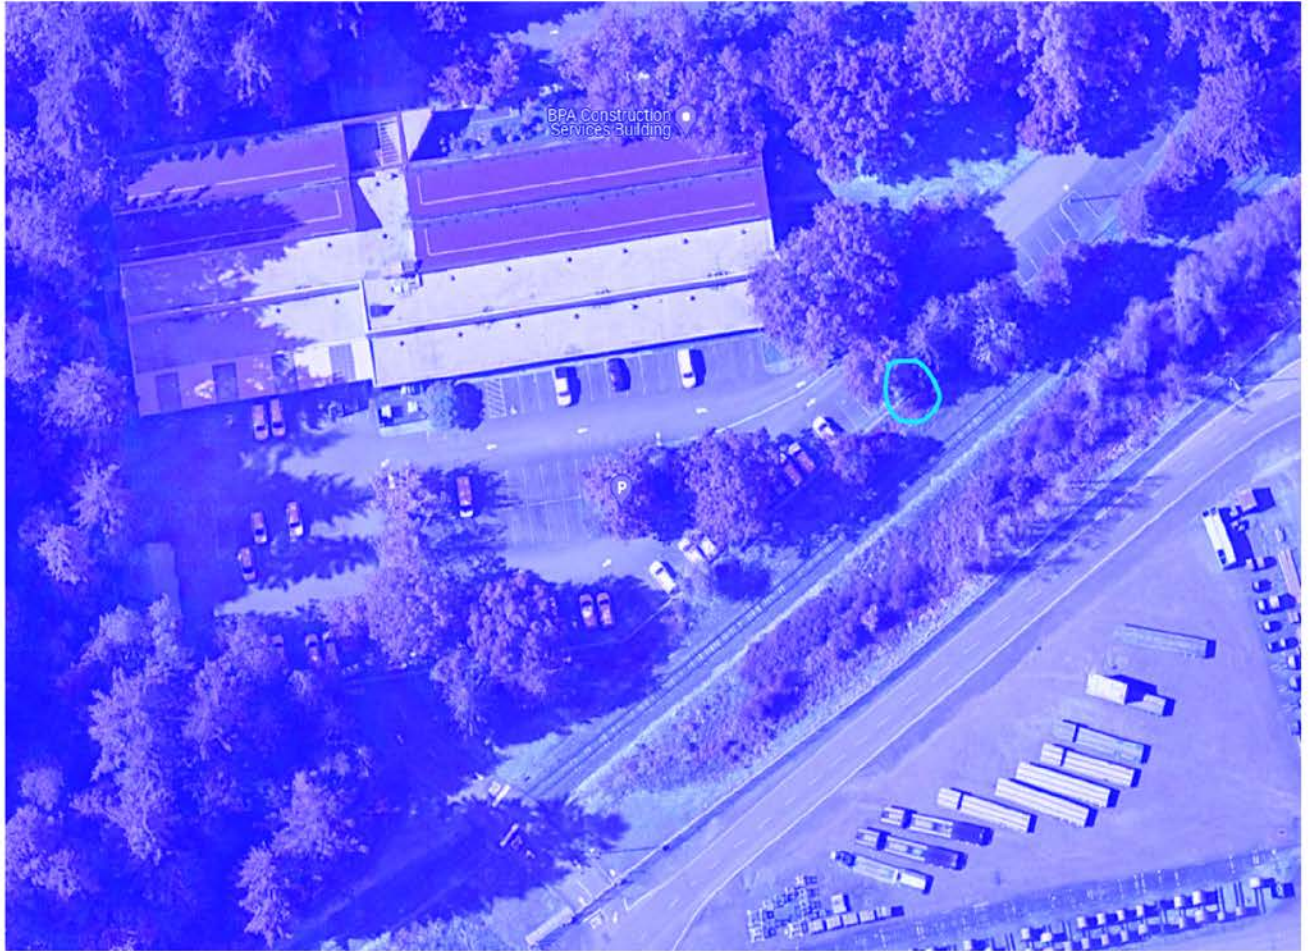
At approximately 0625 hours, I conducted a perimeter security patrol of the back parking lot of the CSB and noticed that the fencing near Gate 28 had been tampered with. There were three visible cuts to the fencing 1/3 from the top going down. I checked the immediate surrounding area for further damage to the perimeter fence or government vehicles and no other damage was found. I continued the rest of the patrol and found no other damage. At 0635 hours I reported the found damage to AMS and the on-shift supervisor for further guidance. At approximately 0725 hours Patrol S/O (b)(6) 5-3) came on Post to assist with marking the damage area of the fence. No further action was taken.

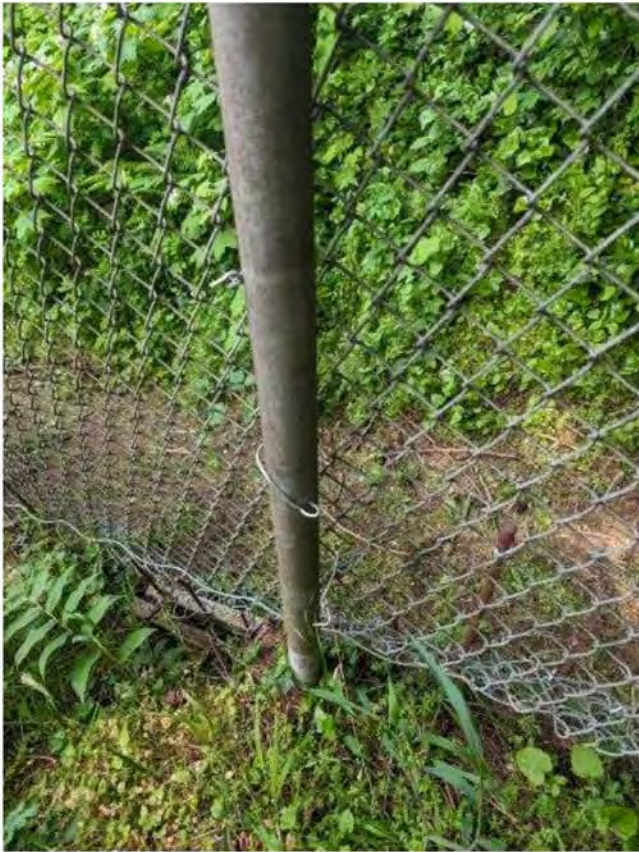
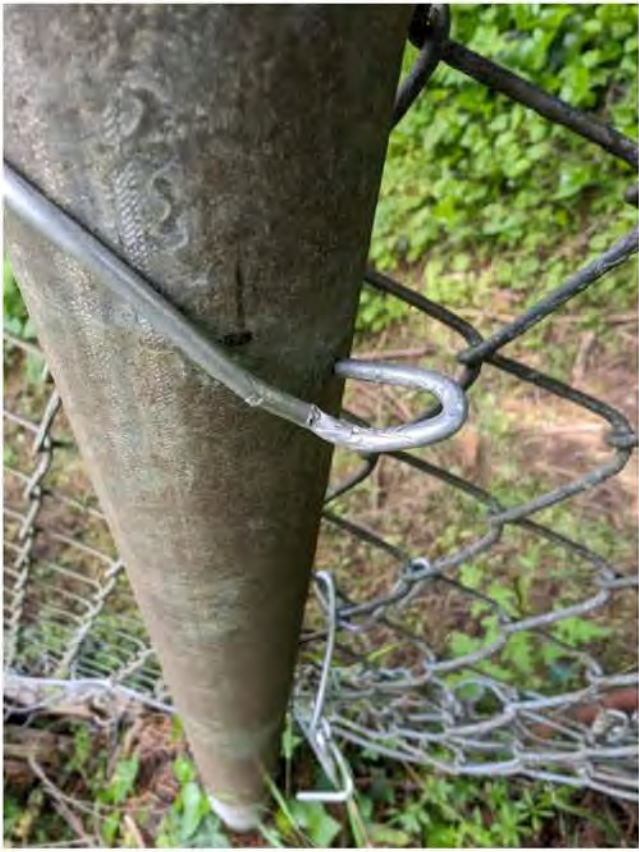
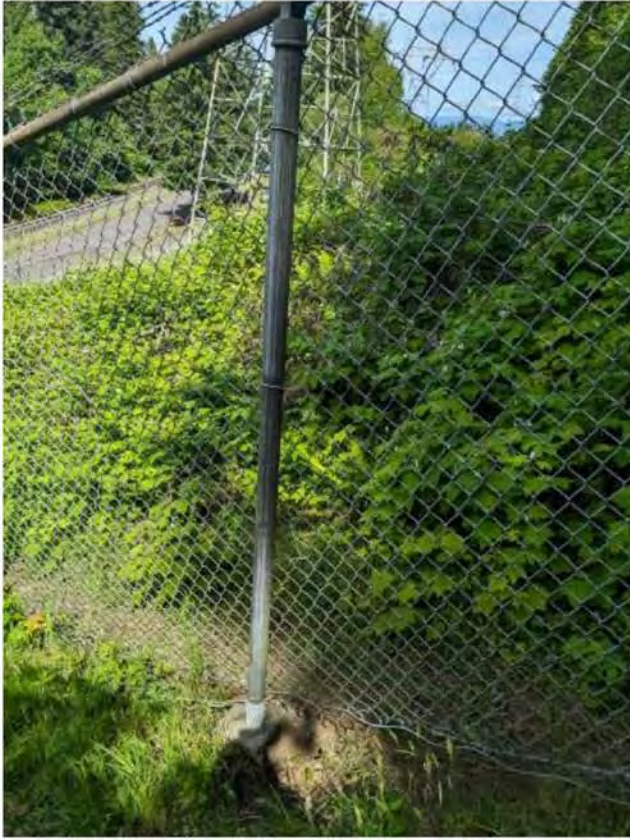
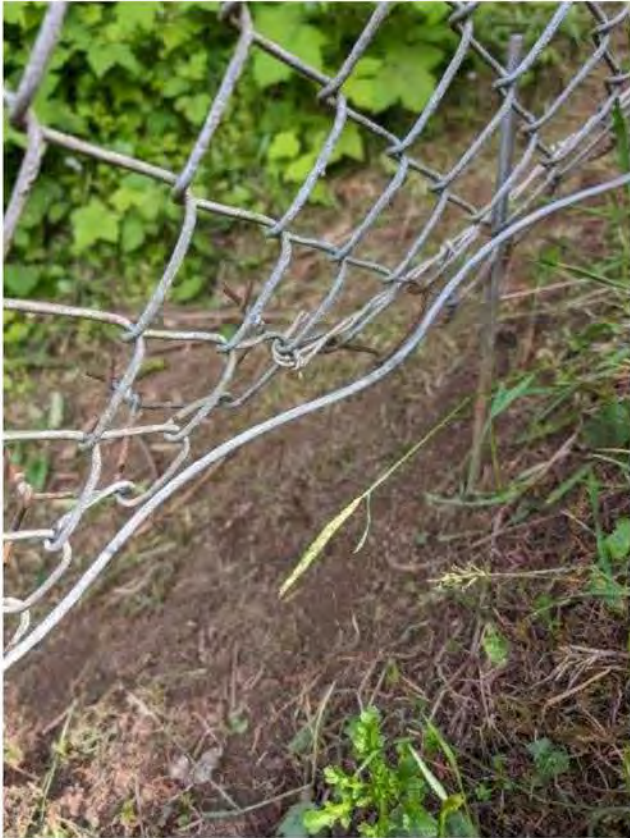
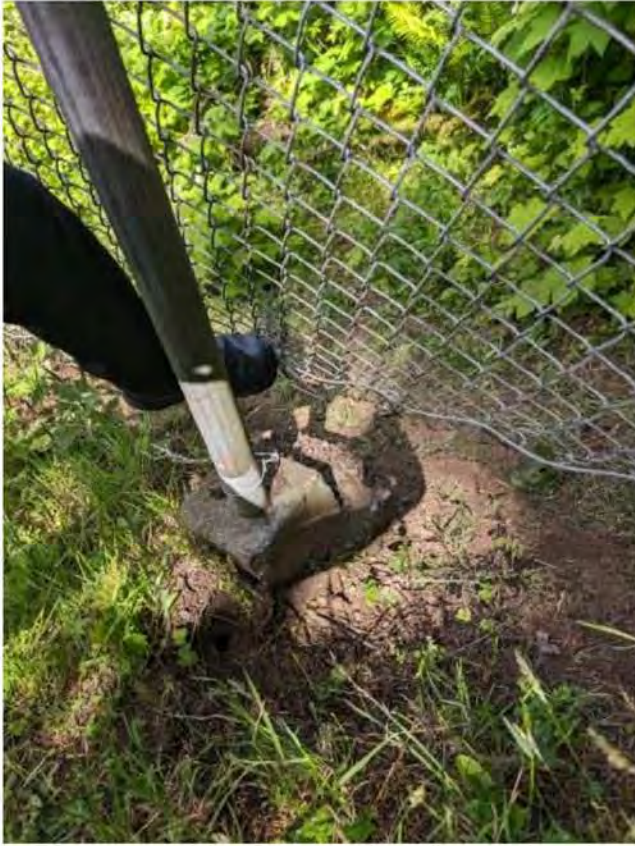
As I walked down the fence-line towards the warehouse wire spools and Flammable Storage (Z-814) I found what appeared to be a hole animals could get through going under the fence line but was not big enough for people. Upon further investigation I observed the fence ties for that location had also been removed and the fence could easily be pulled back and crawled under. The barbed wire that ran at the bottom of the fence had been cut and bent backwards on both sides. I proceeded to document the incident and reported the new findings to Lt. (b)(6). After completing a walkthrough of the area, I resumed my patrol duties.
