Project Title: Main Unit 2 Blade Sleeve Upgrade and Rehabilitation

Dam and Reservoir Project: Lower Granite

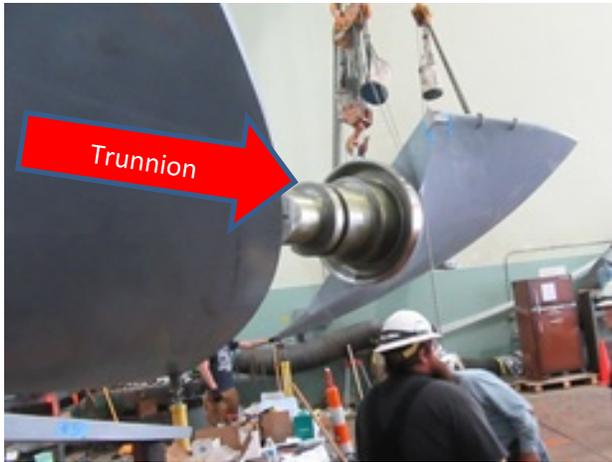
Photo 1–Removal of Turbine Blade

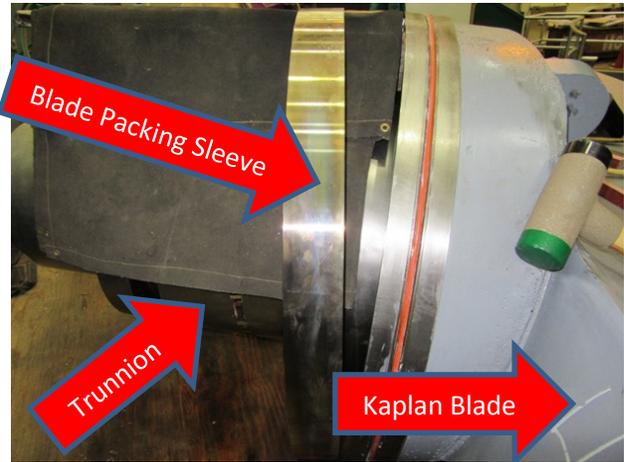
Photo 2–Turbine Blade Close Up
Blade Packing Sleeve Removed

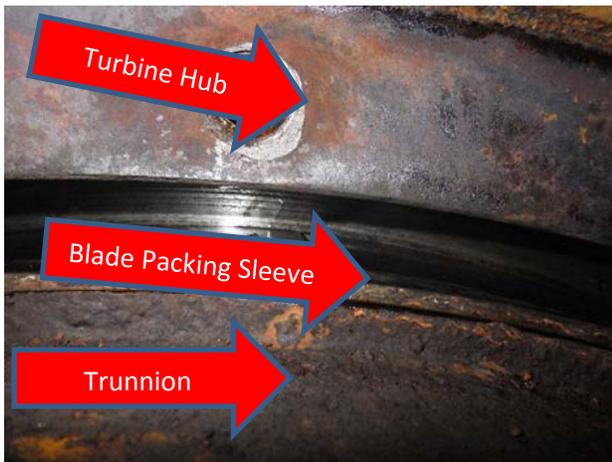
Lower Granite Unit 2 blade sleeves were installed in 2006. A blade sleeve failed in 2016 and an interim repair was completed in April 2017 utilizing a combination of a custom designed rubber seal and filling in the wear ring groove on the blade trunnion with epoxy. This repair required that the unit no longer operate as a fully-adjustable Kaplan unit, but rather as a fixed-position blade unit due to the absence of the wear sleeve. A similar interim repair to that completed at Lower Granite Unit 2 was previously performed at John Day dam and reservoir project on Unit 6 and at Cordell Hull dam (a Corps dam in Tennessee) on Unit 1. The repair on John Day Unit 6 failed after about 12 months. The Cordell Hull repair improved upon the approach utilized at John Day and so far has lasted for about 24 months. These lessons learned were incorporated into the Lower Granite Unit 2 interim repair. Despite this improvement, an expedited permanent upgrade is prudent for Lower Granite Unit 2 to minimize the risk of a future failure and achieve fully-adjustable Kaplan capability to operate efficiently across differing flow levels.

Photo 3– Unit #2 Failed Blade Packing Sleeve and
Other Turbine Components

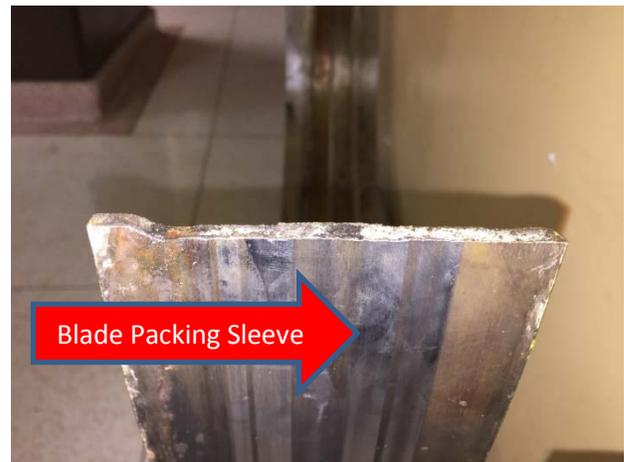
Photo 4 – Extreme Close-up of Blade Packing
Sleeve after Removal from Unit Shows Fatigue on
Left Side

This project will upgrade the blade sleeves on Unit 2 for Lower Granite utilizing a similar approach to that used to address Lower Granite Unit 1's blade sleeves. For Unit 1, the blade sleeves were fabricated out of 17-4 PH SS, instead of 410 SS. The 17-4 PH SS is not prone to stress corrosion cracking (SCC) and has very good wear resistance.
