Summary Background Document for New Capital and Non-Routine Expense Hydropower Project

Project Title: Main Units 1-6 Discharge Ring Upgrade and Turbine Blade Cavitation Repair

Dam and Reservoir Project: Little Goose Lock and Dam

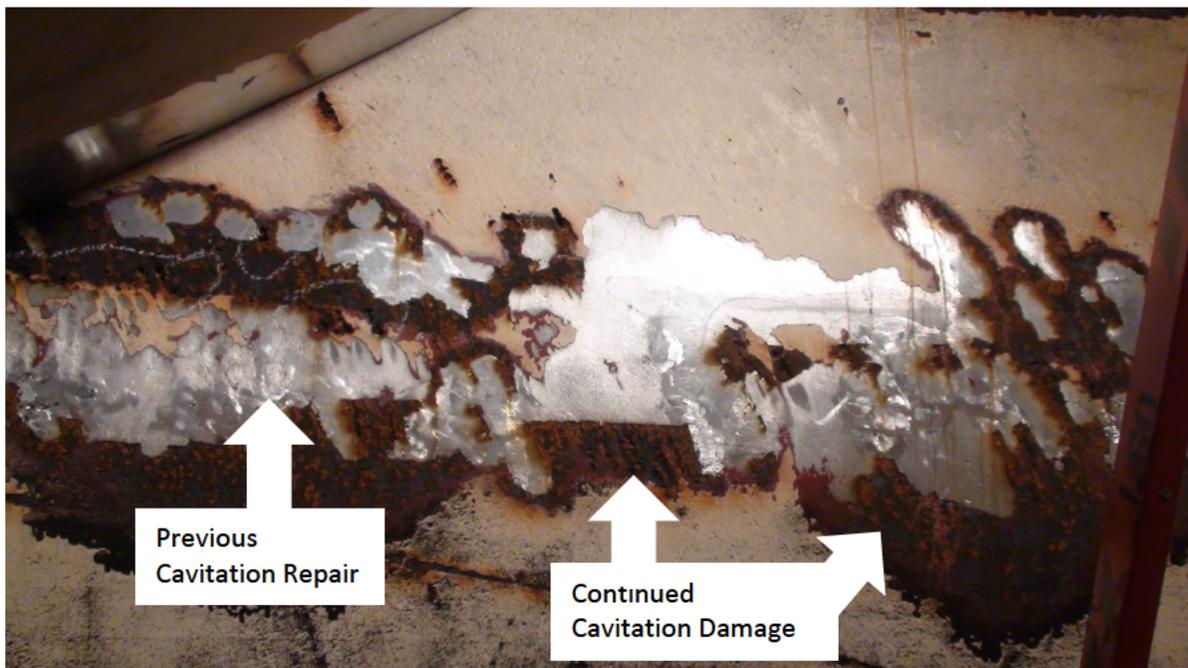
There is extensive erosion damage to the discharge ring and turbine blades on all the main units (MUs) at Little Goose dam and reservoir project (project), due to cavitation (see Pictures 1 through 7). Cavitation erosion damage occurs during sudden pressure drops when liquid is changed to water vapor or bubbles. Cavitation generally occurs on the discharge ring at the level of operation of the end of turbine blades and underside of turbine blades. The discharge ring is defined as the area just below the wicket gates and walls opposite of the turbine blades. There have been several attempts to repair the cavitation damage during annual and overhaul unit outages by project staff; however, the extent of the cavitation damage has increased dramatically and requires additional funding and resources to make the repairs. At the completion of the cavitation work, while the MUs are unwatered, the Kaplan blade seals will be replaced with new seals to reduce the risk of oil loss to the river.

Picture 1: Typical Discharge Ring Damage and Repair
Previous Cavitation Repair with Stainless Steel Overlay:
Observed New or Continued Cavitation near Repaired Areas.

(Recommended): This alternative would upgrade the discharge rings, by installing the stainless steel liner, restore the turbine blades to original dimensions for optimum operations, and replace the turbine blade seals.

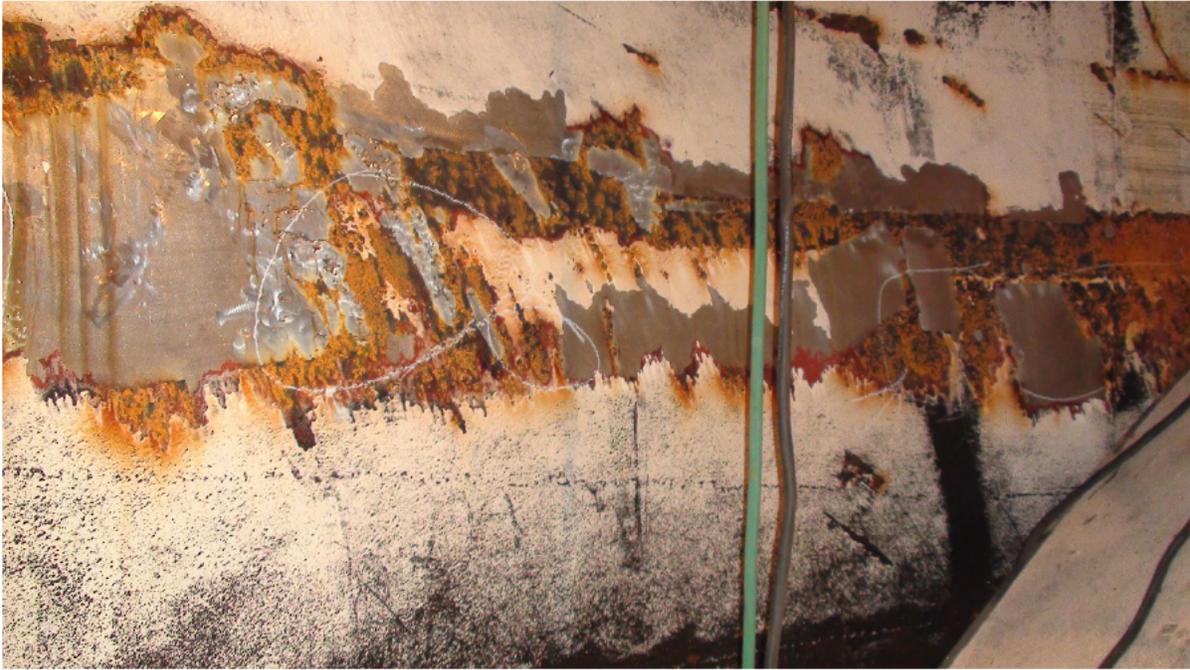
Picture 2: Typical Cavitation Damage on Discharge Ring and Previous Repairs:
Observed New or Continued Cavitation near Repaired Areas.

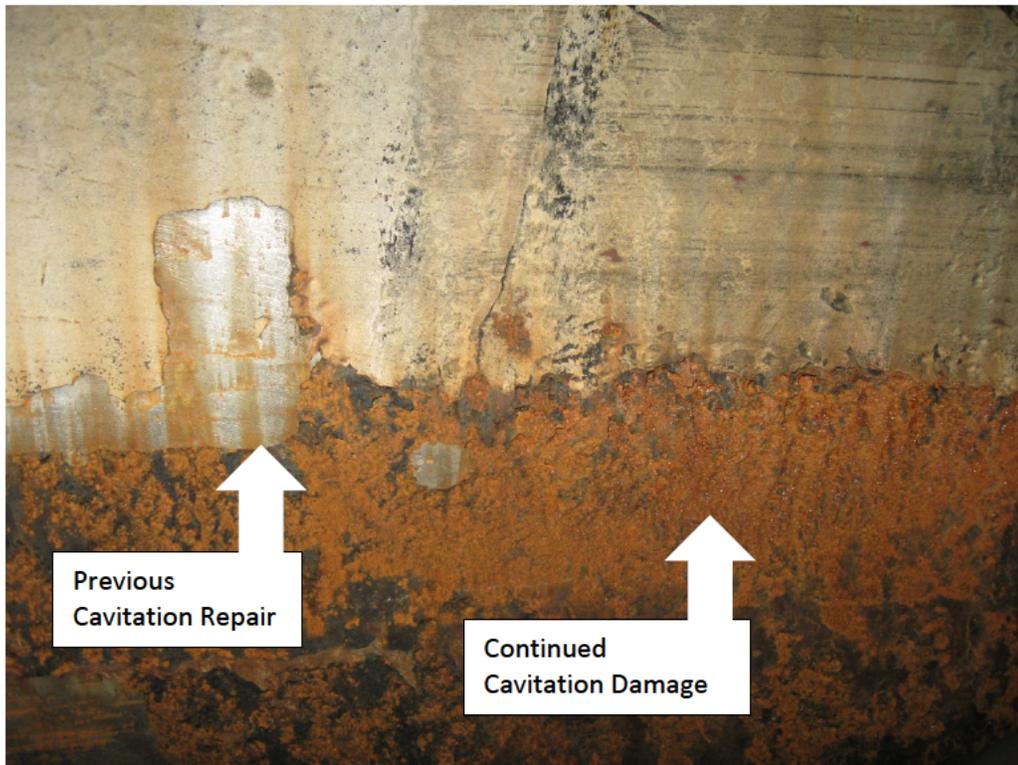
Picture 3: Close Up View of Discharge Ring:
Previous Repairs and Continued Cavitation Damage

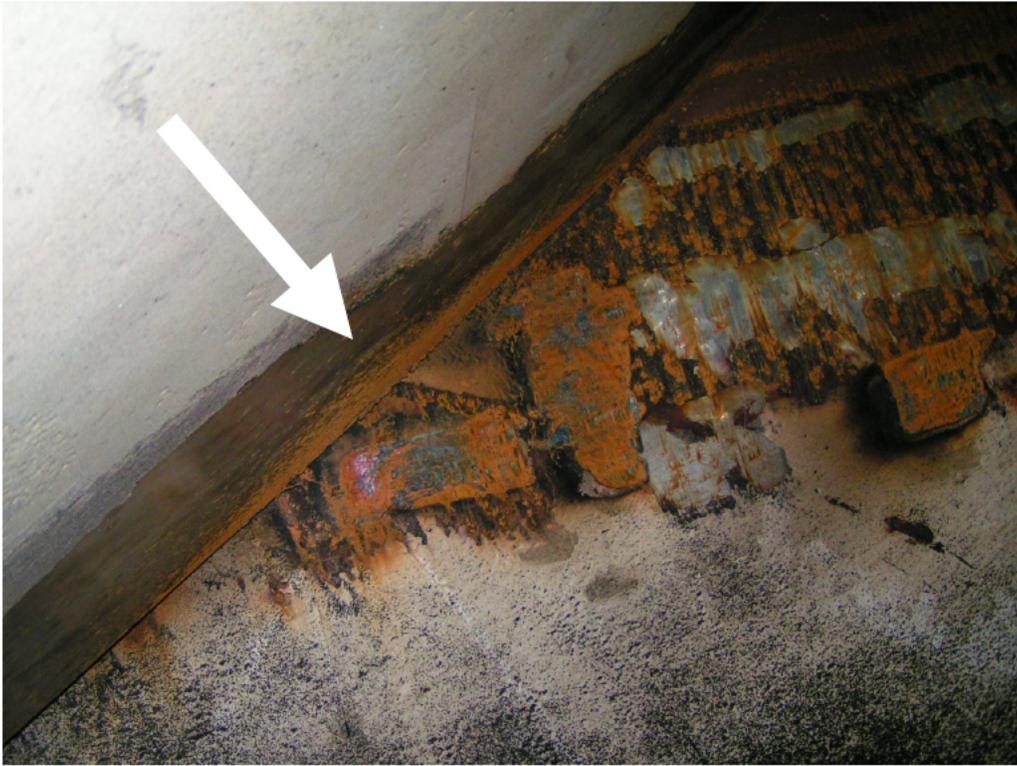
Picture 4: Typical Turbine Blade Cavitation Damage at Blade End

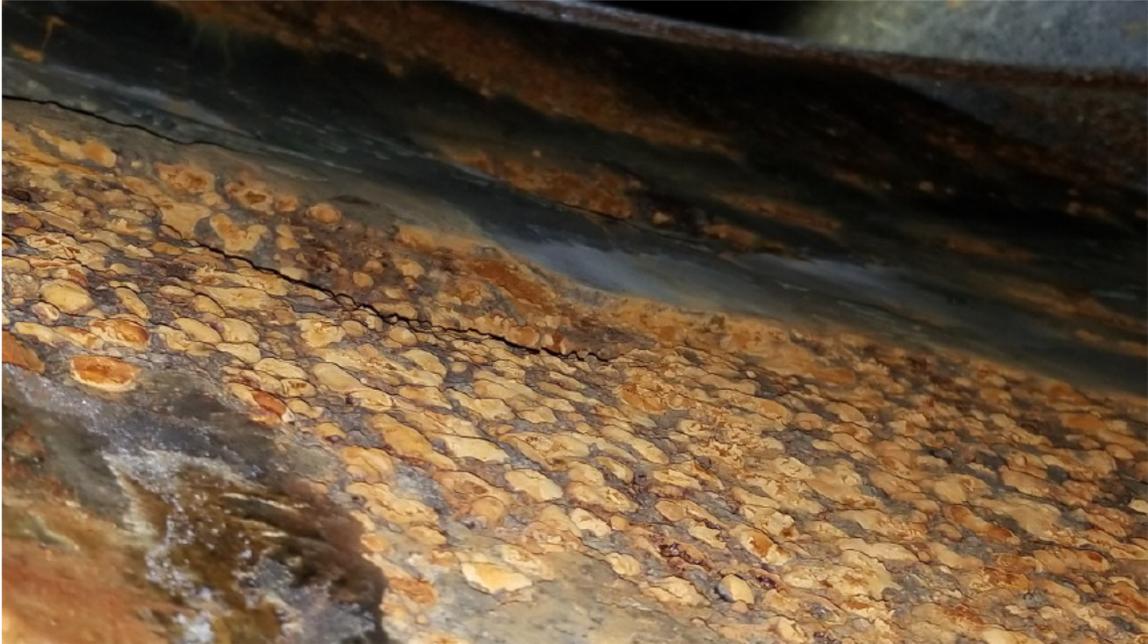
Picture 5: Typical Cavitation Damage – Pitting and Corrosion Close Up

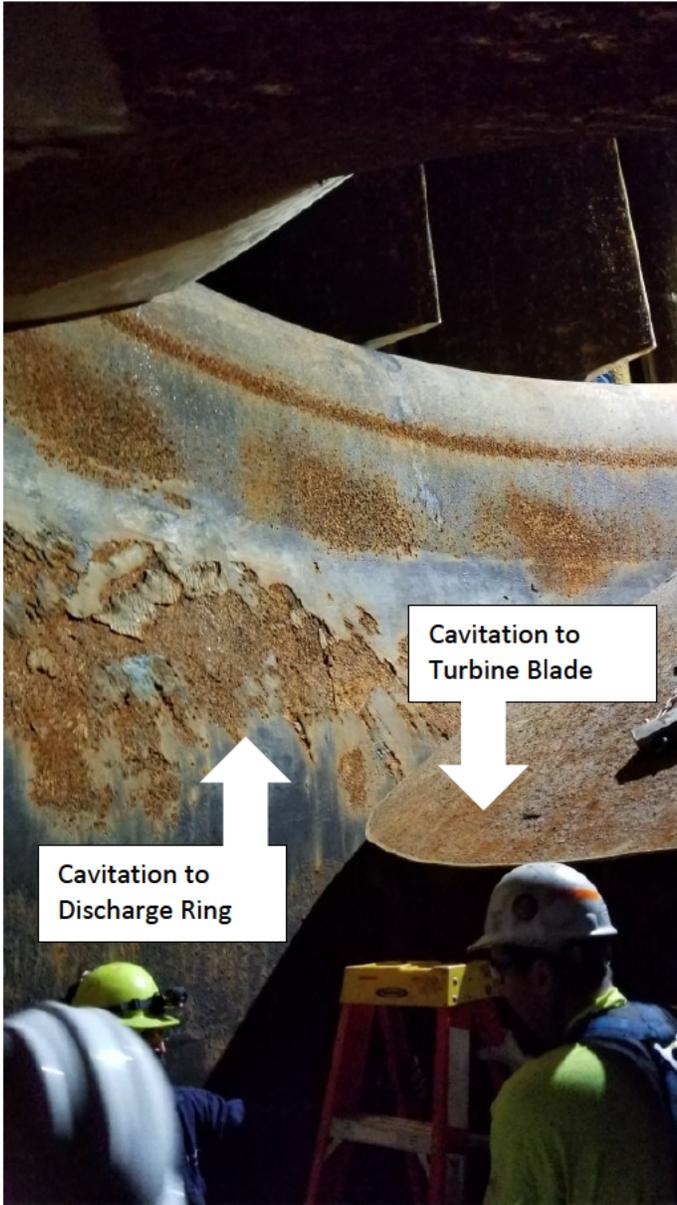
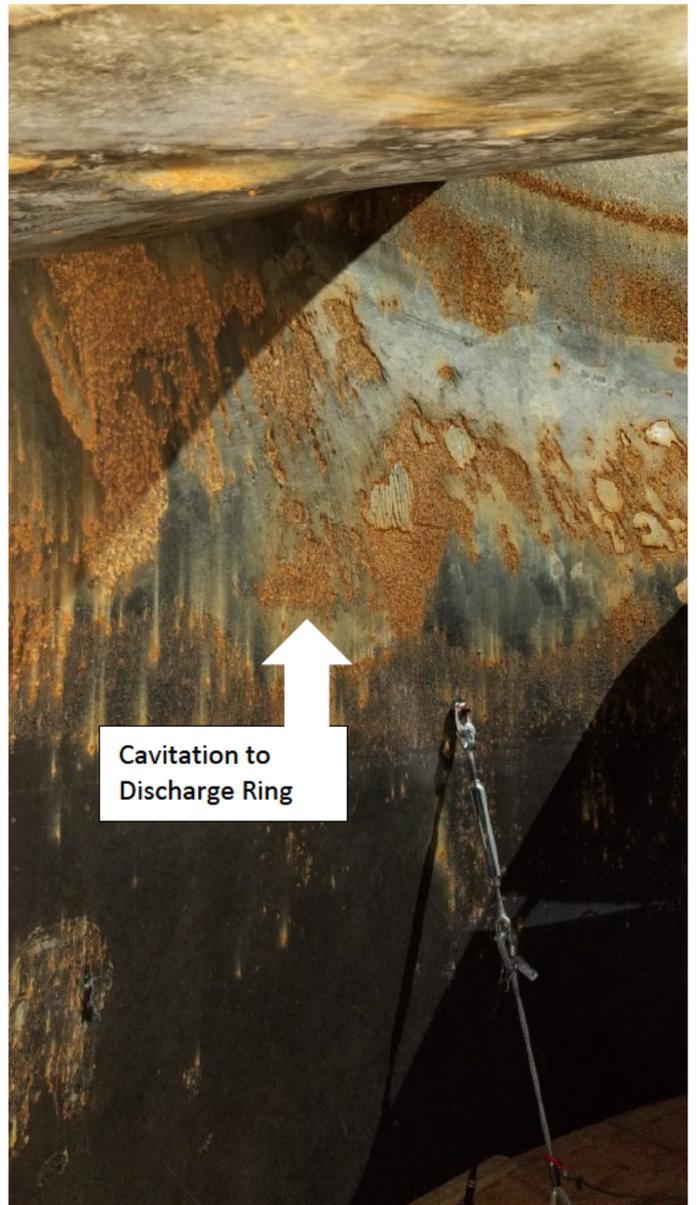
Pictures 6 & 7: Typical Discharge Ring and Blade Damage
