Sayano-Shushenkaya Hydro Power Project

Pat Regan

- On August 17, 2009 the Sayano-Shushenkaya Power Plant in Siberia suffered a catastrophic failure in a turbine-generator unit
- 75 people lost their lives in the accident

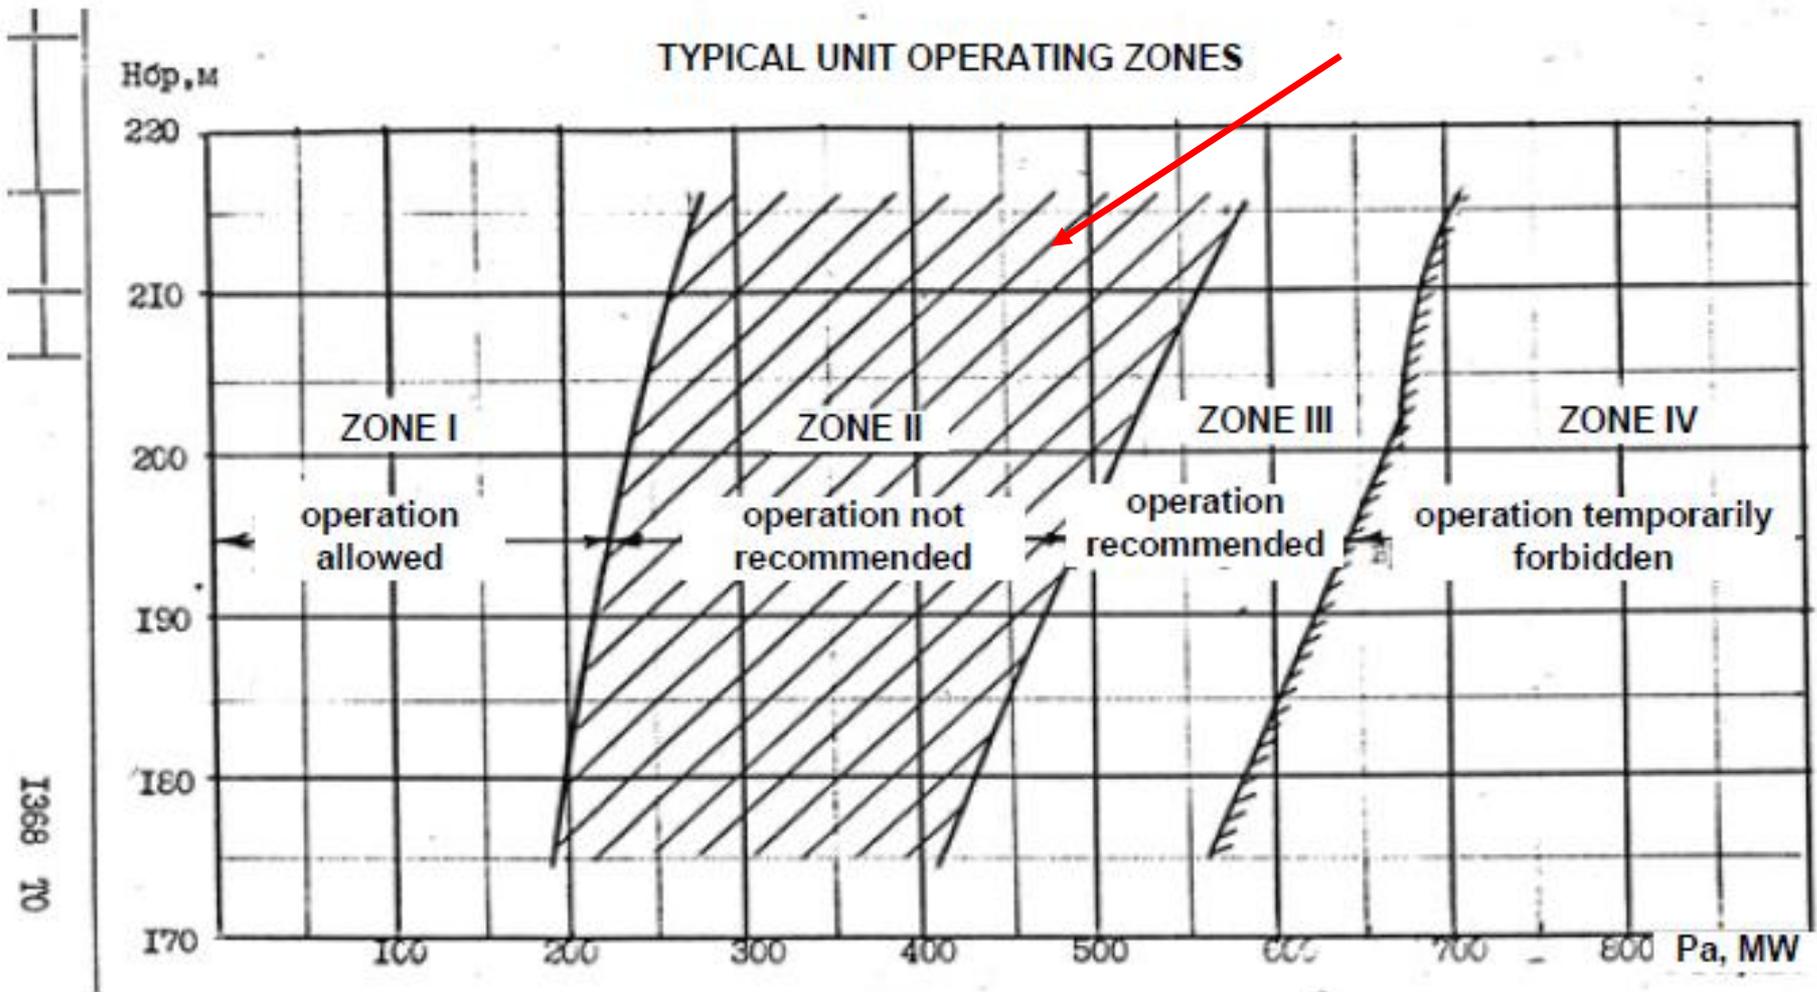
Fig. 4.5.1. Performance Parameters of a Hydroelectric Unit with a RO230/833-V-677 Turbine

- Full scale tests by the turbine manufacturer identified zones of head-flow combinations that produce excessive vibrations
 - “Zone II – Under the runner there is a powerful central whirl with a rotation frequency of 0.4-0.8 Hz. This frequency determines the frequency of turbine bearing vertical vibration, axial force, and pressure fluctuations in all points of the turbine’s flow duct (except from fluctuations under the turbine cover, where along with whirl frequency other determinant frequencies are 4.76 and 200-300 Hz.”

- “Operation of the turbine is coincident with strong hydraulic shocks in the flow area and loud noises.”
- “The amplitudes of pressure fluctuations in the scroll case and draft tube reach 15-22 m of water column, and under the turbine cover – 36 m water column, vertical vibration of the turbine bearing 230 micro-meter, generator power oscillations 18-20 MW, axial force fluctuations – 150 ton-force”

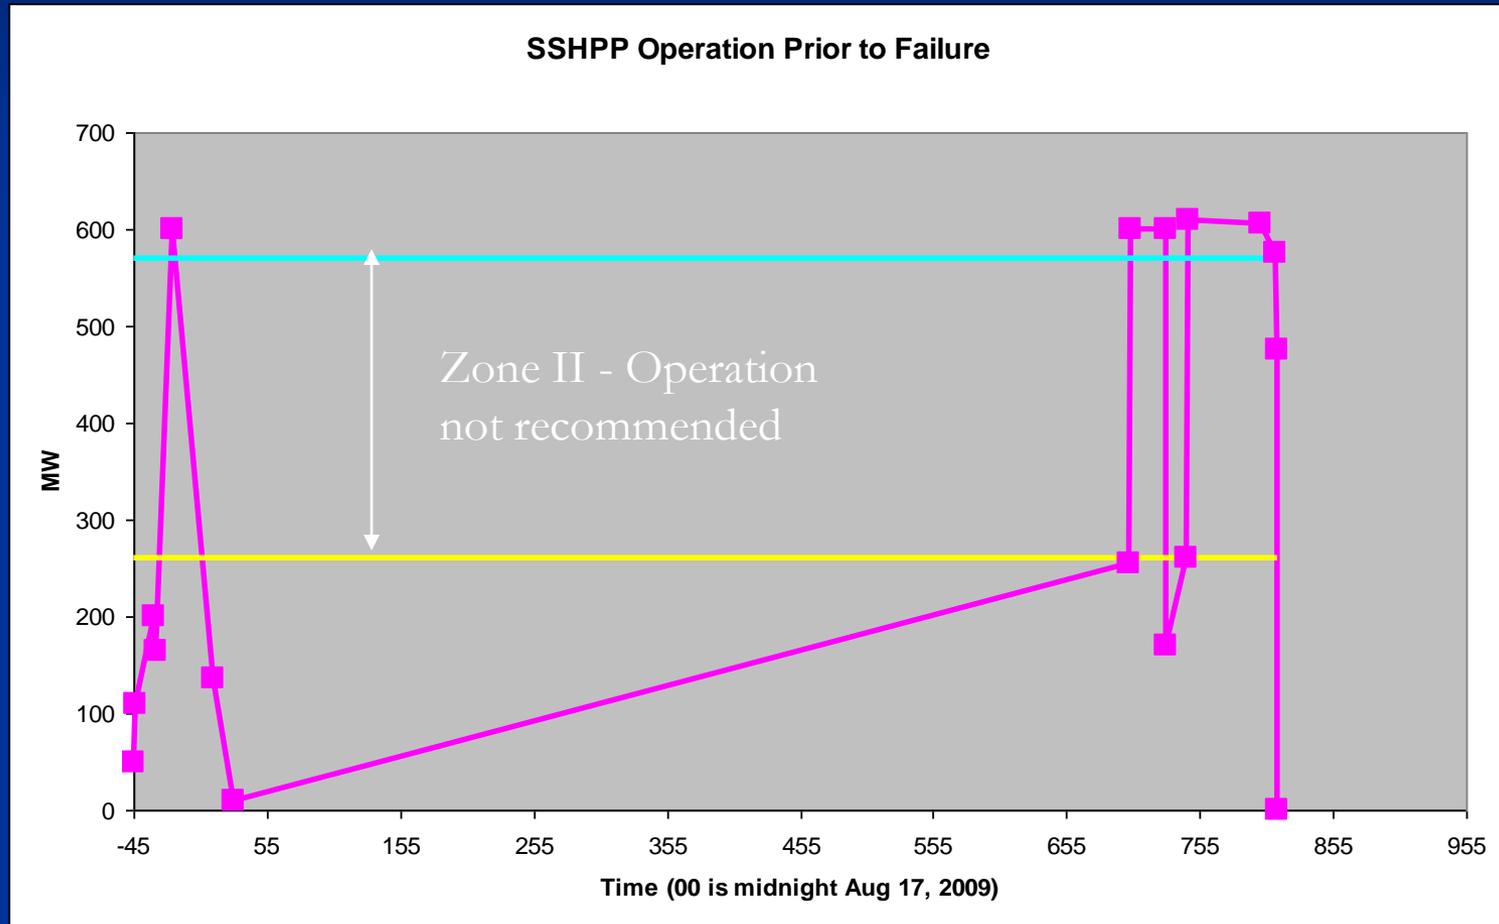
Date/Time	Power Output	Vibration amplitude of turbine bearing	Pressure under Head Cover (kgf/cm ²)
Manufacturer allowable	600 MW	0.160 mm	
2009-03-12 After maint.	601 MW	0.137 mm	
2009-08-17 0800	600 MW	0.200 mm	3.4
2009-08-17 0813	475 MW	0.840 mm	3.5

- Standard Operating Procedures required a unit to be shut down if vibration increased above 0.16 mm. This was not done.

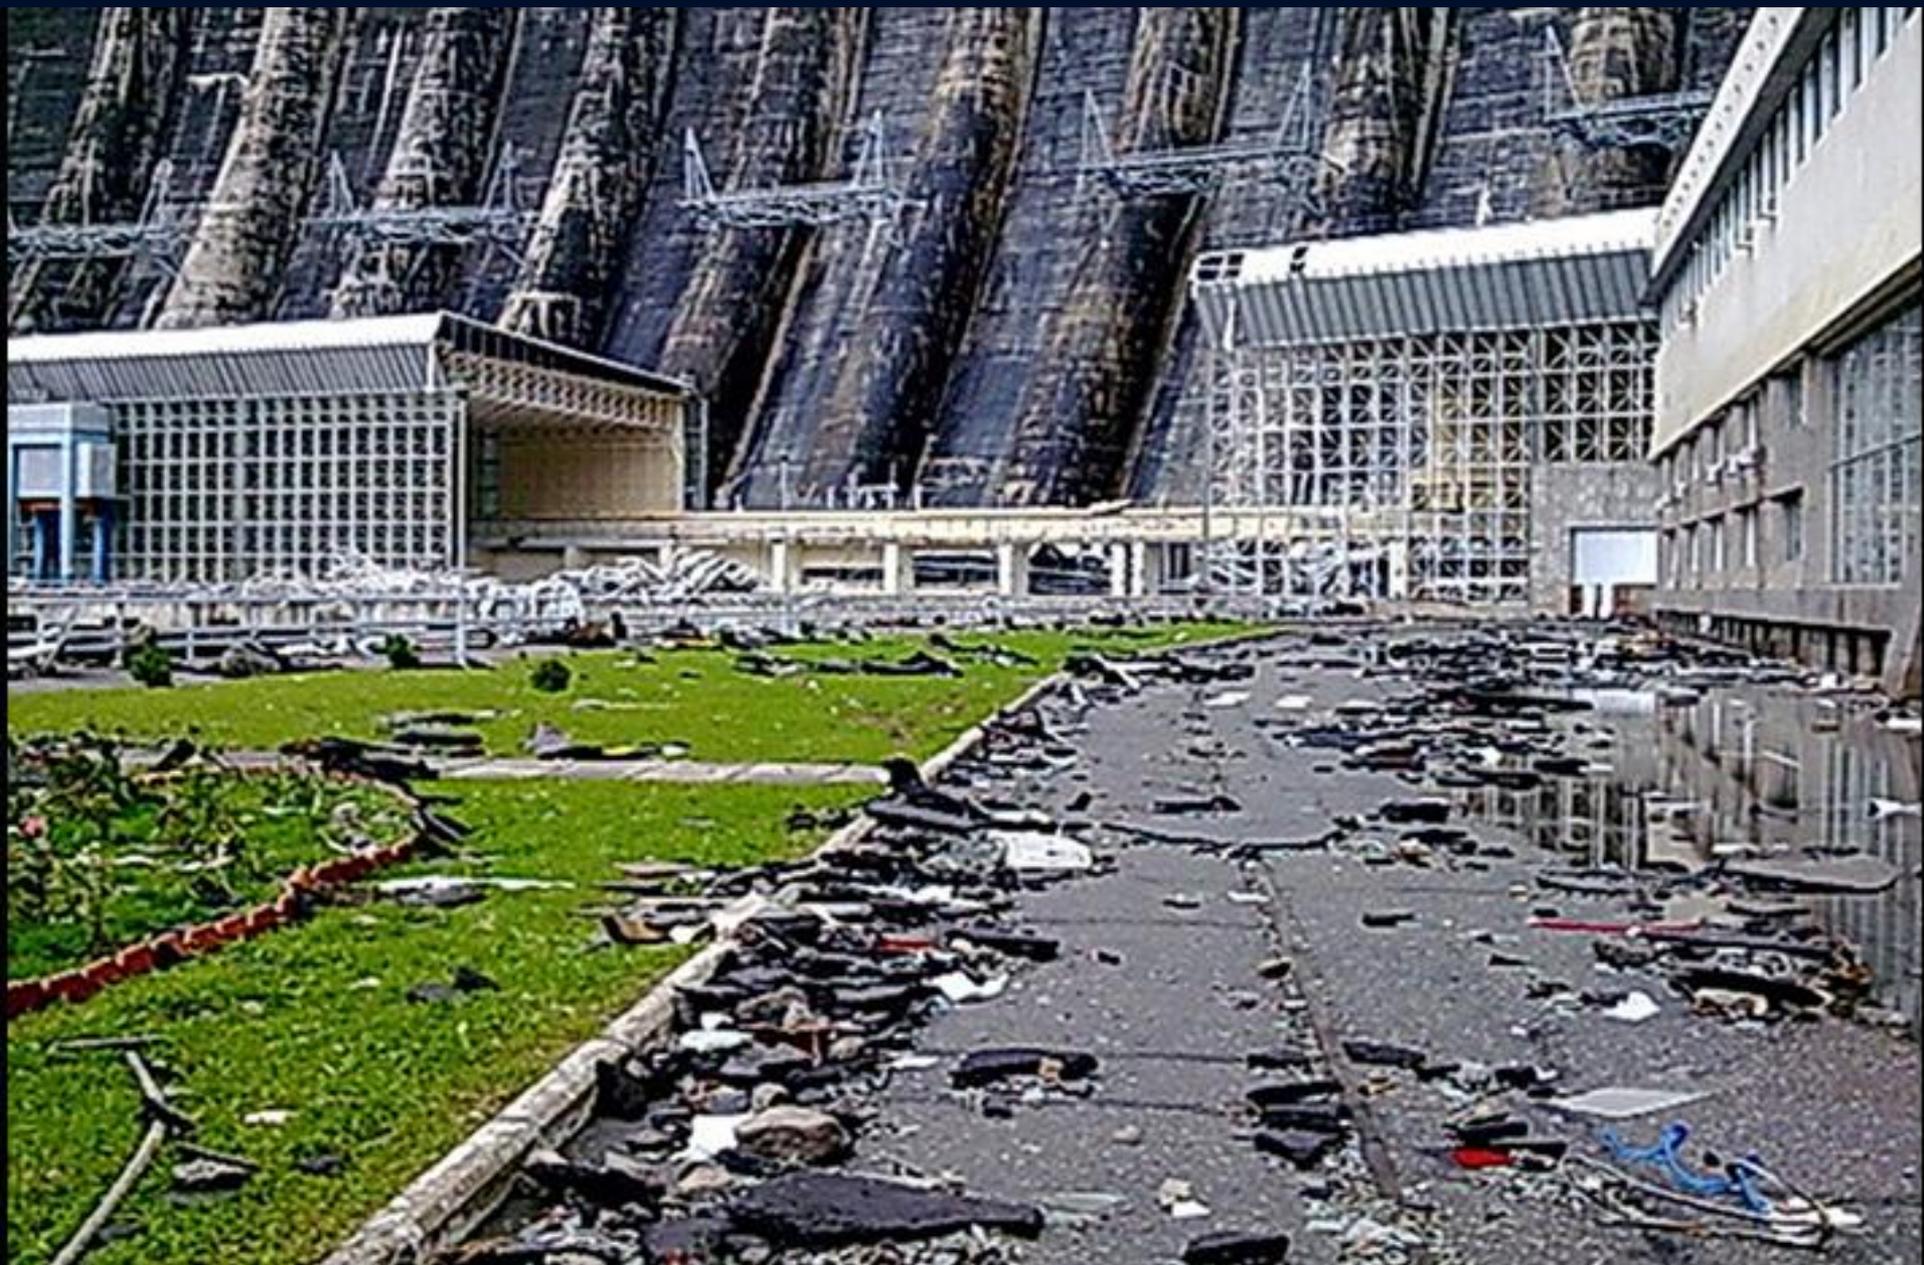
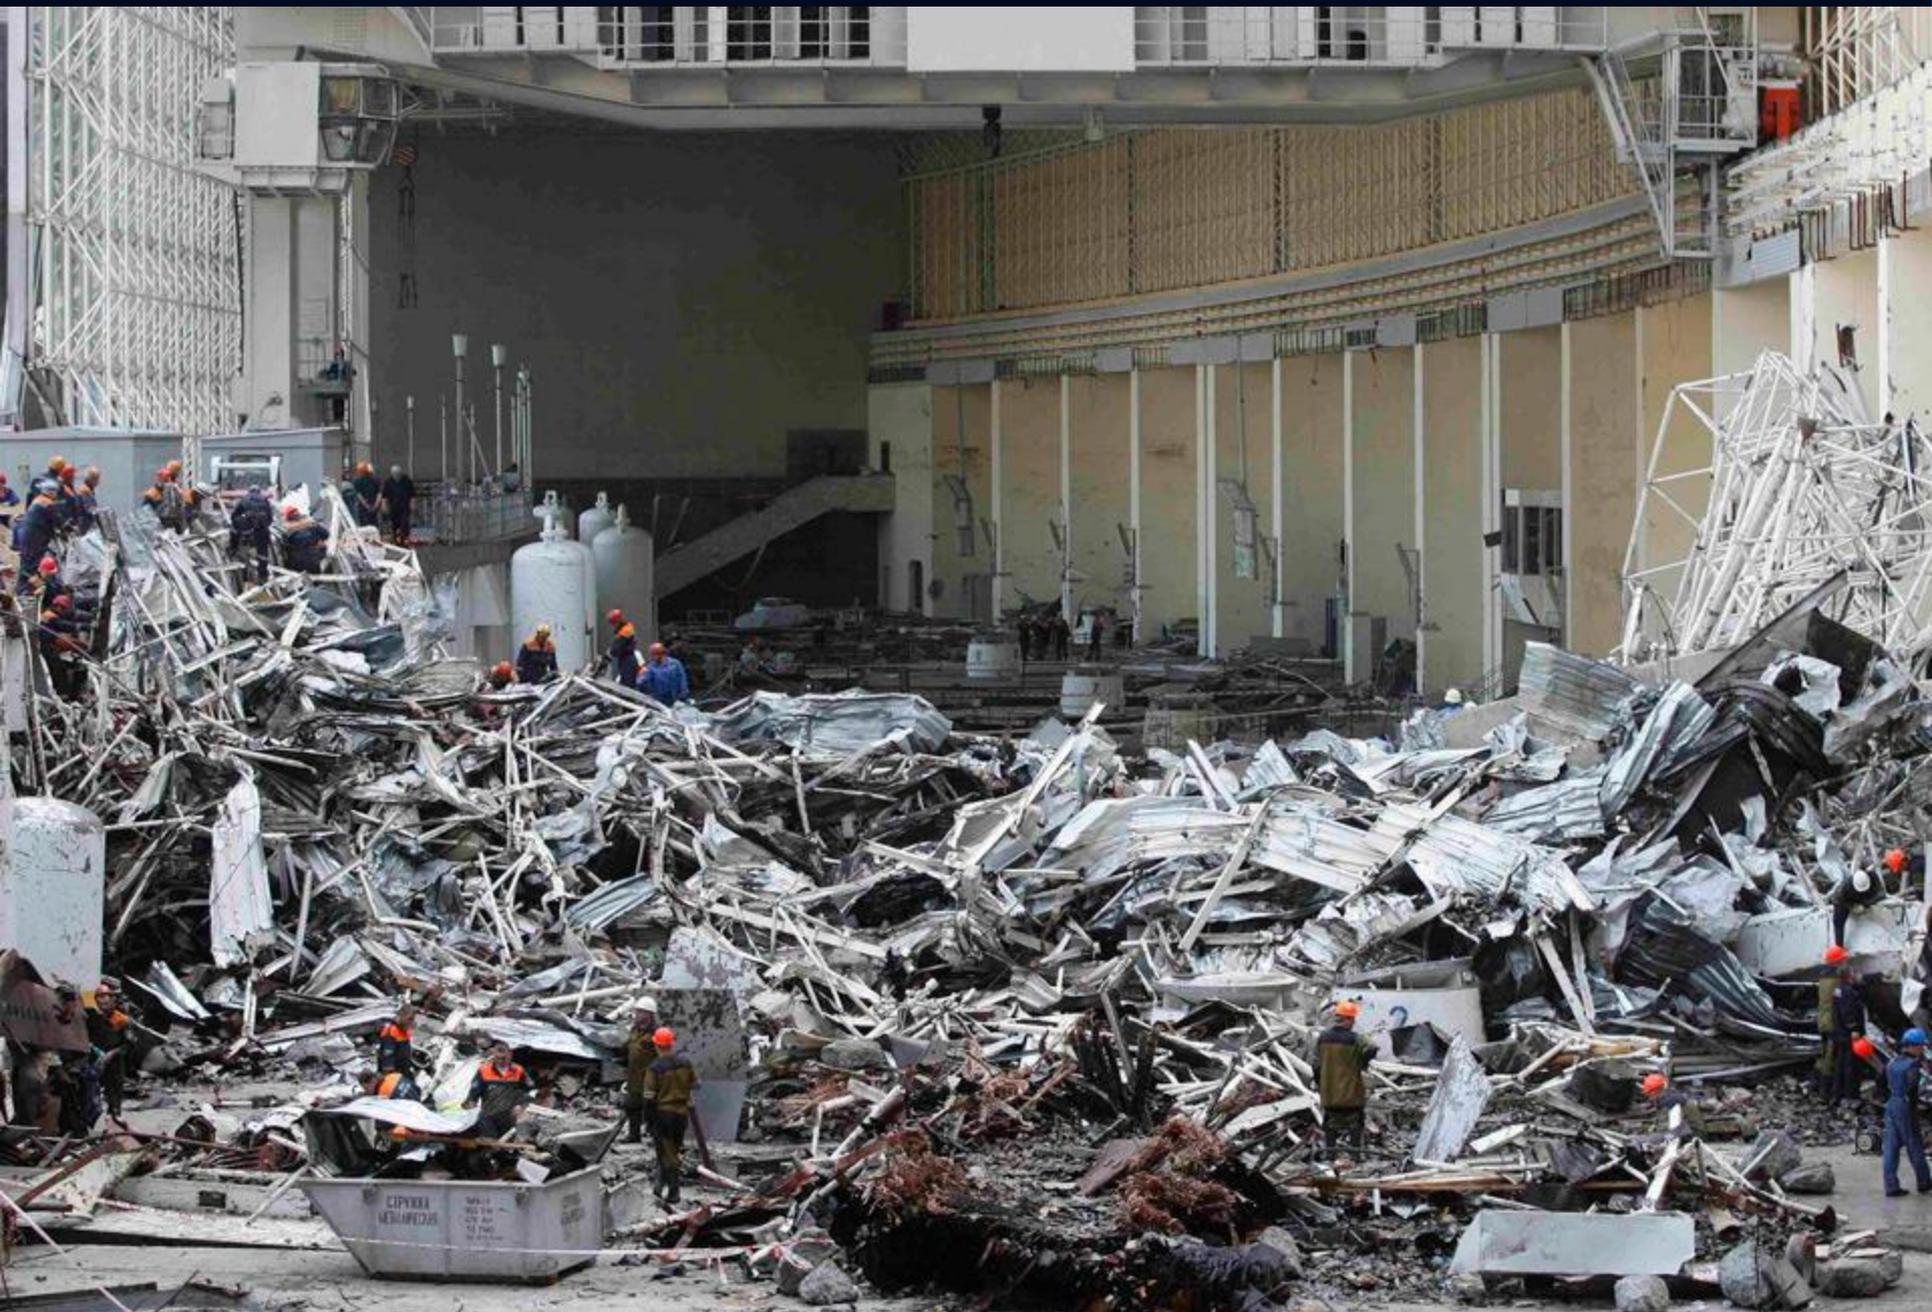
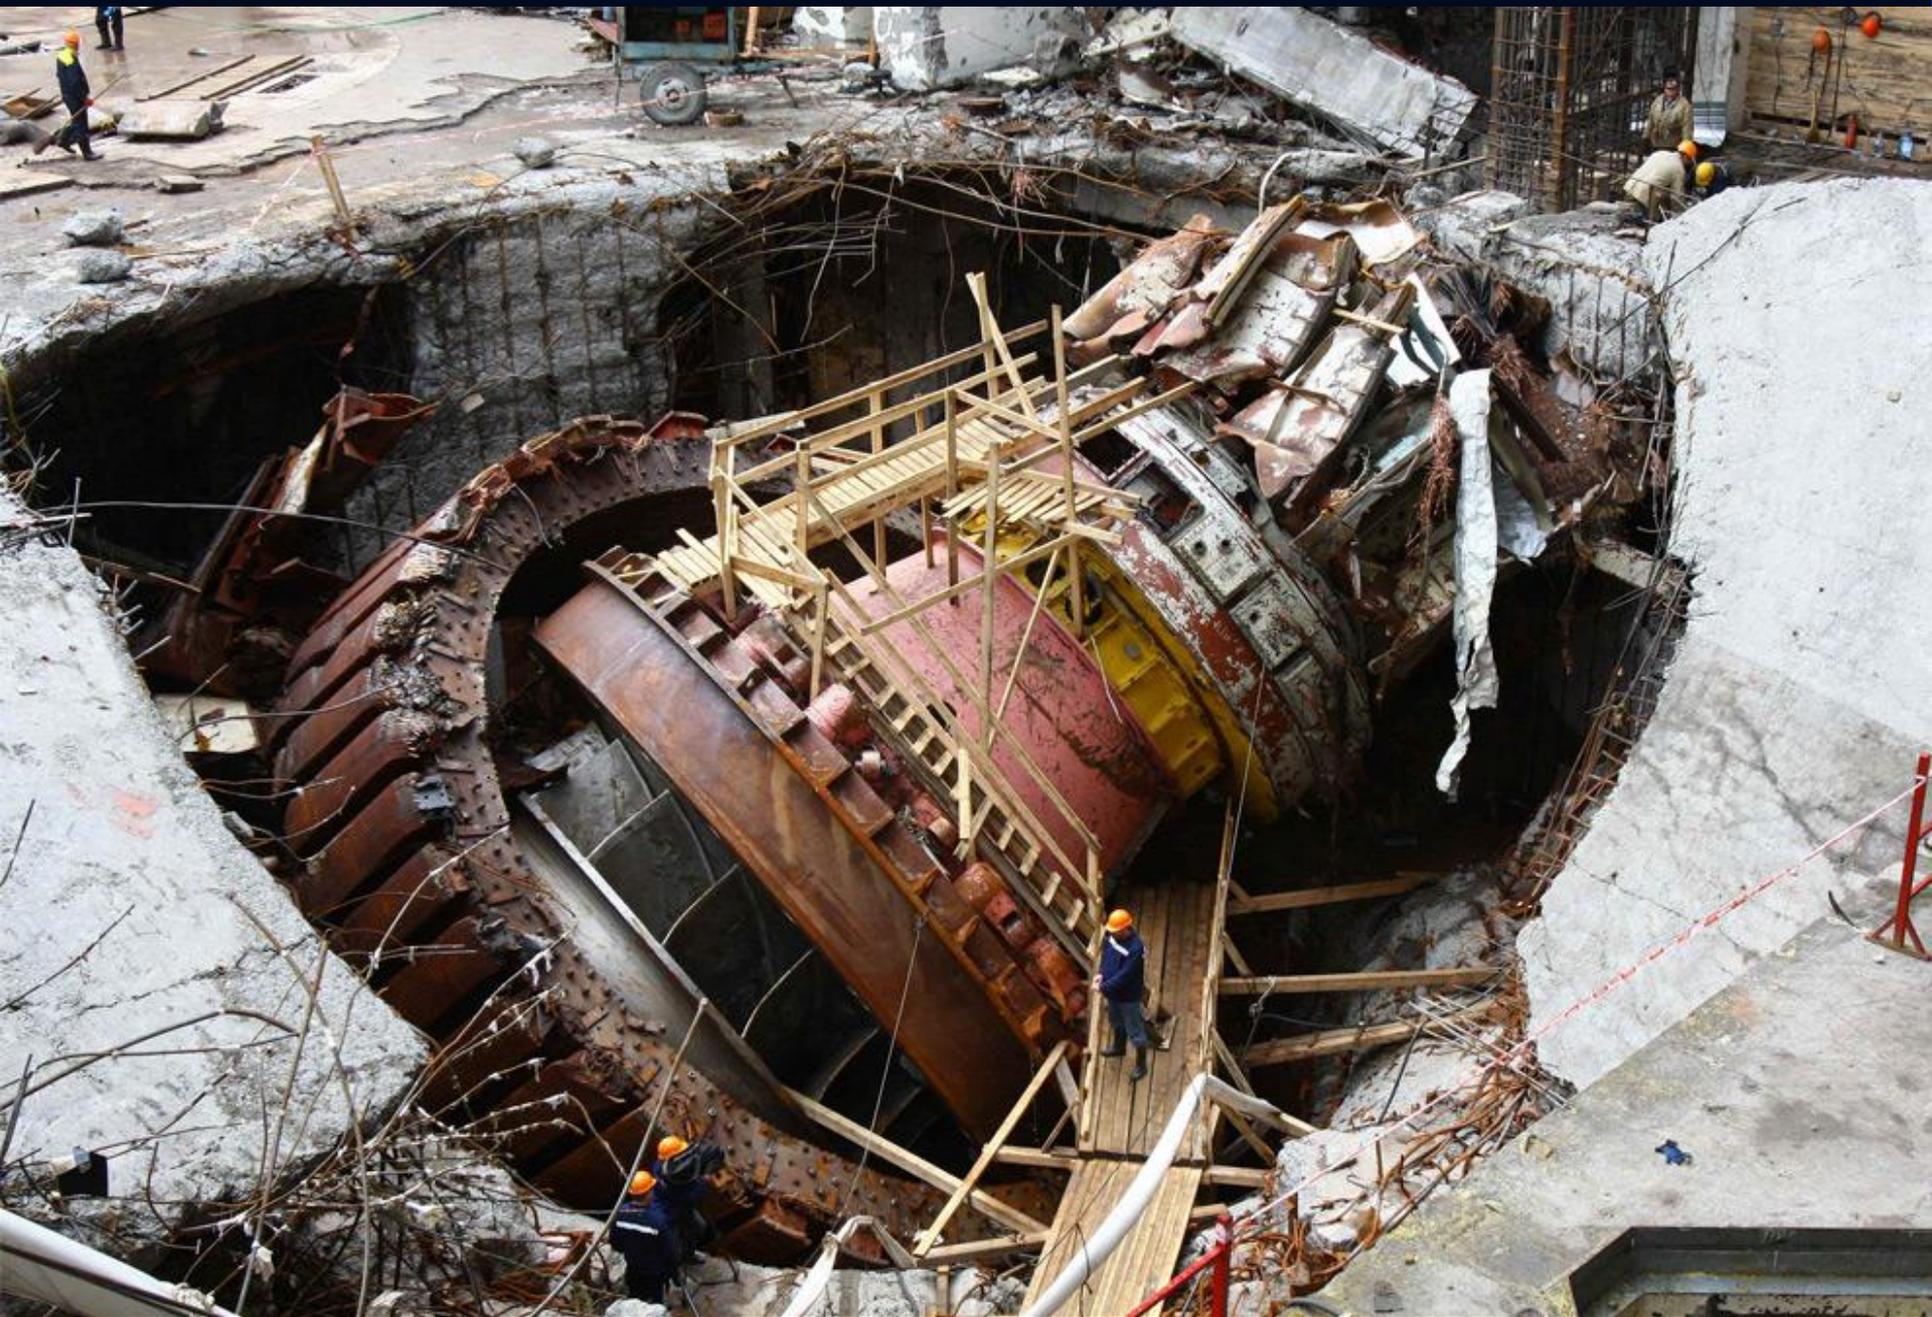
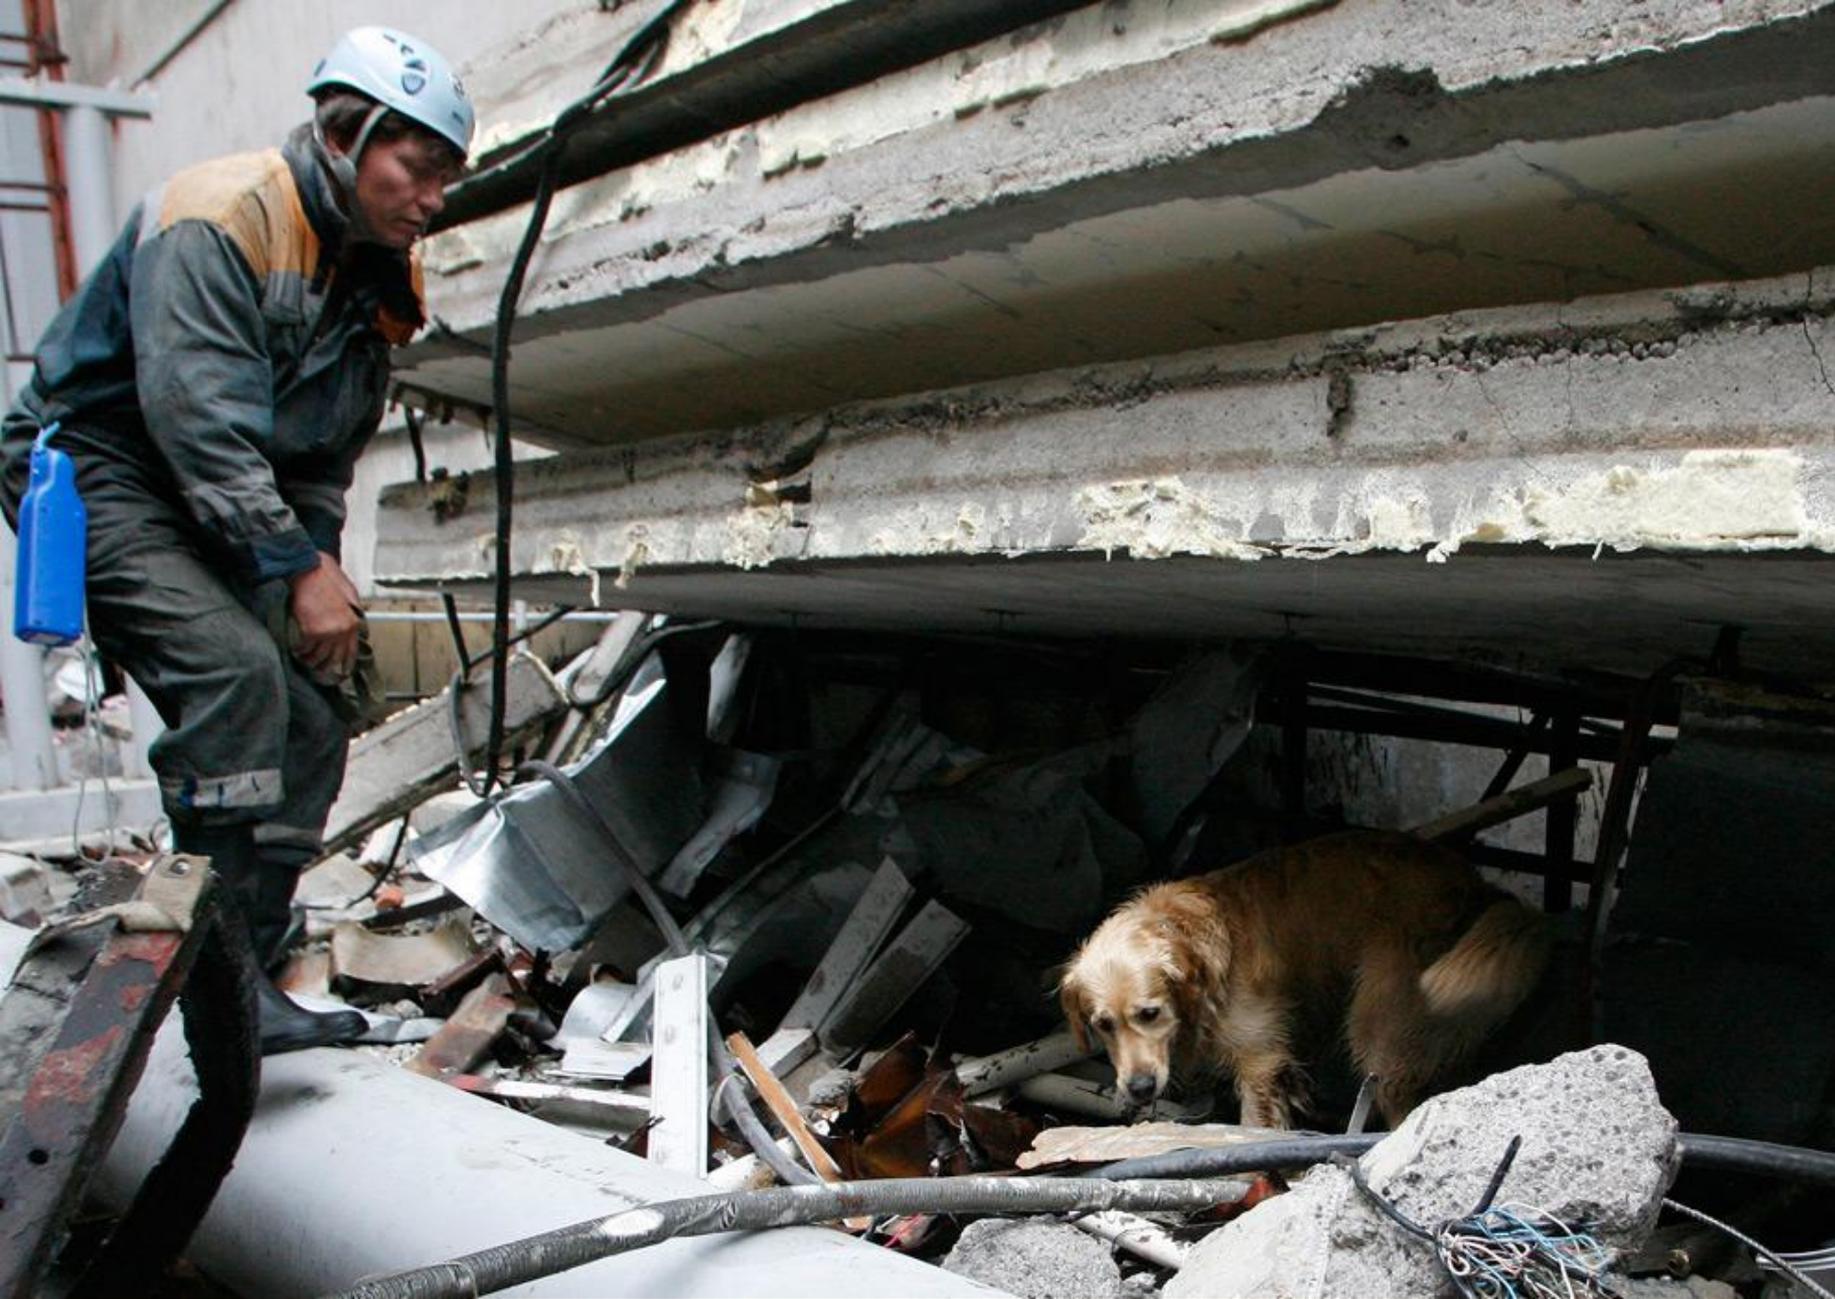
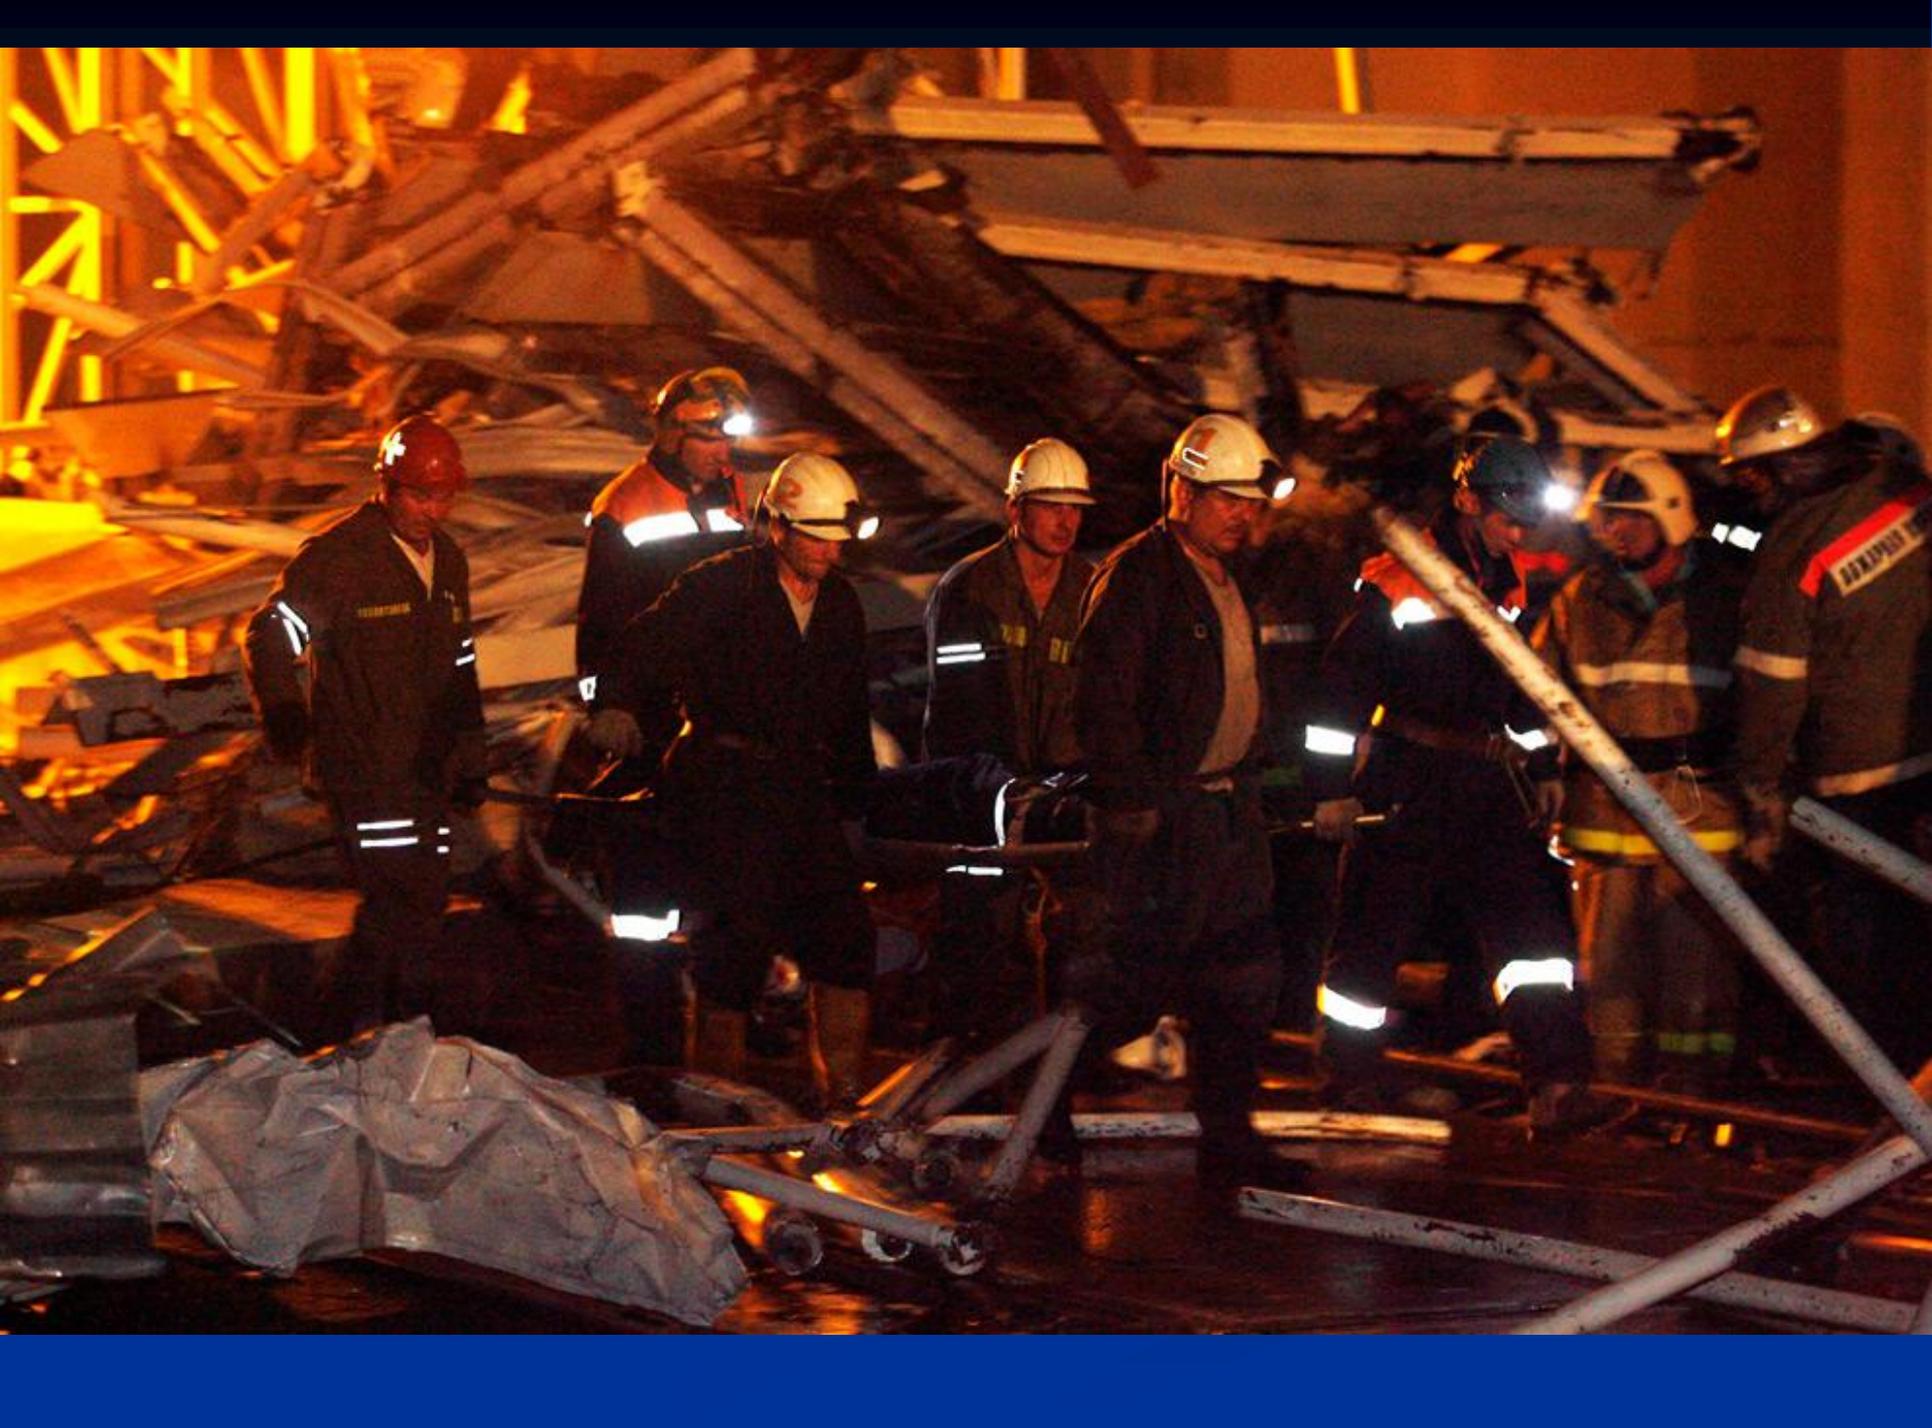
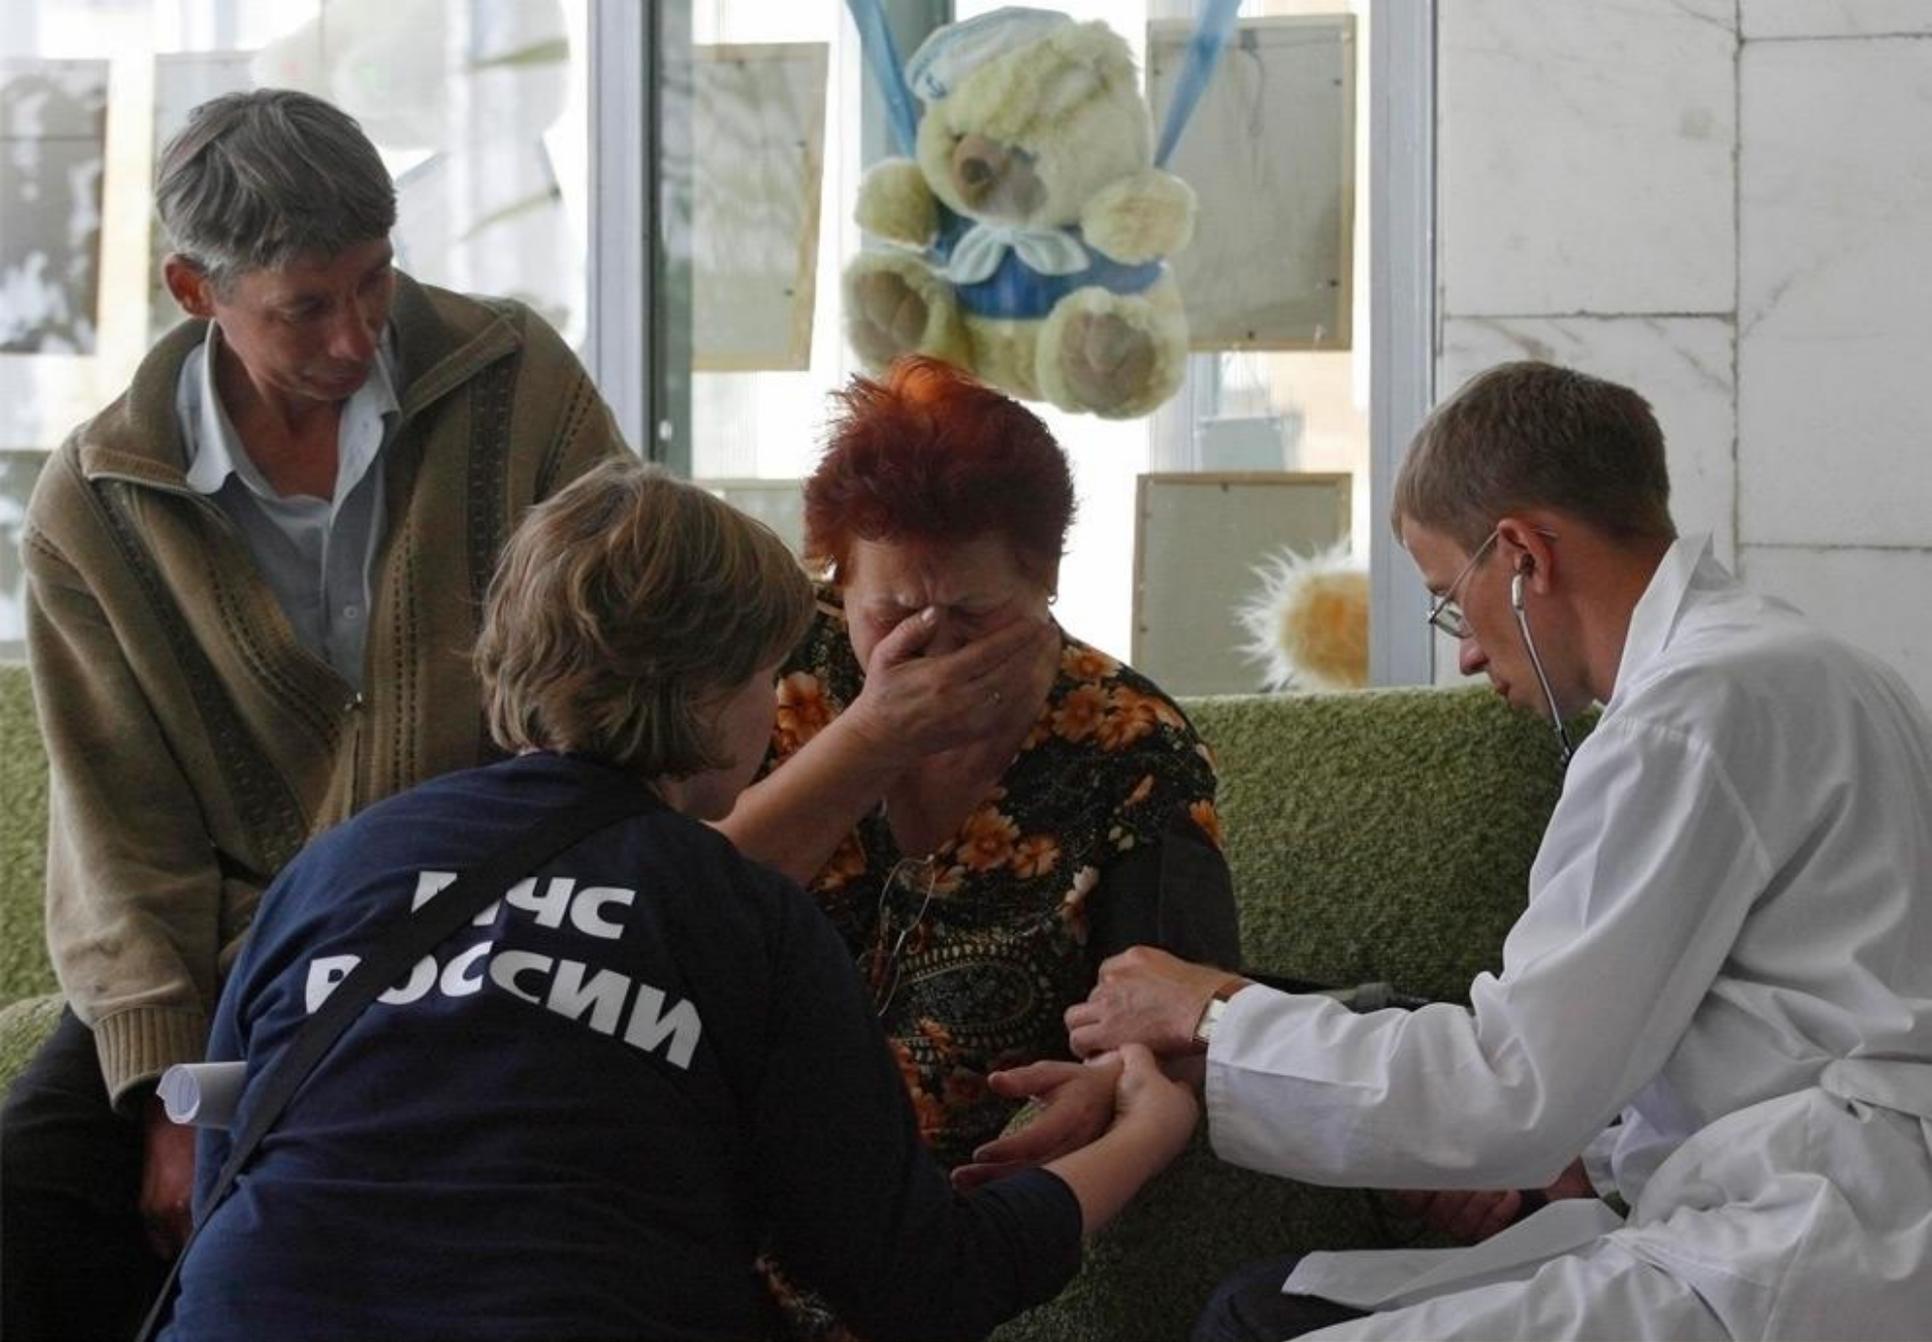
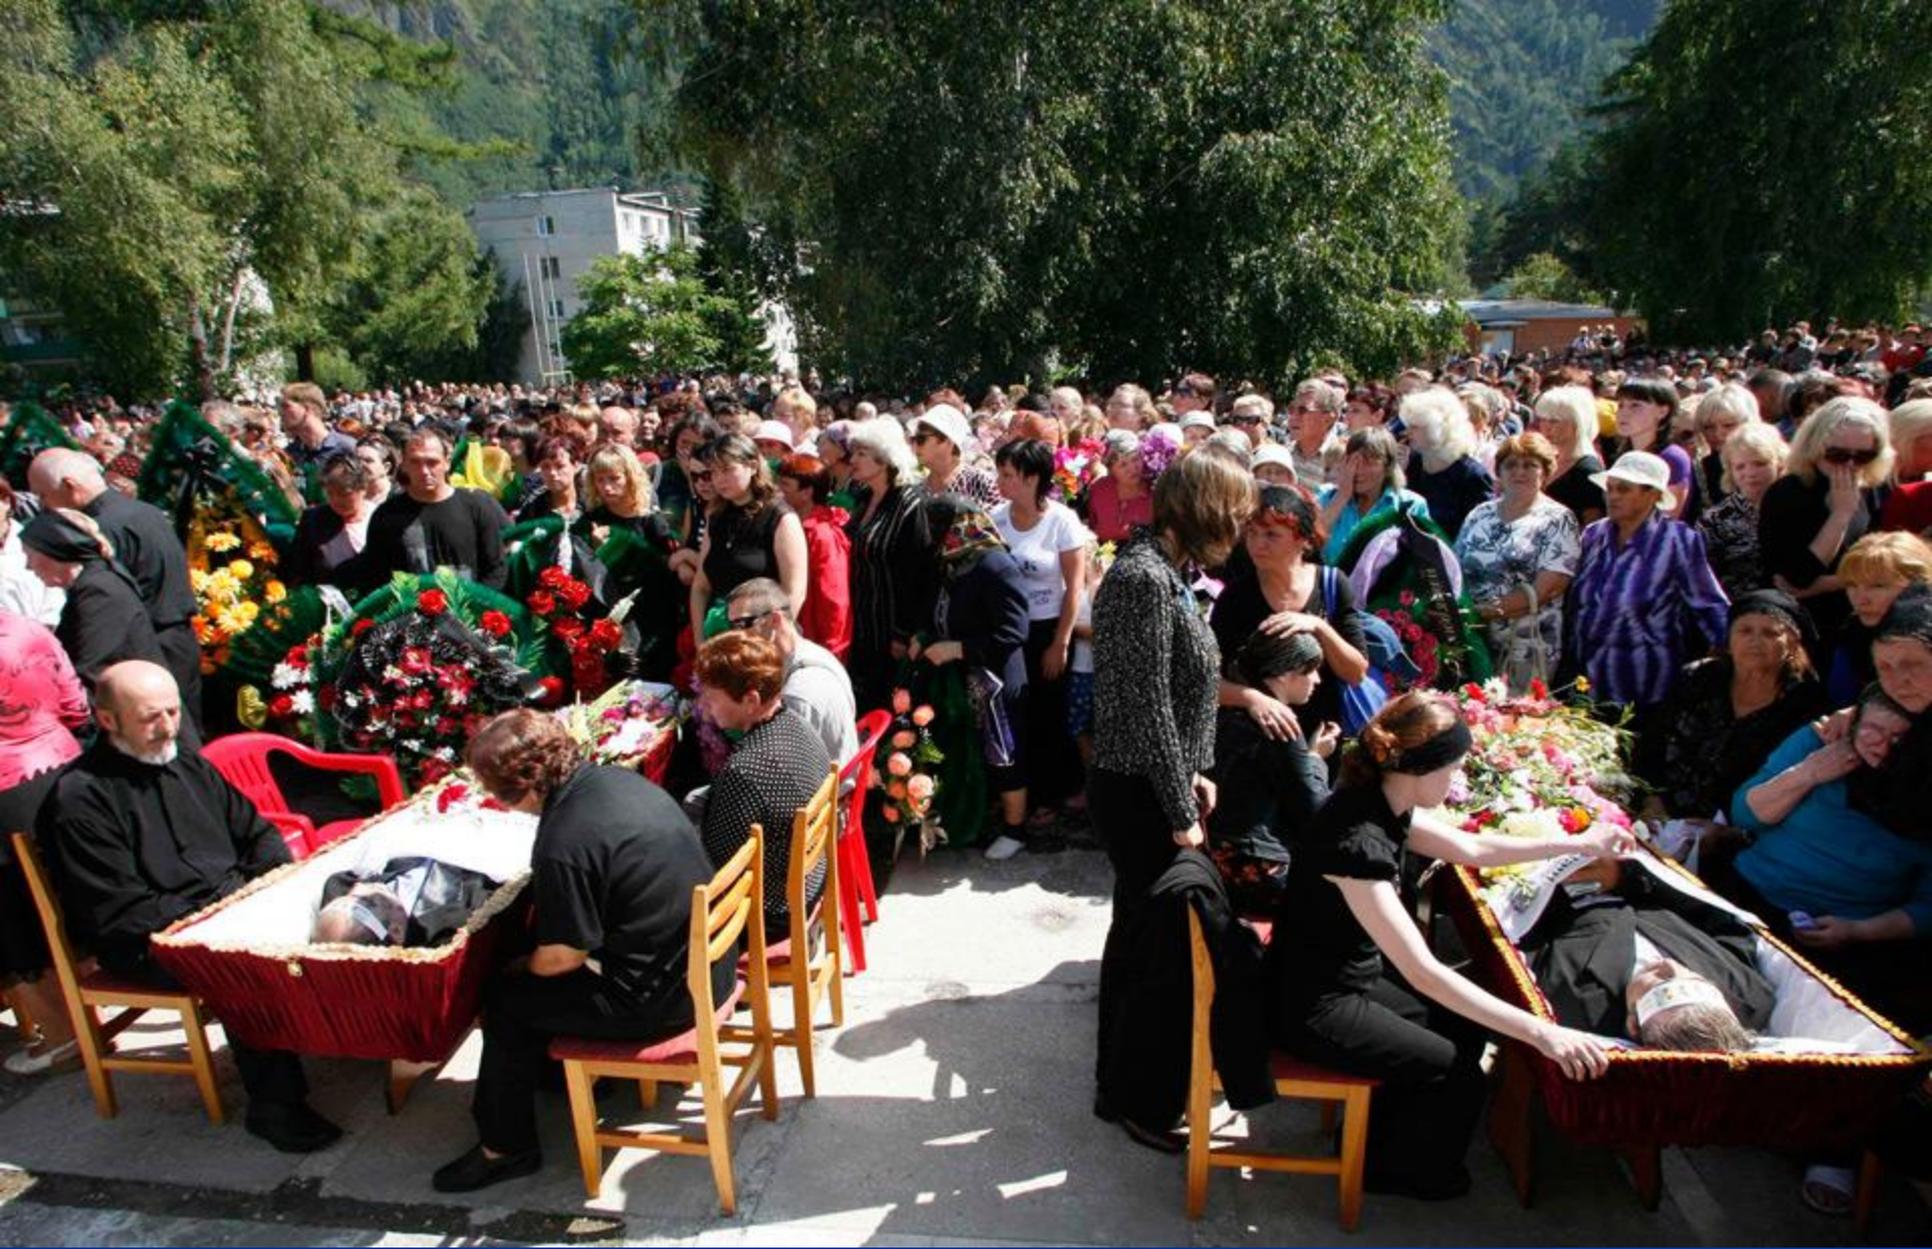
- Ultimately the failure was caused by failure of the bolts holding down the head cover.
- Post-failure investigations discovered:
 - 41 of the 80 bolts showed evidence of fatigue cracking with an average fracture area of 65%
 - 2 bolts failed without evidence of fatigue cracking
 - 6 bolts were in tact and showed no evidence of stripped threads. This is interpreted to indicate there were NO nuts on these bolts

- In a group of seven adjacent bolts, 4 showed no evidence of having nuts at the time of failure, 2 had fatigue cracking over 95% of their area and the last had fatigue cracking over 35% of its area.
- Essentially, over a 51 degree section of the headcover, there was only 6% of the design clamping force.
