Wanapum Dam Spillway Gate Trunnion Bearings

Nathan Manning
Grant County PUD

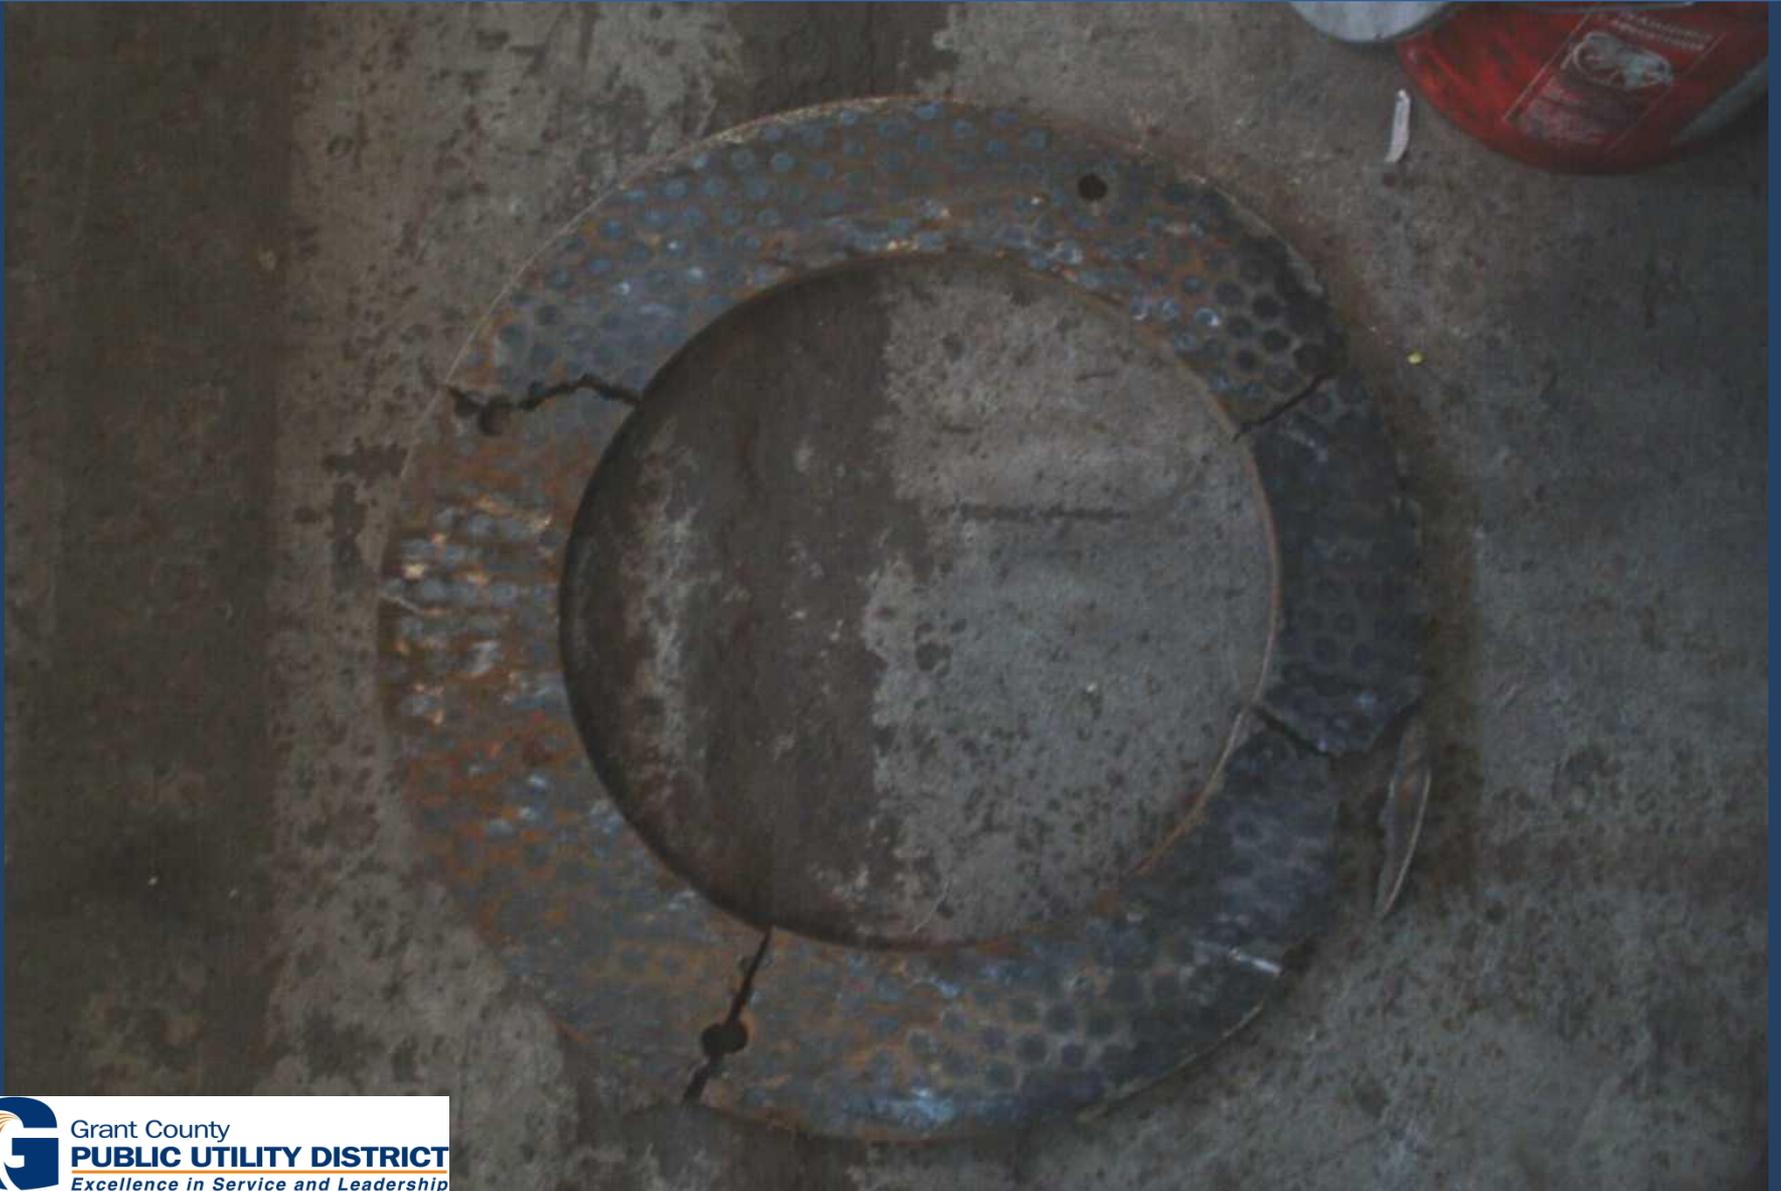
- 1999 FERC Part 12 Inspection
- Cracked / Crumbling Thrust Washers Observed at Priest Rapids
- Cracked Thrust Washer Observed at Wanapum
- Lab Analysis Determined Type C86100 Manganese Bronze
- Ammonia Induced Stress Corrosion Cracking

Priest Rapids Thrust Washer

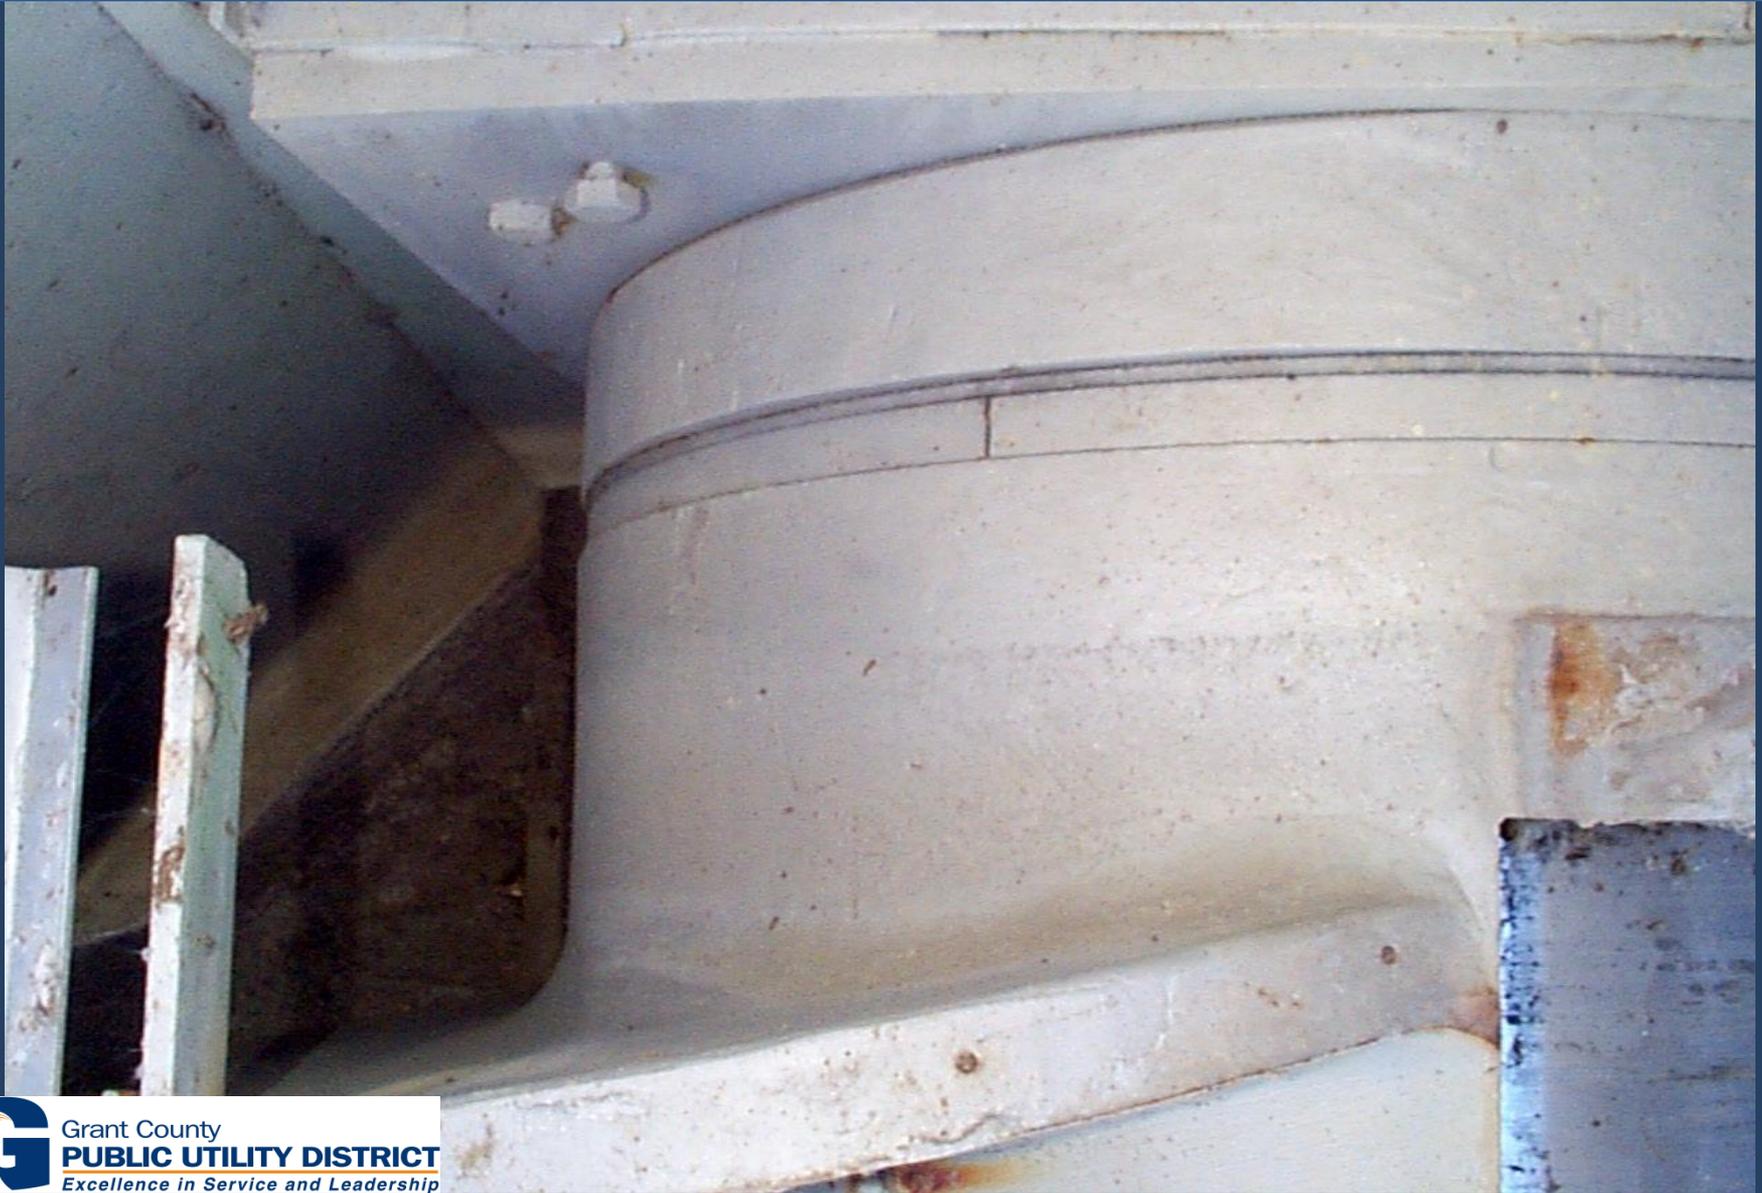
Wanapum Thrust Washer Crack

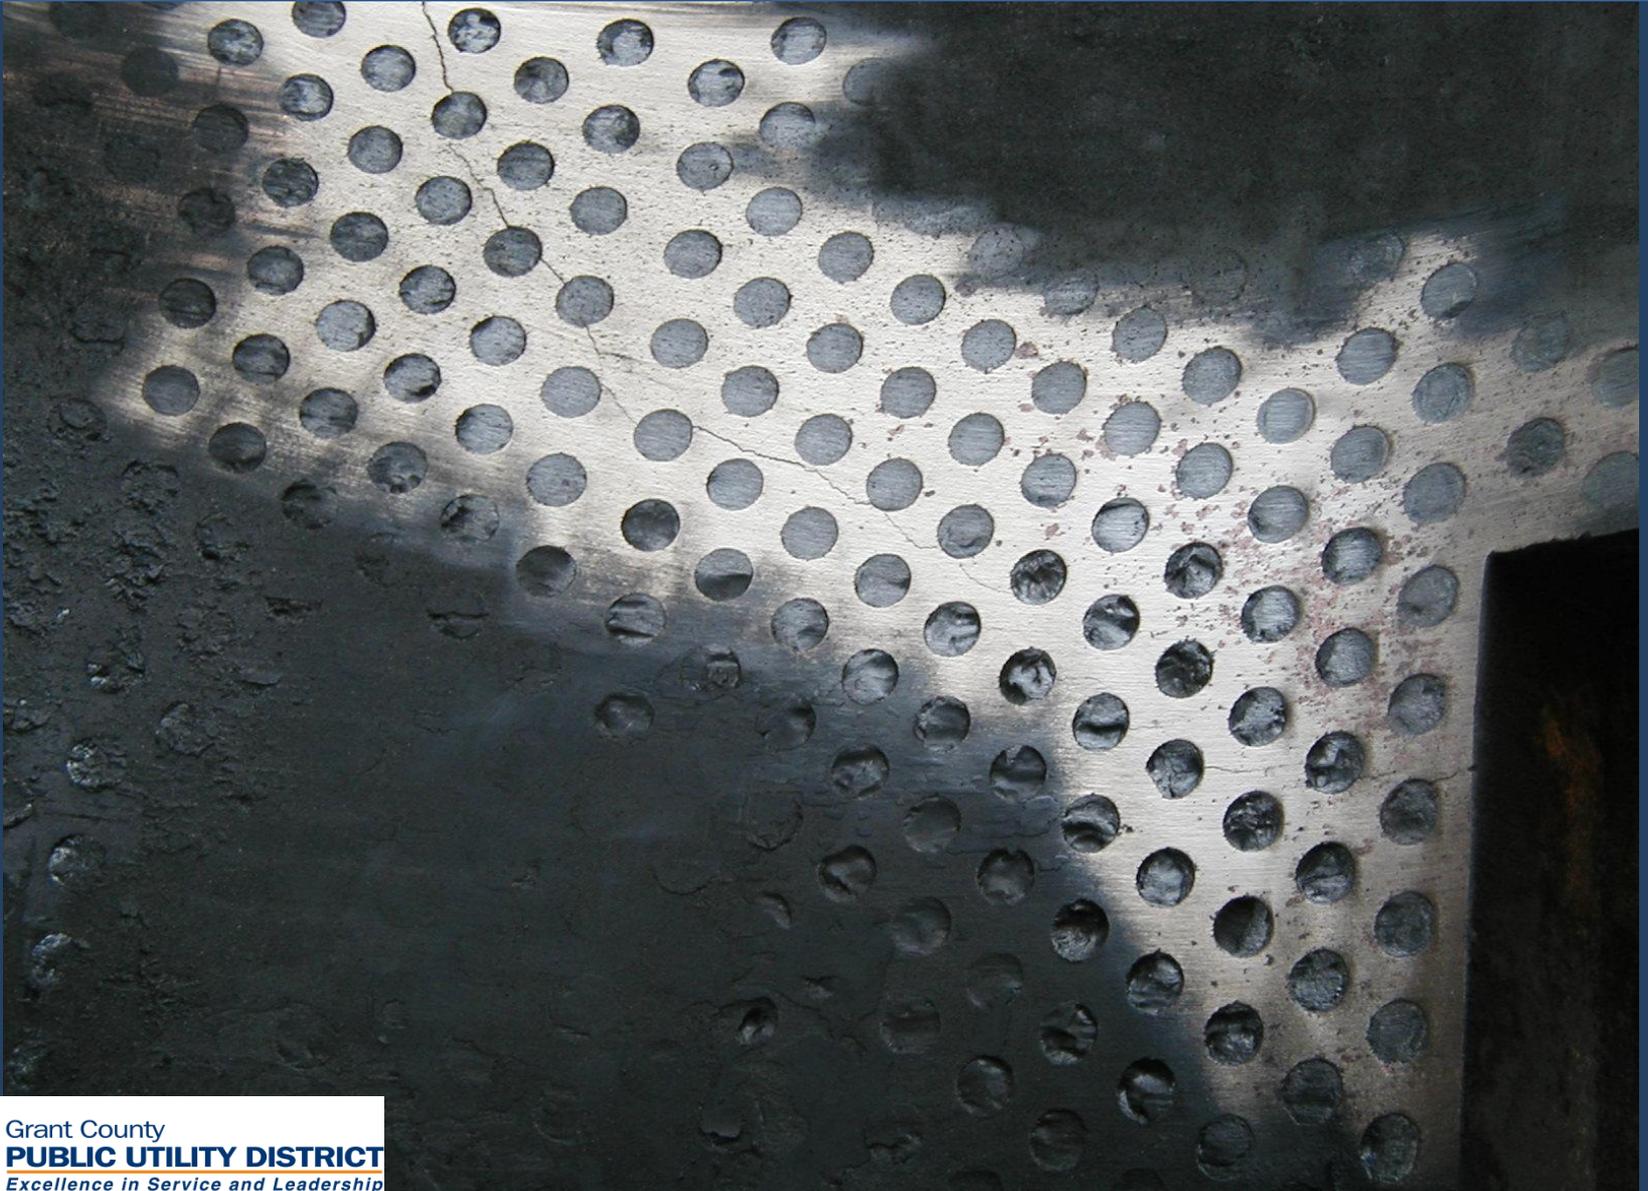
Wanapum Bushing Crack

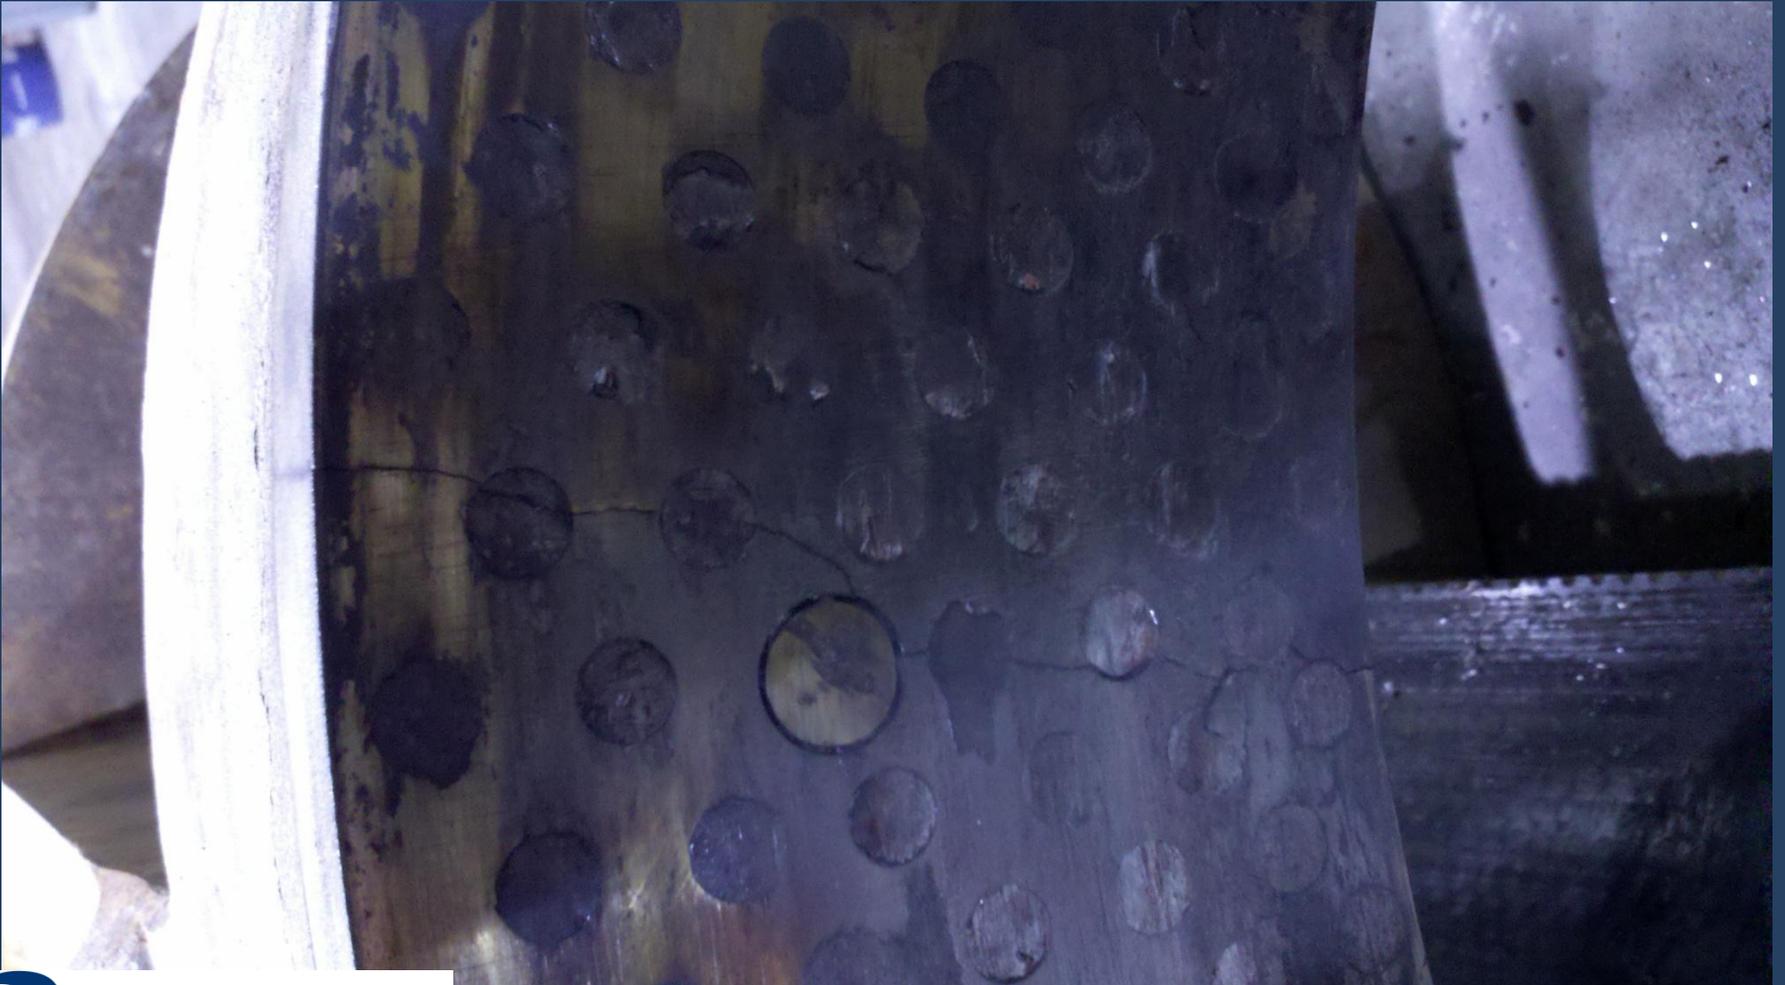
Wanapum Thrust Washer Crack

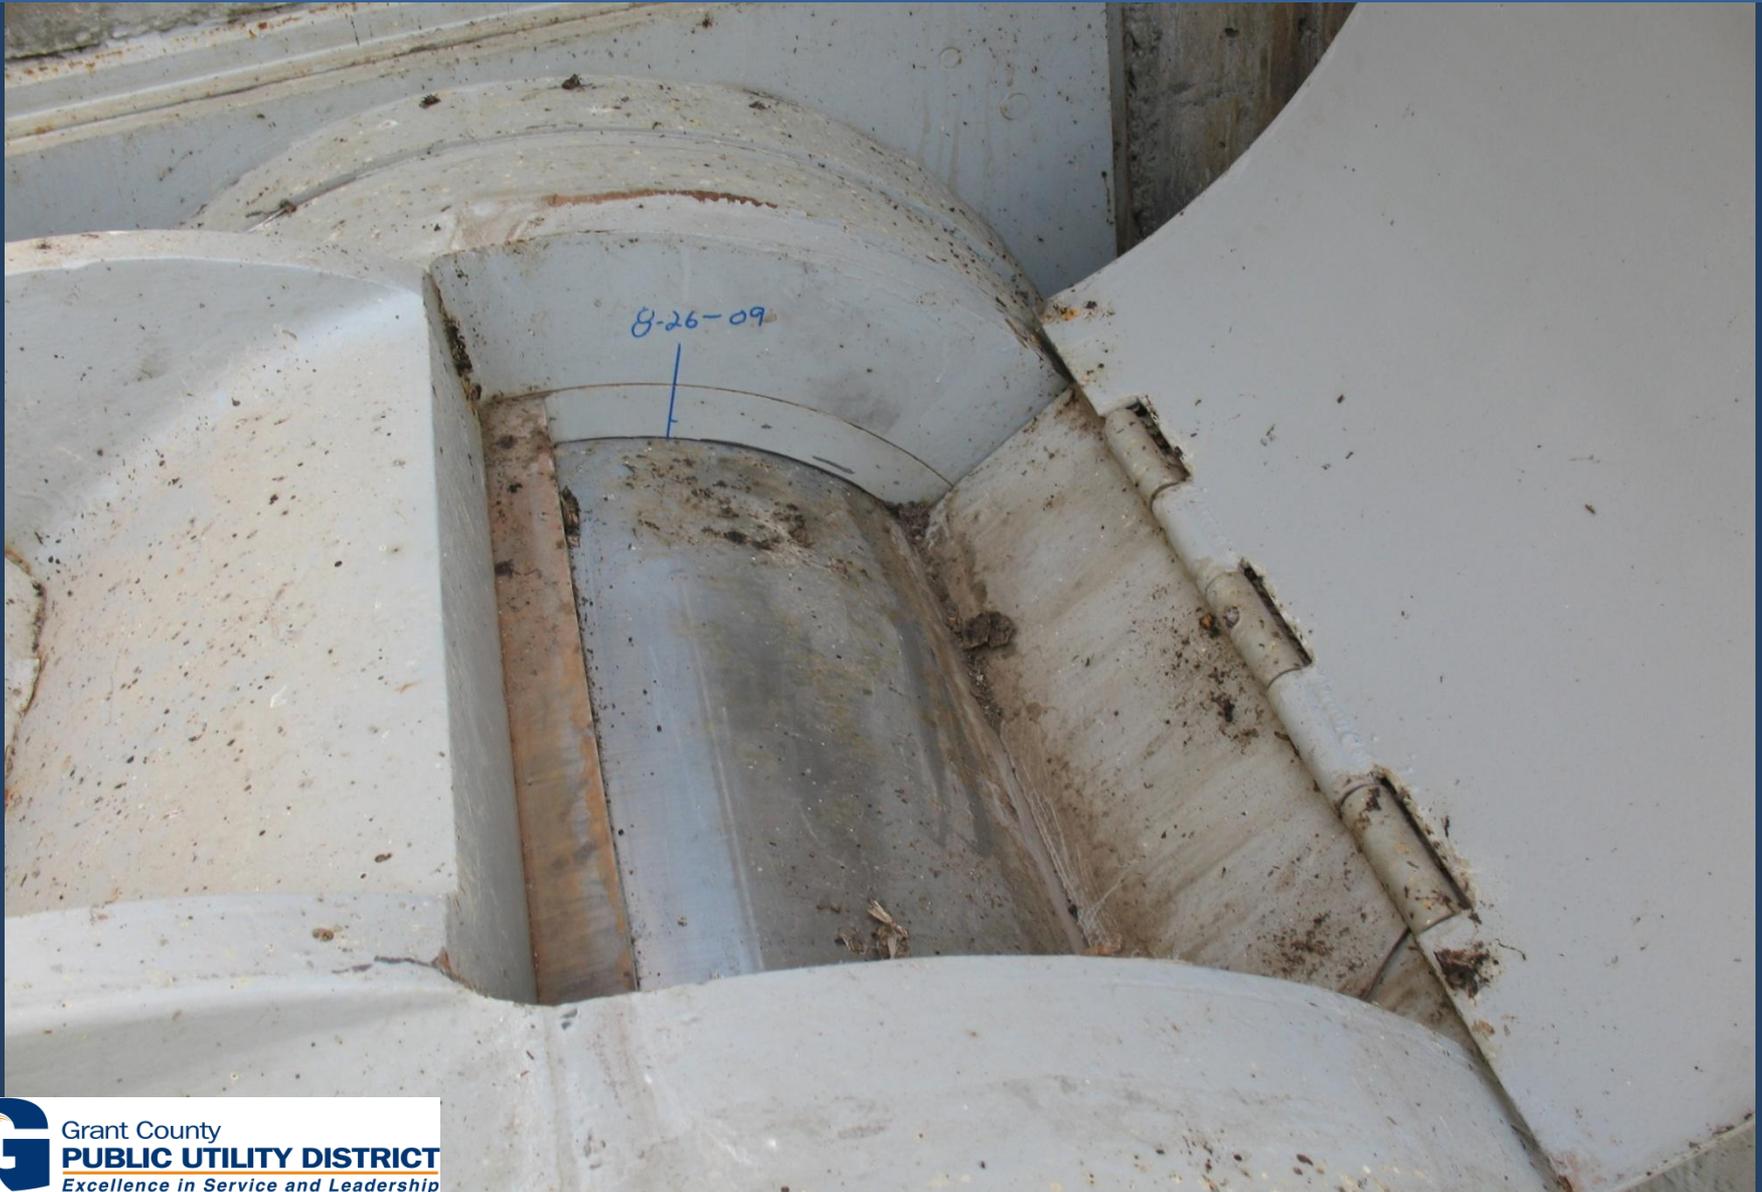
- Rotated Pins at Priest Rapids – Remedied with Stronger Keeper Plate Bolts
- Rotated Pins at Wanapum (11 of 24) – Doweled Pin to Prevent Future Rotation
- One Bearing Rotated Inside Housing
- Loose Tubular Support Bolts Possibly Due to Stretch
- Burn Type Wear Marks Observed on Some Pins

Wanapum Rotated Bearing

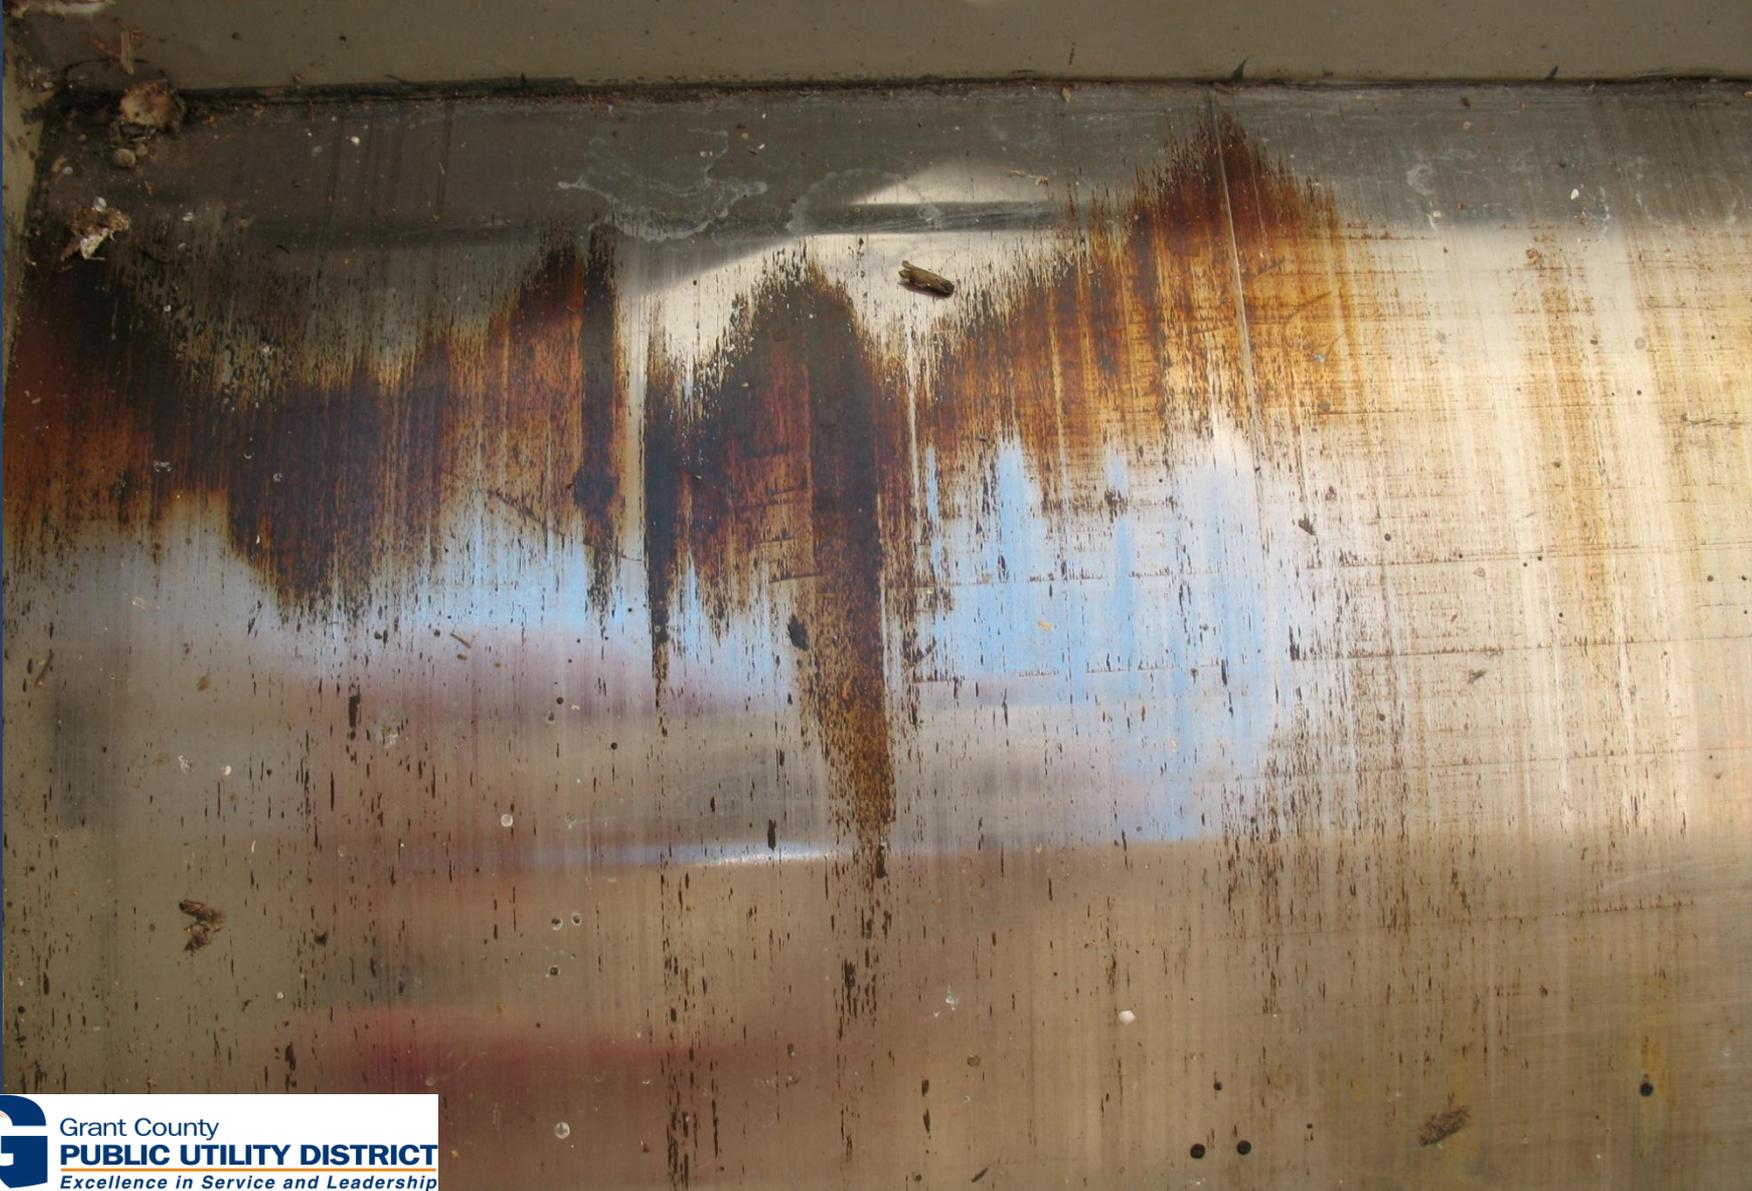
Wanapum Pin Wear Marks
