Eugene Water & Electric Board

Generator Inspection and Testing

Generator Testing, Inspection and Maintenance Program Development

2014 Generator Testing and Inspection Report

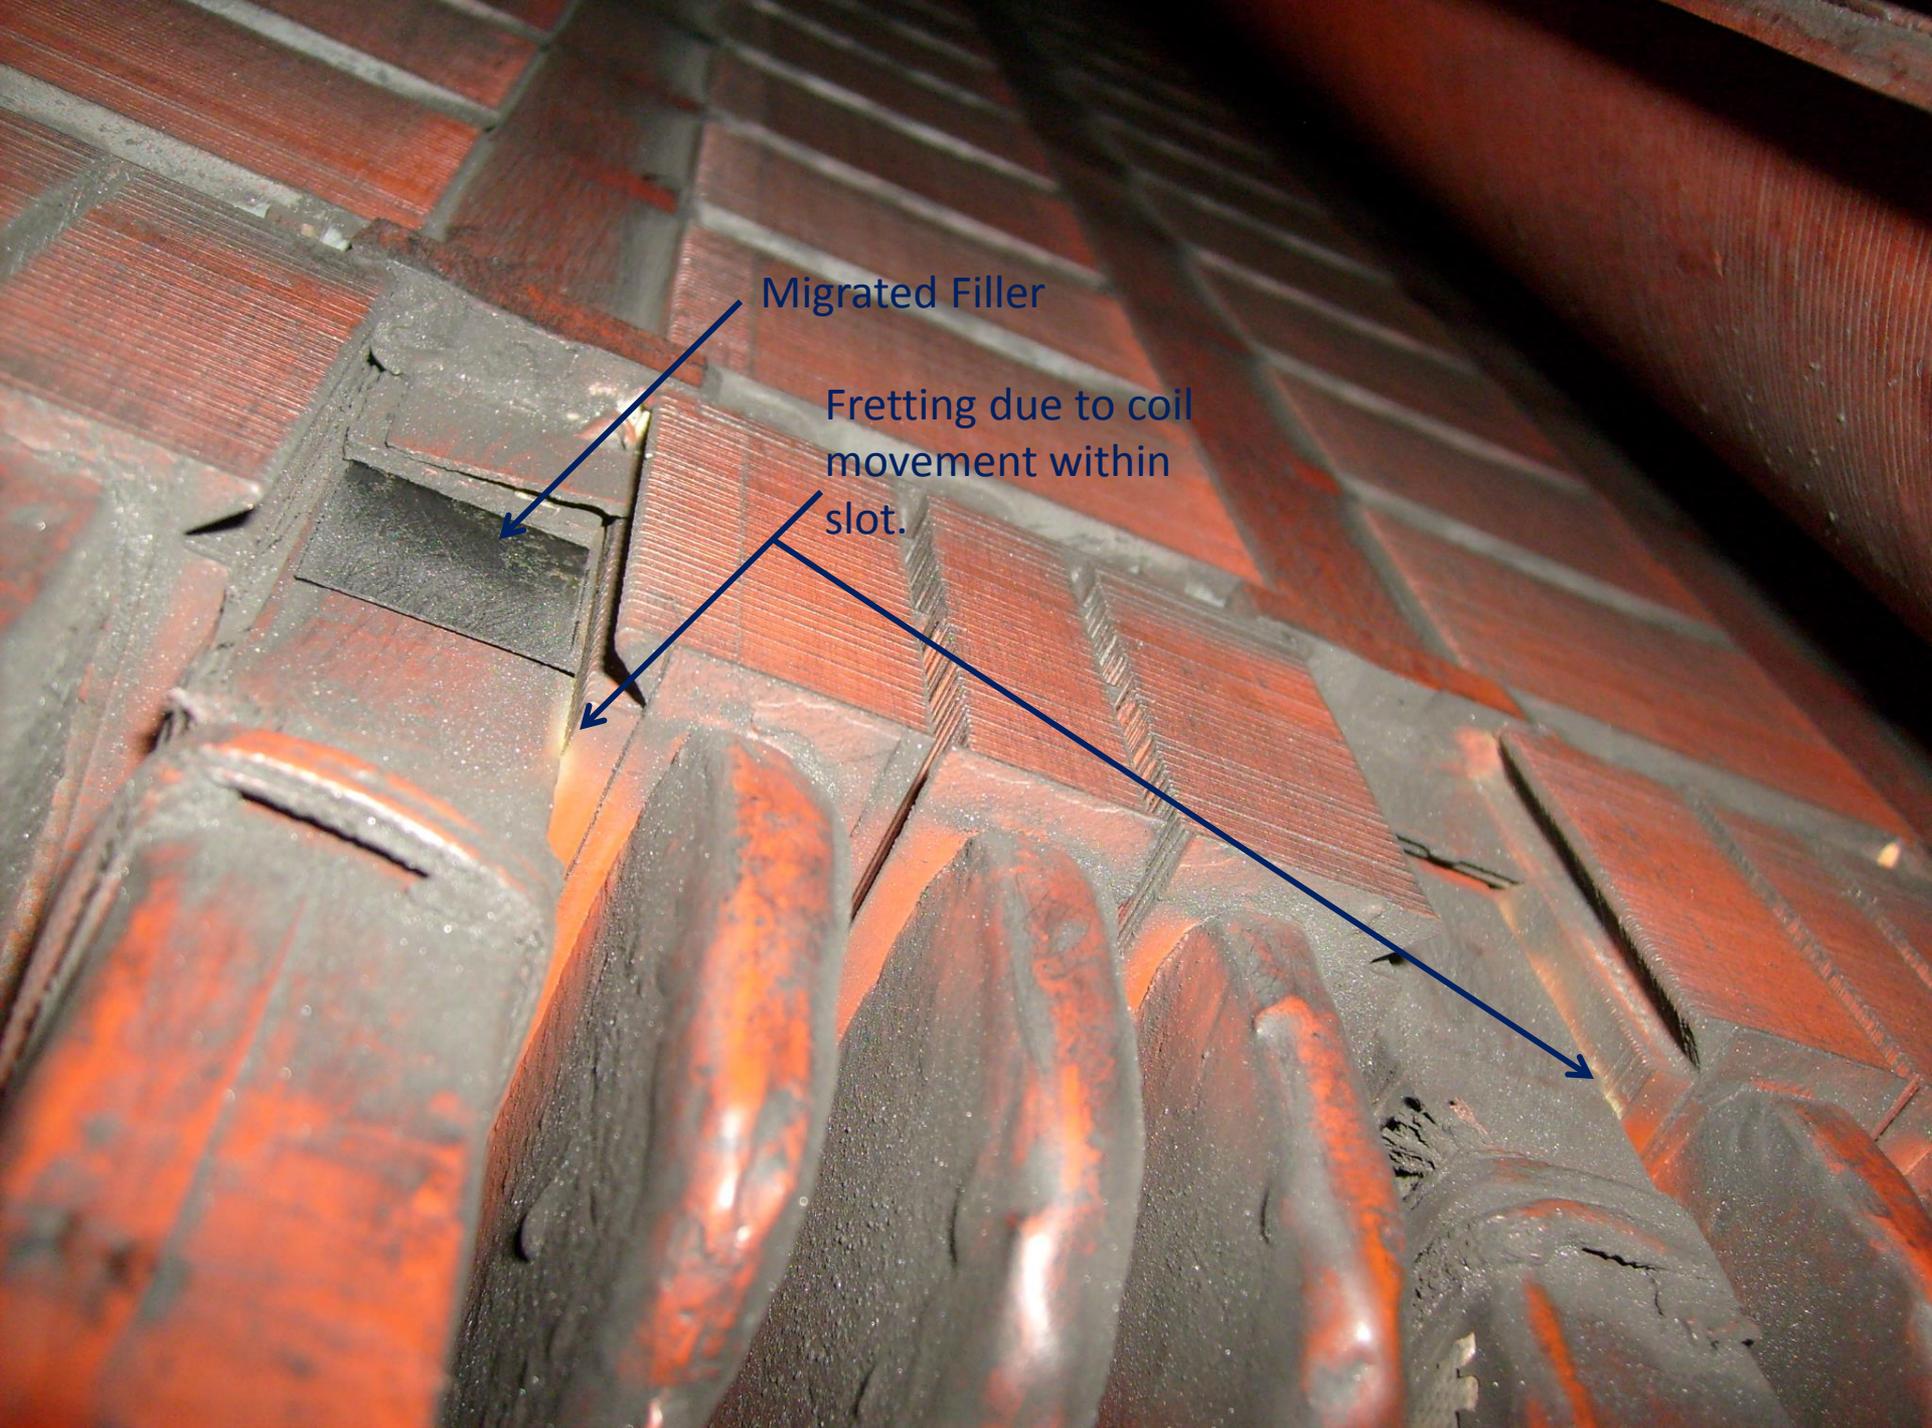
Migrated Filler

Fretting due to coil
movement within
slot.

- End winding partial discharge damaged areas were painted over.
- Unit end winding was cleaned.
- Migrated fillers were repaired.

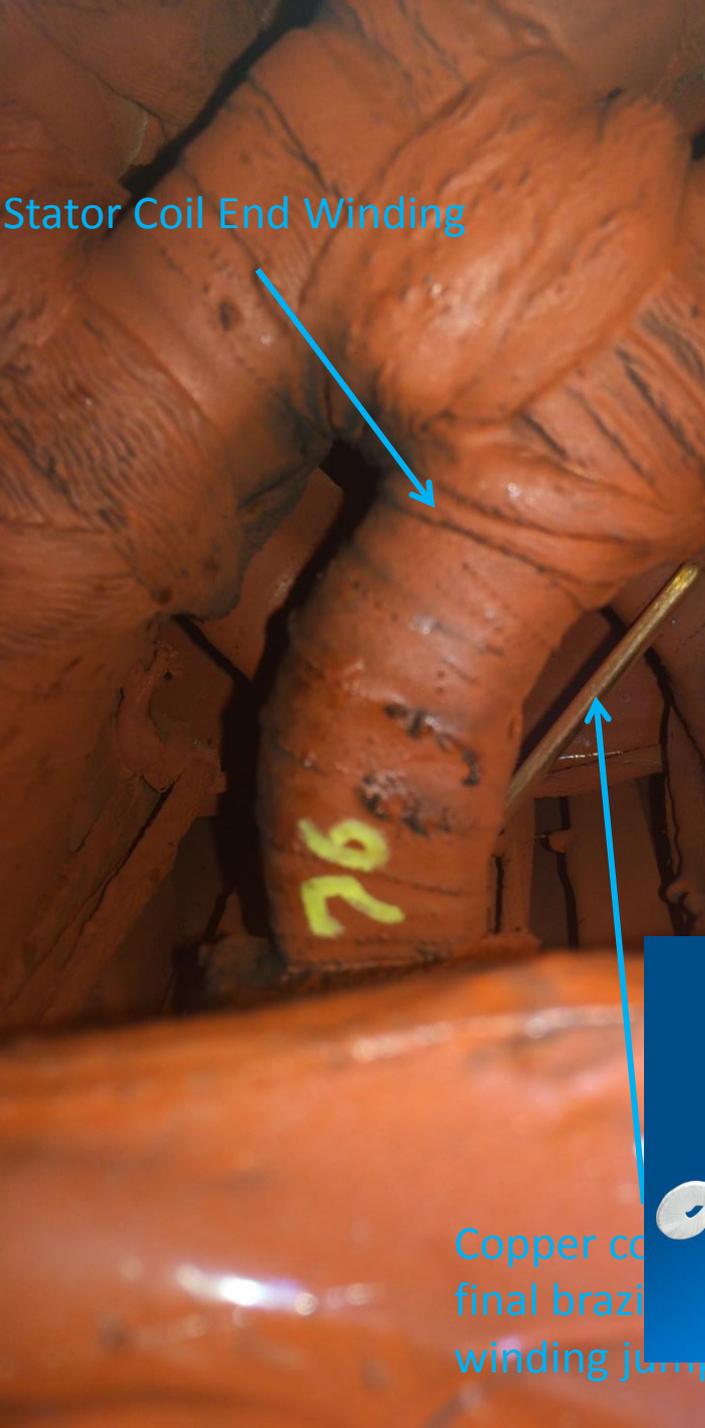
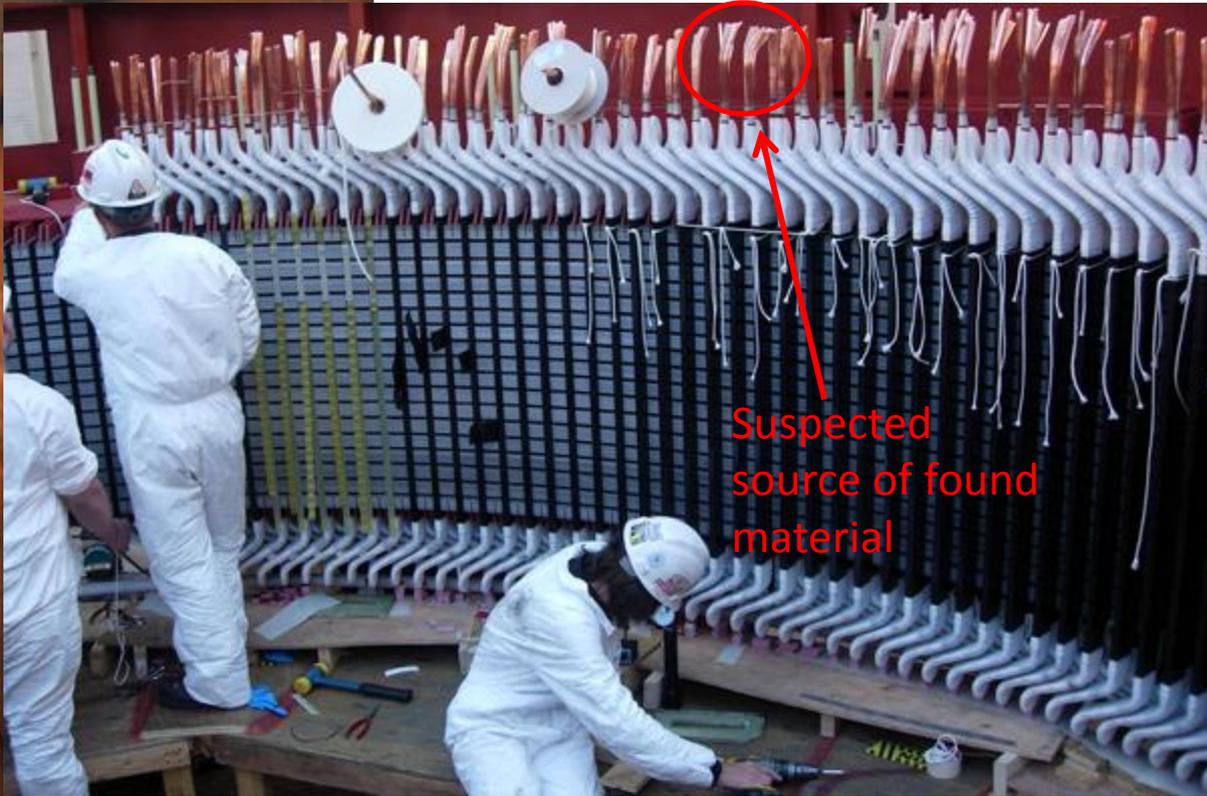
Suspected source of found material

Copper coil
final braze
winding jumpers.

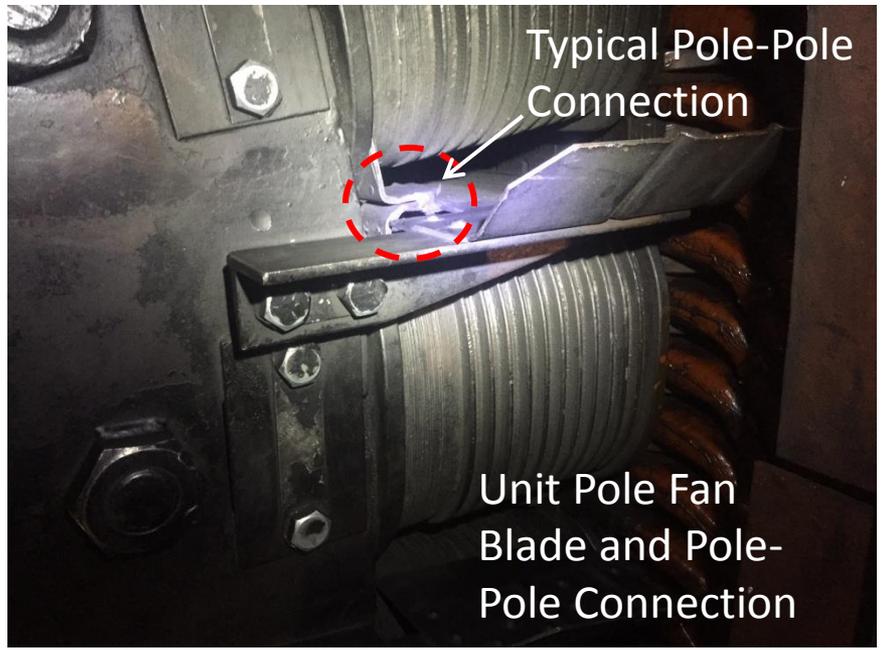
Typical Pole-Pole
Connection

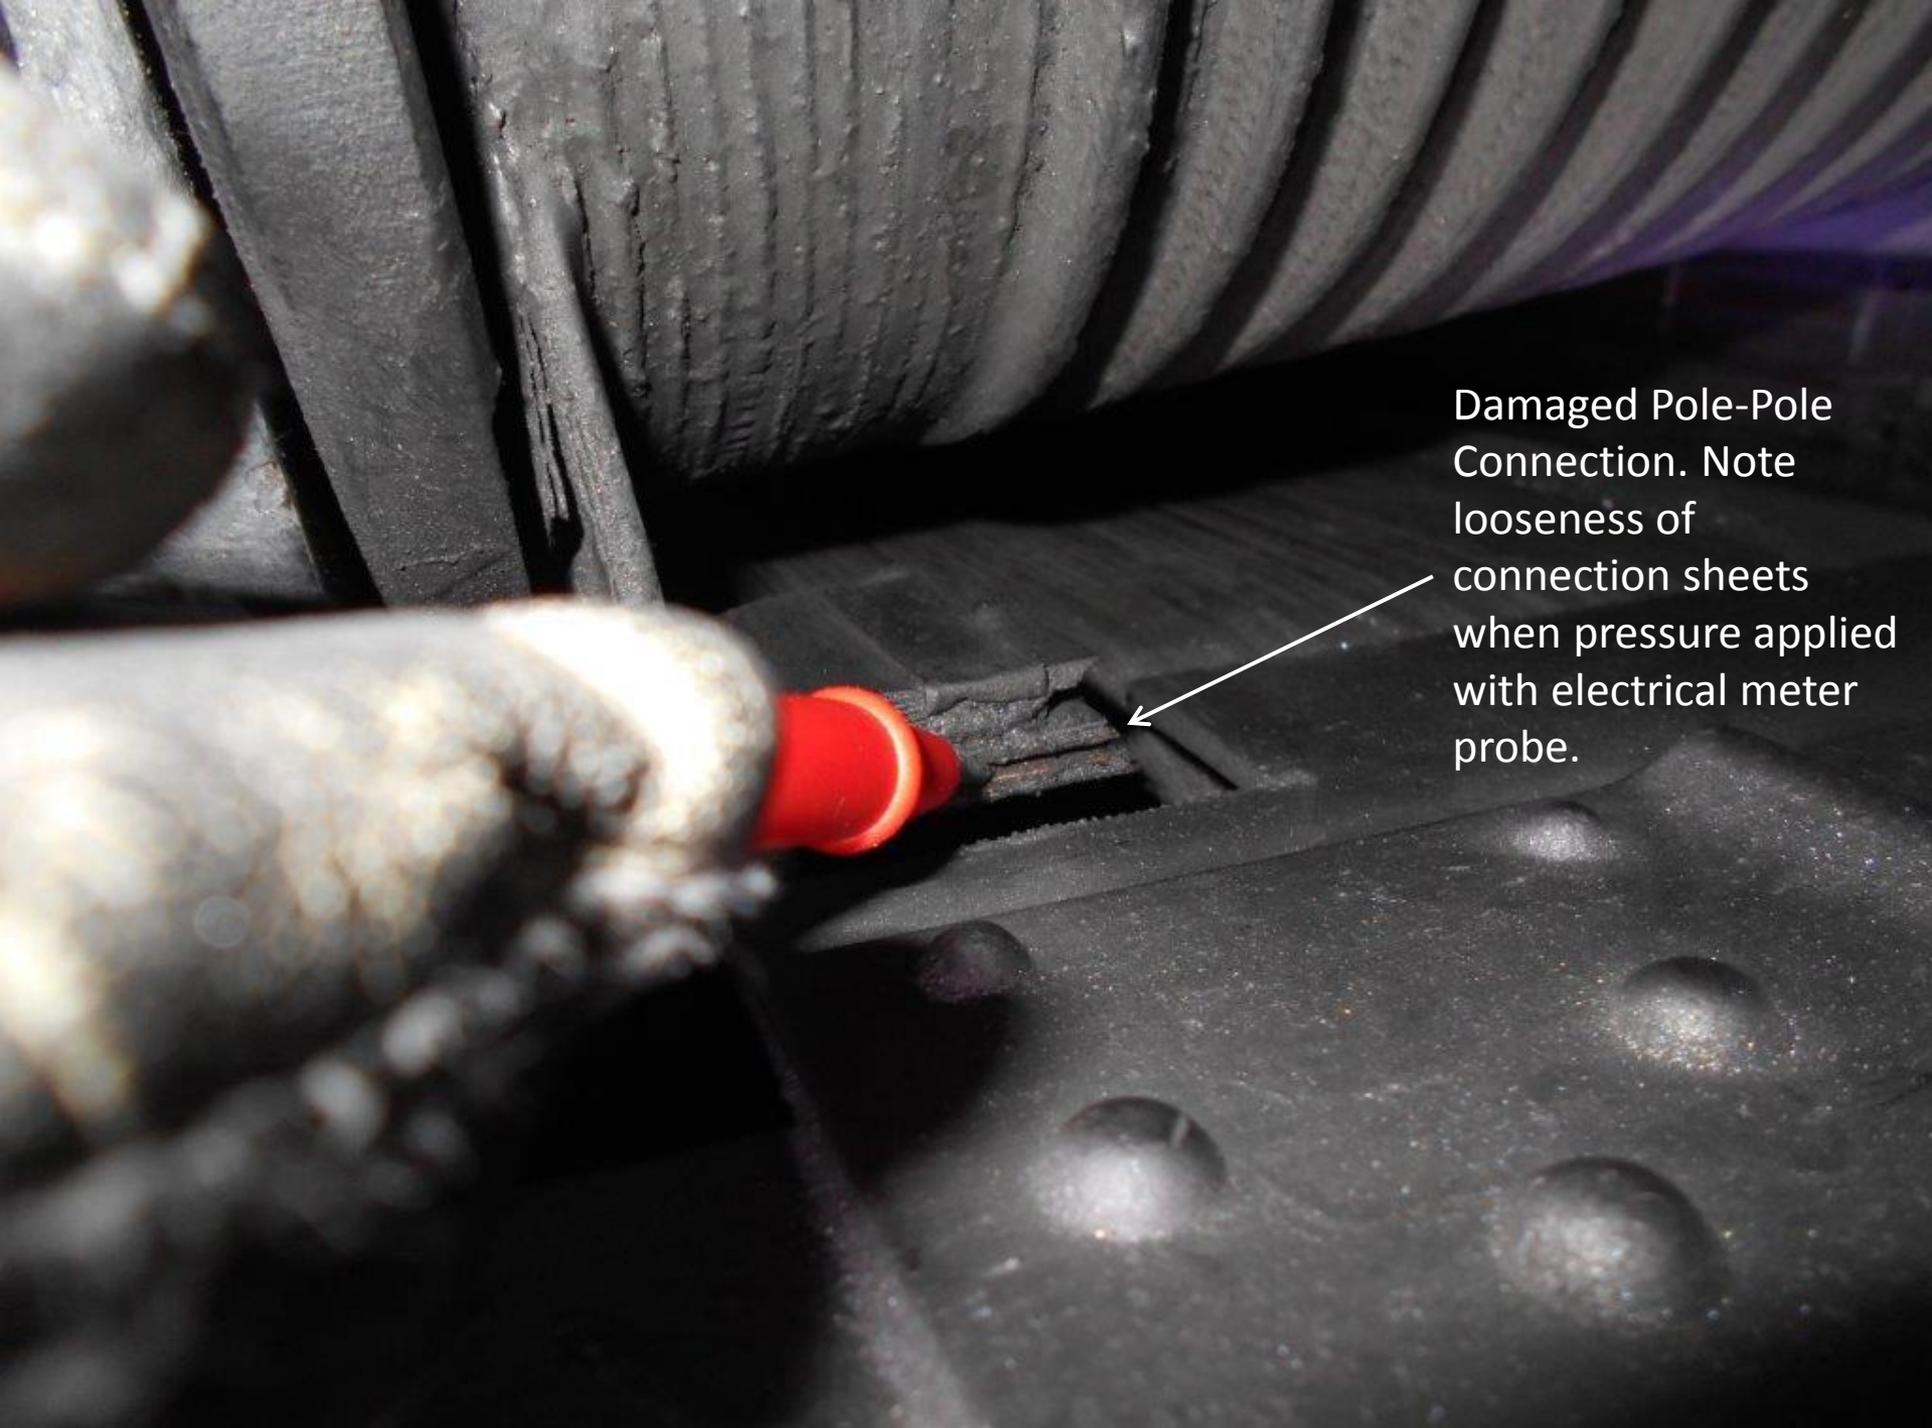
Damaged Pole-Pole Connection. Note brazed end cap on this portion is missing.

Damaged Pole-Pole Connection. Note looseness of connection sheets when pressure applied with electrical meter probe.

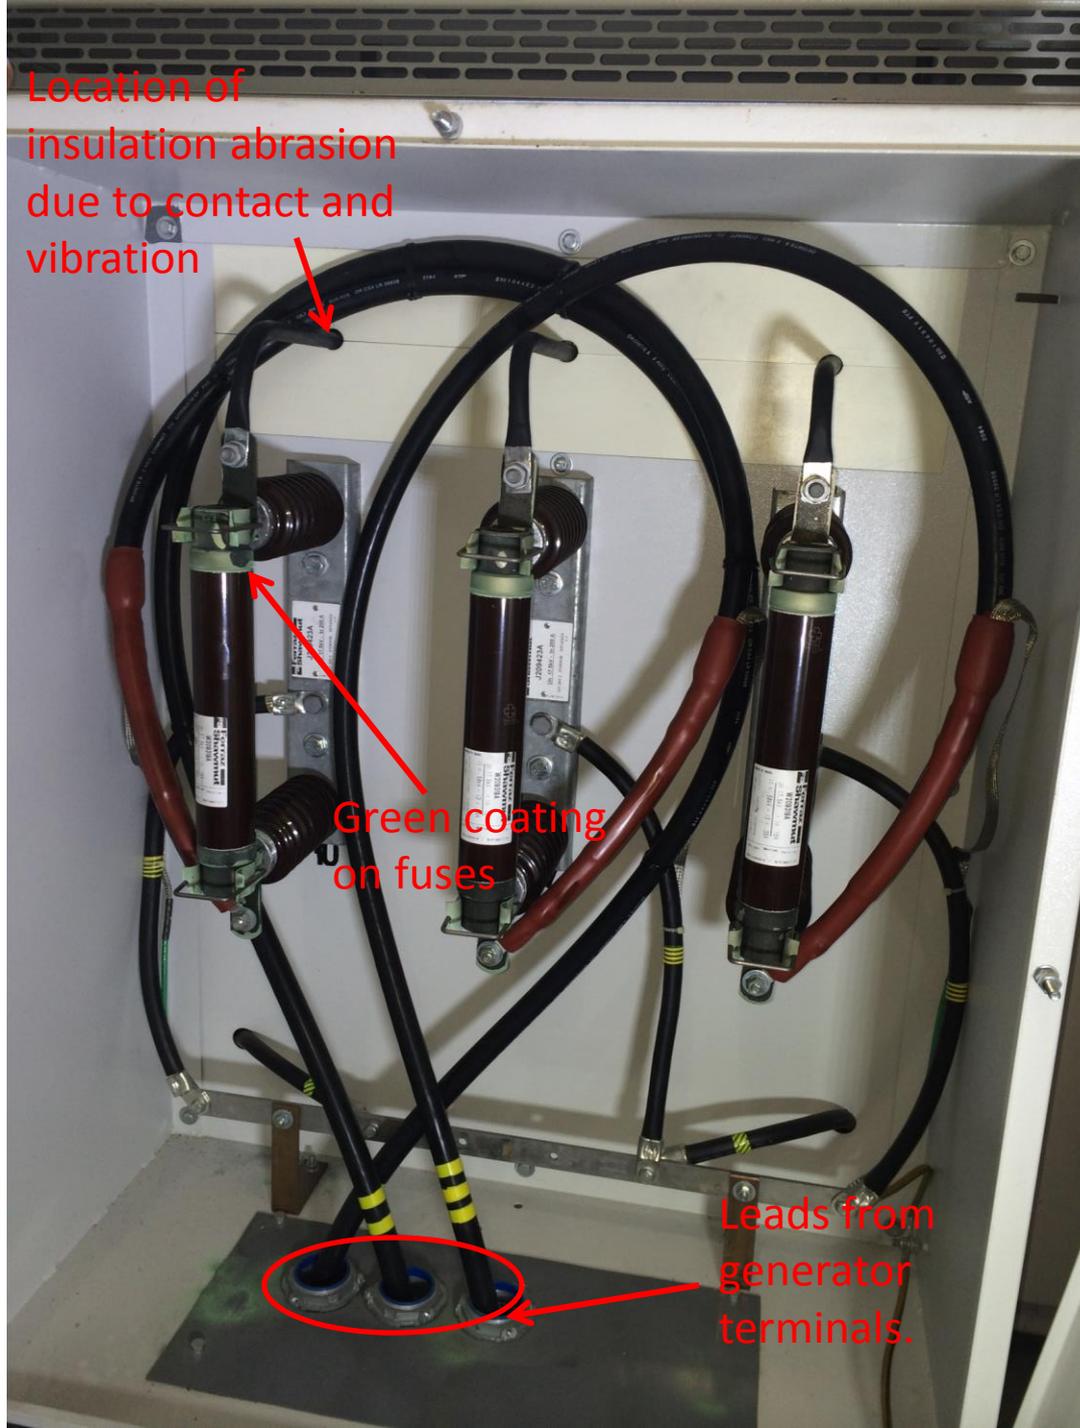
Location of
insulation abrasion
due to contact and
vibration

Green coating
on fuses

Leads from
generator
terminals.

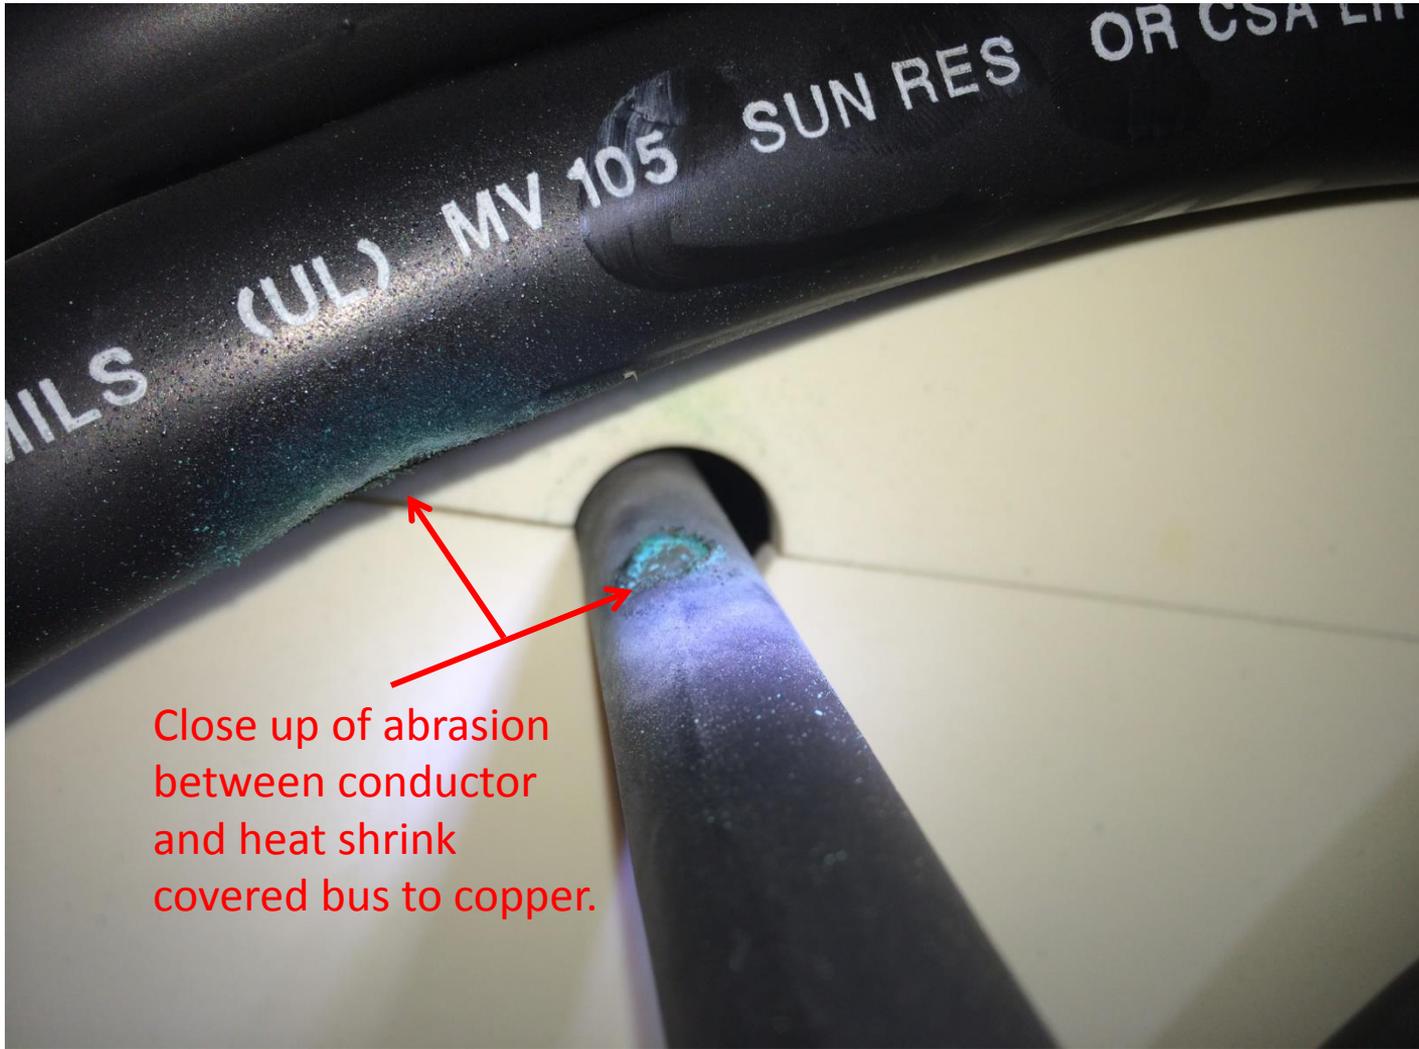
Close up of abrasion
between conductor
and heat shrink
covered bus to copper.
