# Howard A. Hanson Dam Seepage Issues, Risk Assessment and Repairs

Richard Smith, PG  
Seattle District  
U.S. Army Corps of Engineers  
May 2012

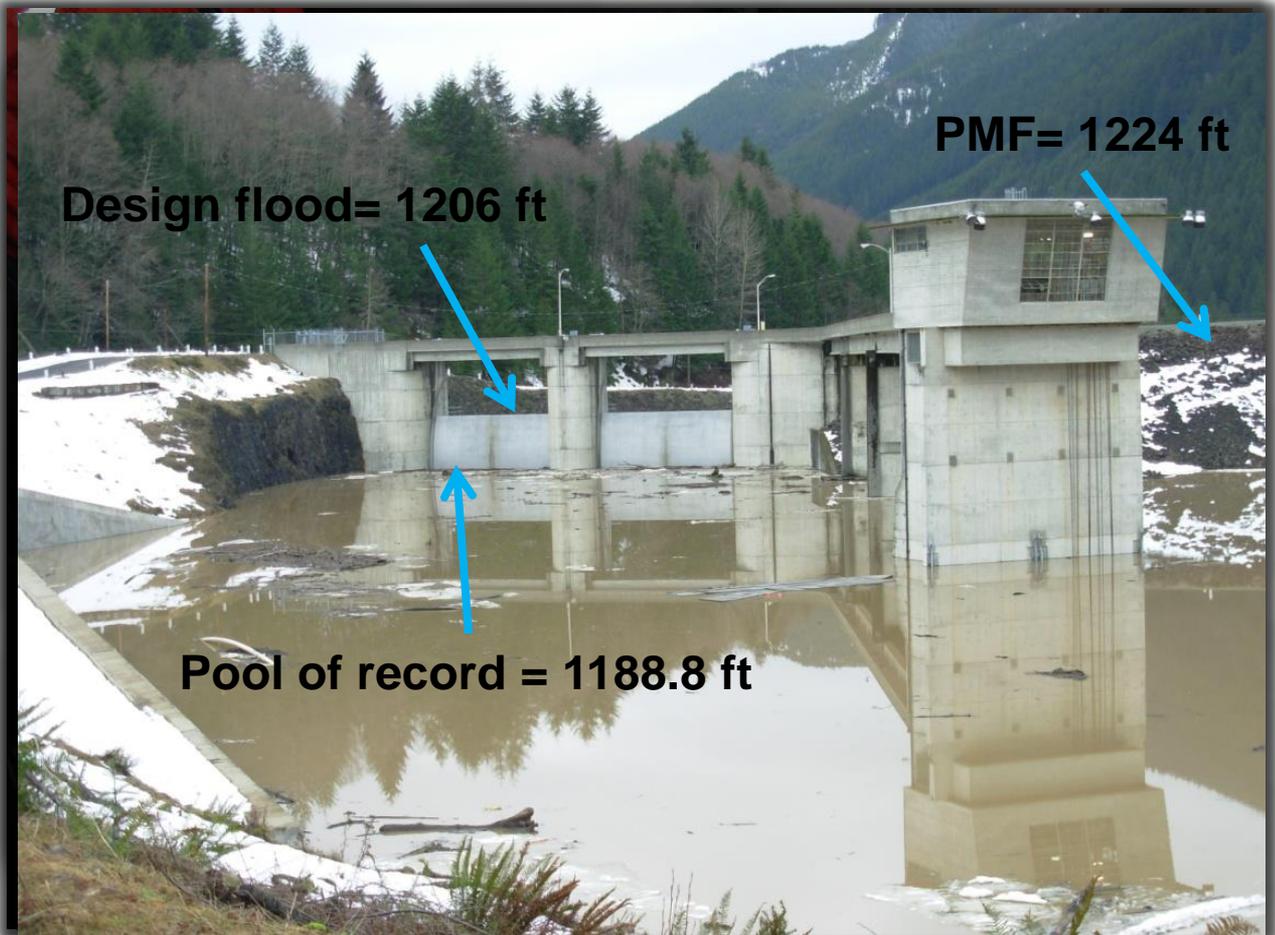
Pool of Record

Vertical Tunnel Drains

Turbidity from Tunnel Drain

Depression on Upstream Face

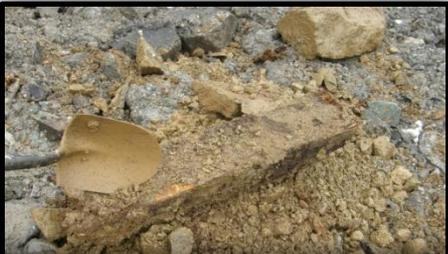
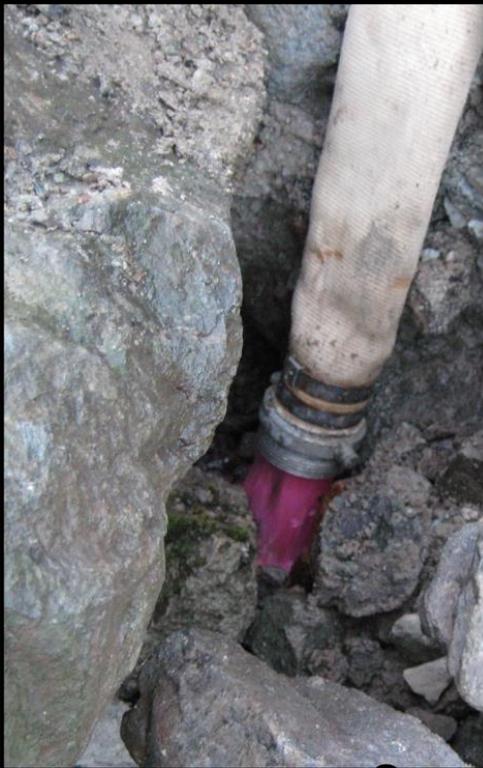
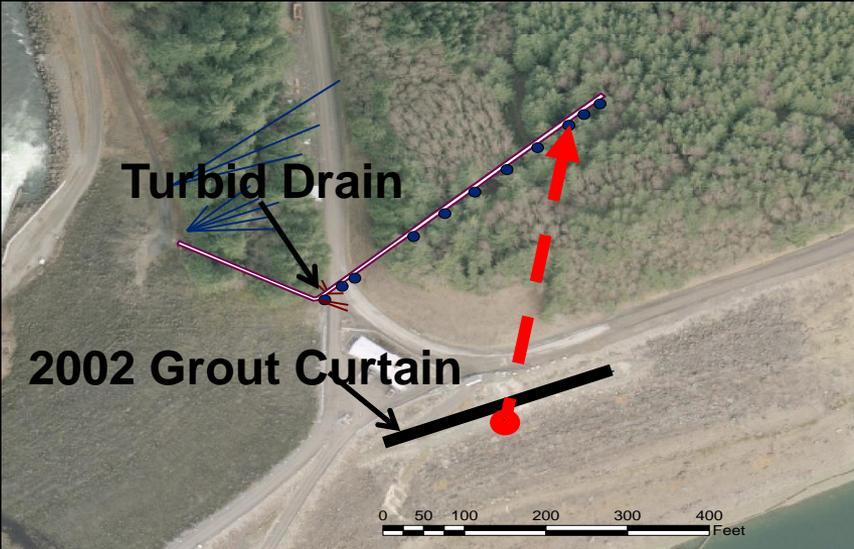
Unfiltered Vertical Drains

No Hydraulic Connection  
Between Turbid Drain  
and Depression

Depression Caused by Collapse  
of 1950's Era Exploration Tunnel.

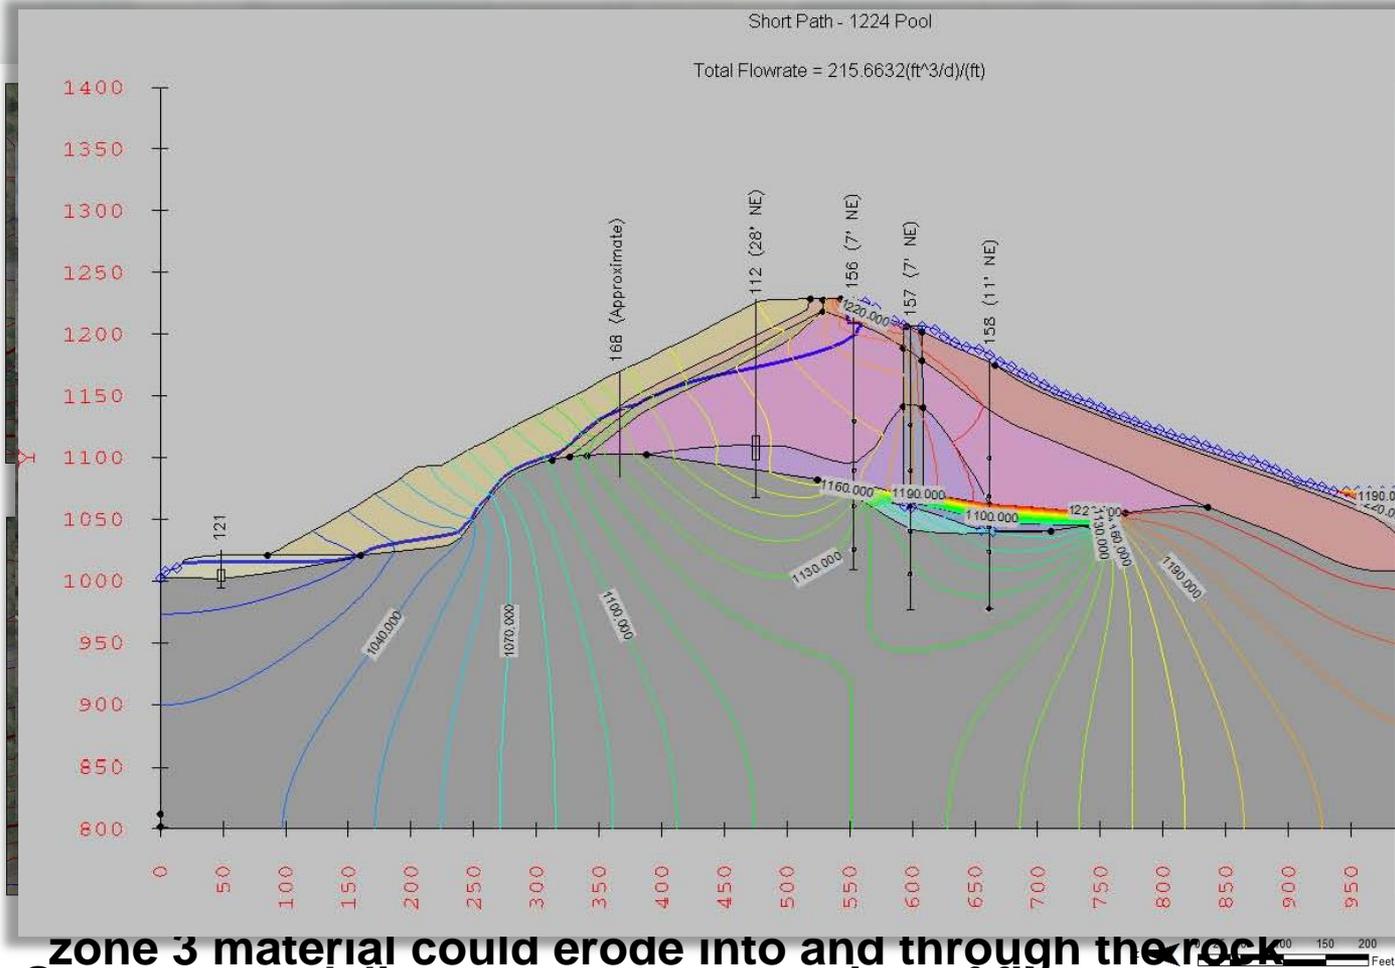
# Short Path Seepage Failure Mode

Downstream filter & drain

Lack of gravel drain

Filter incompatibility

zone 3 material could erode into and through the rock shell. Seepage modeling suggests saturation of filter material. Gravel drain ends at edge of rolled rock fill then incompatible material under greater than design flood pool conditions. rock shell and rock toe in contact with zone 3 filter.

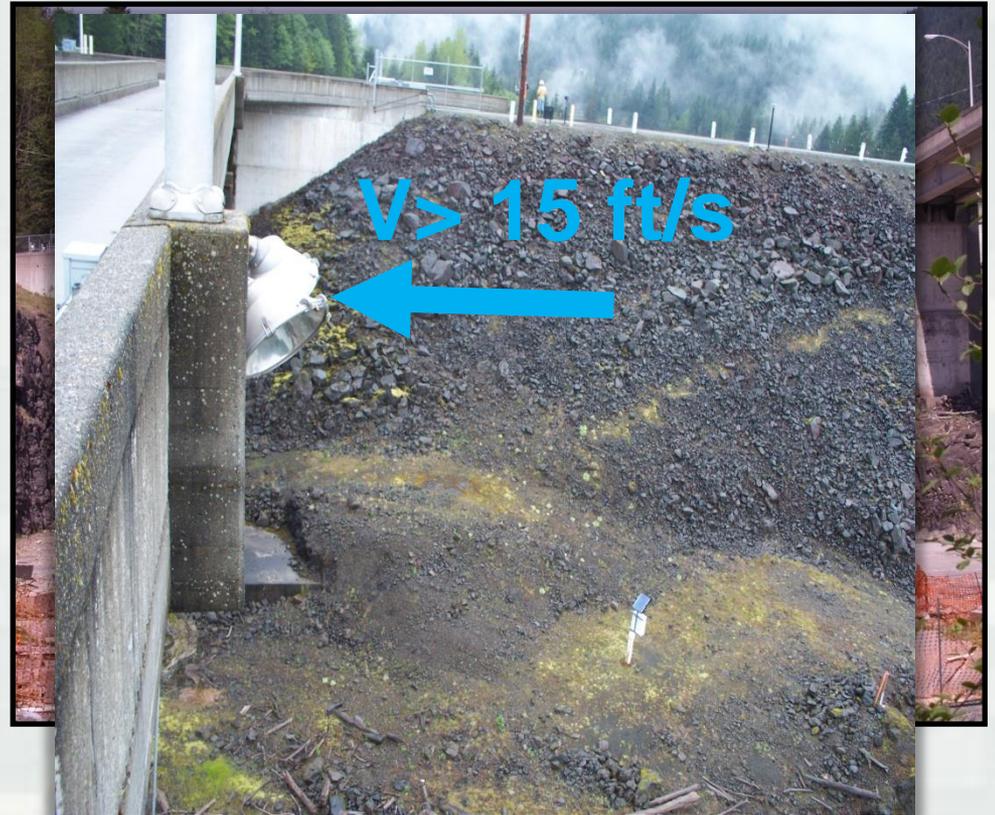
PFM 3 – Spillway debris plugging

High velocity, modeled water flow toward spillway.  
PFM 17 – Left embankment erosion

Spillway plugged by debris  
would lead to dam overtopping.

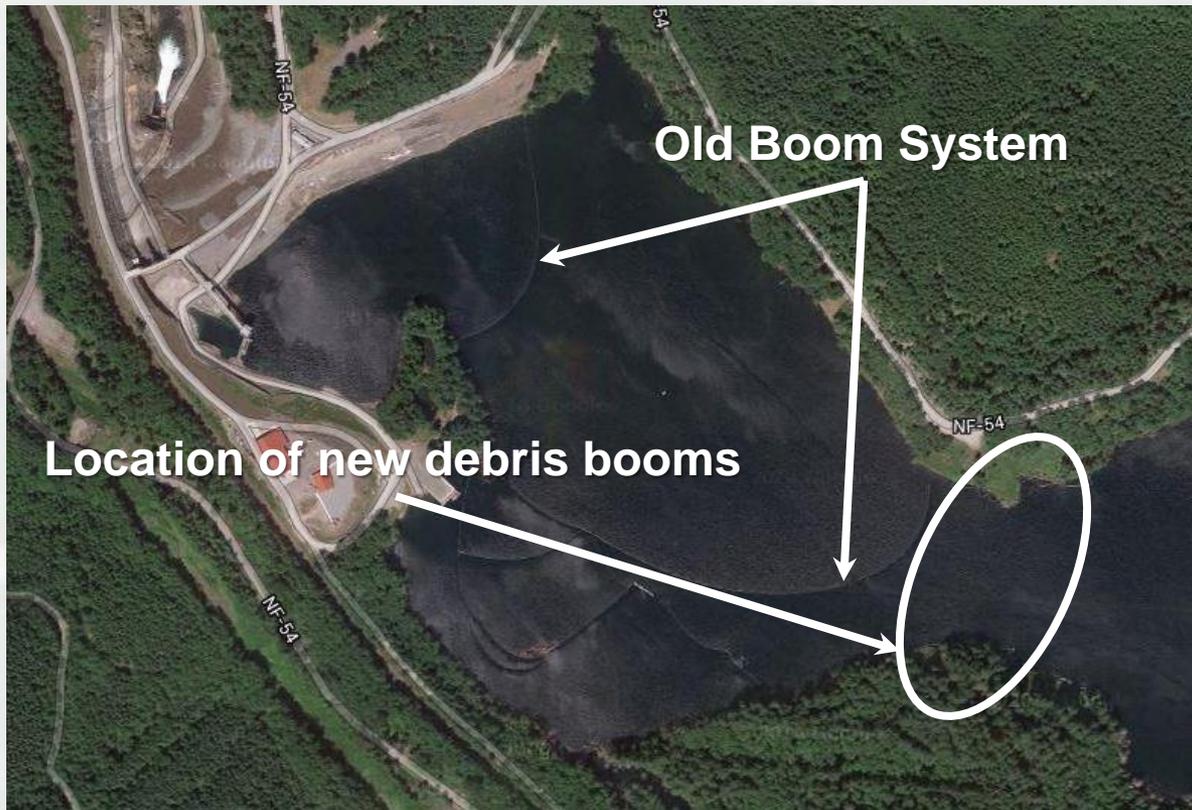
Original debris boom system barrier at elevation MFL 206 - not functional when spillway gates opened.
