Unit #5 and Unit #6
Head Cover Erosion
Repair Project

PUGET
SOUND
ENERGY

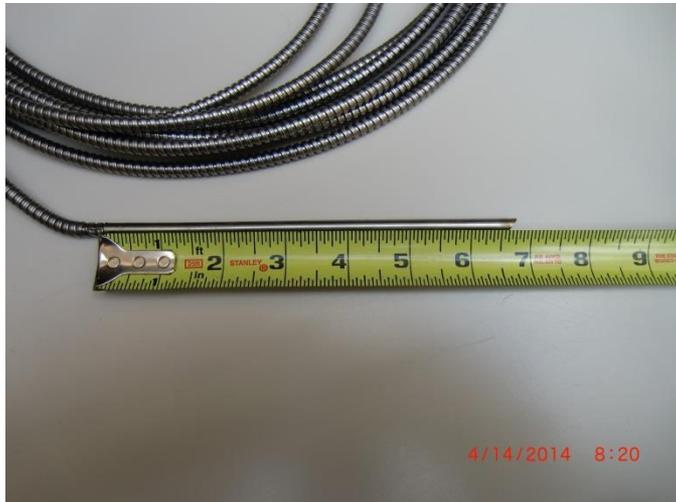
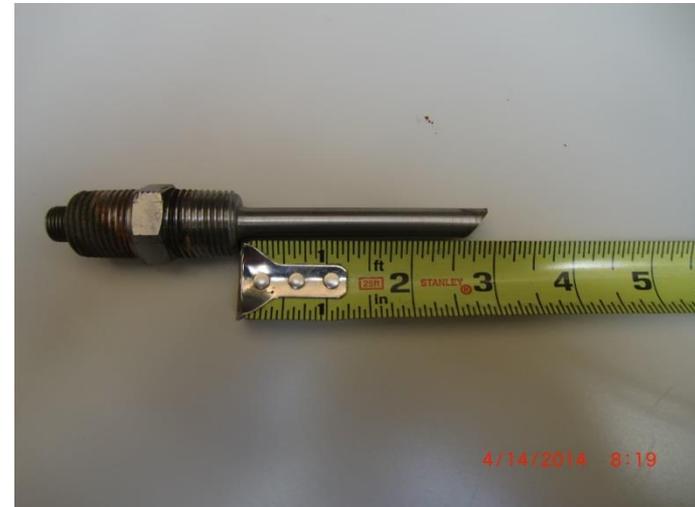
- February 2013 – the new Unit #6 was commissioned.
- March 2014 - An unexplained RTD failure for the upper stationary seal ring. Water was encountered when attempting to replace the RTD which was installed in a thermowell.
- The wear pattern on both the RTD and the thermowell suggested physical contact with the crown of the runner.

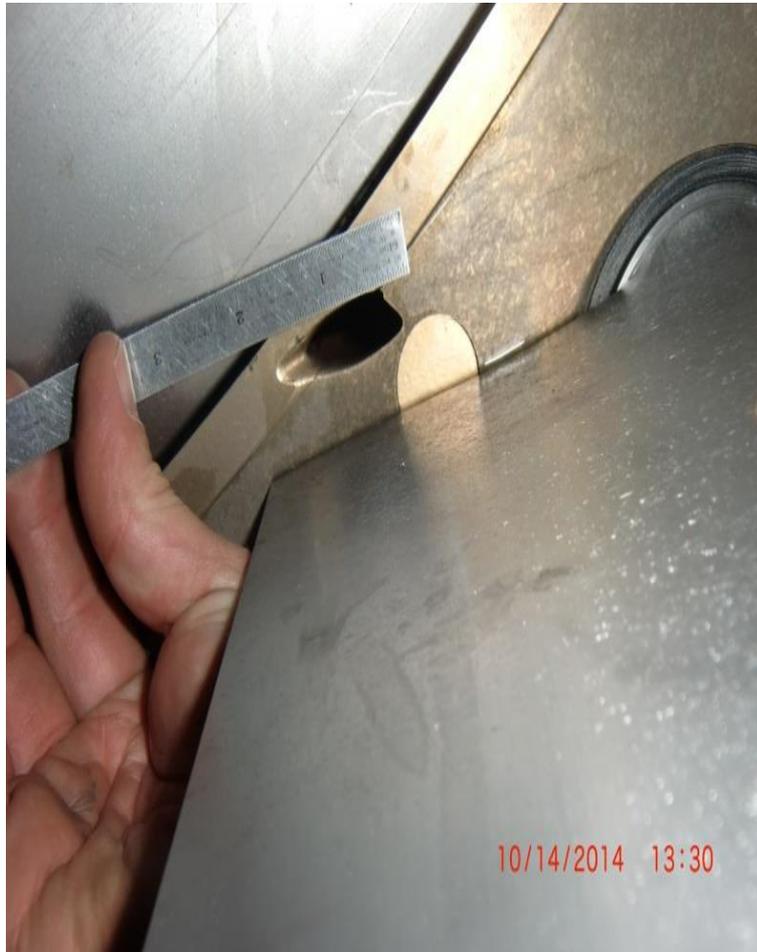
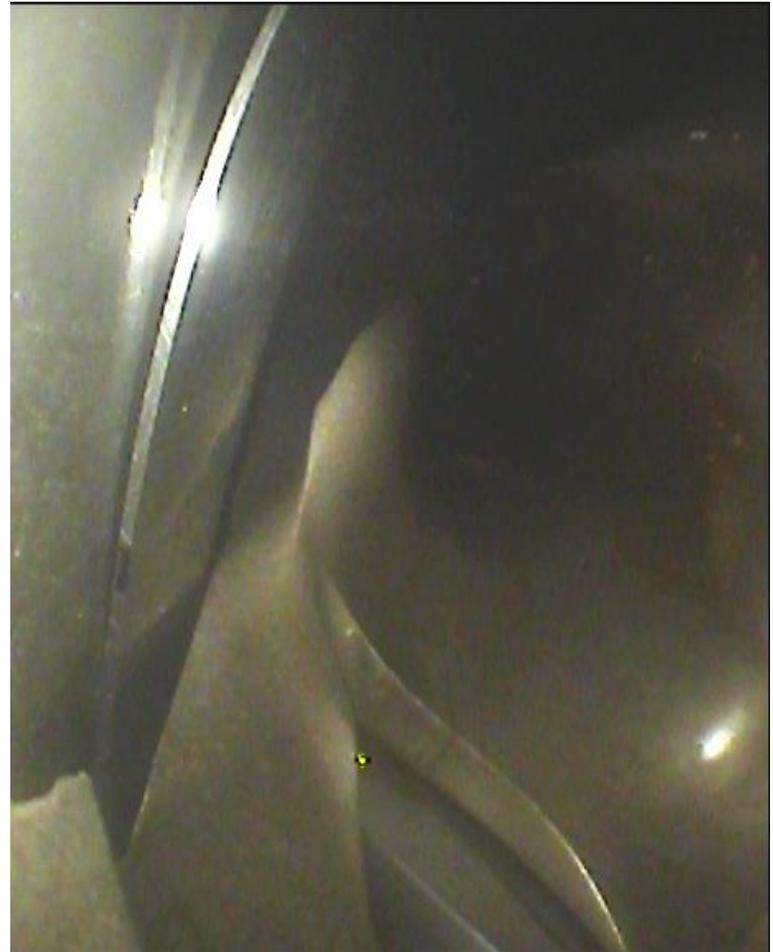
Unit #6 Head Cover Erosion

- April 2014 – Initial borescope inspection through the RTD hole in the head cover with inconclusive results, couldn't locate physical damage on the runner crown.
- October 2014 – Cavitation warranty inspection of Unit #6, the extent of the erosion damage to the head cover and upper stationary seal ring is fully realized.

- 7,130 total operating hours prior to cavitation warranty inspection.
- Stationary upper seal ring - Nickel Aluminum Bronze (B271, C95500).
- Rotating upper seal ring – Stainless Steel (A182, grade F6NM).
- Unit #6 immediately removed from service and negotiations were initiated with the turbine supplier.

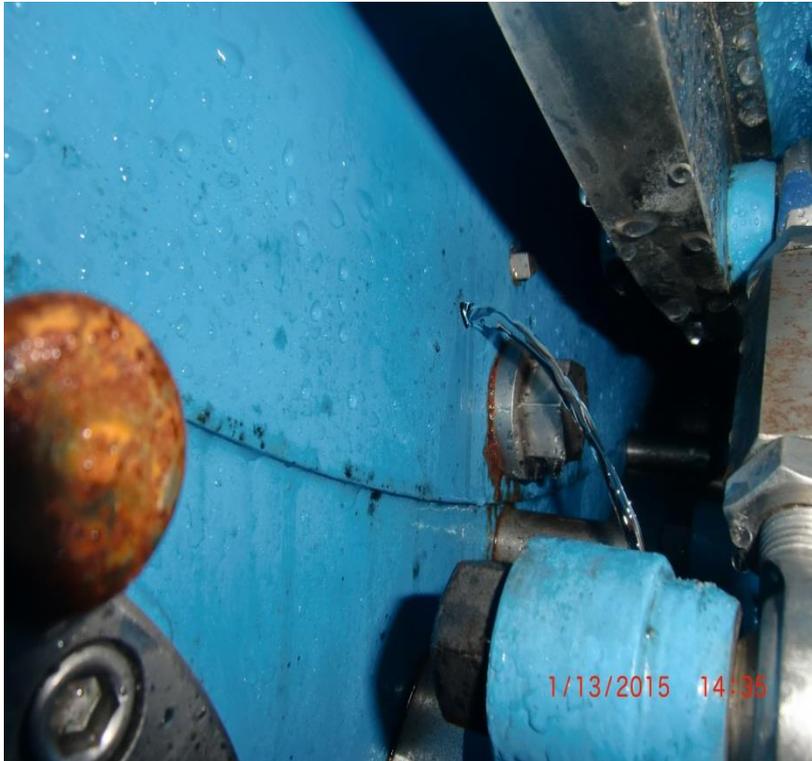
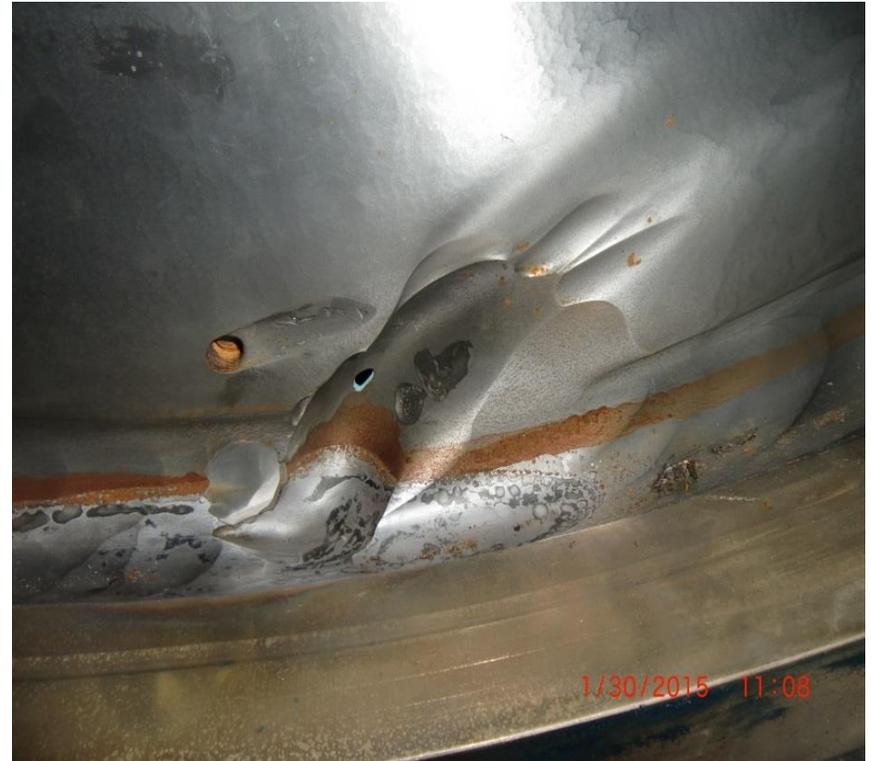
Unit #5 Head Cover Erosion

- Commissioned in October 2013.
- October 2014 – Initial inspection of Unit #5 head cover due to the erosion conditions discovered on Unit #6. Total accumulated operating time was 5,545 hours, the upper seal ring clearances were found to be within specification and some erosion was noted on the plugs for the upper seal ring inspection ports.
- January 2015 – A hole appears through the Unit #5 head cover, total accumulated operating time was 7,397 hours.
- The head cover is fabricated from 1” thick A-36 carbon steel.

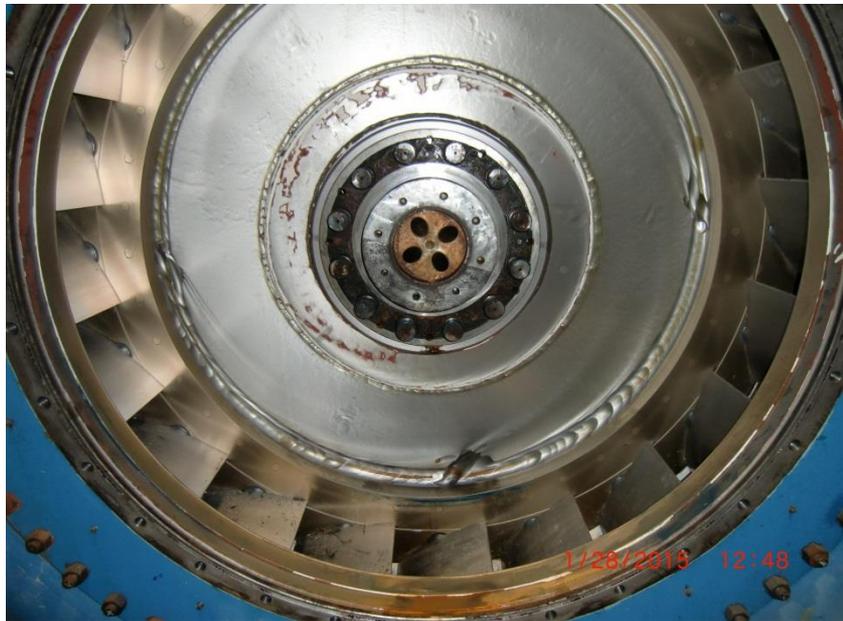
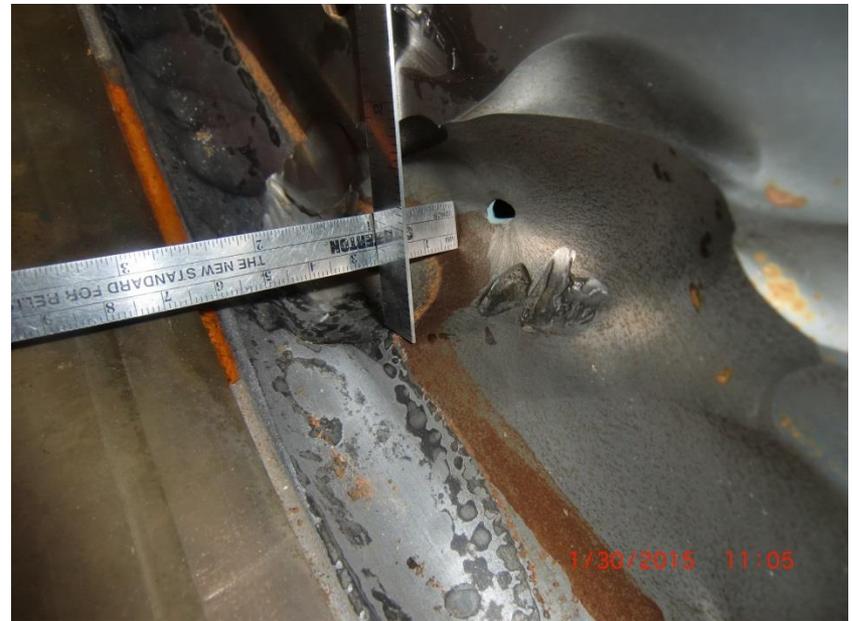
- Severe erosion around the entire circumference of the head cover immediately adjacent to the upper stationary seal ring.

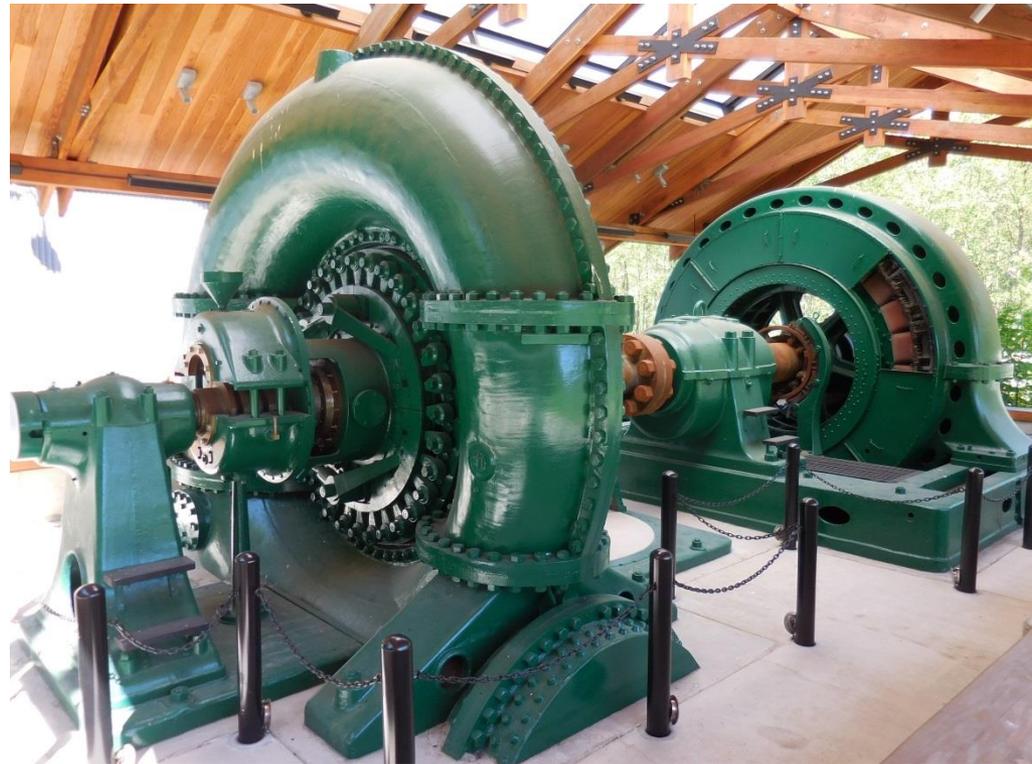
- The original Unit #5 was built by Platt Iron Works and it was a very early Francis turbine design with virtually no replaceable wear surfaces within the water passage.
