Project Title: Headgate Repair Pit Upgrade

Dam and Reservoir Project: Lower Monumental Dam

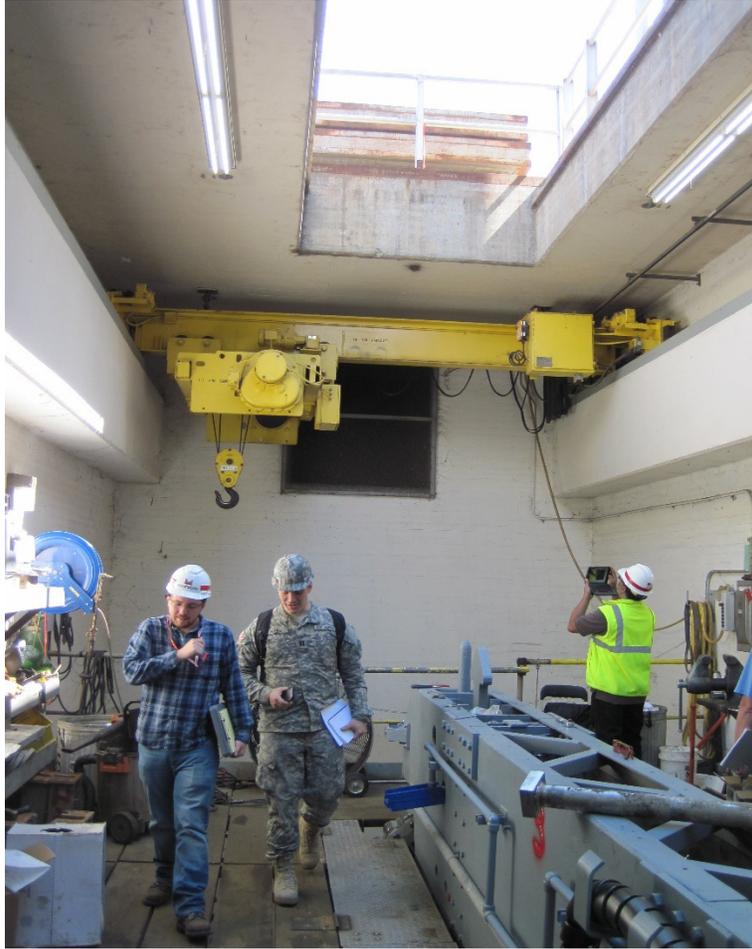
The Lower Monumental dam and reservoir project powerhouse was originally constructed in the 1960s with an approximately sixty-foot deep headgate repair pit equipped with work level walkways, distributed lighting, utilities and equipment to maintain the powerhouse headgates. A headgate, also called an intake gate, is a structure that is lowered in front of a hydroelectric generating unit to block off the flow of water into the unit so that maintenance can be performed. Maintenance activities on the headgates that occur in the gate repair pit include general corrosion repair requiring sandblasting and paint and replacement of components that ensure reliable operation of the gate, reduce corrosion and prevent water from entering the work area when the headgate is installed. Since the original construction of the powerhouse, fish screens have been added to the generating units. These screens are also maintained in the headgate repair pit, but, since screens were not utilized when the pit was built, the pits are not designed to suitably accommodate the dimensions of the fish screens in order to perform repairs. Because of this, gaps between the scaffolding and the fish screens present fall hazards for Corps staff.

Lower Monumental Headgate Repair Pit, including wooden planks.

This alternative would replace the scaffolding and add adjustable work platforms on all scaffolding levels which would allow for a better fit with gates and screens being worked on, thus improving safety and accessibility to the work areas. Receptacles, lighting, drainage, and exhaust systems will be upgraded to address all of the deficiencies of the current arrangement. The new structure would meet current capacity and safety standards. Platform extensions will retract to allow for adequate clearance when placing headgates and fish screens within the repair pit and eliminate gaps that present fall hazards when fully extended. The new ventilation system will provide adequate air flow in the repair pit and prevent infiltration to the powerhouse. The new lighting will be designed to provide sufficient light and eliminate current explosion hazards. The only disadvantage of this alternative is the initial cost.

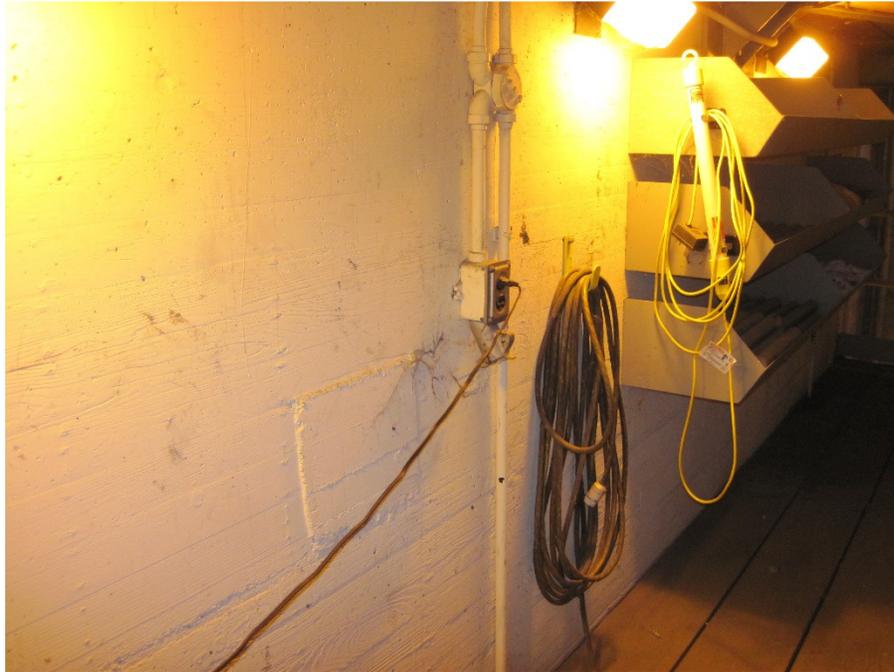
This project will upgrade the headgate repair pit within the Lower Monumental powerhouse to meet safety requirements and provide an efficient work environment. The current scaffolding does not meet current safety codes (OSHA and NFPA) or provide an efficient work environment to perform headgate rehabilitation and necessary fish screen repairs. There is also wood planking in the scaffolding that presents a fire hazard during welding operations and load restrictions that are limiting to Corps work. The existing drainage system is poorly designed with insufficient slope to effectively drain, leaving the floor continually wet and slippery; the project will improve the floor slope and be modified to eliminate this safety issue. The repair pit also does not have sufficient ventilation, adequate lighting, or explosion-proof lighting needed to perform required painting and welding operations.

Lower Monumental Headgate Repair Pit: lighting and extension cords.

The upgraded system will be designed to accommodate work on headgates, hydraulic gate cylinders, and fish screens. The new design will incorporate an extendable work platform that will make work more efficient and safe by enabling it to retract to allow additional clearance for all gates and screens and to extend to fit to variously sized equipment thereby eliminating existing gaps that can lead to fall hazards. The design will also allow for room for the overhead crane to operate to transport materials and equipment between floors/tiers. Each tier of the scaffolding will have the lighting systems upgraded with explosion proof vapor tight wall-mounted light fixtures, new 120V and 240V welding outlets to prevent trip and fire hazards from extension cords. The capacity of the
