# Phase I General Route Characterization and Geologic Hazard Assessment

## I-5 Corridor 500 kV Transmission Line Oregon/Washington

File No. 2081-032-00

November 22, 2010

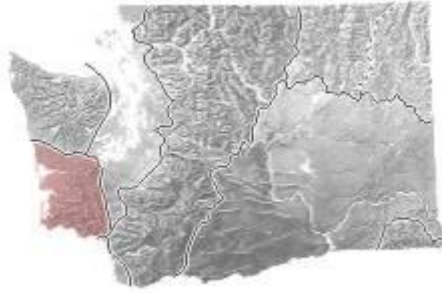
### Segments 1 - 3 and A through E

Segments 1 through 3 and A through E are mapped within **Willapa Hills province**, which rises to 3,110 feet above sea level locally and is part of the Coast Range. The province is situated between the Olympic Mountains to the north and the Columbia River to the south.

Tertiary age igneous and sedimentary rocks are exposed in the Willapa Hills. Beginning with the Eocene Crescent Formation basalts (**basalt flows**), thick sequences of sedimentary (**Tertiary and older sedimentary rock**) and volcanic rocks of Eocene through Miocene age are present.

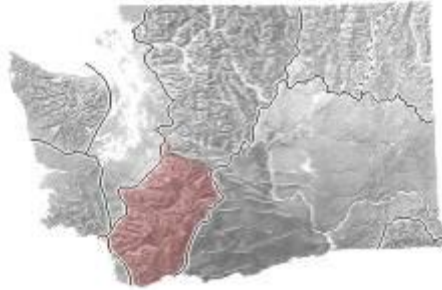
### Segments 4-24, 26-34, F - P, U-W

Route Segments 4 through 24, 26 through 34, F through P and U through W are located in the southern portion of the Cascade mountain range. The **South Cascade** province in Washington consists predominantly of Cenozoic volcanic rocks and associated deposits. Basalts of the Columbia Basin (**Basalt Flows and Intrusive Rocks**) lap onto the southern Cascades to the east, and the Puget Lowland is situated to the west. To the south, the Cascade Range is severed by the gorge of the Columbia River.

By the end of the Mesozoic, basement rocks were eroded to a plain on which sediments were deposited during the Eocene. These sediments are now represented by non-marine shales, siltstones, and sandstones (**Tertiary and Older Sedimentary Rocks and Deposits**).

Basalt and andesite (**Andesite Flows and Intrusive Rocks**) volcanism of the Cascades were initiated during the Eocene age. During the Oligocene, the Neogene, and through Quaternary time, mountain building in the form of volcanism predominated. Volcaniclastics, lahars, ash beds, and mud flows from volcanic centers filled depressions (**Volcaniclastic Deposits**) in the southern Cascades. They interfingered with nearshore sediments to the west. During the middle and late Miocene, Columbia River basalt flowed (**Basalt Flows**) up against the eastern flanks of the Cascades; these flows were later arched upward with uplift of the range.

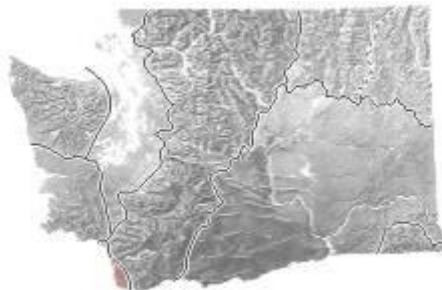
### Segments 25, 35- 52, Q - T

Segments 25, 35 through 52 and Q through T are generally located in the **Portland Basin province** that marks the northern terminus of the Willamette Lowland of Oregon. In Washington, the northern portion of the

Portland Basin is characterized by the low topographic relief of western Clark County.

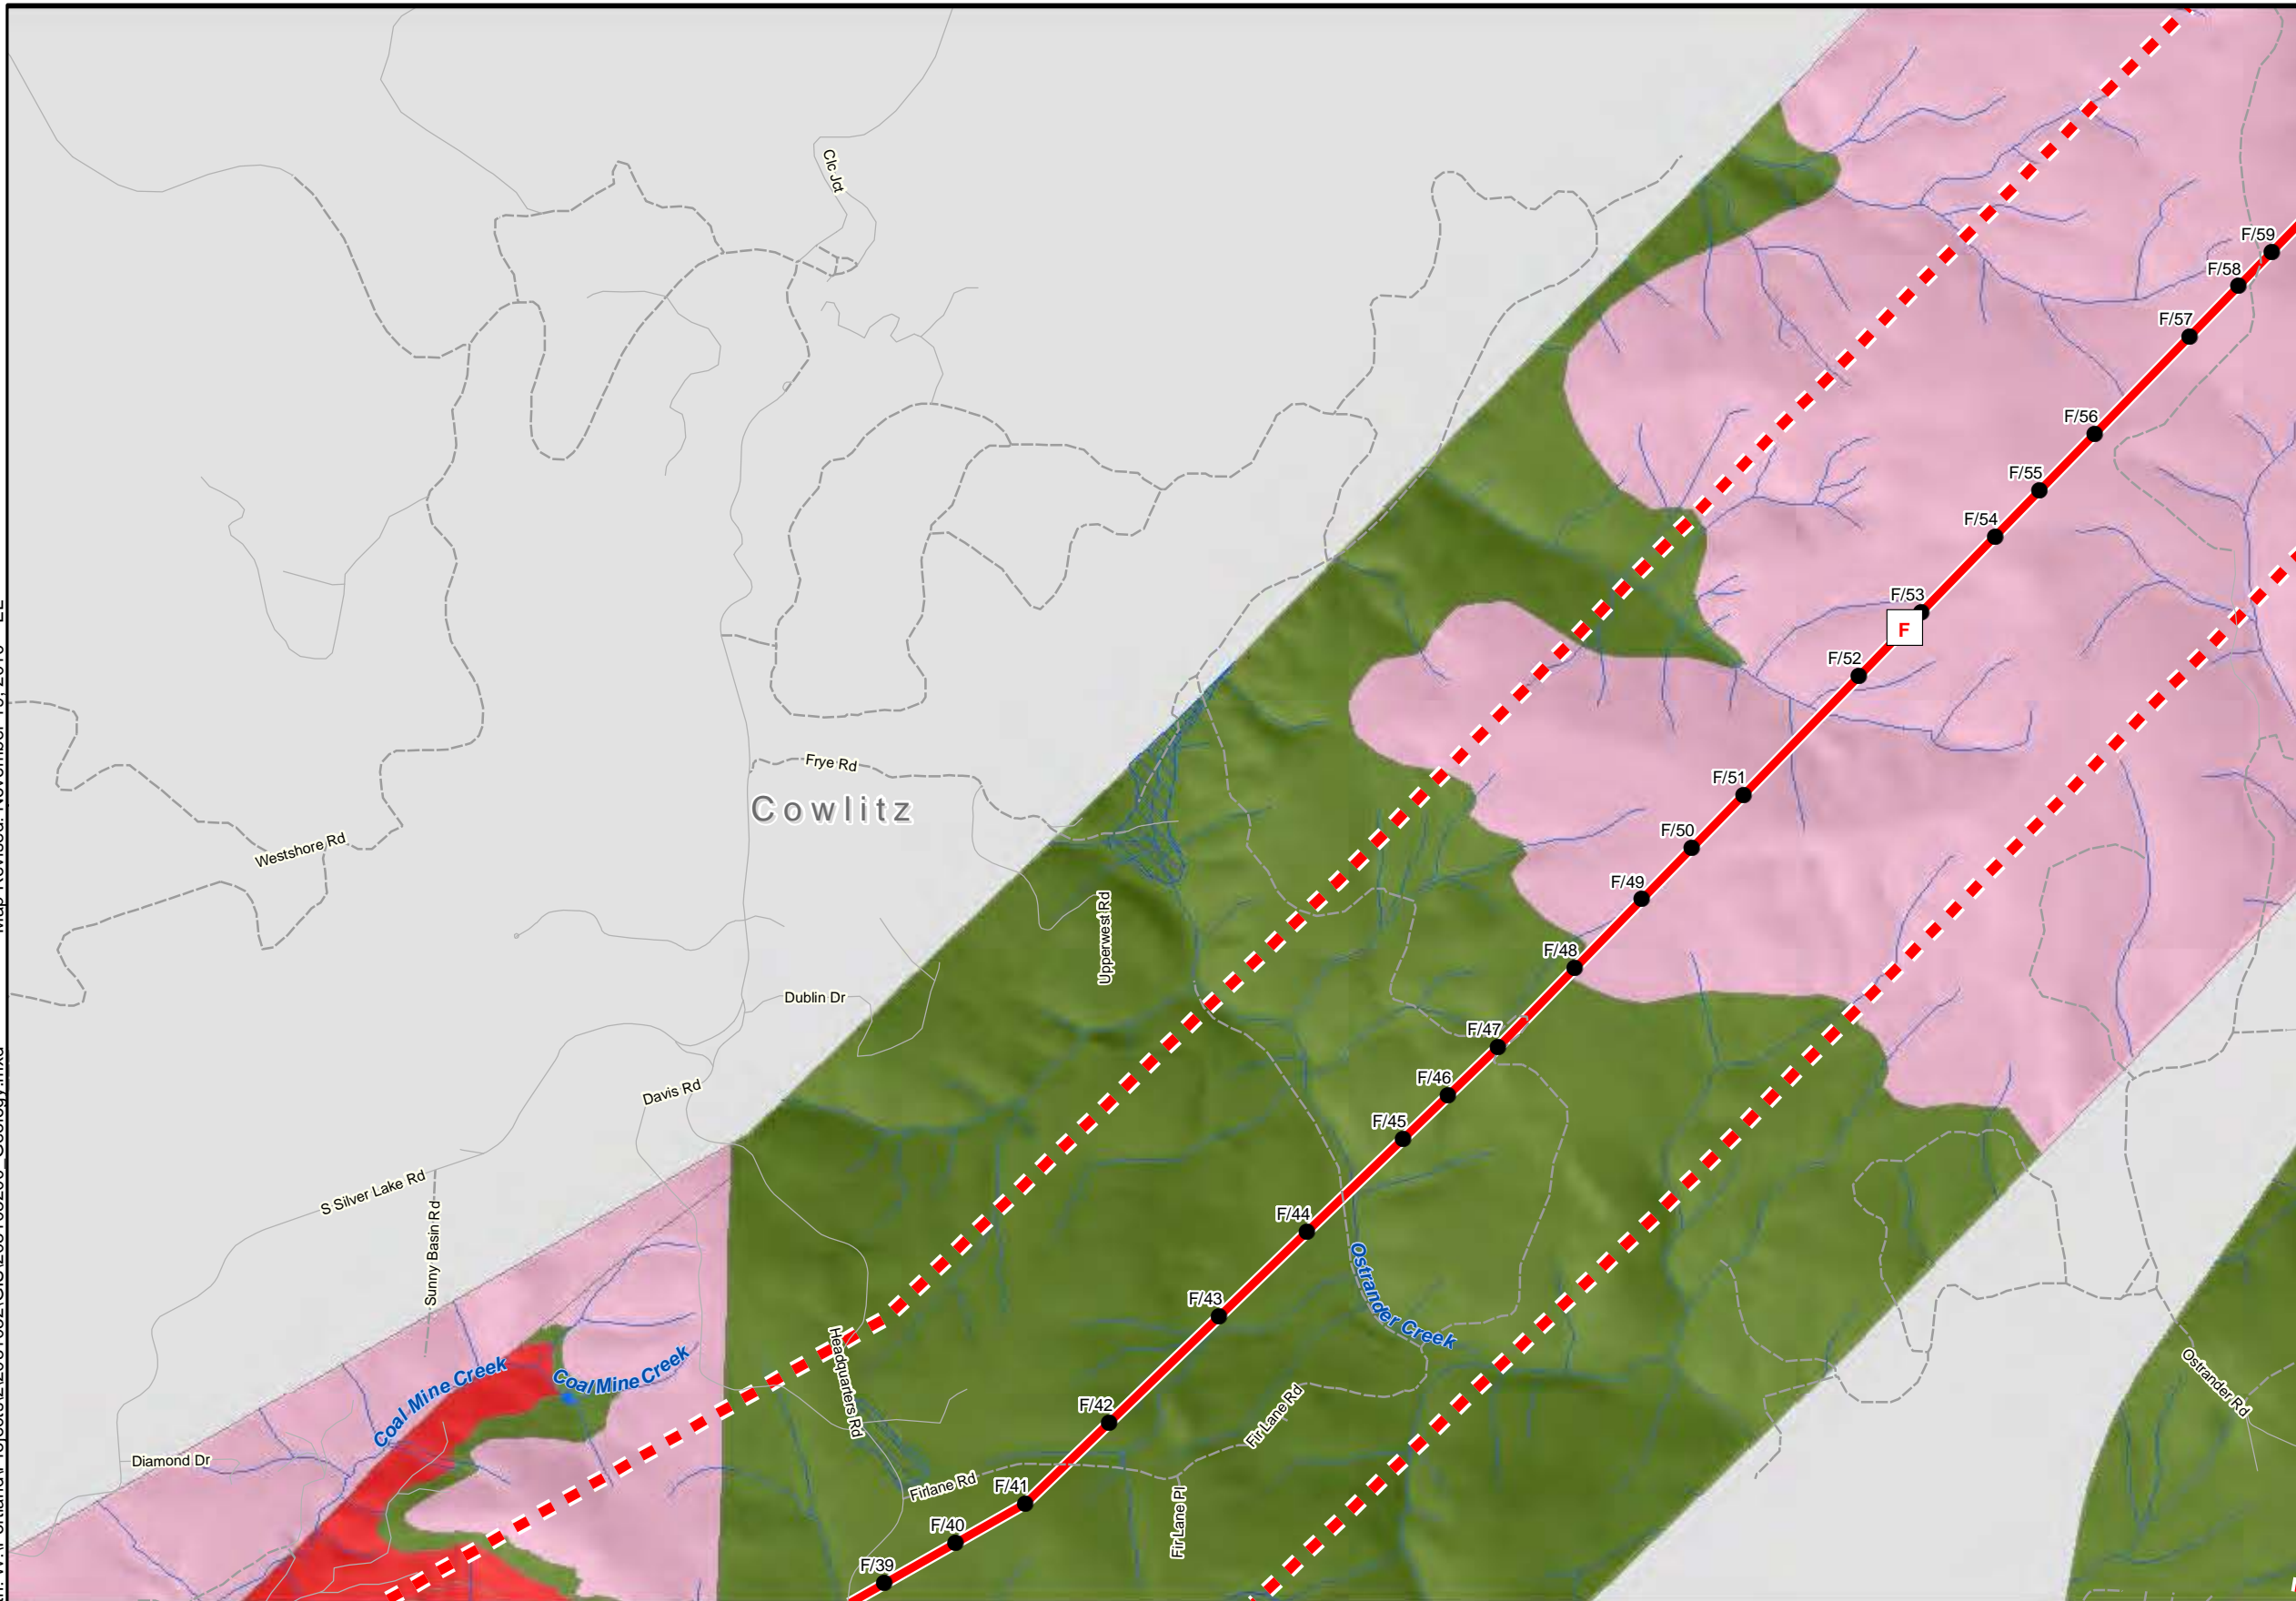
Map Page  
 A2  
 Sheet  
 5 of 156

Geology, Shallow Bedrock, Shallow Groundwater  
 BPA I5 Transmission Corridor Project  
 Clark, Cowlitz and Multnomah Counties

In general the segments cross three physiographic provinces that include the Willapa Hills, South Cascades and Portland Basin (from north to south). Province descriptions were developed from Lasmanis (1991). Key geologic unit descriptions referenced in the attached “Geology, Shallow Bedrock and Depth to Bedrock” maps (Sheets 1 through 52) are provided in parenthesis below where appropriate.
