FY 2000 In-Stream Habitat Projects

CHARLEY CREEK PROJECT #1 FISH HABITAT IMPROVEMENT
 PLAN VIEW
 CHARLEY CREEK, ASOTIN COUNTY, WA.
 USDA NATURAL RESOURCES CONSERVATION SERVICE

The objectives of the 1998 projects are to meet the goals outlined above by using bioengineering methods of structural design applicable to stream type and conditions. The term bioengineering, as used in this document, refers to the use of living (tree and shrub plantings) and inert materials (rock, logs, and root wads) combined with sound engineering principles for the purpose of streambank stabilization, in-stream fish habitat development, and riparian habitat restoration. Nearly every structure planned, either as a single structure or as a component of a multiple structure system, will provide numerous benefits in progressing toward the above goals. **Appendix A** contains generic structure drawings, descriptions, construction, benefits and a description of the NRCS/District tree planting agreement and species list.

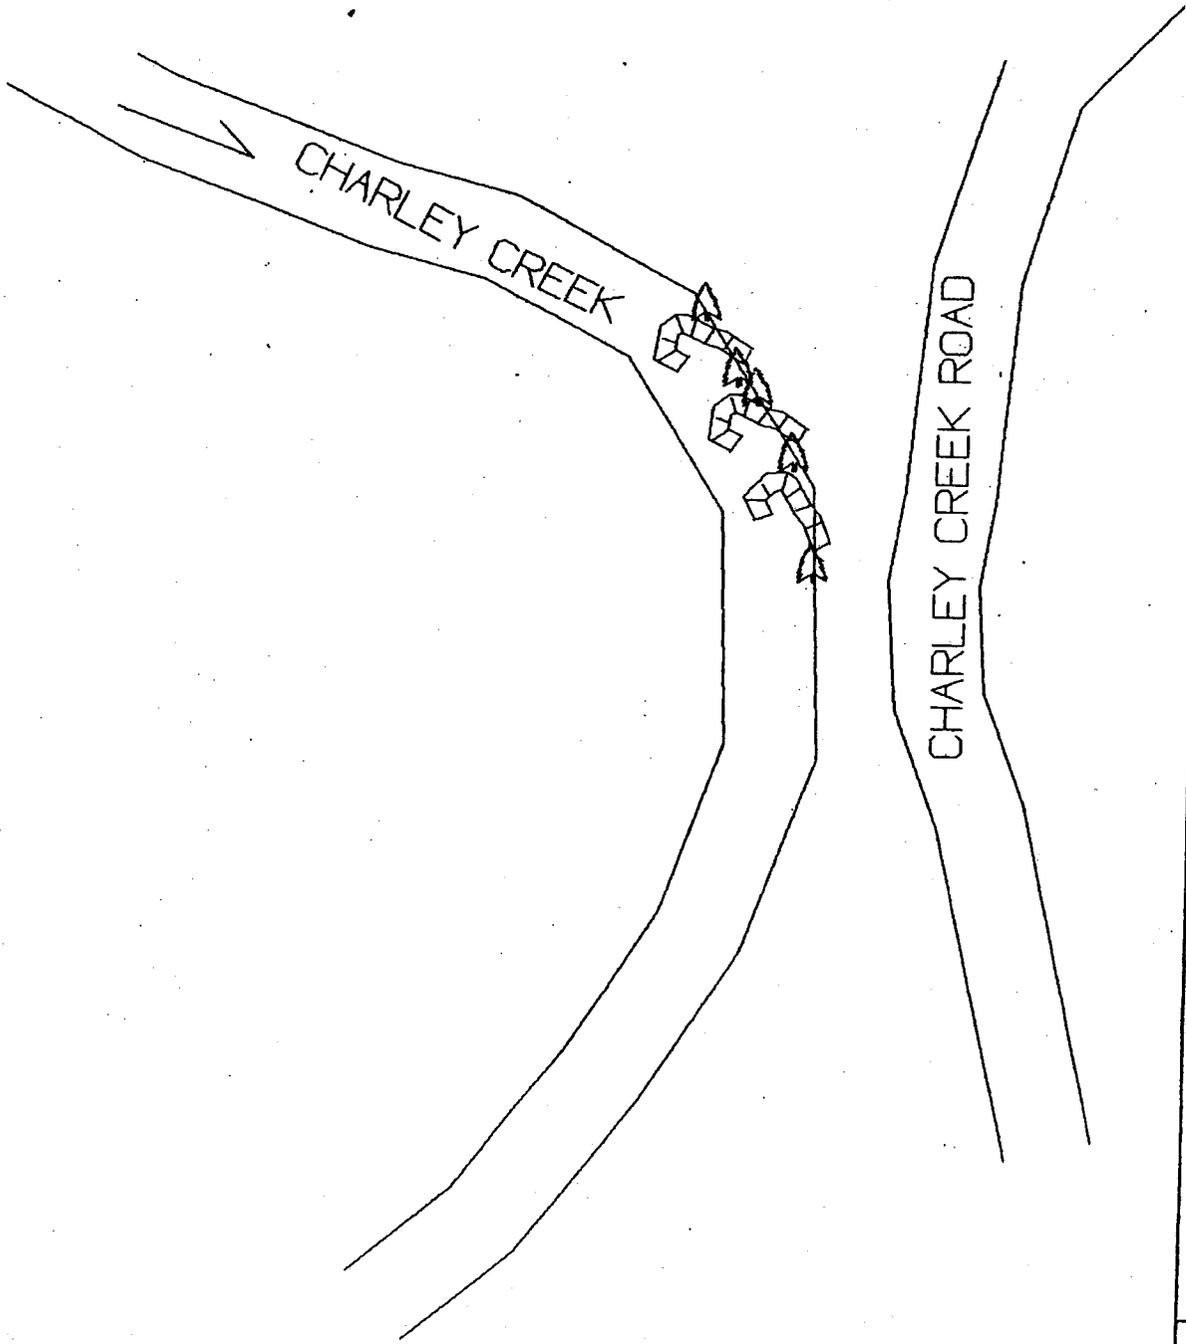
The purpose of this project is to create pool forming structures, to stabilize an actively eroding bank, and place large woody materials for complex cover.

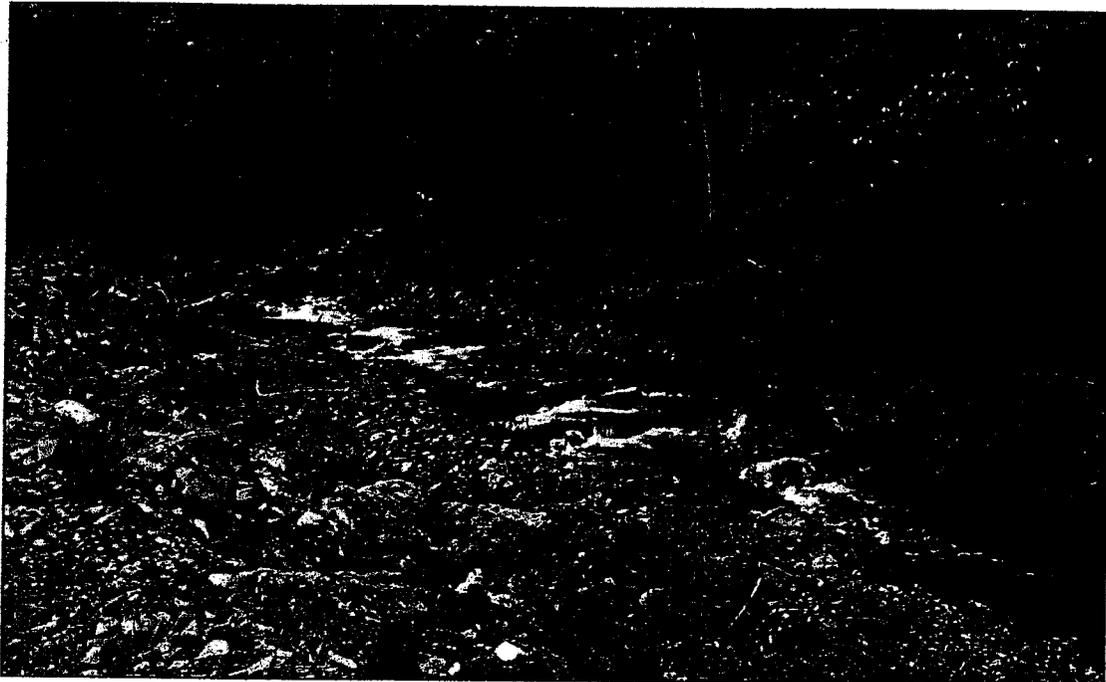
Step Pool Reference on Southfork of Asotin Creek

Reference of step pool conditions we are trying to mimic.

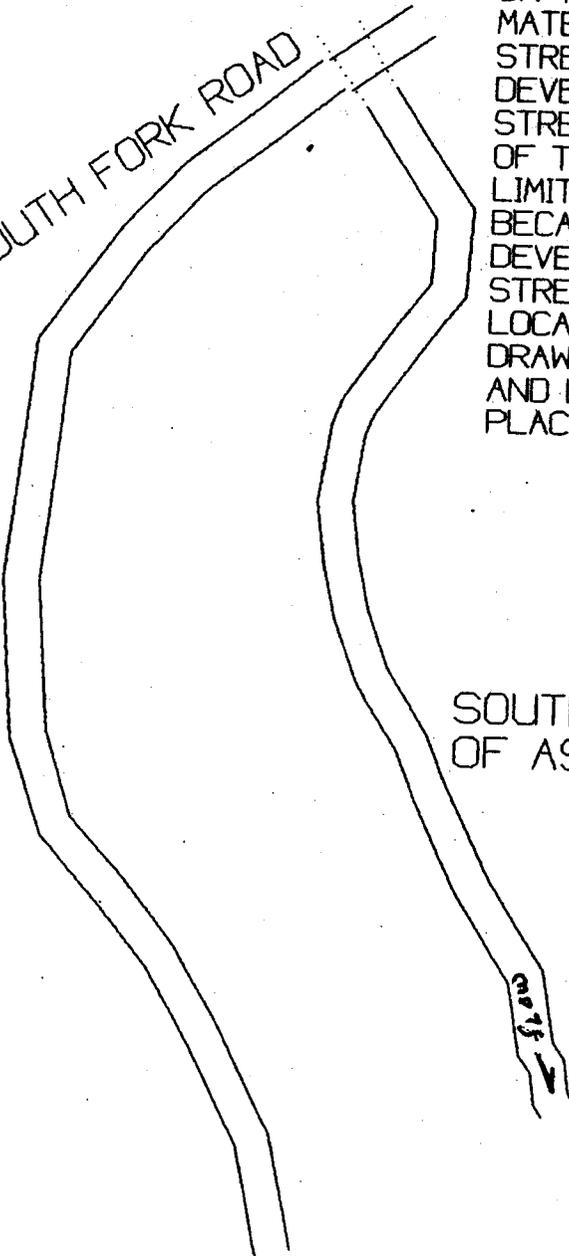
SOUTH FORK ROAD

THE PURPOSE OF THIS PROJECT IS TO INSTALL RESTING POOLS IN THIS SECTION OF THE SOUTH FORK. ROCK AND WOODY MATERIALS FOUND ON THE SITE OR LIMITED IMPORTED MATERIALS WILL BE PLACED IN THE STREAM TO MIMIC NATURALLY DEVELOPED POOLS FOUND IN THIS STREAM SECTION. DISTURBANCE OF THE STREAM AND BANKS WILL LIMITED. BECAUSE THE POOLS WILL BE DEVELOPED WHERE THERE IS STREAM ACCESS. THE DRAWING IS FOR LOCATION ONLY. THE ATTACHED DETAIL DRAWINGS OF BOULDER PLACEMENTS AND LARGE WOODY MATERIALS PLACEMENT WILL BE USED.

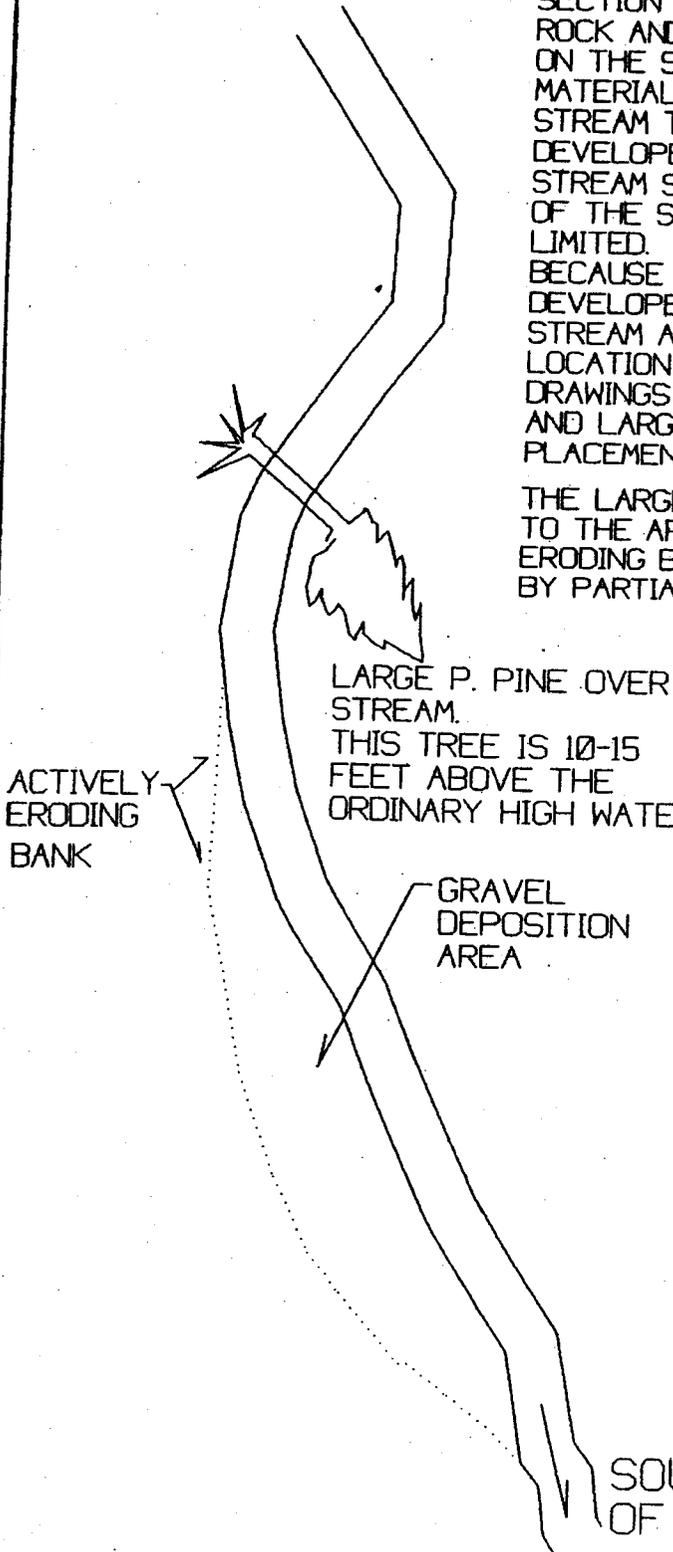
THE PURPOSE OF THIS PROJECT IS TO INSTALL RESTING POOLS IN THIS SECTION OF THE SOUTH FORK. ROCK AND WOODY MATERIALS FOUND ON THE SITE OR LIMITED IMPORTED MATERIALS WILL BE PLACED IN THE STREAM TO MIMIC NATURALLY DEVELOPED POOLS FOUND IN THIS STREAM SECTION. DISTURBANCE OF THE STREAM AND BANKS WILL BE LIMITED. BECAUSE THE POOLS WILL BE DEVELOPED WHERE THERE IS STREAM ACCESS, THE DRAWING IS FOR LOCATION ONLY. THE ATTACHED DETAIL DRAWINGS OF BOULDER PLACEMENTS AND LARGE WOODY MATERIALS PLACEMENT WILL BE USED.

THE LARGE P. PINE WILL BE MOVED TO THE AREA MARKED AS "ACTIVELY ERODING BANK". IT WILL BE ANCHORED BY PARTIAL BURIAL AND ROCK PLACEMENT.

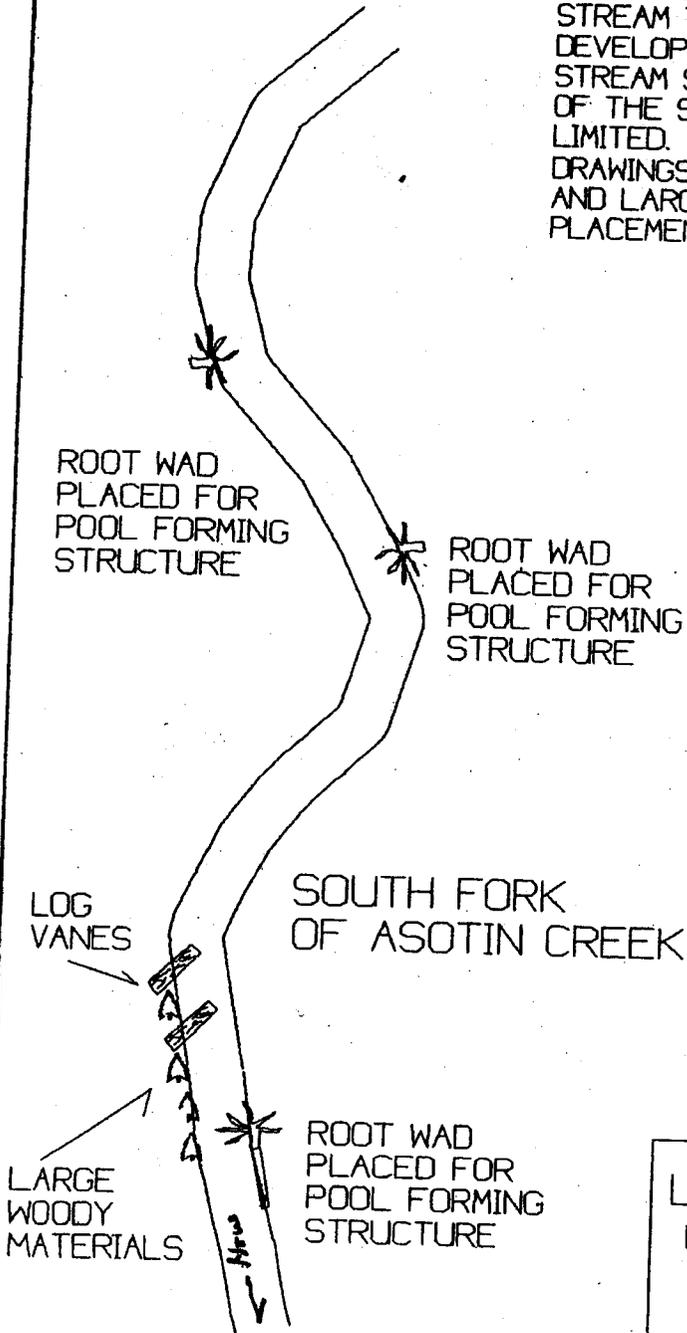
THE PURPOSE OF THIS PROJECT IS TO INSTALL RESTING POOLS IN THIS SECTION OF THE SOUTH FORK. ROCK AND WOODY MATERIALS FOUND ON THE SITE OR LIMITED IMPORTED MATERIALS WILL BE PLACED IN THE STREAM TO MIMIC NATURALLY DEVELOPED POOLS FOUND IN THIS STREAM SECTION. DISTURBANCE OF THE STREAM AND BANKS WILL BE LIMITED. DRAWINGS OF BOULDER PLACEMENTS AND LARGE WOODY MATERIALS PLACEMENT WILL BE USED.

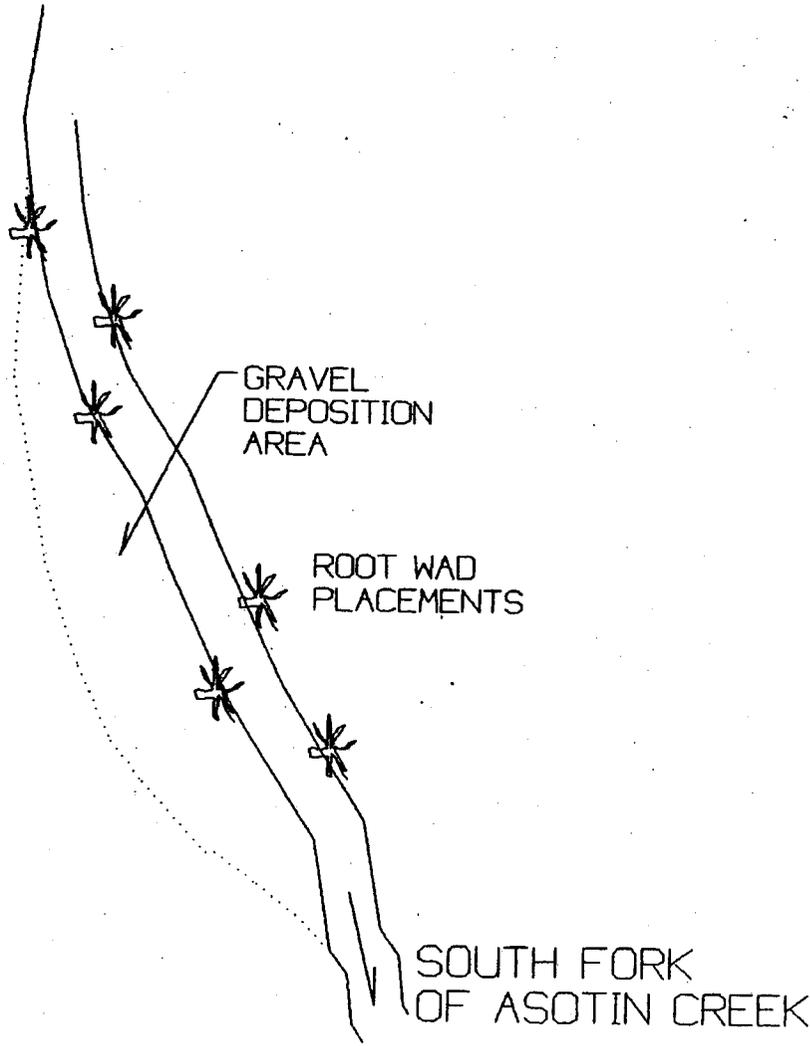
THE PURPOSE OF THIS PROJECT IS TO INSTALL RESTING POOLS IN THIS SECTION OF THE SOUTH FORK. ROCK AND WOODY MATERIALS FOUND ON THE SITE OR LIMITED IMPORTED MATERIALS WILL BE PLACED IN THE STREAM TO MIMIC NATURALLY DEVELOPED POOLS FOUND IN THIS STREAM SECTION. DISTURBANCE OF THE STREAM AND BANKS WILL BE LIMITED.

BECAUSE THE POOLS WILL BE DEVELOPED WHERE THERE IS STREAM ACCESS, THE DRAWING IS MAINLY FOR LOCATION. THE ATTACHED DETAIL DRAWINGS OF BOULDER PLACEMENTS AND LARGE WOODY MATERIALS PLACEMENT WILL BE USED.

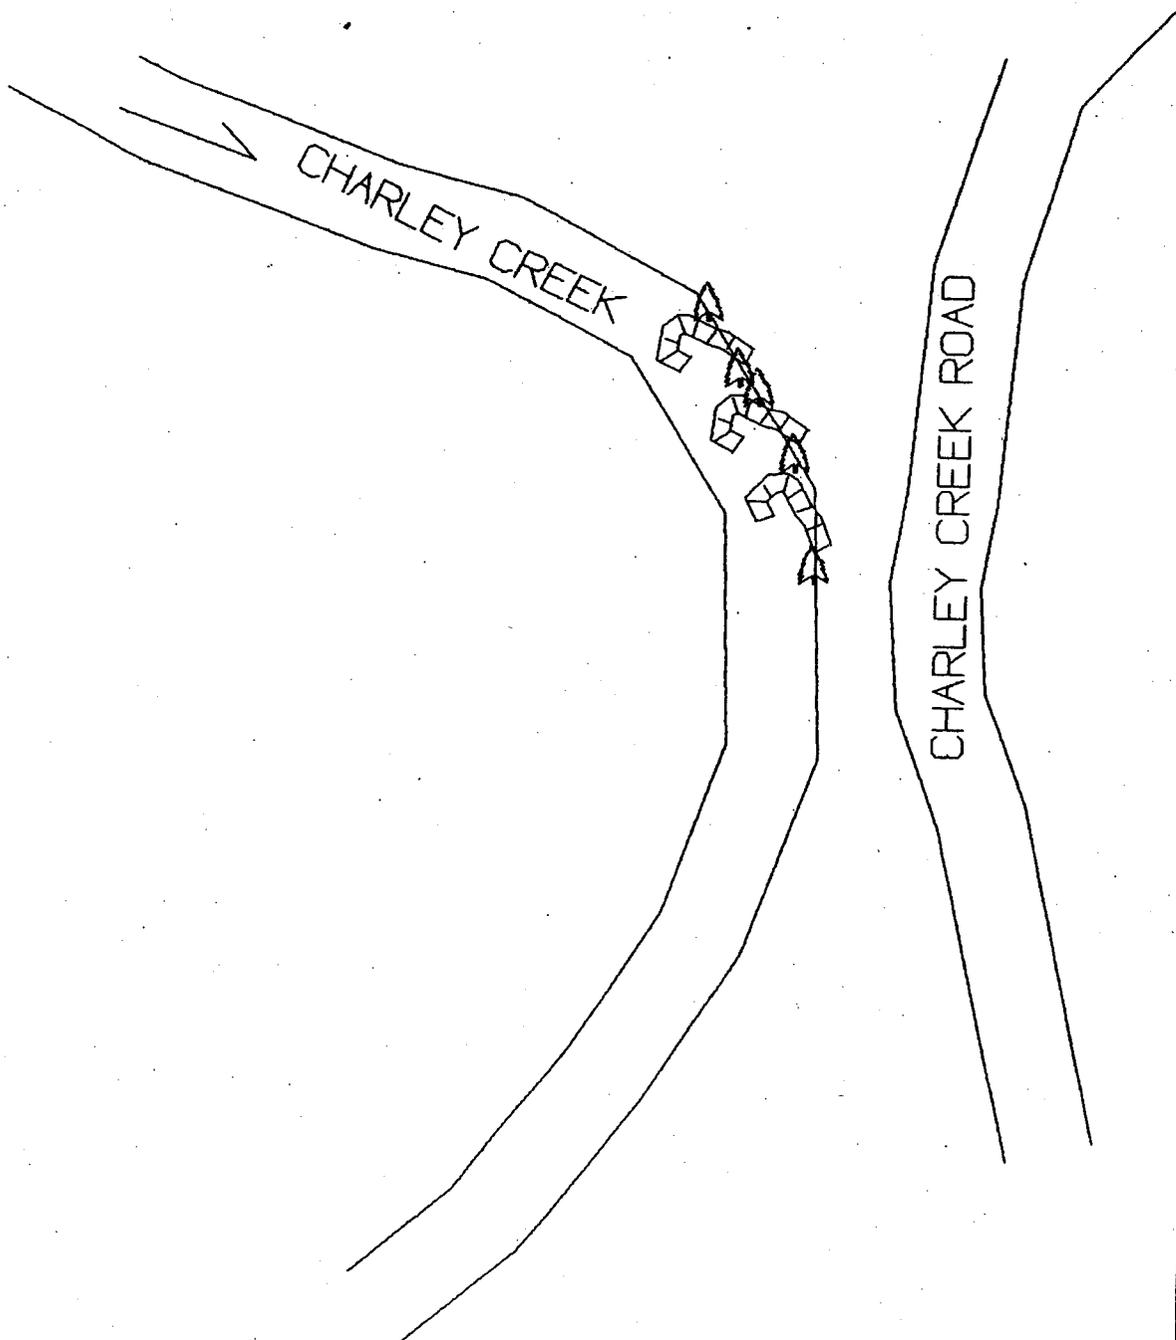
CHARLEY CREEK PROJECT #1 FISH HABITAT IMPROVEMENT
PLAN VIEW
CHARLEY CREEK, ASOTIN COUNTY, WA.

The purpose of this project is to create pool forming structures, to stabilize an actively eroding bank, and place large woody materials for complex cover.

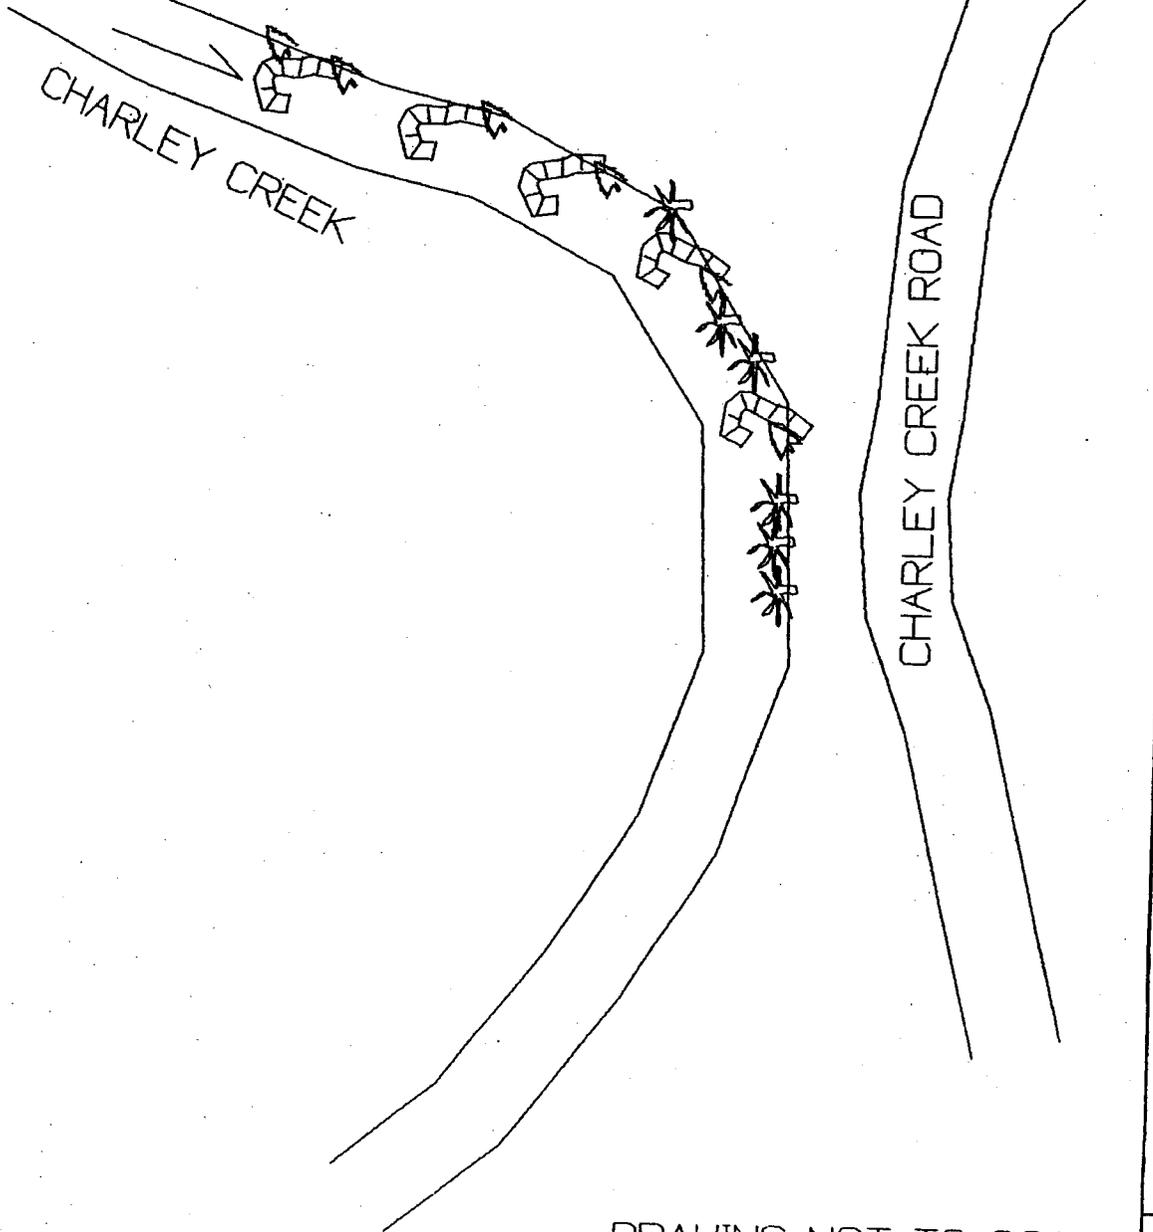
CHARLEY CREEK PROJECT #2 FISH HABITAT IMPROVEMENT
PLAN VIEW
CHARLEY CREEK, ASOTIN COUNTY, WA.
USDA NATURAL RESOURCES CONSERVATION SERVICE

The purpose of this project is to create pool forming structures, to stabilize an actively eroding bank, and place large woody materials for complex cover.

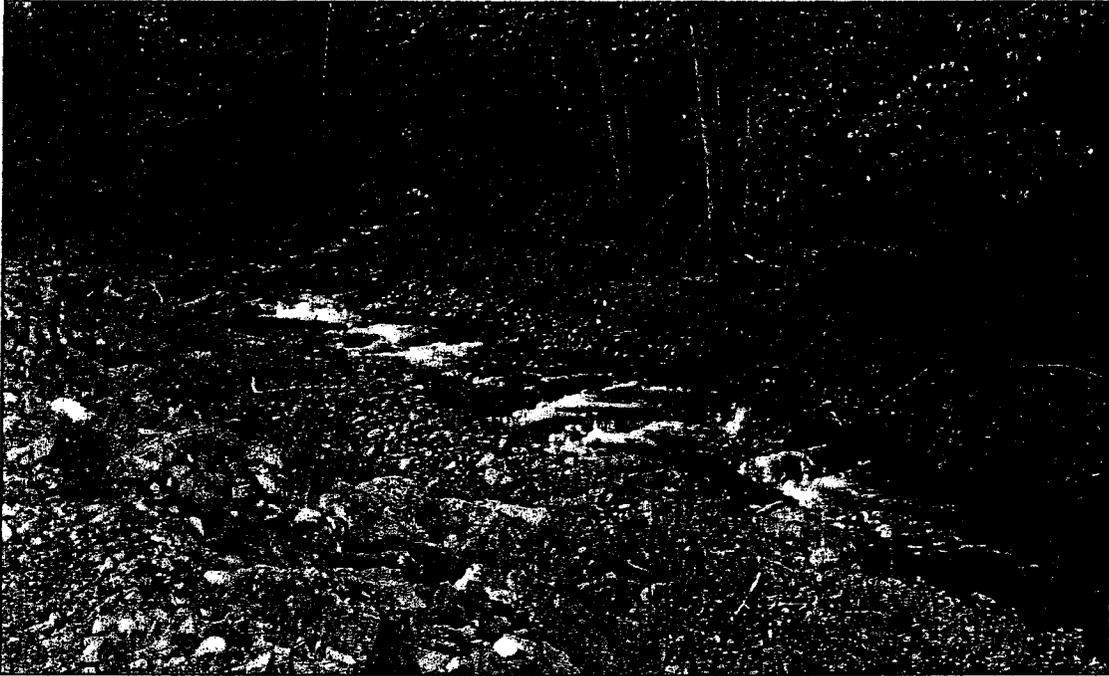
Step Pool Reference on Southfork of Asotin Creek

Reference of step pool conditions we are trying to mimic.

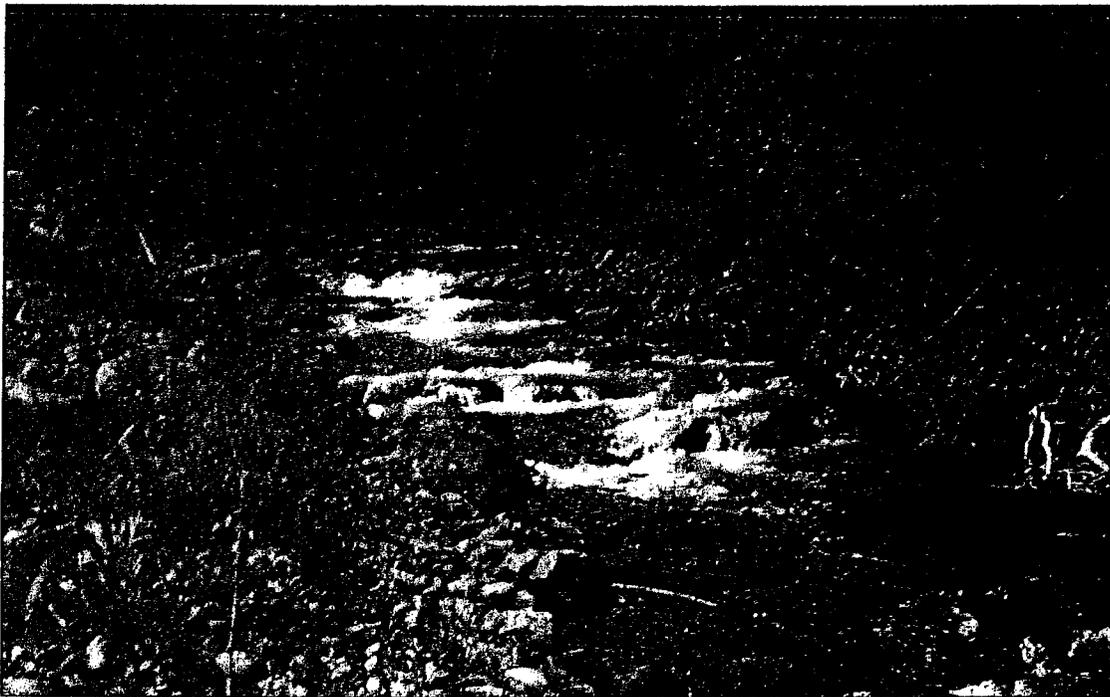
We will be adding wood to system, but this is an example of what we want to achieve.

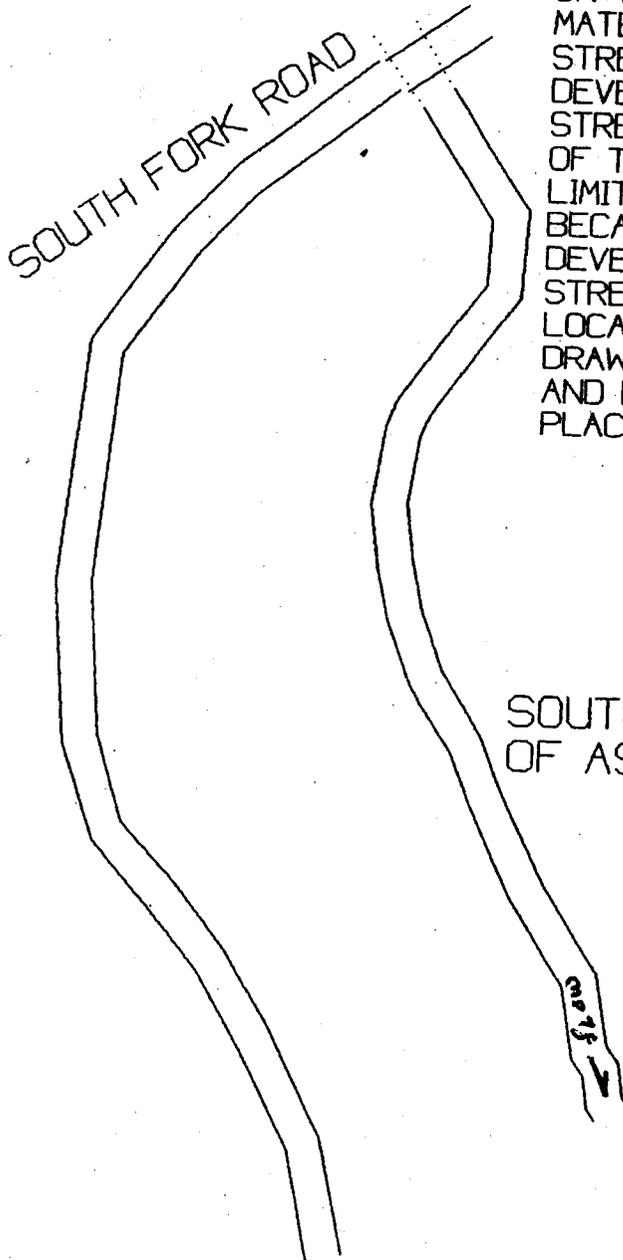
SOUTH FORK OF ASOTIN CREEK PROJECT #1
 SEC 27, T9N, R44E
 RIVER MILE 3.5

THE PURPOSE OF THIS PROJECT IS TO INSTALL RESTING POOLS IN THIS SECTION OF THE SOUTH FORK. ROCK AND WOODY MATERIALS FOUND ON THE SITE OR LIMITED IMPORTED MATERIALS WILL BE PLACED IN THE STREAM TO MIMIC NATURALLY DEVELOPED POOLS FOUND IN THIS STREAM SECTION. DISTURBANCE OF THE STREAM AND BANKS WILL BE LIMITED. BECAUSE THE POOLS WILL BE DEVELOPED WHERE THERE IS STREAM ACCESS, THE DRAWING IS FOR LOCATION ONLY. THE ATTACHED DETAIL DRAWINGS OF BOULDER PLACEMENTS AND LARGE WOODY MATERIALS PLACEMENT WILL BE USED.

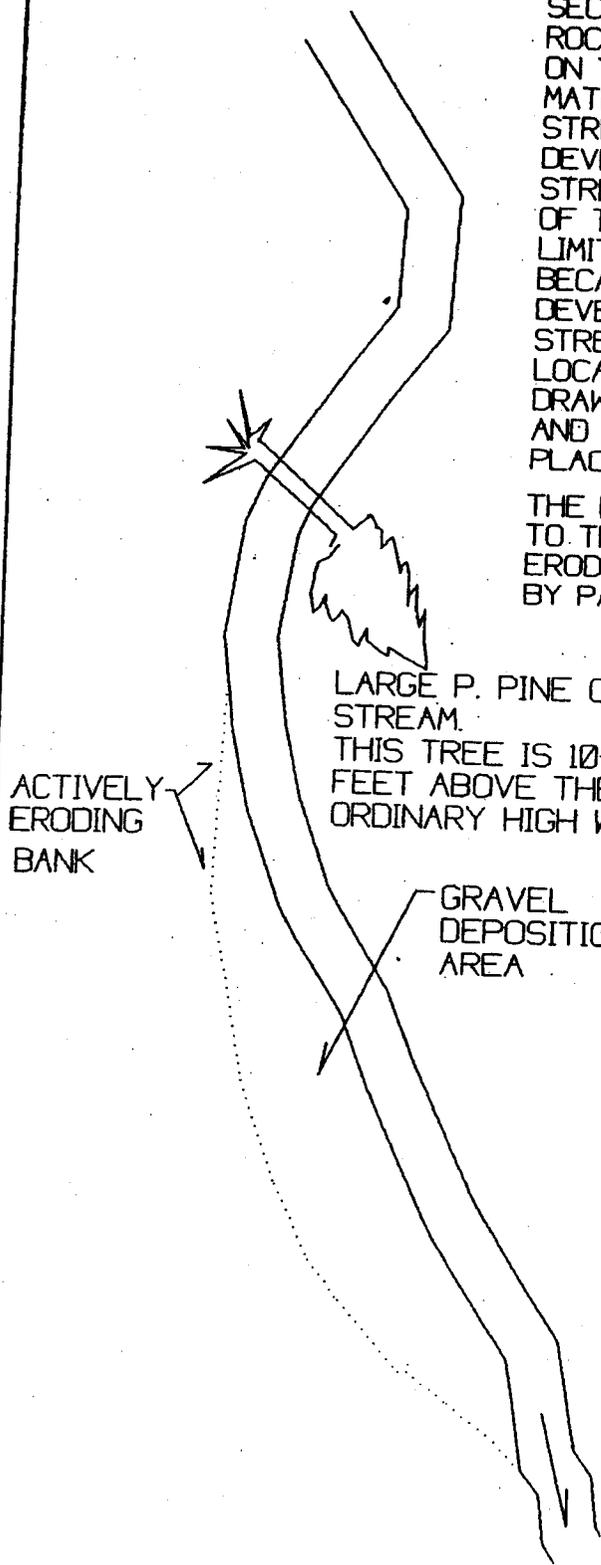
THE PURPOSE OF THIS PROJECT IS TO INSTALL RESTING POOLS IN THIS SECTION OF THE SOUTH FORK. ROCK AND WOODY MATERIALS FOUND ON THE SITE OR LIMITED IMPORTED MATERIALS WILL BE PLACED IN THE STREAM TO MIMIC NATURALLY DEVELOPED POOLS FOUND IN THIS STREAM SECTION. DISTURBANCE OF THE STREAM AND BANKS WILL BE LIMITED. BECAUSE THE POOLS WILL BE DEVELOPED WHERE THERE IS STREAM ACCESS, THE DRAWING IS FOR LOCATION ONLY. THE ATTACHED DETAIL DRAWINGS OF BOULDER PLACEMENTS AND LARGE WOODY MATERIALS PLACEMENT WILL BE USED.

THE LARGE P. PINE WILL BE MOVED TO THE AREA MARKED AS "ACTIVELY ERODING BANK". IT WILL BE ANCHORED BY PARTIAL BURIAL AND ROCK PLACEMENT.

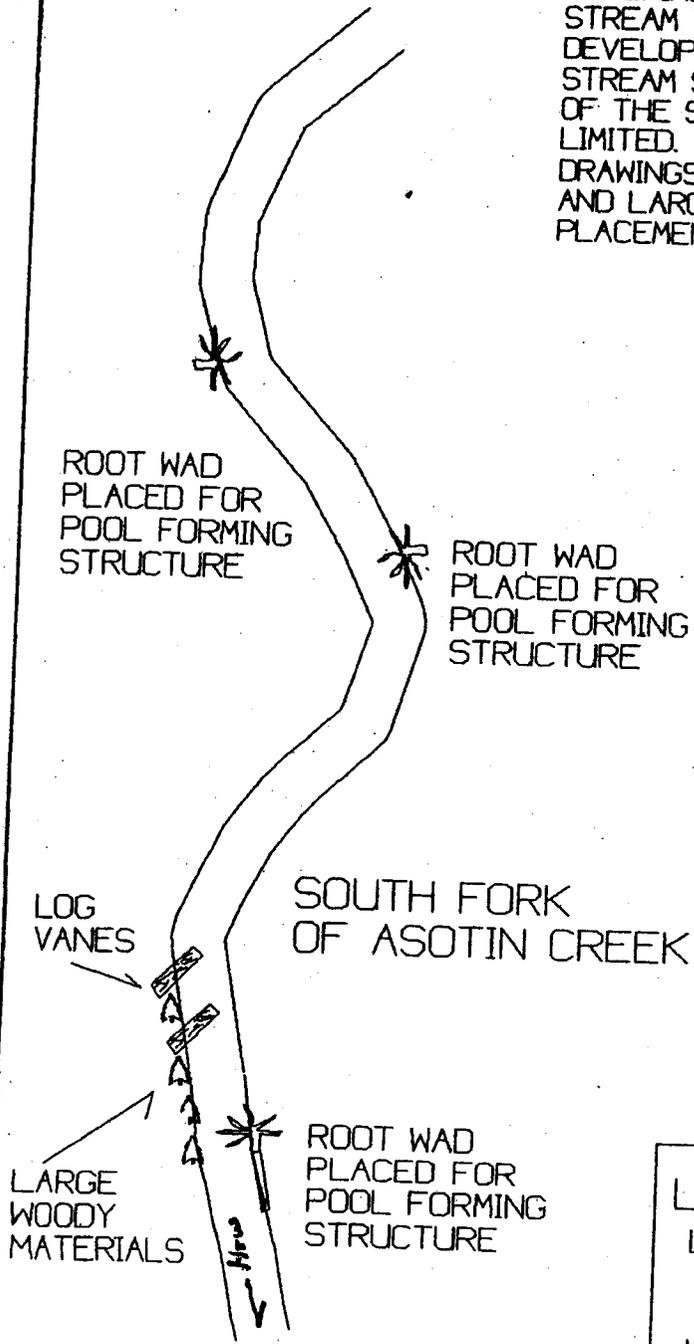
THE PURPOSE OF THIS PROJECT IS TO INSTALL RESTING POOLS IN THIS SECTION OF THE SOUTH FORK. ROCK AND WOODY MATERIALS FOUND ON THE SITE OR LIMITED IMPORTED MATERIALS WILL BE PLACED IN THE STREAM TO MIMIC NATURALLY DEVELOPED POOLS FOUND IN THIS STREAM SECTION. DISTURBANCE OF THE STREAM AND BANKS WILL BE LIMITED. DRAWINGS OF BOULDER PLACEMENTS AND LARGE WOODY MATERIALS PLACEMENT WILL BE USED.

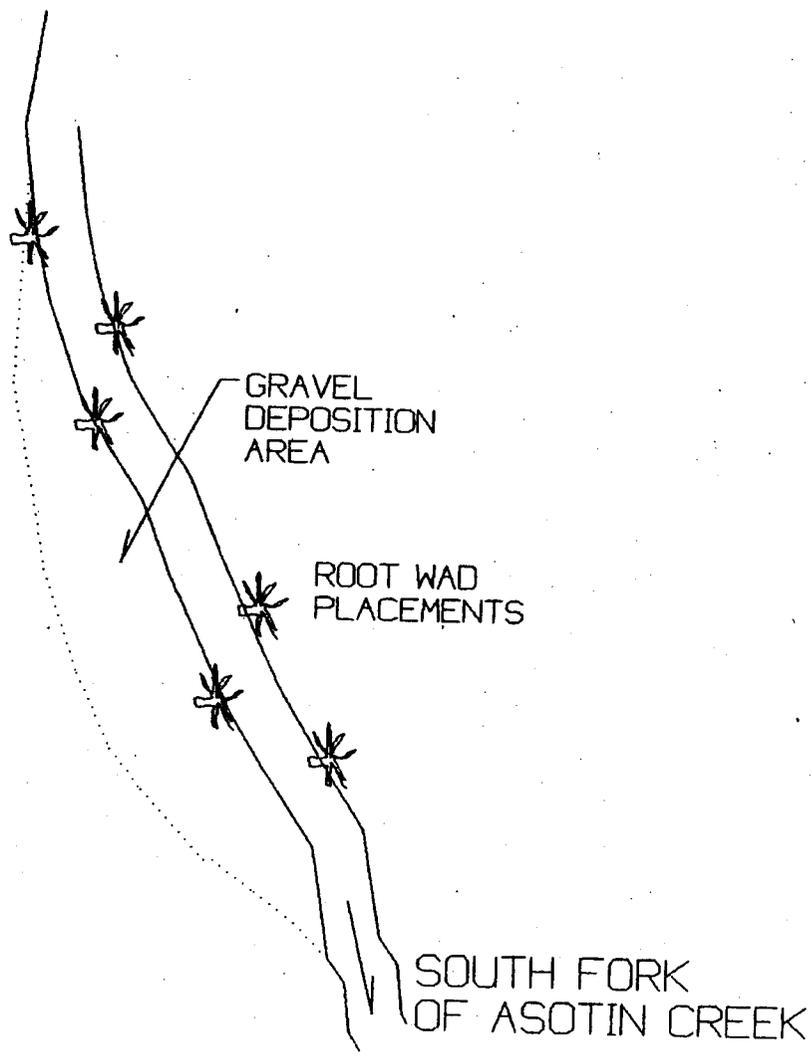
THE PURPOSE OF THIS PROJECT IS TO INSTALL RESTING POOLS IN THIS SECTION OF THE SOUTH FORK. ROCK AND WOODY MATERIALS FOUND ON THE SITE OR LIMITED IMPORTED MATERIALS WILL BE PLACED IN THE STREAM TO MIMIC NATURALLY DEVELOPED POOLS FOUND IN THIS STREAM SECTION. DISTURBANCE OF THE STREAM AND BANKS WILL BE LIMITED. BECAUSE THE POOLS WILL BE DEVELOPED WHERE THERE IS STREAM ACCESS, THE DRAWING IS MAINLY FOR LOCATION. THE ATTACHED DETAIL DRAWINGS OF BOULDER PLACEMENTS AND LARGE WOODY MATERIALS PLACEMENT WILL BE USED.

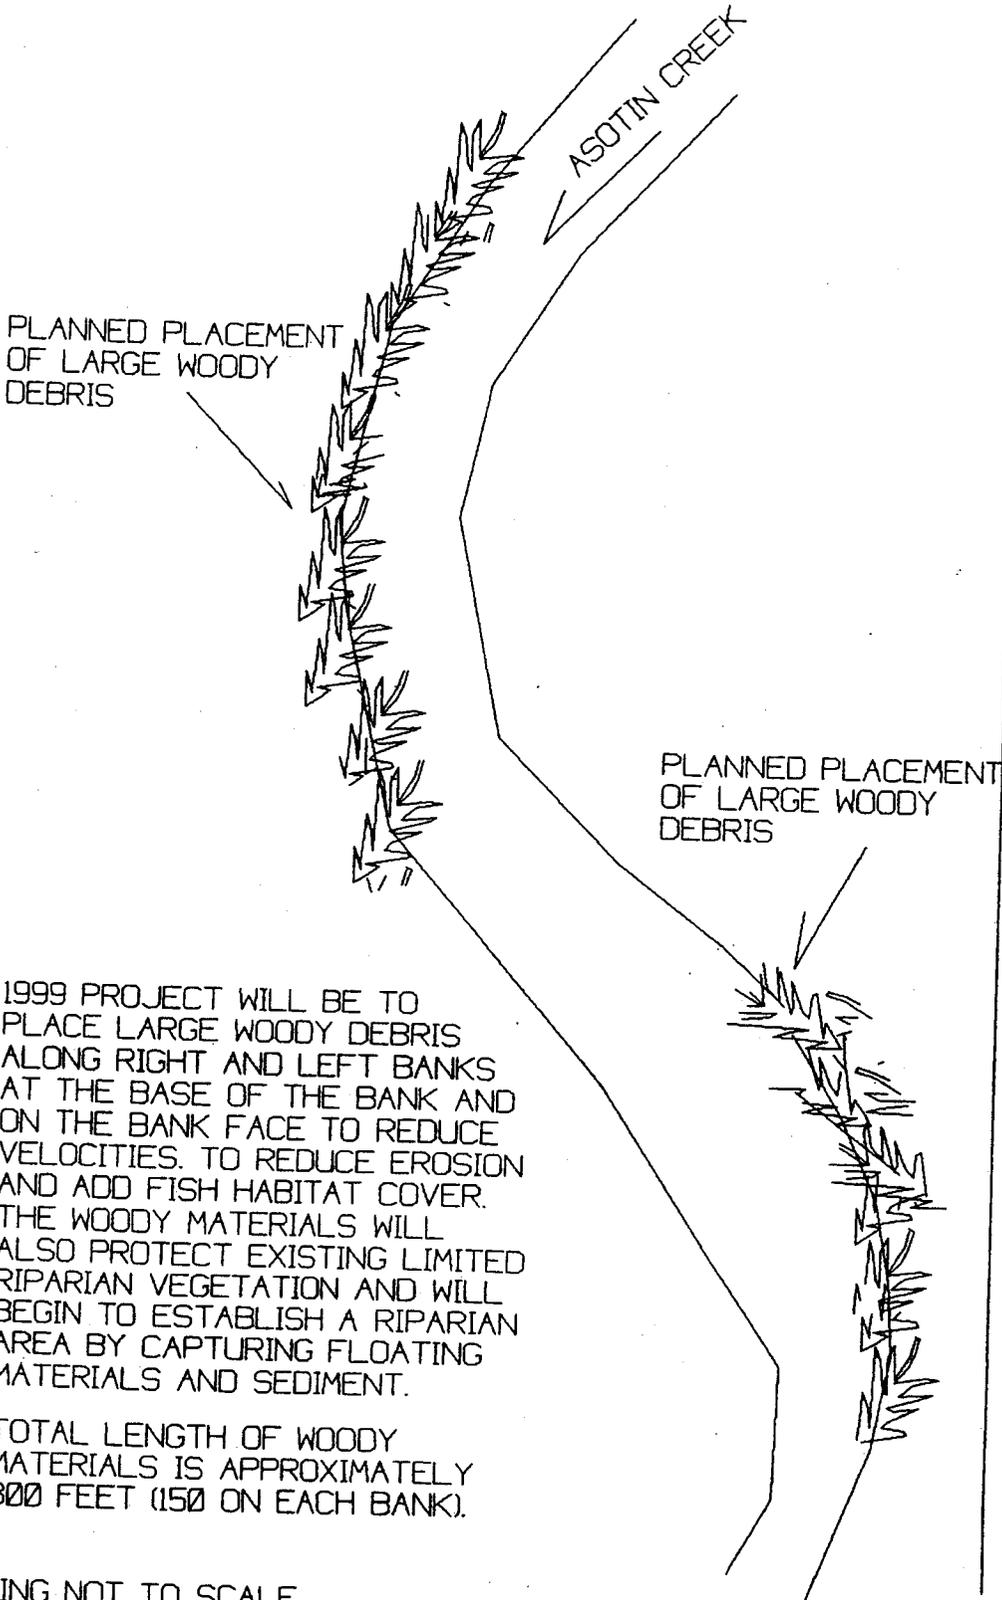
PLANNED PLACEMENT
OF LARGE WOODY
DEBRIS

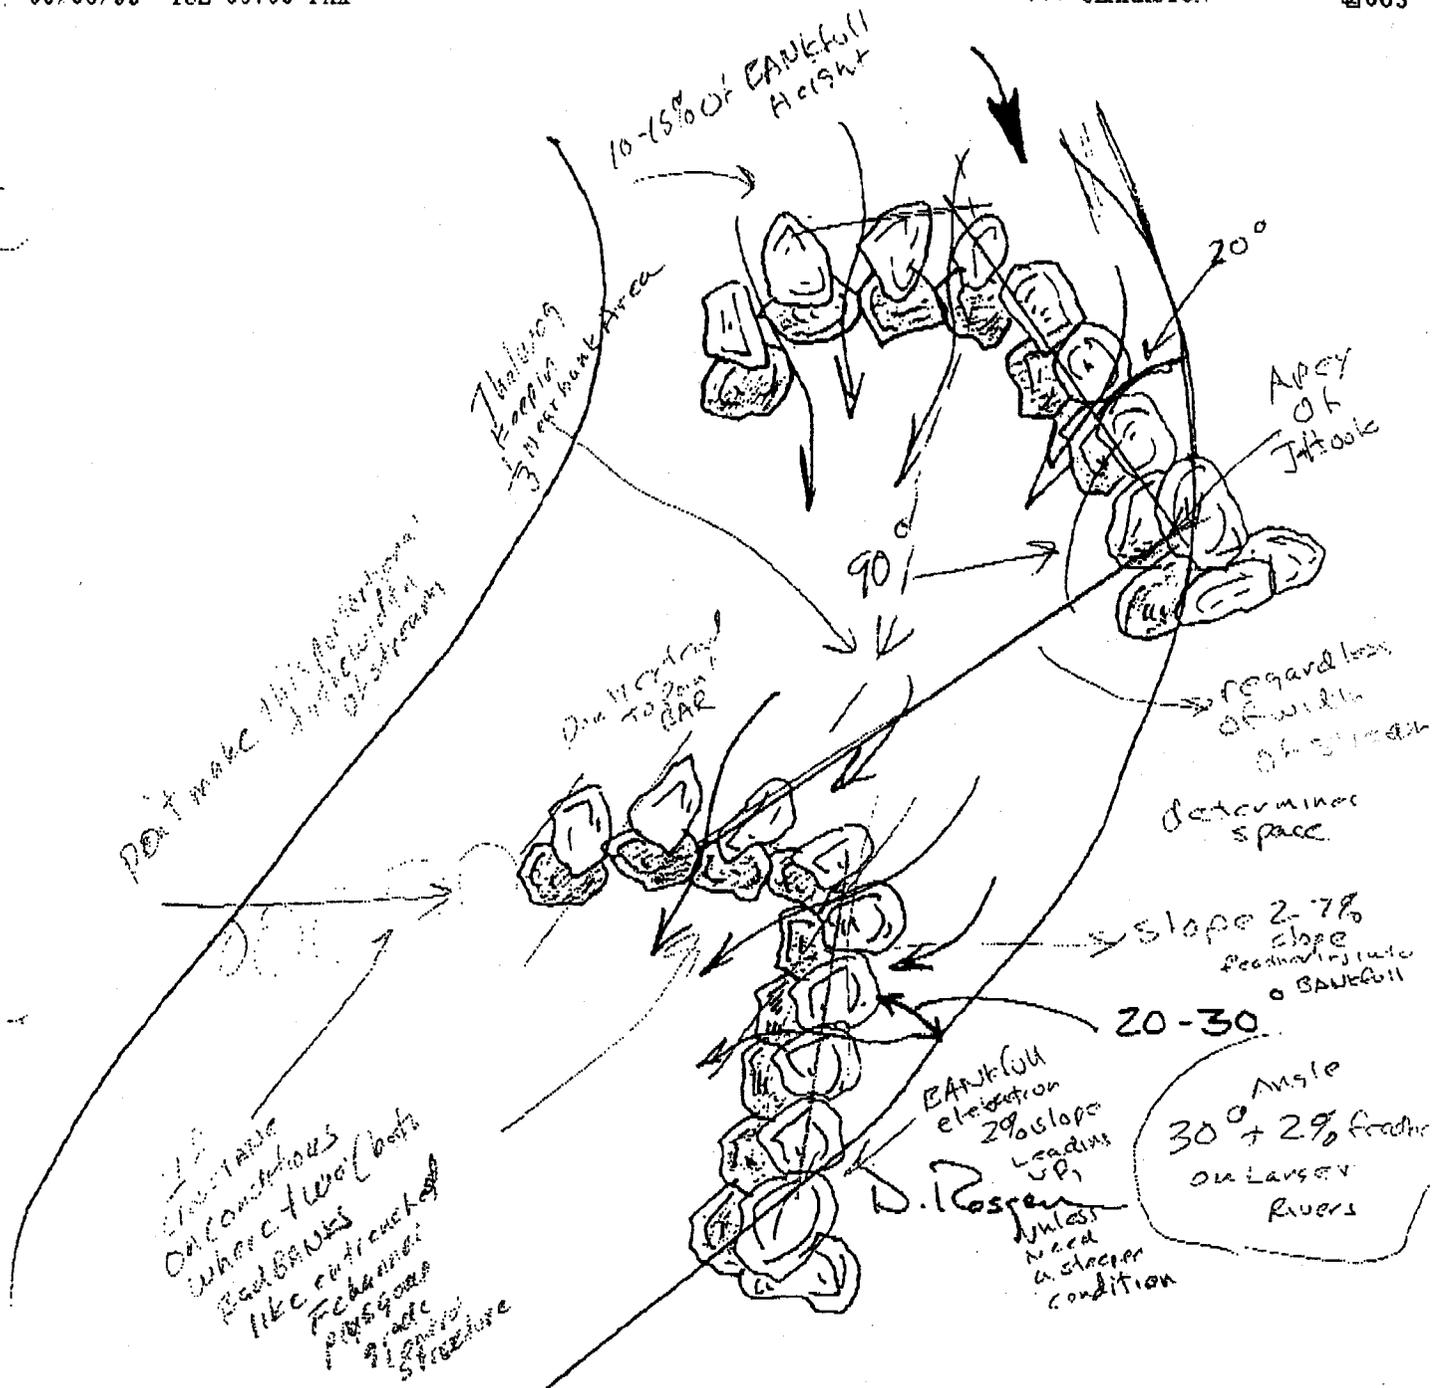
SHEET NO. 2 OF 6

Don't make this for bottom, just for top of stream

10-15% of BANKFULL HEIGHT

BANKFULL elevation 2% slope leading UP, unless need a steeper condition

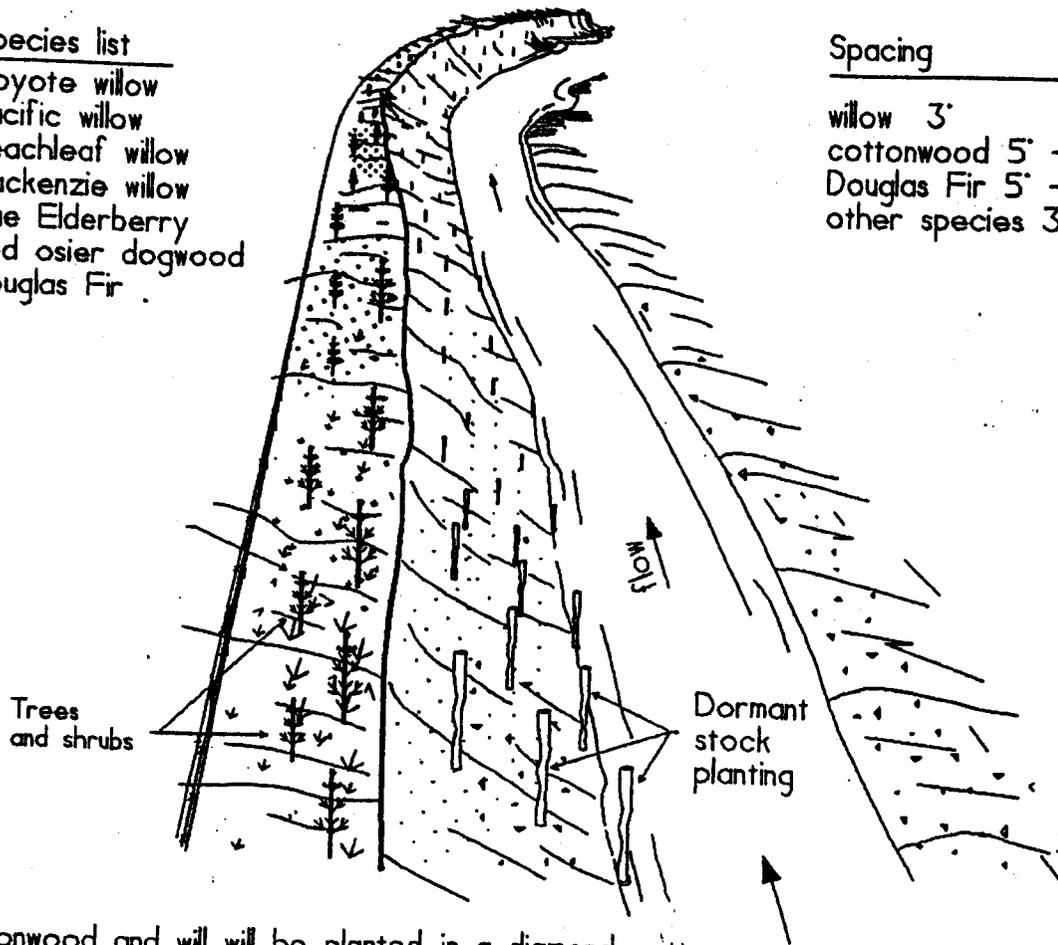
- willow 3'
- cottonwood 5' - 8'
- Douglas Fir 5' - 8'
- other species 3' - 5'

Cottonwood and willow will be planted in a diamond pattern along the stream bank: deep enough to reach sufficient summer moisture. Other species will be planted in clumps or groups at staggered locations along the top of bank or field edge (as directed by District Manager or NRCS conservationist).

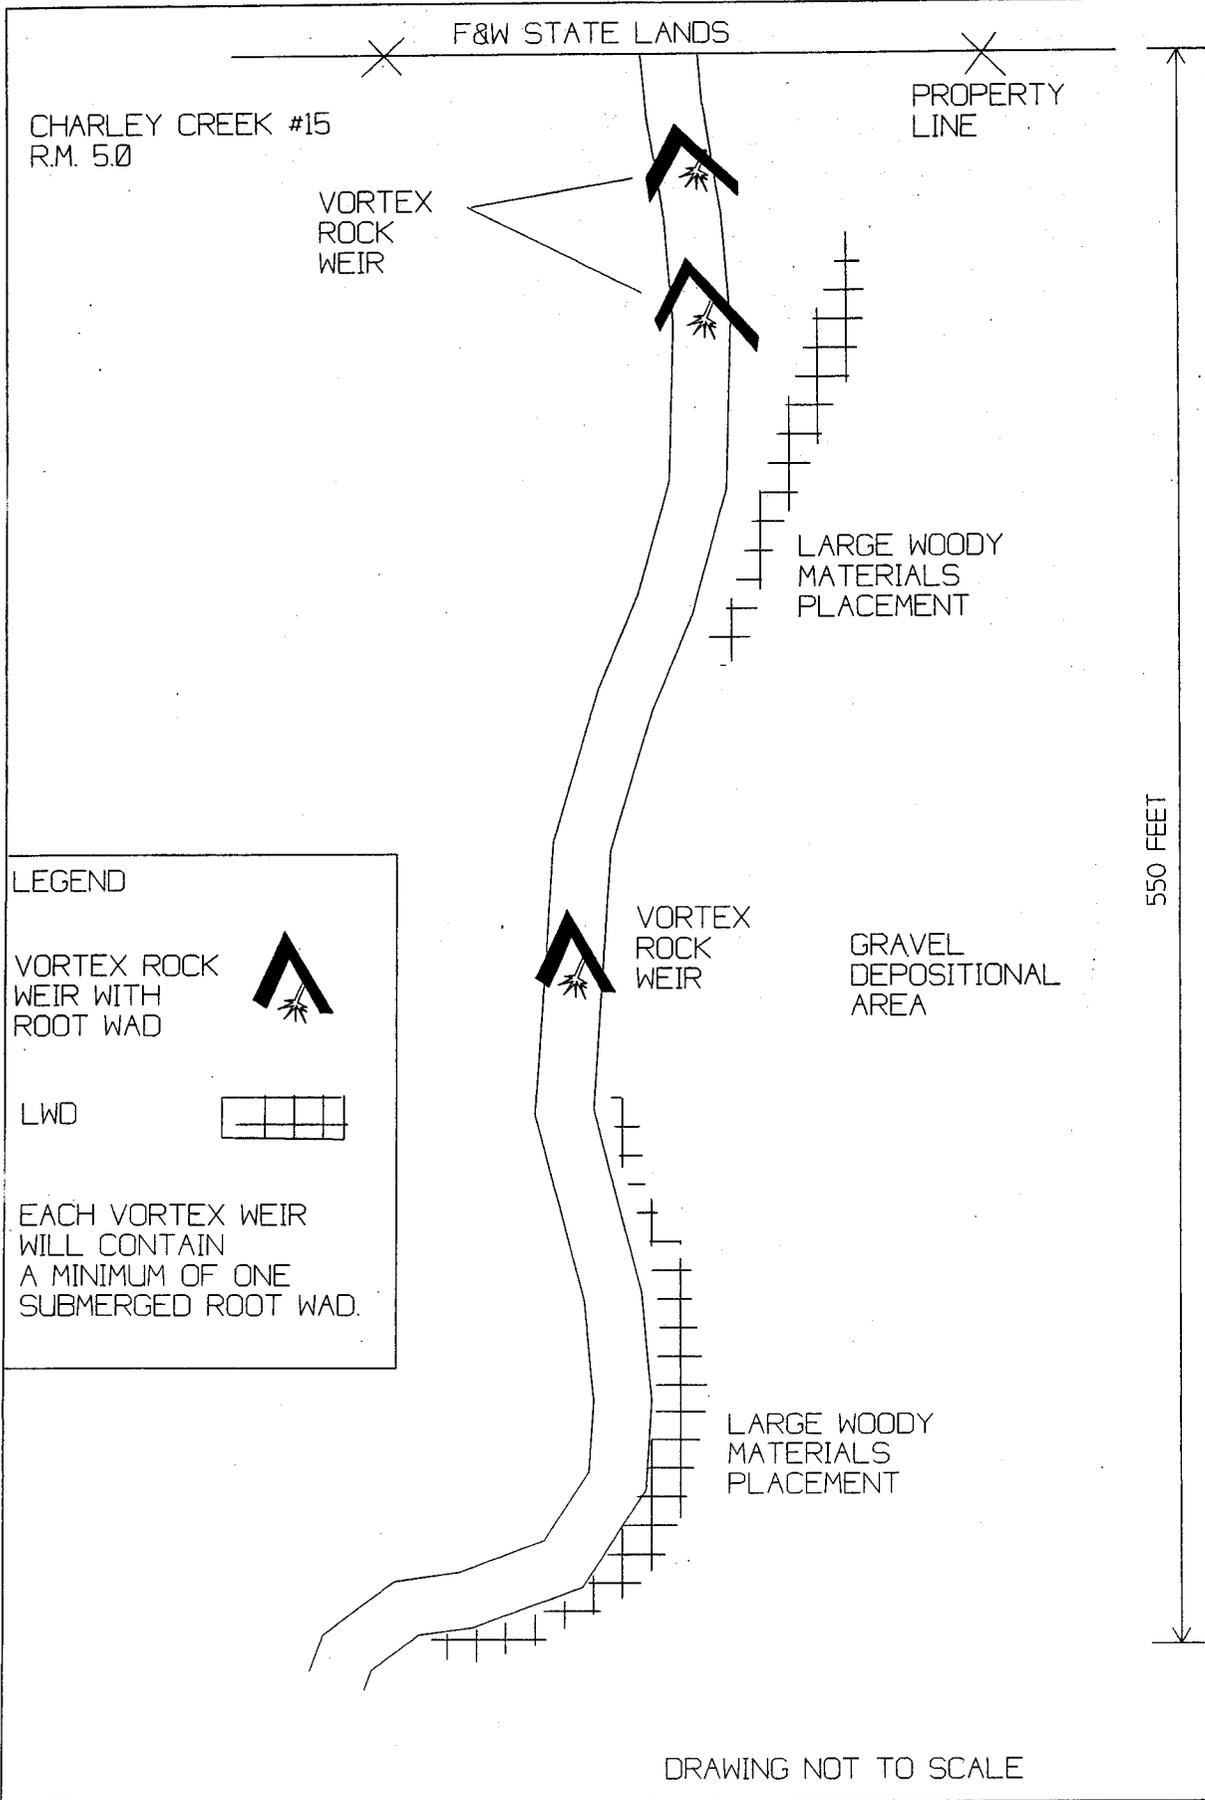
Lower section of site.

VORTEX ROCK WEIR WITH ROOT WAD
