FY 2000 In-Stream Habitat Projects

CHARLEY CREEK PROJECT #1 FISH HABITAT IMPROVEMENT
 PLAN VIEW
 CHARLEY CREEK, ASOTIN COUNTY, WA.
 USDA NATURAL RESOURCES CONSERVATION SERVICE

The objectives of the 1998 projects are to meet the goals outlined above by using bioengineering methods of structural design applicable to stream type and conditions. The term bioengineering, as used in this document, refers to the use of living (tree and shrub plantings) and inert materials (rock, logs, and root wads) combined with sound engineering principles for the purpose of streambank stabilization, in-stream fish habitat development, and riparian habitat restoration. Nearly every structure planned, either as a single structure or as a component of a multiple structure system, will provide numerous benefits in progressing toward the above goals. **Appendix A** contains generic structure drawings, descriptions, construction, benefits and a description of the NRCS/District tree planting agreement and species list.

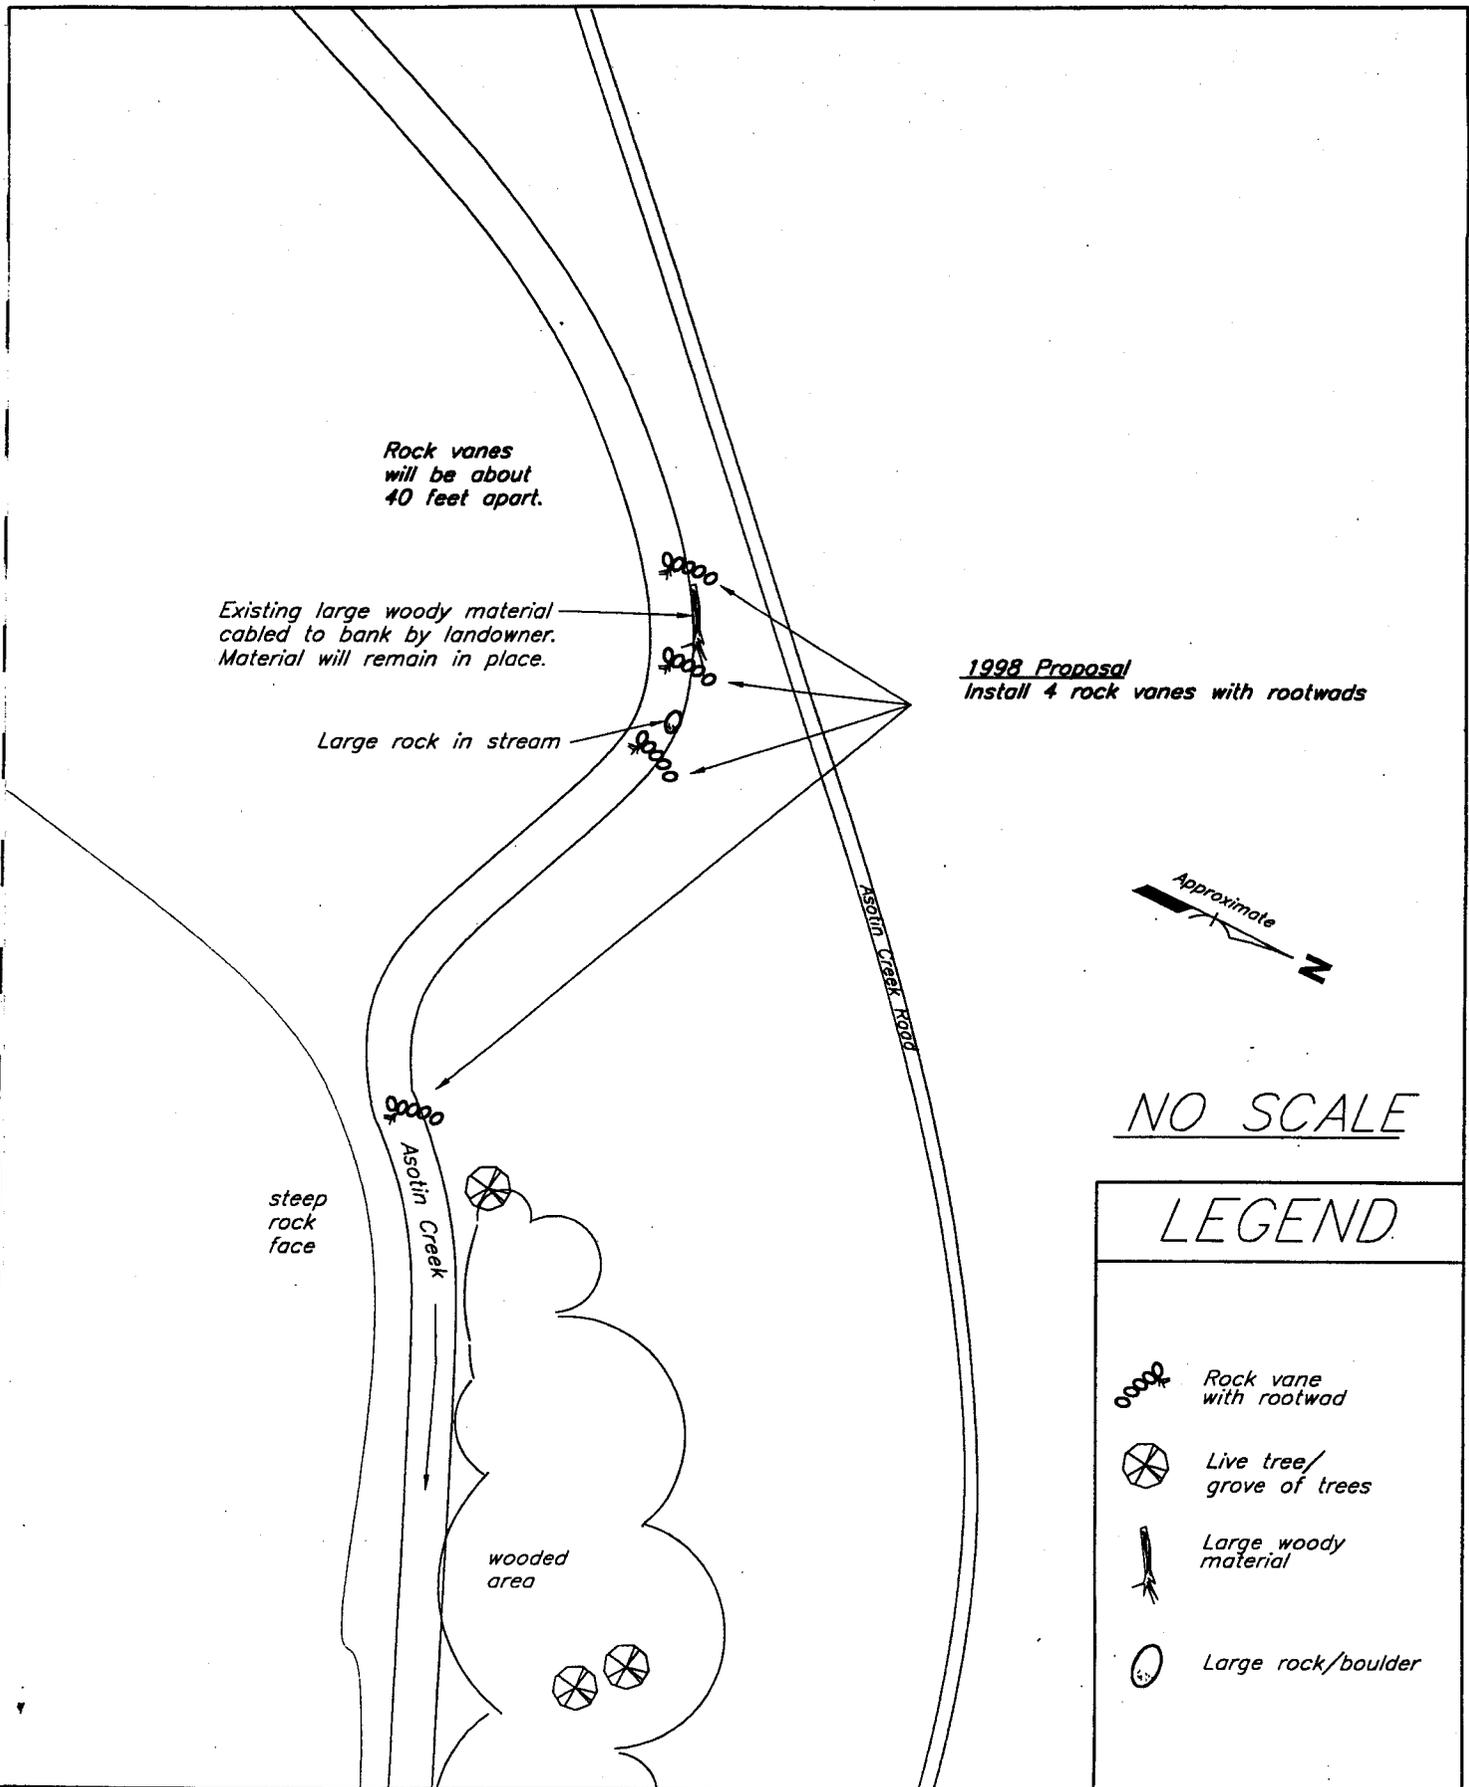
Downstream view. Cabled tree, rock vanes above and below the structure.

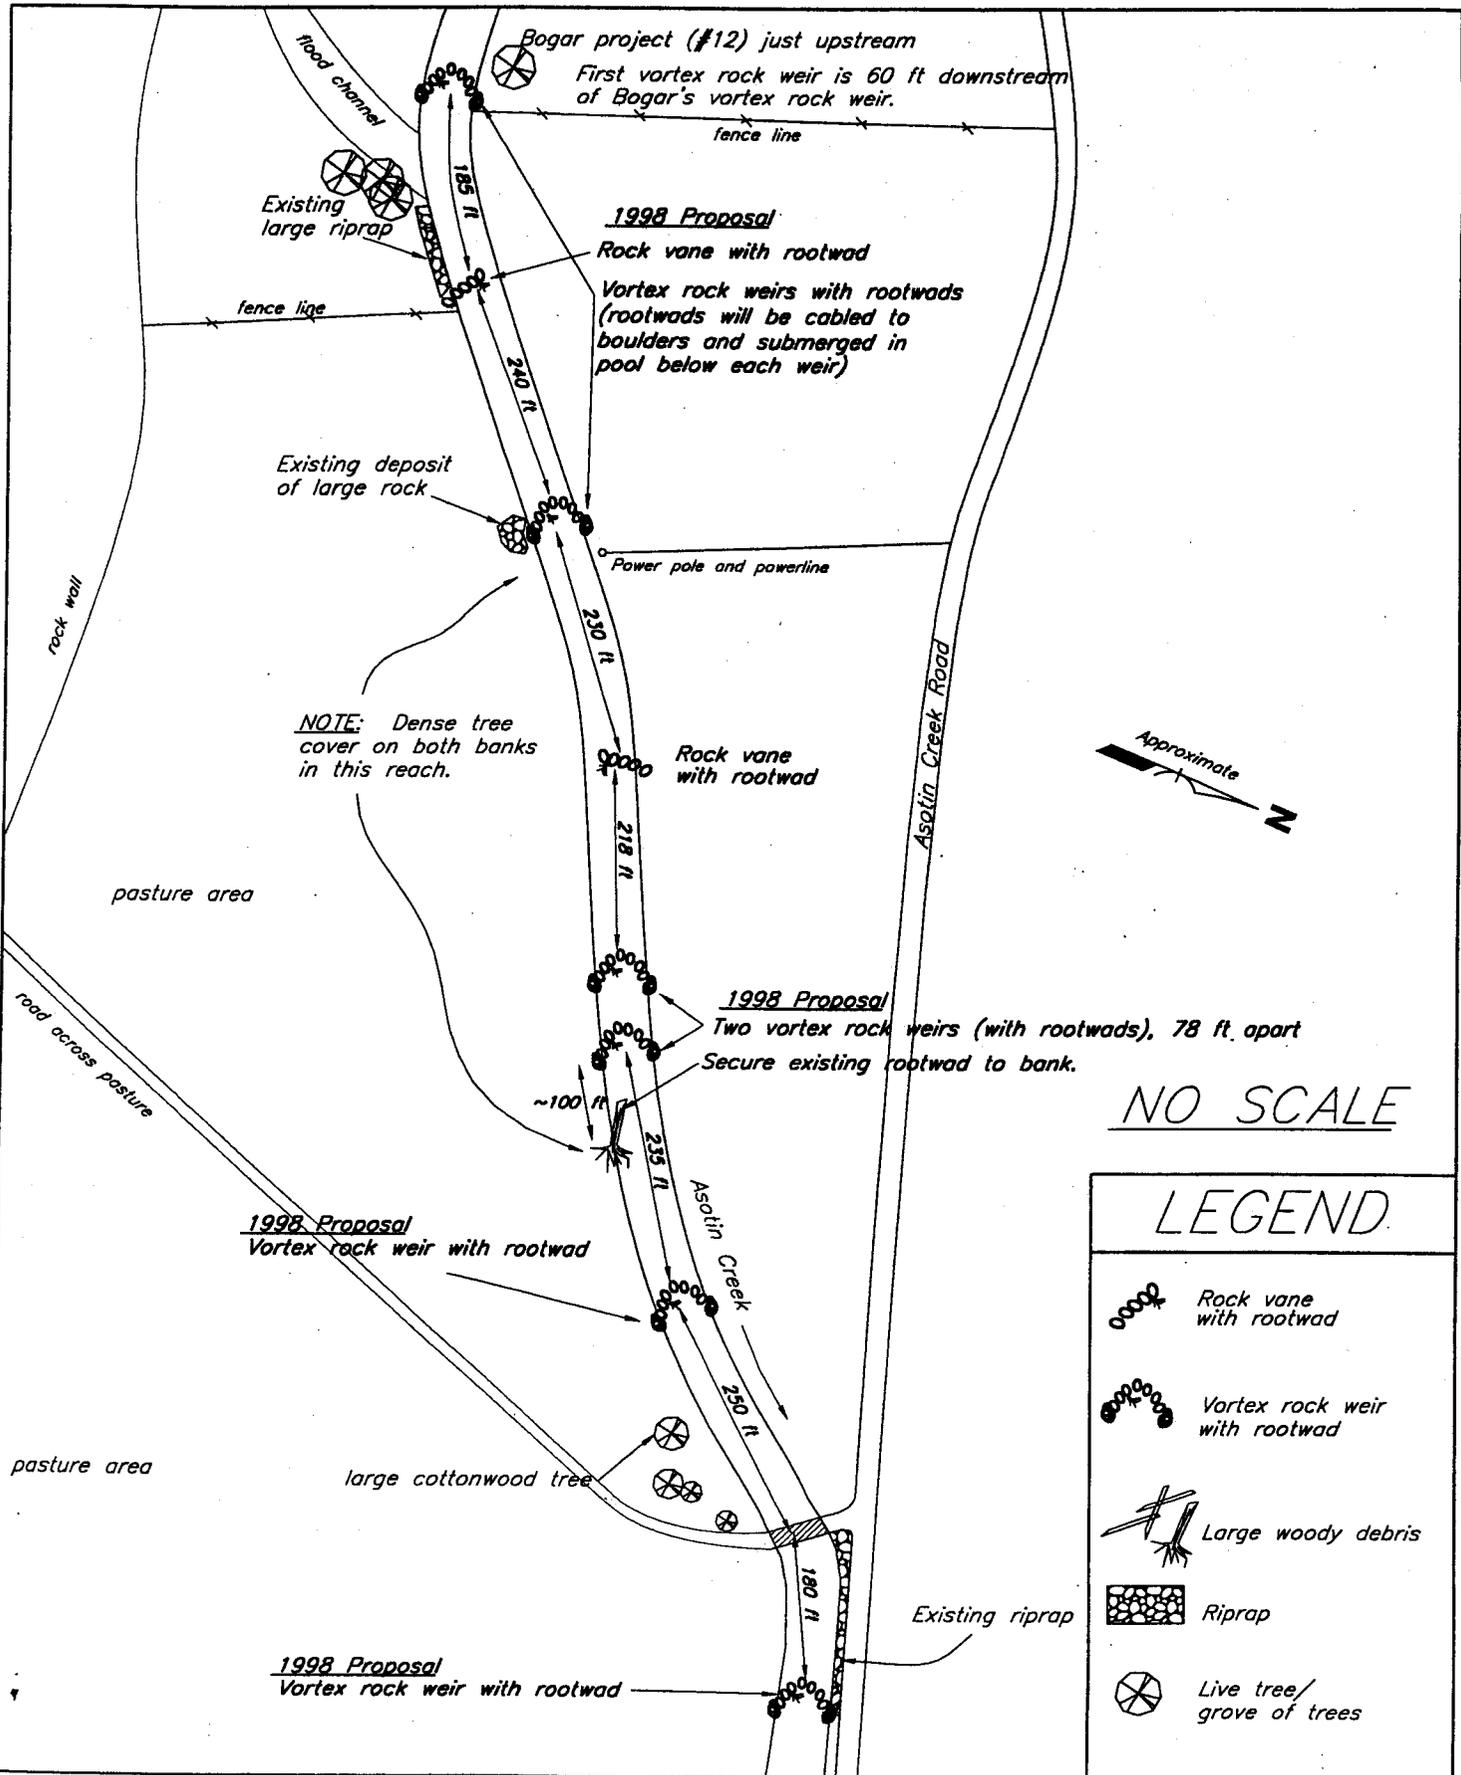
Upstream view. Rock vanes on right bank and vortex rock weir.

LEGEND	
	Rock vane with rootwad
	Vortex rock weir with rootwad
	Large woody debris
	Riprap
	Live tree/ grove of trees

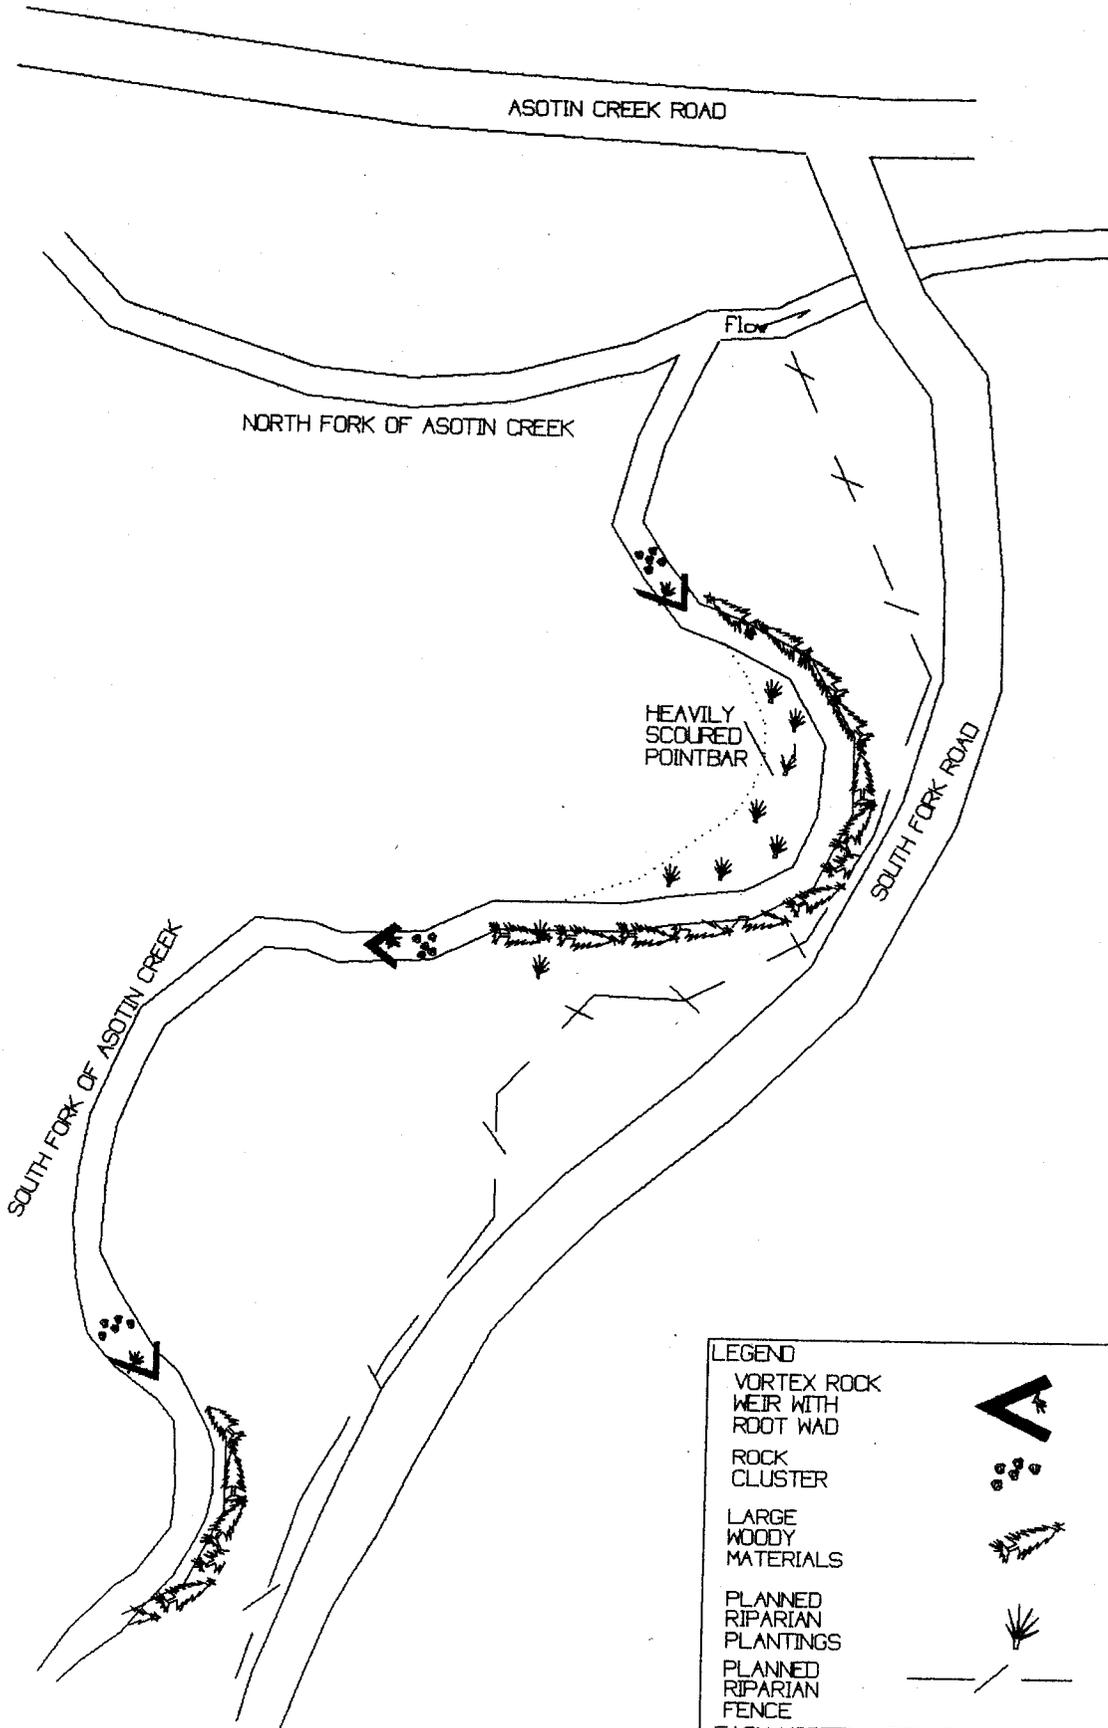
**Right bank LWD debris cabling, vortex rock
weirs w/ boulder clusters in the tailout area.**

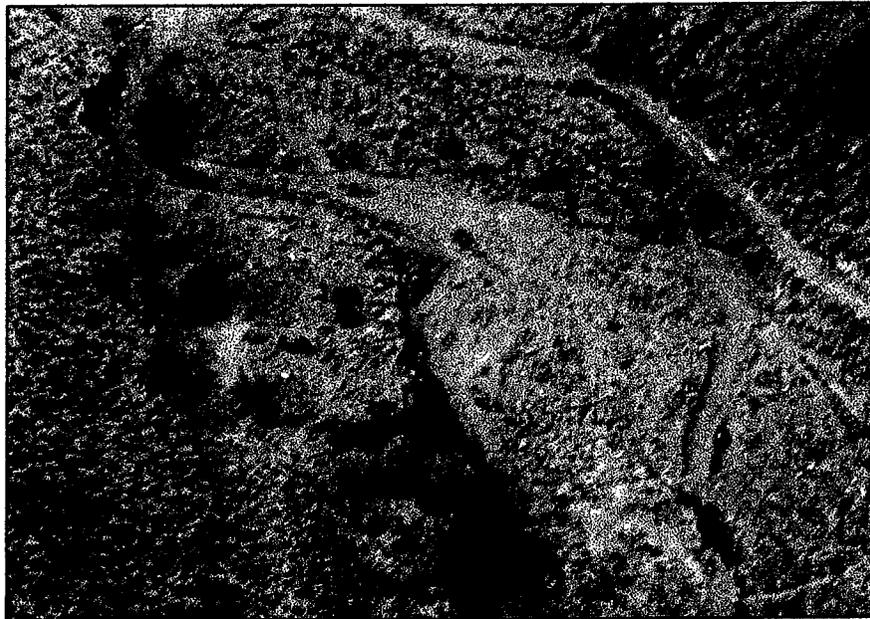
CHARLIE CREEK #16
R.M. 4.5

Downstream view. Site has been fenced and planted with trees.
Install rock vanes and vortex rock weirs to create pools.

Notice flood damage to area. Unstable and denude of vegetation.

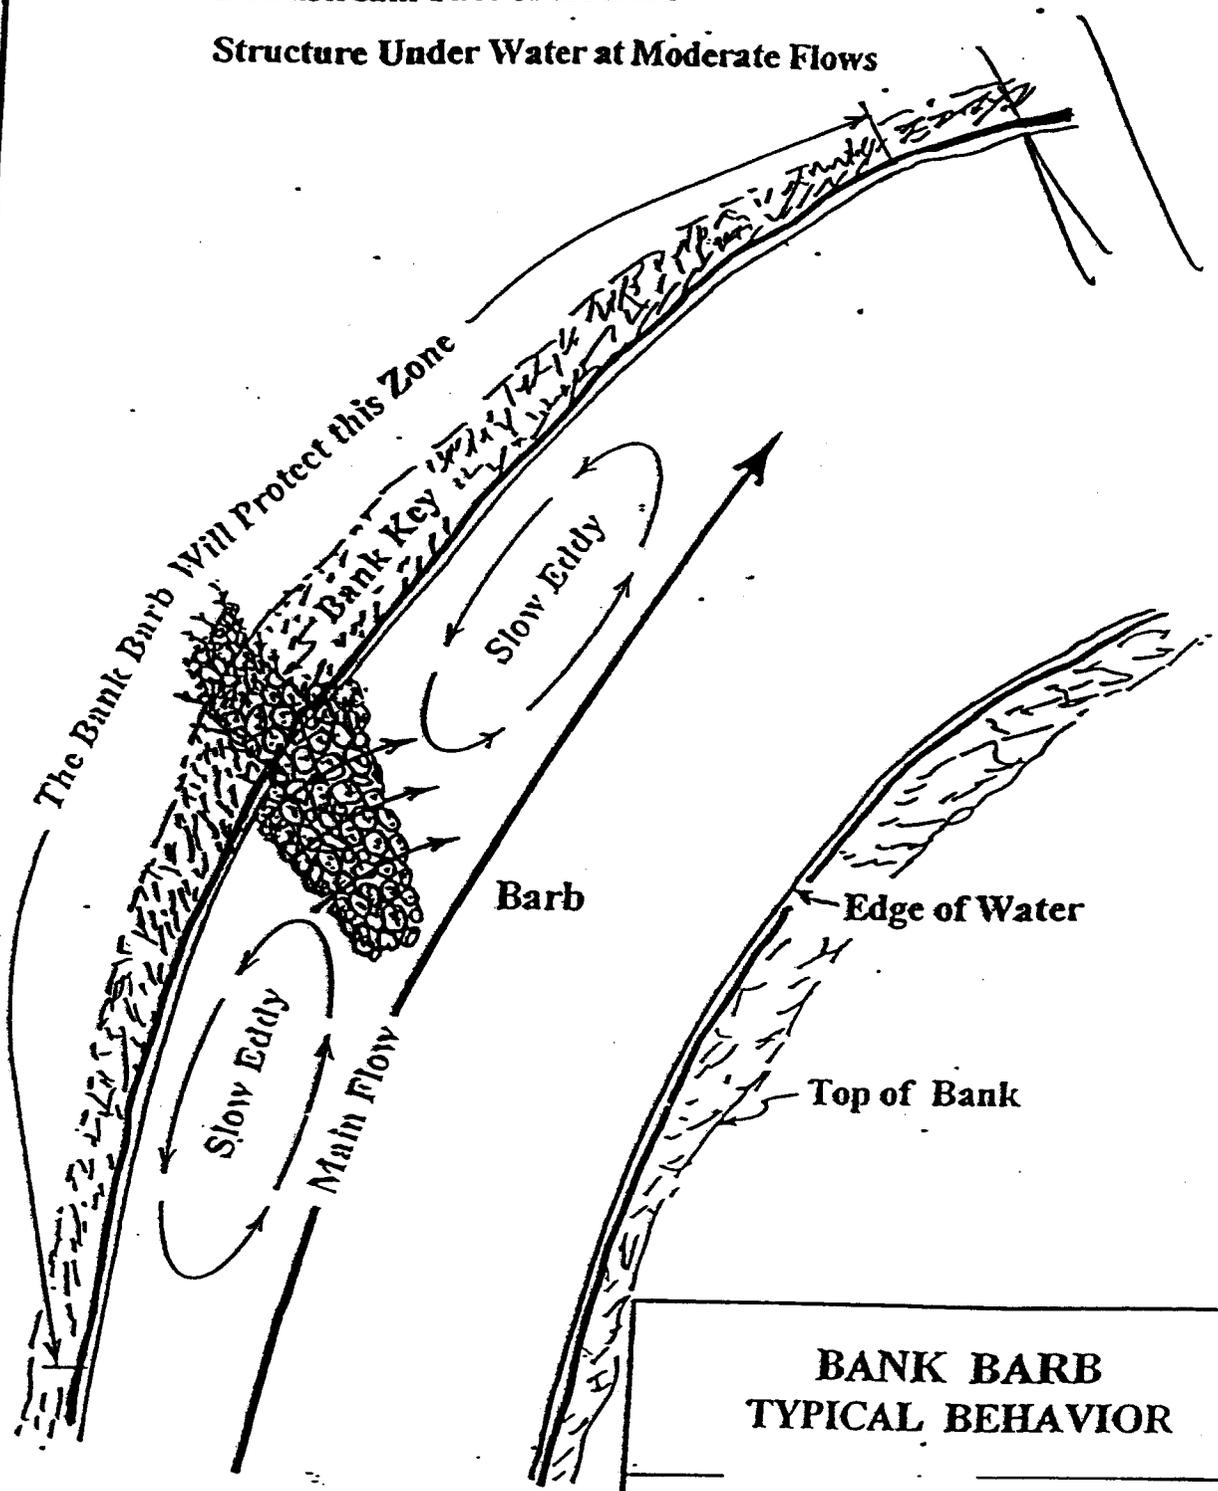
**BANK BARB
TYPICAL BEHAVIOR**

NOTE: Flow Is Directed Perpendicular to the
Downstream Face of the Barb
Structure Under Water at Moderate Flows

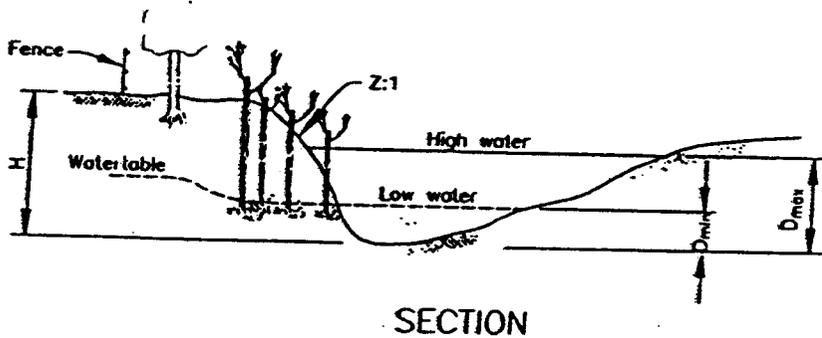
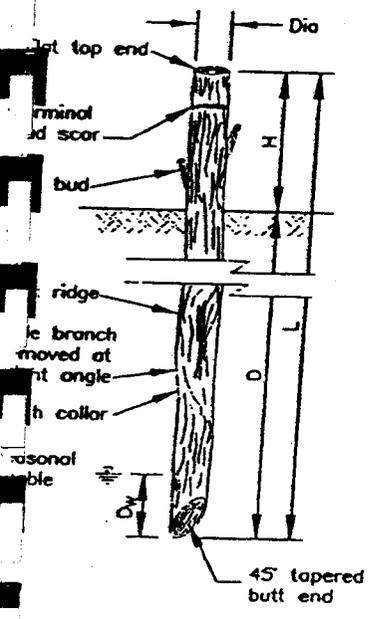
1. All lateral branches shall be trimmed to avoid damage.
2. A minimum of two lateral buds shall be above the planting depth.

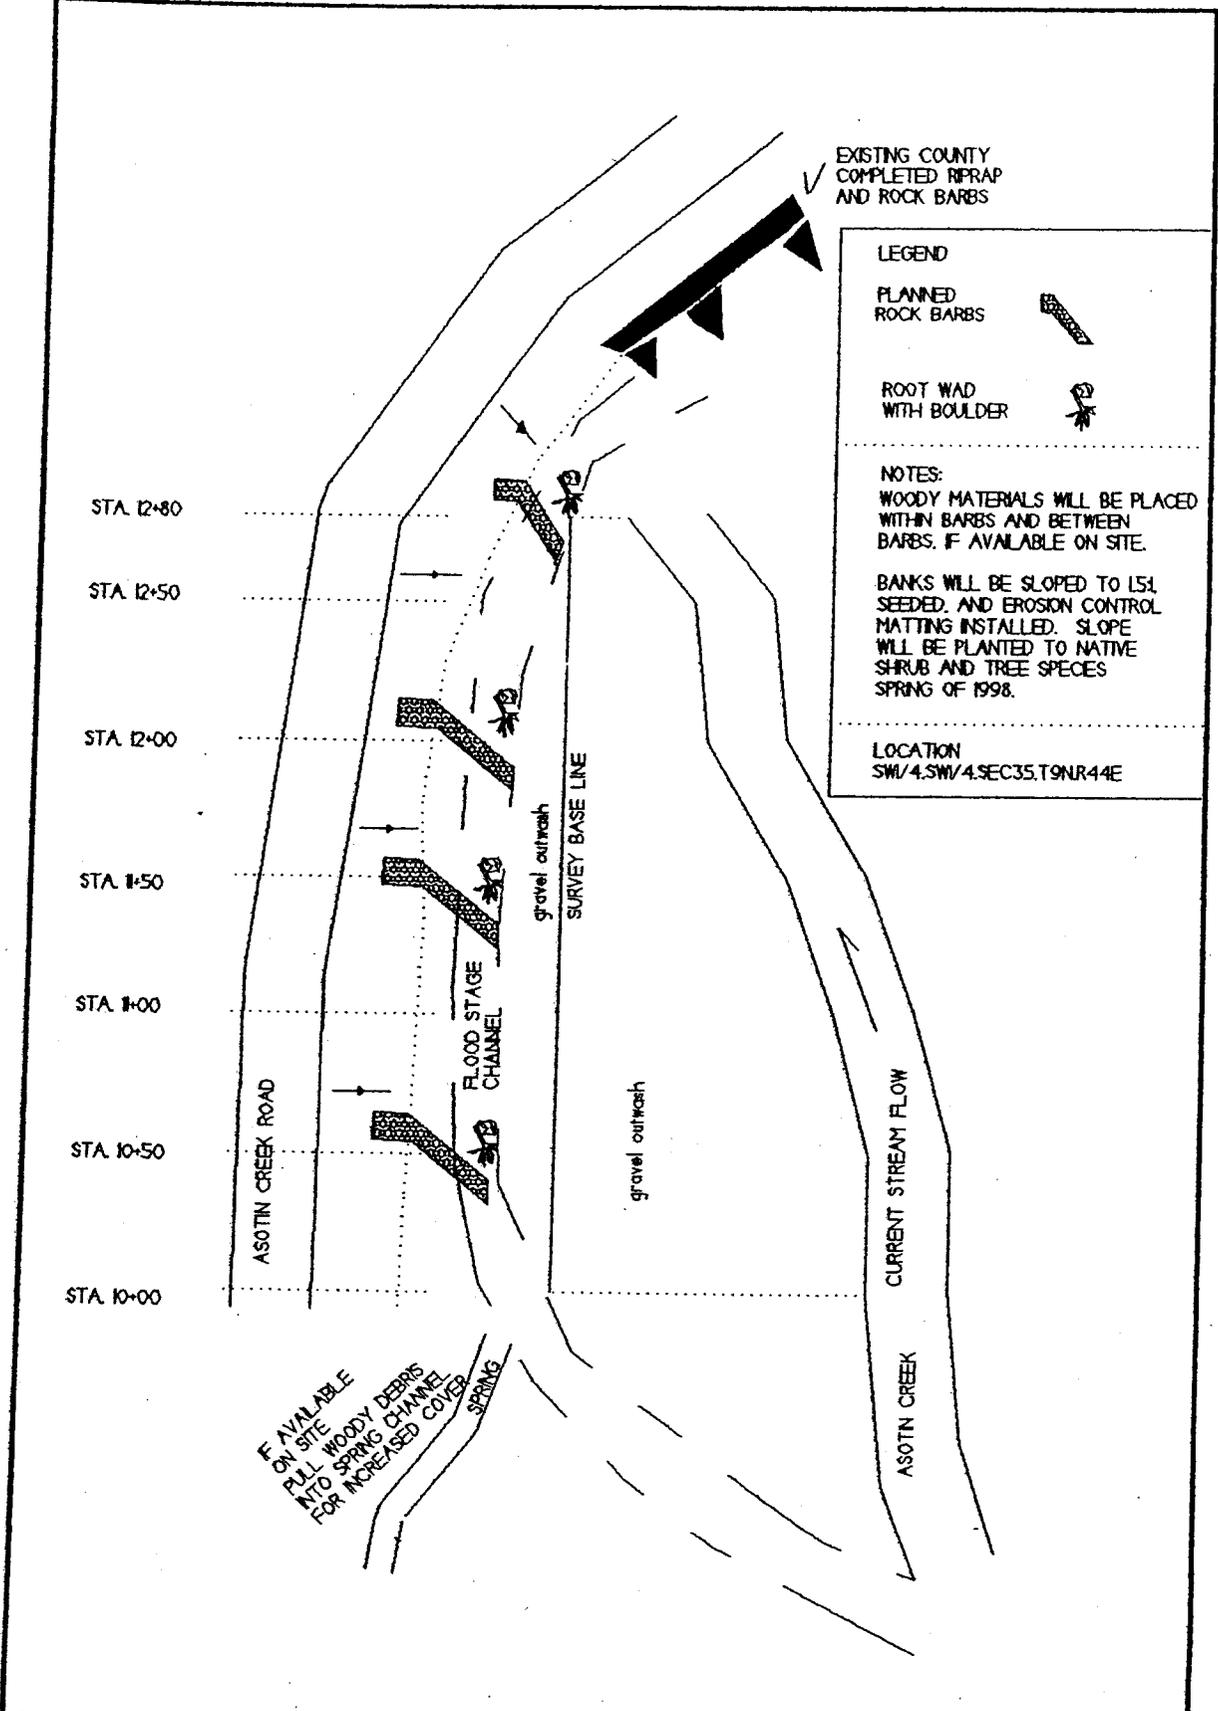
PROJECT LAYOUT BLANKESHIP SITE I ASOTIN CREEK, ASOTIN COUNTY, WASHINGTON	DATE	7/97
	BY	RDS
U.S.D.A. NATURAL RESOURCES CONSERVATION SERVICE	SCALE	
	OTHER

EXISTING COUNTY
COMPLETED RIPRAP
AND ROCK BARBS

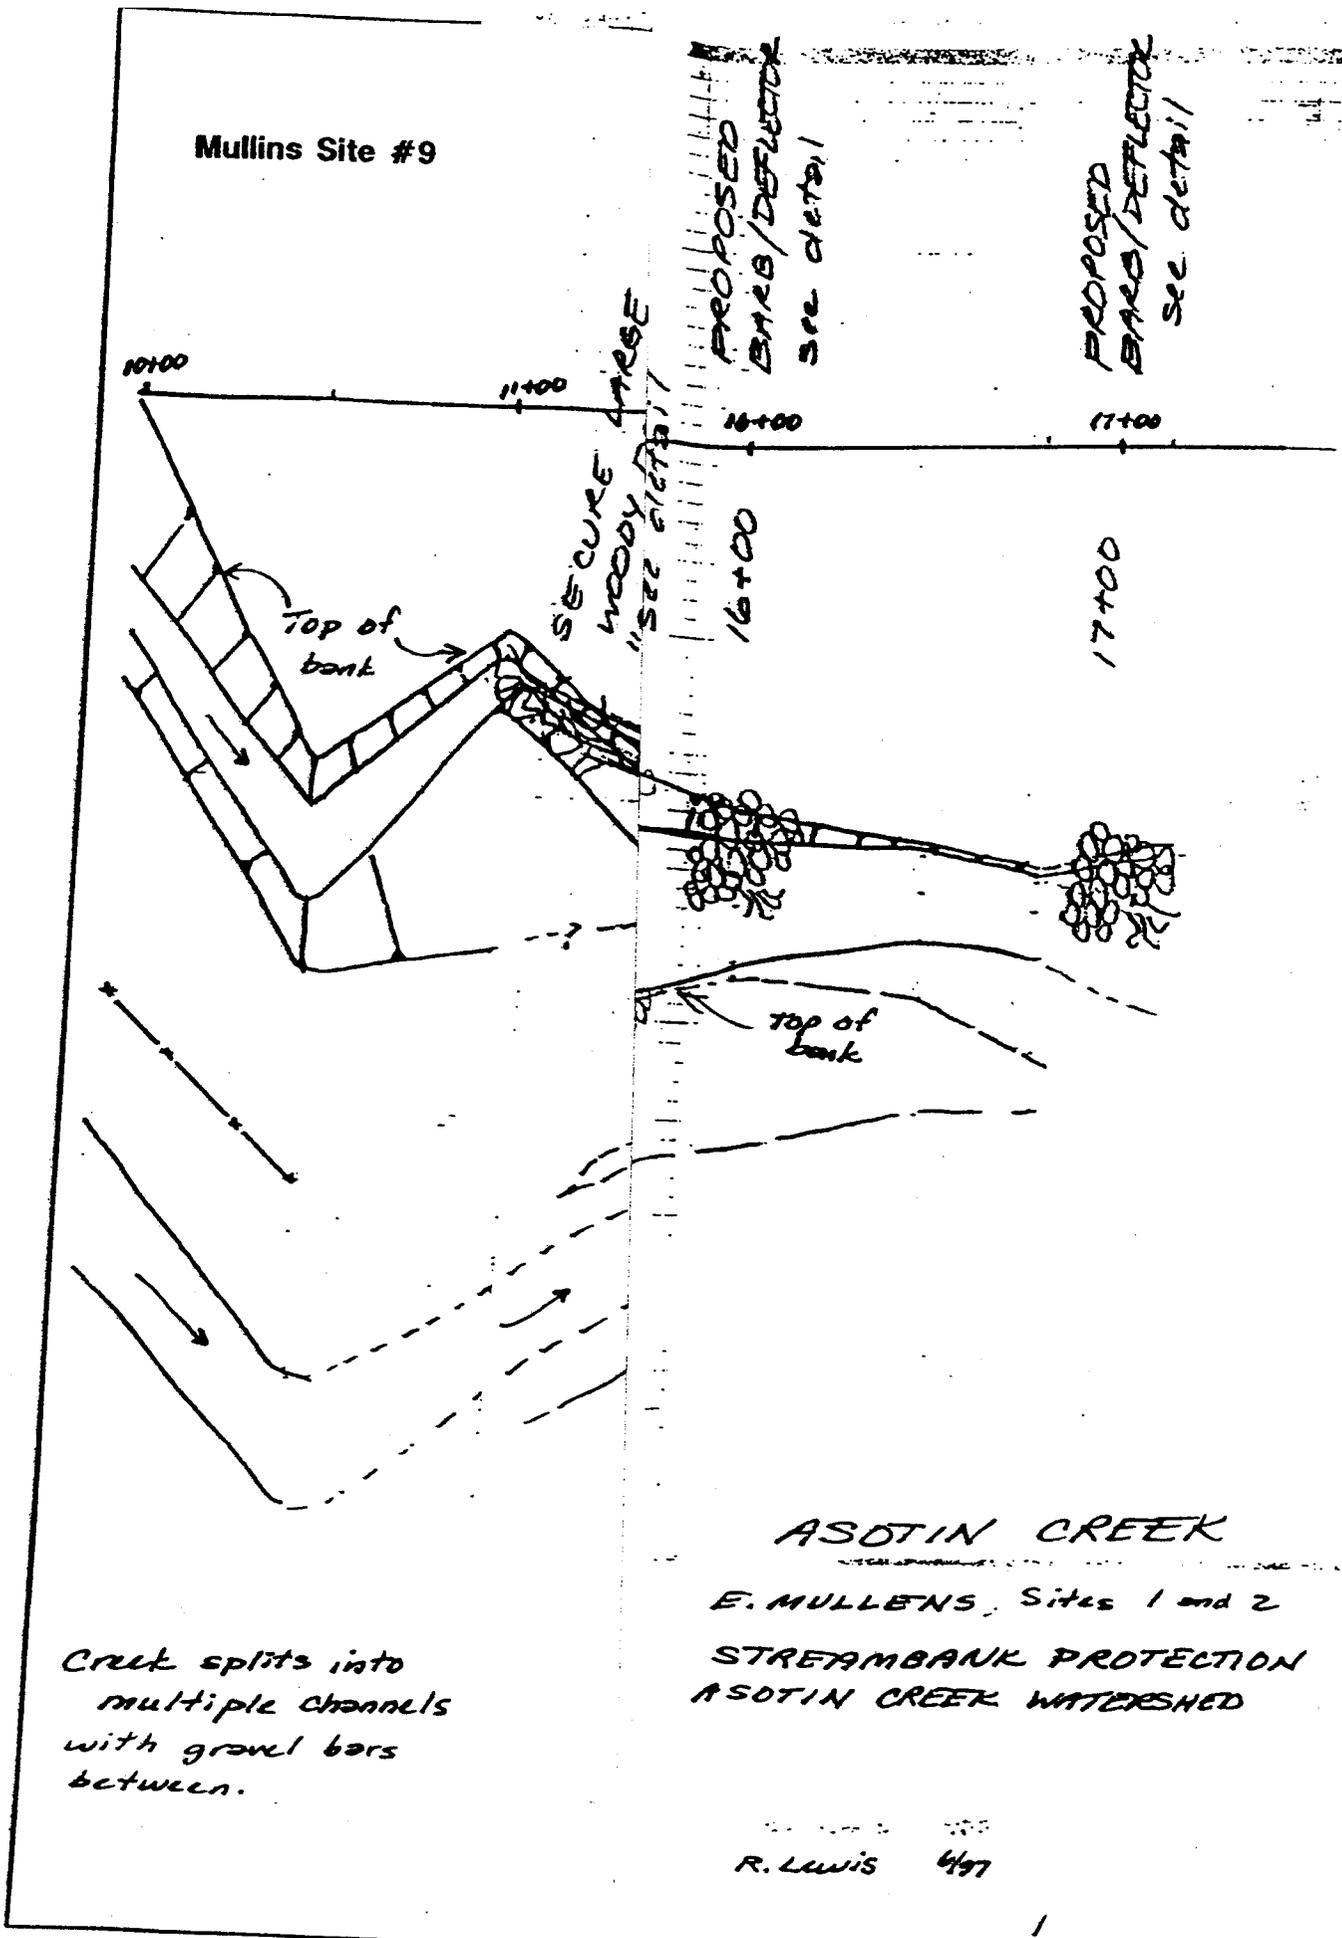
Mullins Site #9

Creek splits into multiple channels with gravel bars between.
