# Mini-Split Ductless Heat Pump Bench Test Results

**To:** Kacie Bedney, Bonneville Power Administration  
**From:** Bob Davis, Ecotope, Inc.  
**Subject:** Mini-Split Ductless Heat Pump Bench Test Results—Final Progress Report

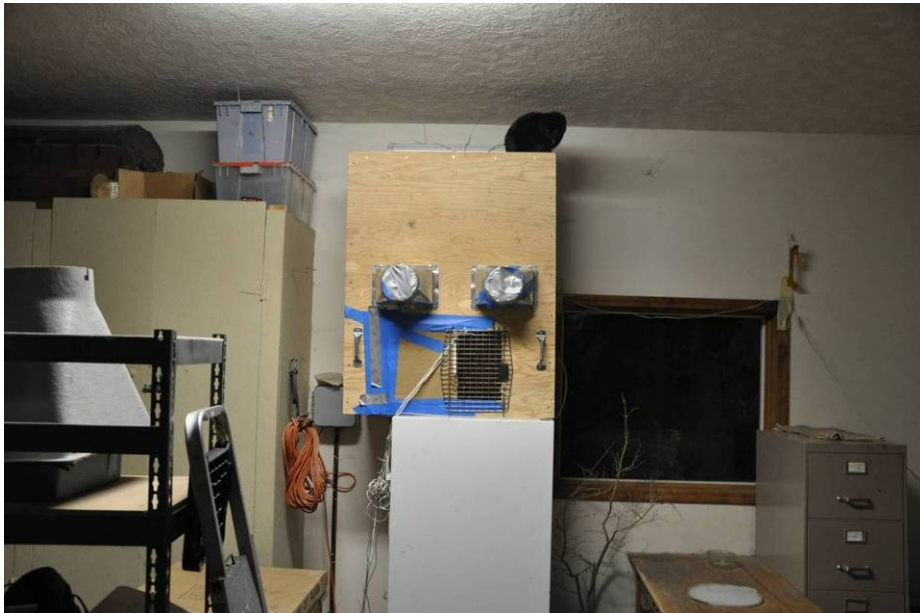
Figure 1. Head-on View of Indoor Unit Test Enclosure

The indoor unit of the tested system is partly enclosed by a plywood box; this enclosure has facilitated measurement of system airflow by use of a depressurization fan (combined with logged measurements of box pressurization during normal system operation). Since this configuration has not been shown before, it is presented below for reference:

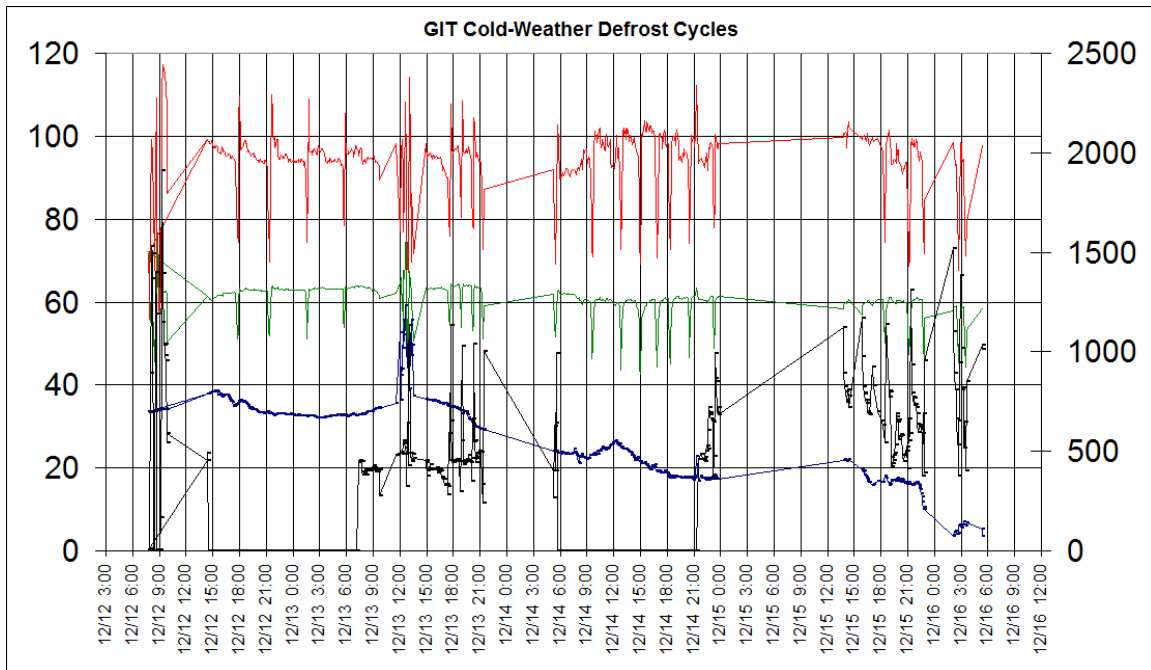
**Figure 2. December 2008 system behavior (emphasis on defrost cycles)**

Figure 2 shows the supply air temperature (red line), return (garage) air temperature (green line), and outside temperature (blue line) and whole-system energy usage (black line) during part of the cold snap. Note ambient temperature started in the high 30's F at the left of the graph and headed downward; there is some data interruption around noon on 12/13 that had to do with a system adjustment. Also, there are some missing power measurements for most of 12/14; this problem was corrected.).

*Note left y-axis label is degrees F and right y-axis label is system power (Watts).*

*Red line is supply air temperature; green line is return air temperature.*

*Blue line is outdoor temperature; black line is DHP power.*

The most interesting aspects of defrost on this mini-split have to do with the overall amount of time spent in the cycle and the range of system energy usage during and after defrost. The best data to consider are found on 12/13 in the afternoon and on 12/15 in the late afternoon/early evening.

During the former period, ambient temperature is in the 30's F. The system goes through about six defrost cycles over the course of an afternoon, with the first (at about noon) being the most significant. This cycle lasts for about 20 minutes. Note the supply air temperature drops to about 70°F for part of the cycle, but just after the cycle ends, the supply air temperature jumps to about 115°F. This behavior is congruent with other defrost cycles; the control logic appears to compensate for the relatively low delivery temperatures during the reverse cycle by boosting output temperatures just after the cycle concludes. This boost comes at a price: increased system energy usage, with power jumping from about 600 Watts (pre-defrost-cycle usage) to over 1000 Watts for the five minutes or so of "boost." After this period is over, the usage settles down. Note that during defrost, the fan airflow (measured in cubic feet per minute [CFM]) also modulates to a very low level to mitigate complaints of discomfort.

During the reverse cycle itself, power usage is modest since the system is taking heat from a mild source and dumping it to a very cold sink (the iced-up coil in the outdoor unit). Since there is no electric resistance backup heat (as would be found in a standard residential heat pump), the overall effect of the reverse cycle is negligible. Also, there are no times where the supply air temperature dips below the return air temperature.

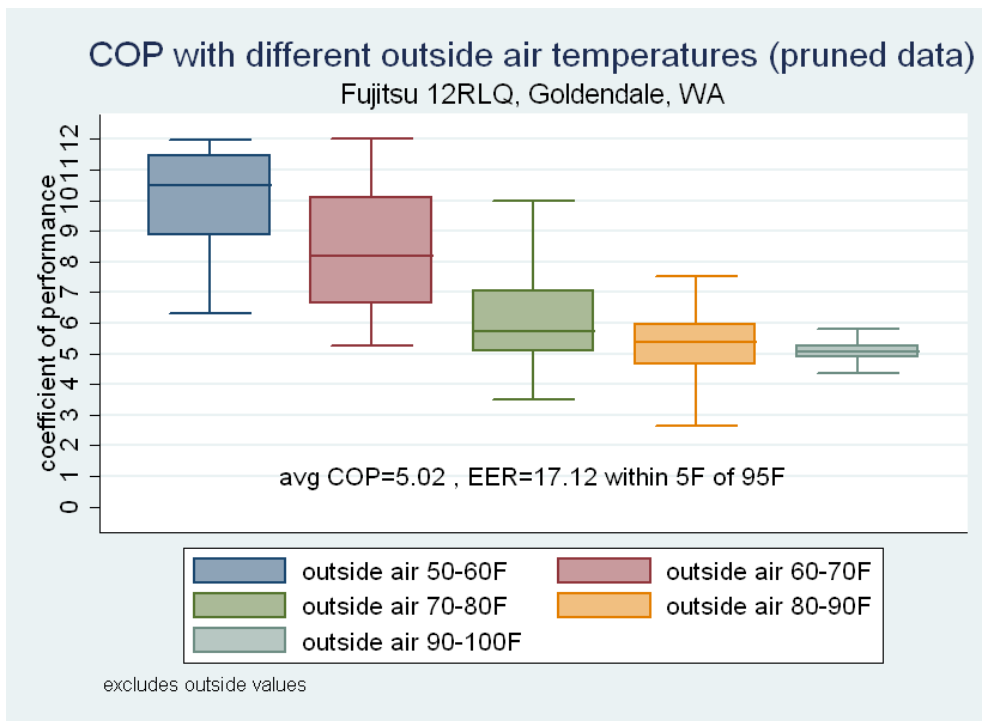
**Figure 7. Summary of Cooling COP at Different Outdoor Temperature Bins Performance on a Very Hot Afternoon (Full-Capacity Forcing)**

A box-and-whisker plot of cooling COP as a function of outdoor temperature (similar to Figure 4, but for cooling) shows the system generally performs better than one would expect given nominal manufacturer’s ratings (EER 12.5). When COP is converted to a pseudo-EER using the 3.413 conversion factor, we find an “EER” estimate of about 17 for all operating conditions within 5°F of the outdoor temperature used in the actual DOE EER test (95°F). Note, though, that almost all operation captured in the graphic is for part-load operation.

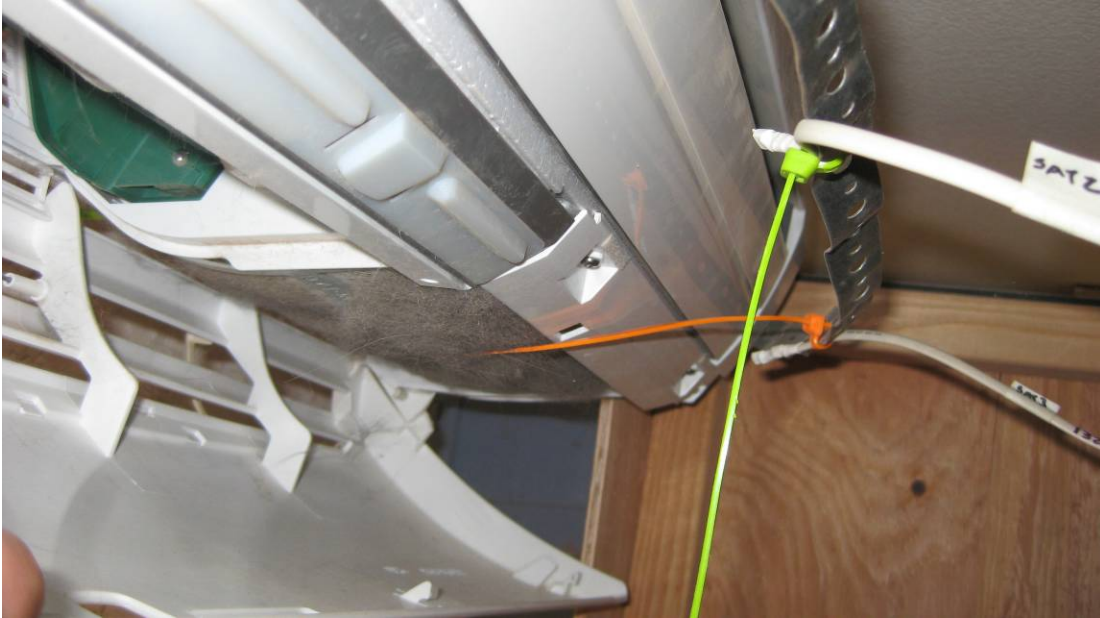
**Figure 8. Fouled Filter in Place in Unit**

A few days before these data were collected, the system was checked out for summer monitoring. During the course of this checkout, we realized there was a problem with the airflow measurement; even on High setting, the system was only delivering about 265 CFM. (Measurements from before had found about 320 CFM on the High setting.) The system filter was evaluated and found to be very dirty. See Figures 4 and 5 for further details. Note the indoor fan on this system does not have an ECM-type motor (which will vary RPM and CFM as resistance to flow increases). This is typical of the inverter-driven DHPs and is a surprise to some.

*(note supply temperature array and side of enclosure box at rear of photo)*

This finding is not terribly surprising but does reinforce the need for regular system maintenance on any HVAC appliance. We built a wire mesh barrier on top of the unit to protect the air inlets during the rest of the summer's testing.

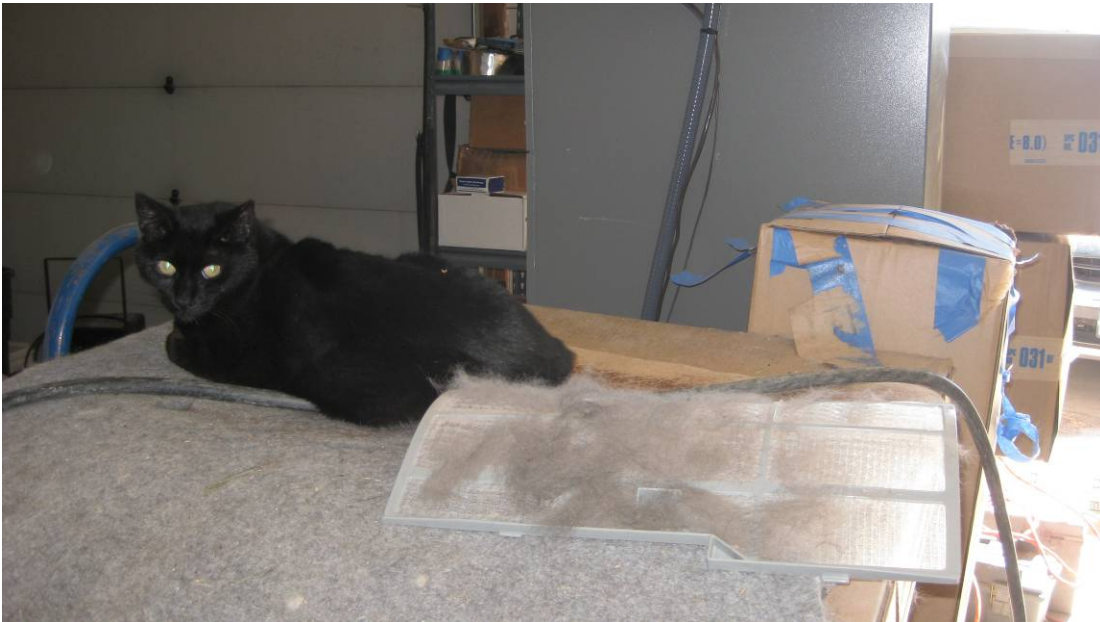
**Figure 9. Partially Cleaned Filter and Source of Fouling**

*(although this cat is not the primary perpetrator)*
