HABITAT IMPROVEMENT PROGRAM HIPIII 2018 ANNUAL MONITORING REPORT

Bonneville
POWER ADMINISTRATION

This is the fifth and likely final annual monitoring report required under the Habitat Improvement Program III Biological Opinions (HIPIII) (NMFS No# 2013/9724, USFWS 01E0FWOO-2013-F-0199) before the HIP4 is released. This report summarizes activities completed in calendar year 2018 and reports on the incidental take resulting from those activities and compares them with previous years.

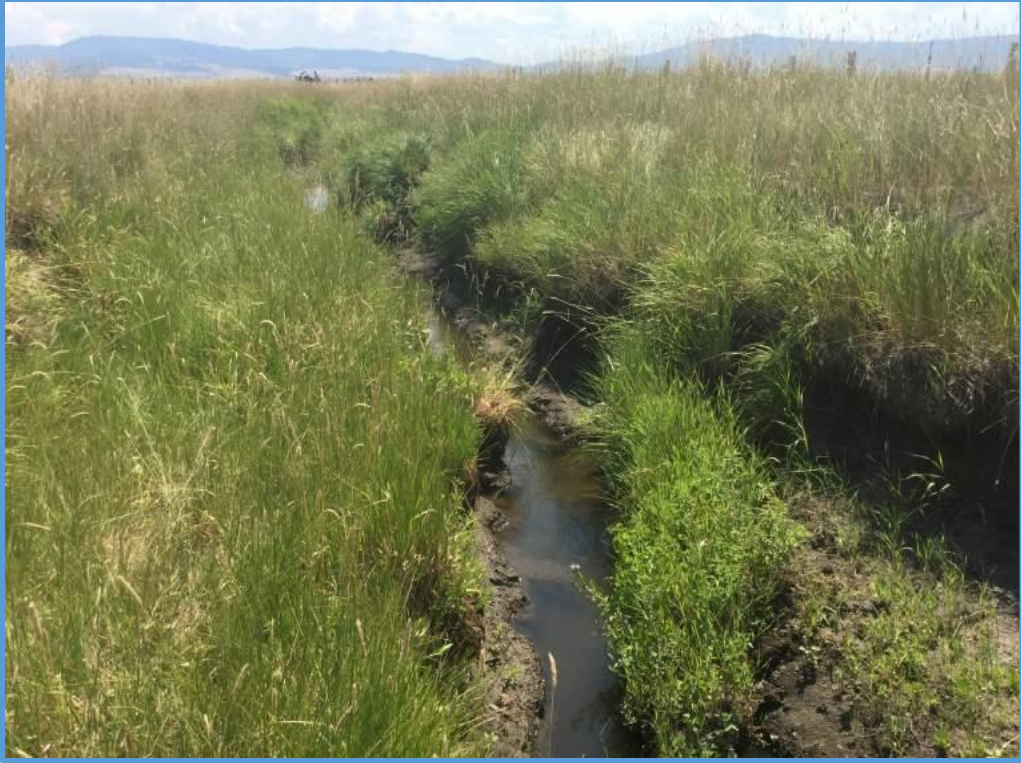
2018001 Fox Creek Prior to Construction

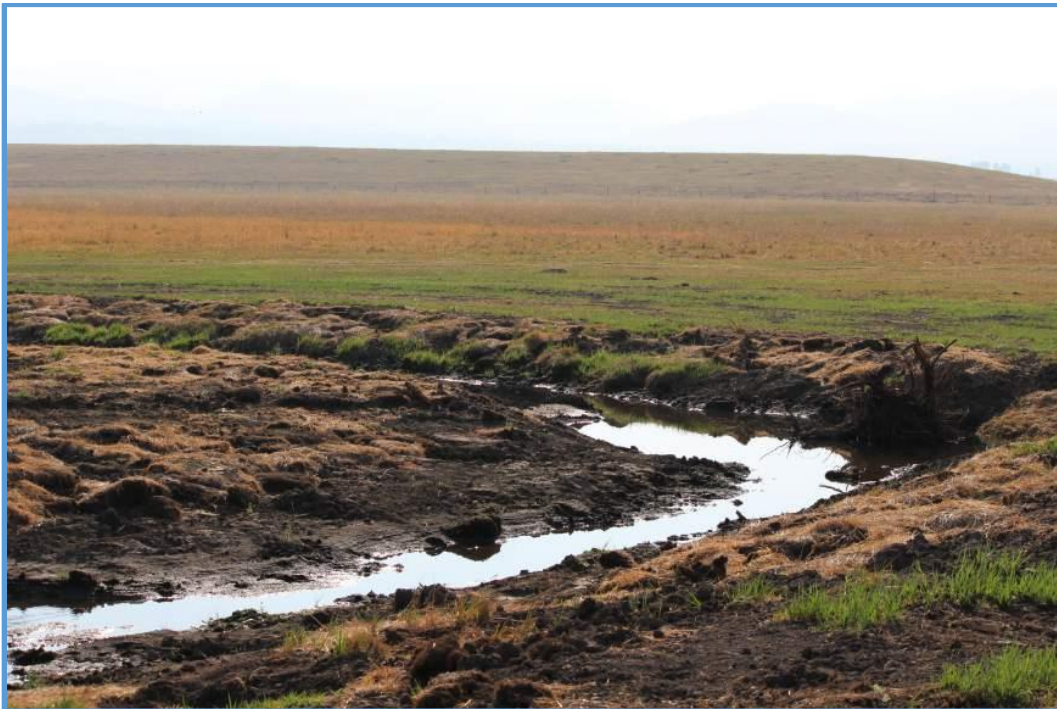
2018001 Fox Creek During Low Flows

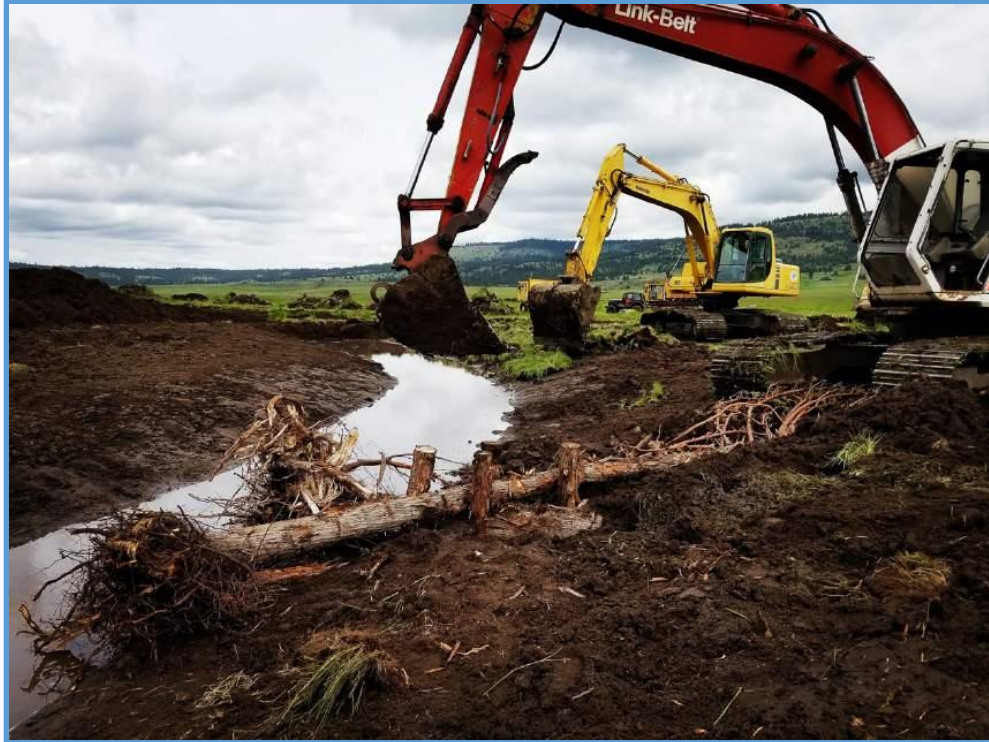
HIPIII NO#	PROJECT
<p>2018001 EXPLANATION</p>	<p>John Day Tributary Passage and Flow – Fox Creek Specific restoration actions include additions of large wood and beaver support structures in the stream channel, reconnection of relic channels to increase sinuosity, re-shaping of floodplain zones, and riparian planting and fencing. Installation of large and small wood structures resulted in releases of fine sediment which due to low flows did not dissipate after 3 monitoring intervals. Fox Creek is an old lakebed and soil is extremely fine with no rock substrate. It was reported that walking through the stream for fish salvages alone creates extensive turbidity. All HIP BMPs were in place including additional measures as needed (installing filter fabric on exposed areas). Turbidity in this area is reasonably likely to be unavoidable.</p>

2018001 Fox Creek Structure Placement resulted in turbidity

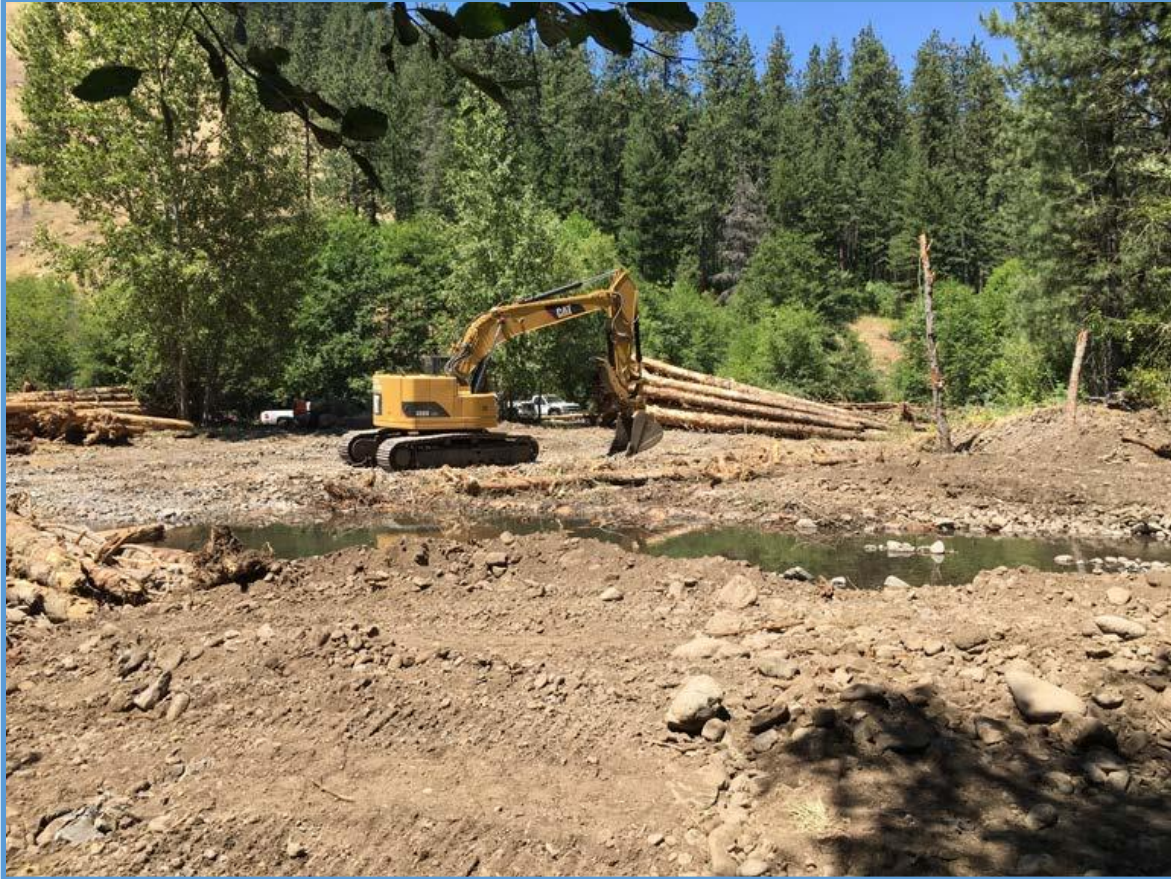
HIPIII NO#	PROJECT
2018027	Umatilla Anadromous Fish – Meacham Creek Bonifer Reach
EXPLANATION	<p>The project design incorporated the following major elements: 1) reshaping of the floodplain and removal or modification of large spur dikes in the floodplain; 2) excavation of a new channel and side channels to move the stream into its historic channel alignment and meanders in the floodplain; 3) incorporation of in-stream habitat features in the new reconfigured channel and placement of large log and rock structures throughout the channel and floodplain; 4) removal of the existing protection levee along the existing channel. Generally, pollution and sediment control measures worked well across the large scale of the project. However, due to the extensive work that took place in one segment of stream, more extensive sediment controls had to be constructed to reduce turbidity to acceptable levels and prior to construction of adequate sediment control BMPs, turbidity did exceed HIP III standards for more than 3 monitoring intervals. However, work was stopped immediately after the exceedance was identified and more BMPs were put into place after turbidity had returned to background levels. After installing the appropriate BMPs, turbidity did not exceed HIP III standards again.</p>

2018027: Umatilla Anadromous Fish – Meacham Creek Bonifer Reach

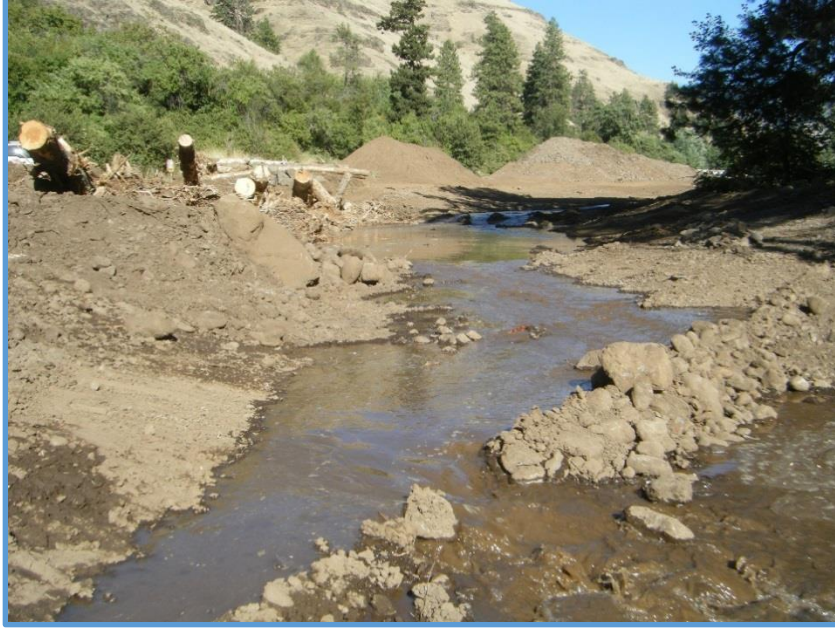
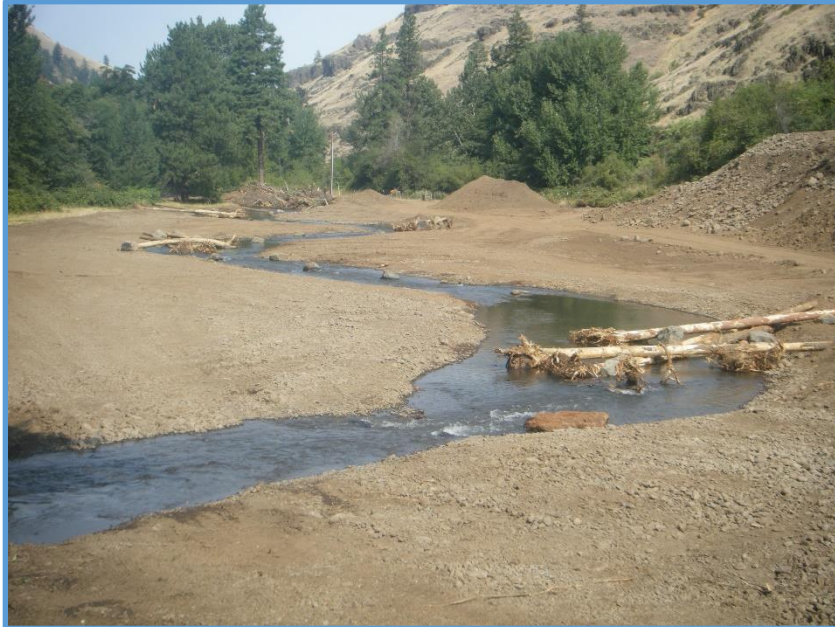
2018063 – Hutchinson Project – Extensive earthwork

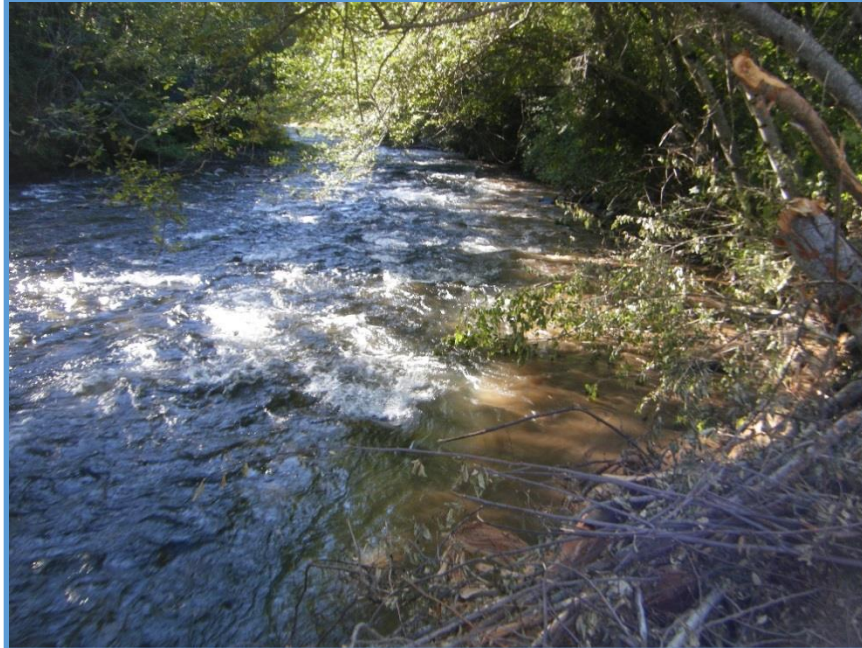
HIPIII NO#	PROJECT
<p>2018063 EXPLANATION</p>	<p>South Fork Walla Walla River – Hutchinson Project Construction work included significant floodplain, alcove, and side channel excavation; and installation of LWD structures, habitat boulders and roughened riffles. Turbidity was minimized and within criteria during construction. Following completion of side channel inlet area work, activation of side channels included pre-washing new side channels, pumping the turbid water to an approved floodplain location with no turbid water returns to the river, and incrementally increasing flow in the new side channels over a period of 3 of 6 hours. Despite this rewating plan, due to the extensive amount of newly excavated surfaces, suspended sediment entered into the SF Walla Walla and was limited to the right bank for <200m downstream and then was rapidly dissipated.</p>

2018063 – Hutchinson Project – Turbidity entering SF Walla Walla River
