# HABITAT IMPROVEMENT PROGRAM

## HIP4

### 2024 ANNUAL MONITORING REPORT

Bonneville  
POWER ADMINISTRATION

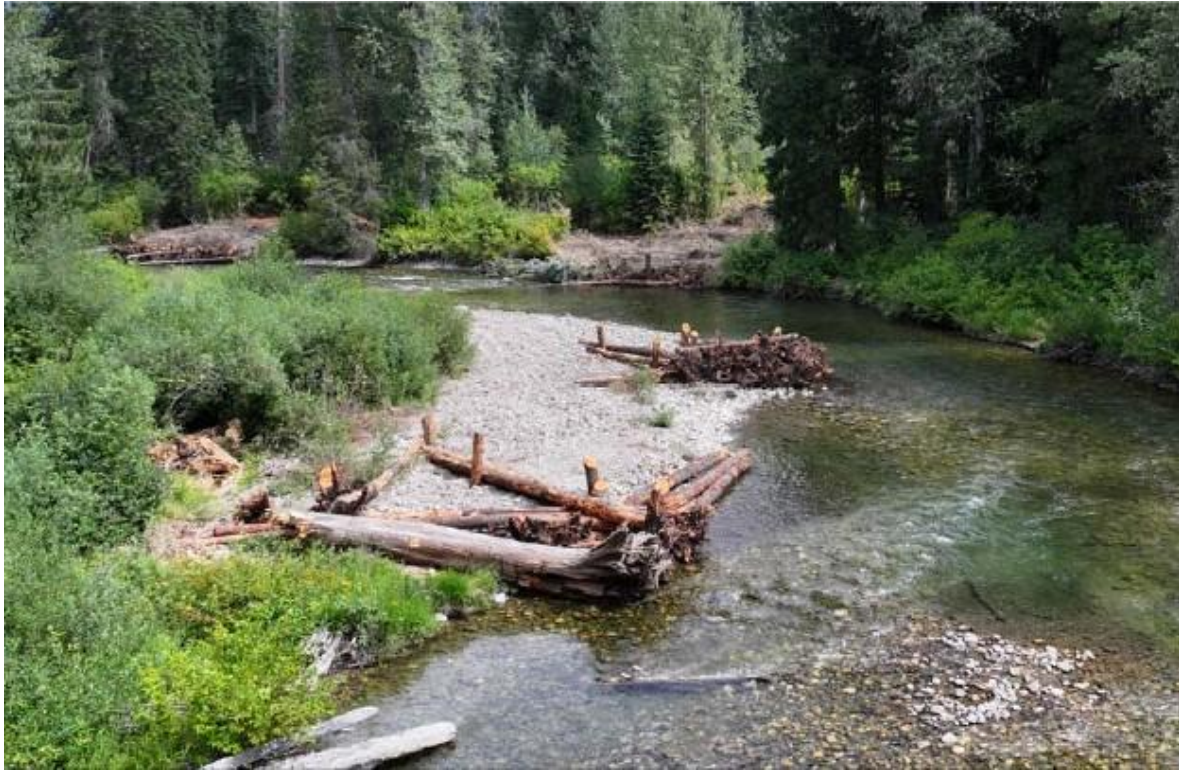
Figure 1. 2024002: Large wood structures on the Chiwawa River for the Chiwawa Outlet Fish Habitat Restoration Project.

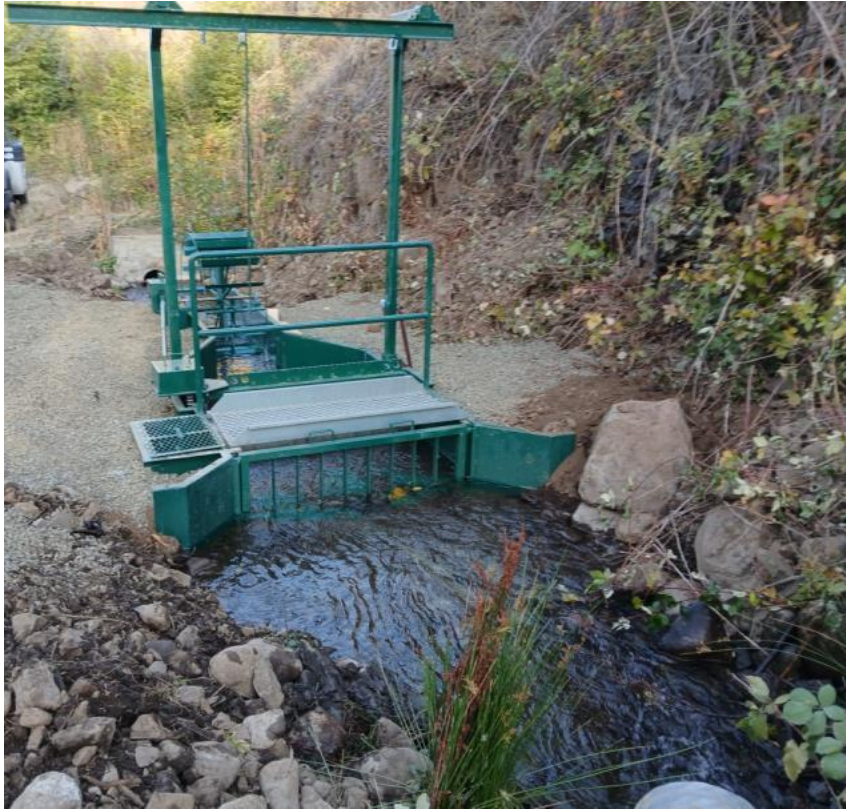
Figure 3. 2024024: New ODFW fish screen at North Fork Walla Walla River #4 site.

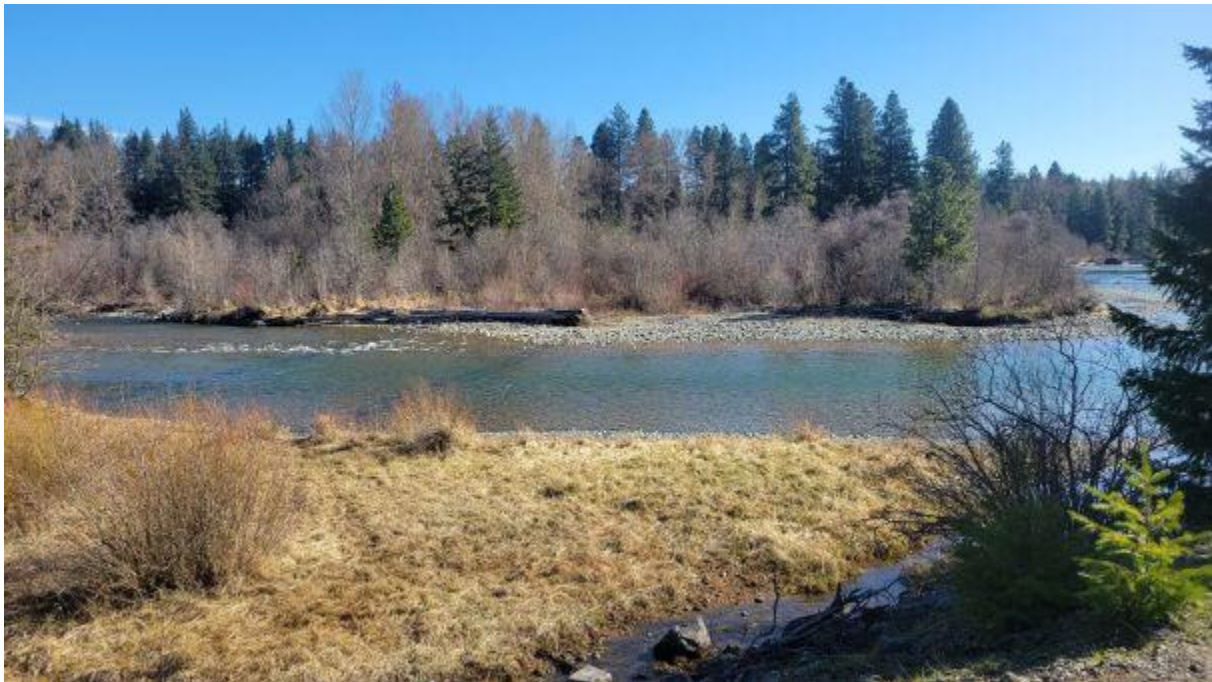
Figure 4. 2024066: Cle Elum River PIT array installed just upstream of the confluence with the Yakima River.

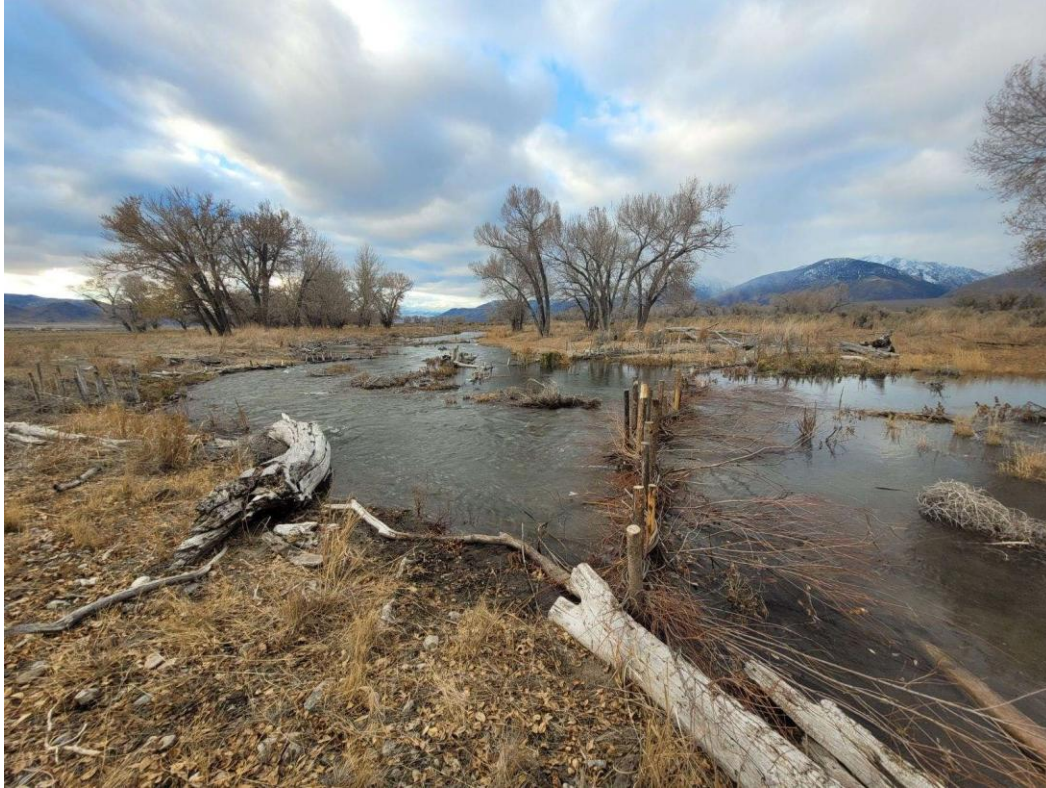
Figure 5. 2024076: BDA structure with willows on the Pahsimeroi River in Idaho.

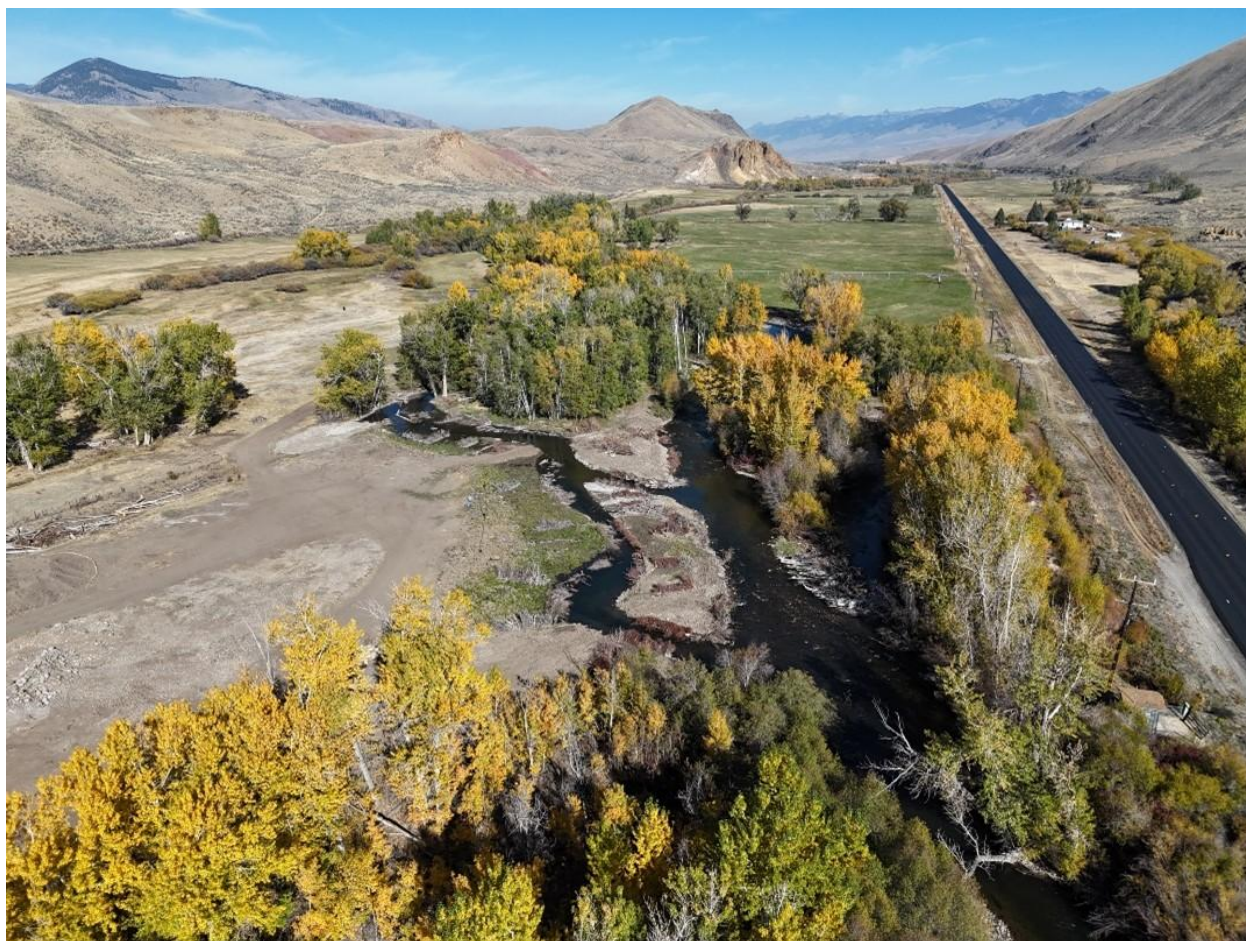
Figure 7. 2024004: Post-project aerial view of the floodplain cut and constructed side channels at the upper end of the project reach

The completed project features a newly excavated floodplain cut that has two side channels delivering water year-round to a relic side channel network that was dry before the project was constructed. Three additional side channels were excavated throughout the project reach to improve off-channel habitat conditions. Riffles were constructed to help raise the water surface elevation to improve floodplain connectivity that had been lost due to channelization. Large wood structures and pools were also constructed to provide cover, rearing, and overwintering habitat for juvenile salmonids. The L-40 diversion was also replaced with a new lateral flow headgate structure that eliminates the need for the landowner to enter the river to replace and repair the former wing dam twice a year.

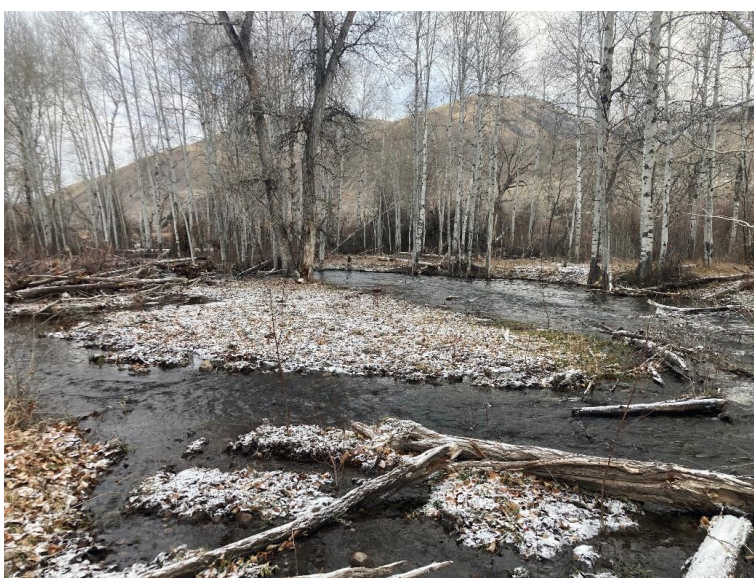
Figure 8. 2024004: Post-project perennial flow in a relic Hayden Creek channel that was dry

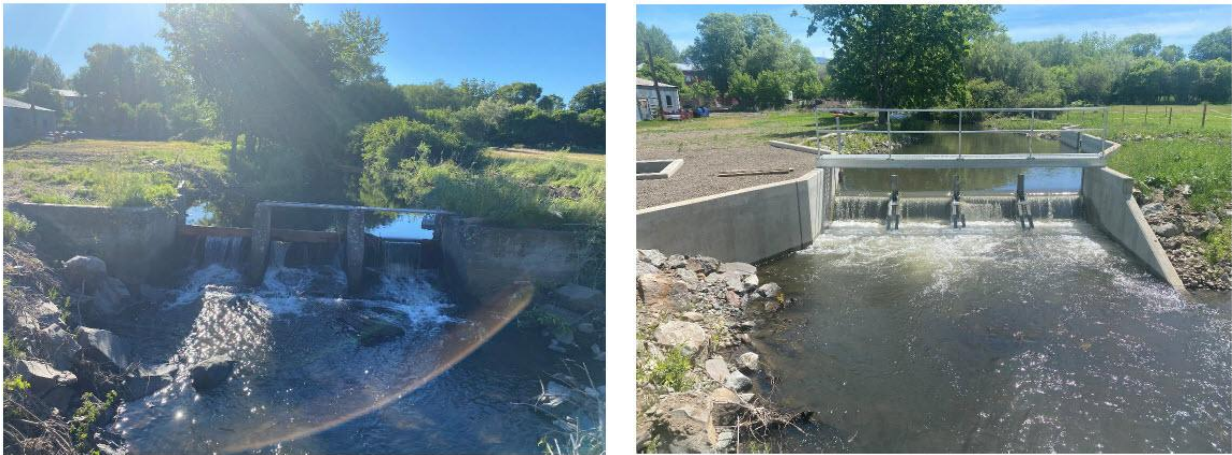
Figure 9. 2024006: Before (left) and after (right) photos of the diversion

The Little Creek Diversion Numbers 5 and 6 (LC 5 and 6) were channel-spanning concrete structures that accommodated stop logs to seasonally divert stream flows into unscreened irrigation intakes. With the stop logs in place during irrigation season, these structures blocked fish passage, and the unscreened irrigation intakes allowed fish into the ditch system. The structures also caused debris to accumulate and created personnel safety issues associated with wading into the river to maintain the structures and clear debris.

The project removed the LC 5 and 6 diversion structures and replaced them with modern steel stanchions. The new structures allow for placing stop logs without entering the river, give more control over the water level at the diversions, and require less maintenance and debris clearing than the former structures. New rotary drum fish screens fabricated by Oregon Department of Fish and Wildlife (ODFW) were installed at each irrigation intake. Fish bypass channels were constructed around each of the new diversion structures to maintain year-round fish passage.

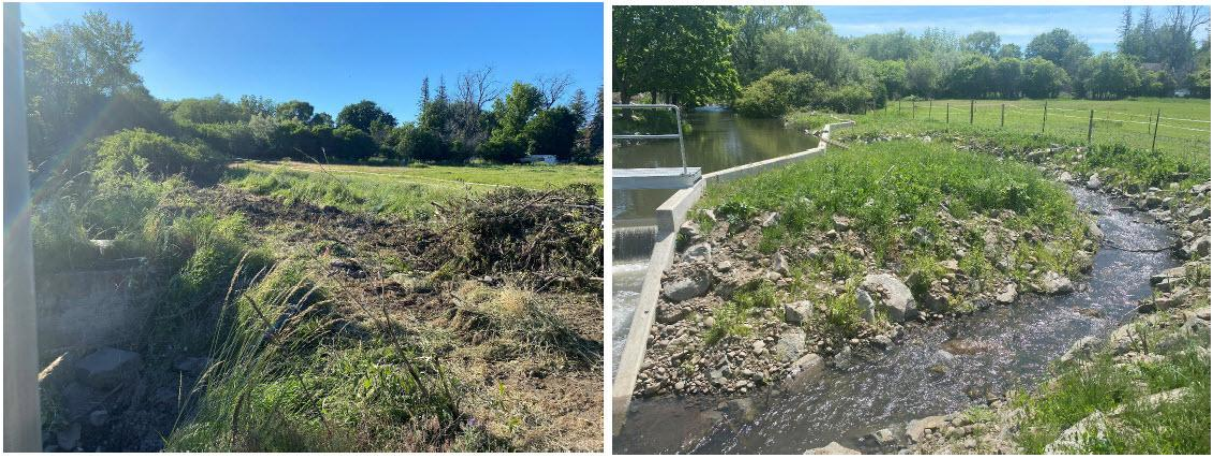
Figure 10. 2024006: Before (left) and after (right) photos of the bypass

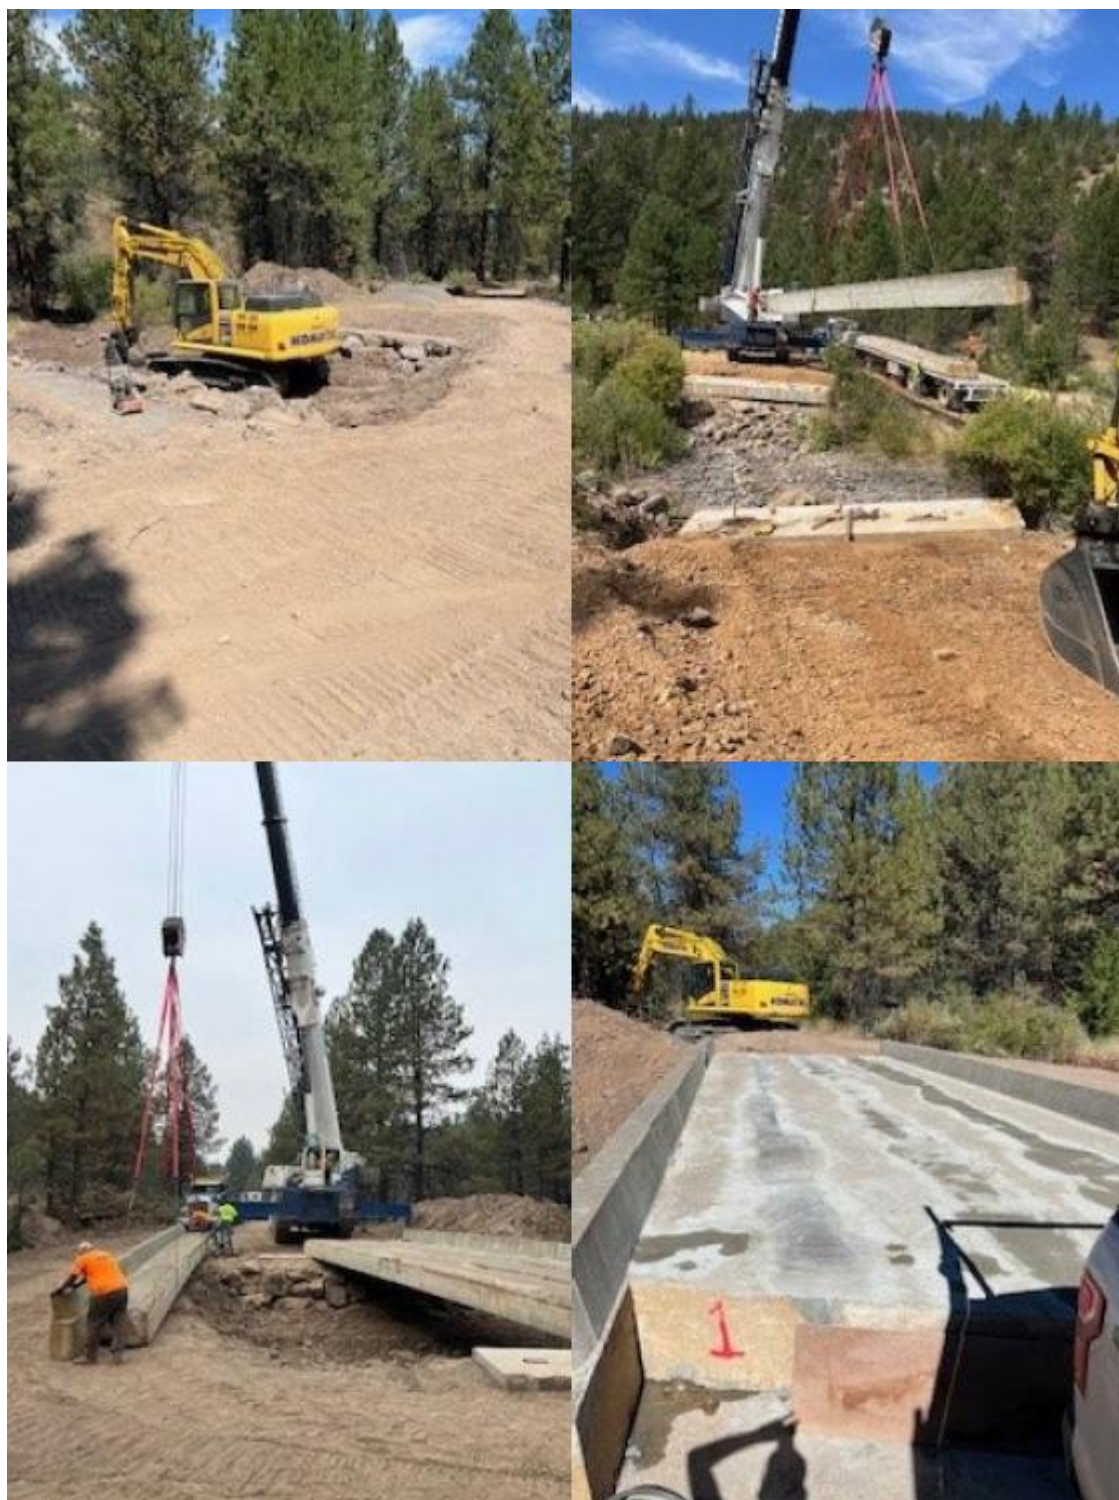
Figure 12. 2024009: Bridge installed at the Dutchman Creek crossing

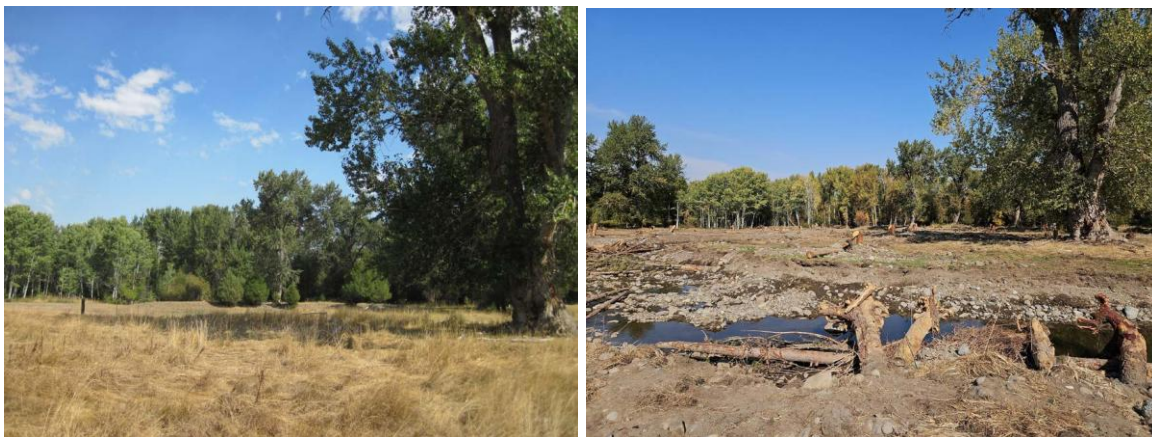
Figure 17. 2024012: Before (left) and after (right) photos of the floodplain and habitat structures

The project involved excavating a new channel complex in the river's historic floodplain. The new complex has one channel designed to be active under most flow conditions and function as a co-dominant channel with the existing mainstem channel. A number of smaller side channels and depressions were also excavated in the floodplain that are intended to inundate during higher springtime flows, reducing velocities in the main river channel and facilitating better interaction with the floodplain. Riprap bank armoring was removed. Spoils from the excavation were used to partially fill remnant cattle watering ponds and the existing channel where it is beginning to erode the bluff. Woody structures formed of logs, slash, and rootwads were placed throughout the channels and floodplain to help reduce flow velocity, create habitat pools, and help retain sediment. Willow tranches were planted throughout the floodplain along the new channels, and additional planting was completed to help re-establish vegetation in the project area.

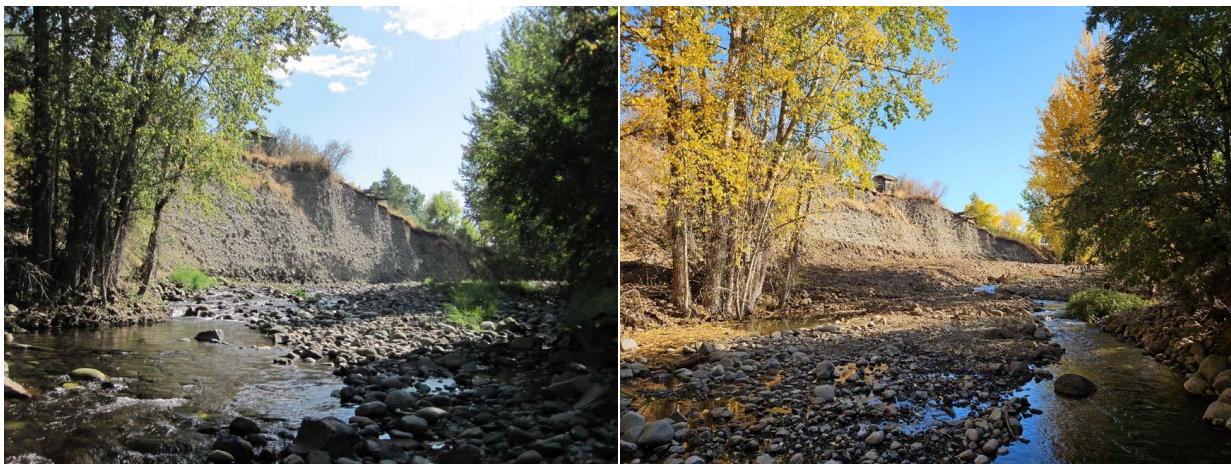
Figure 18. 2024012: Before (left) and after (right) photos of the bluff fill area, large wood structure, and low-flow channel

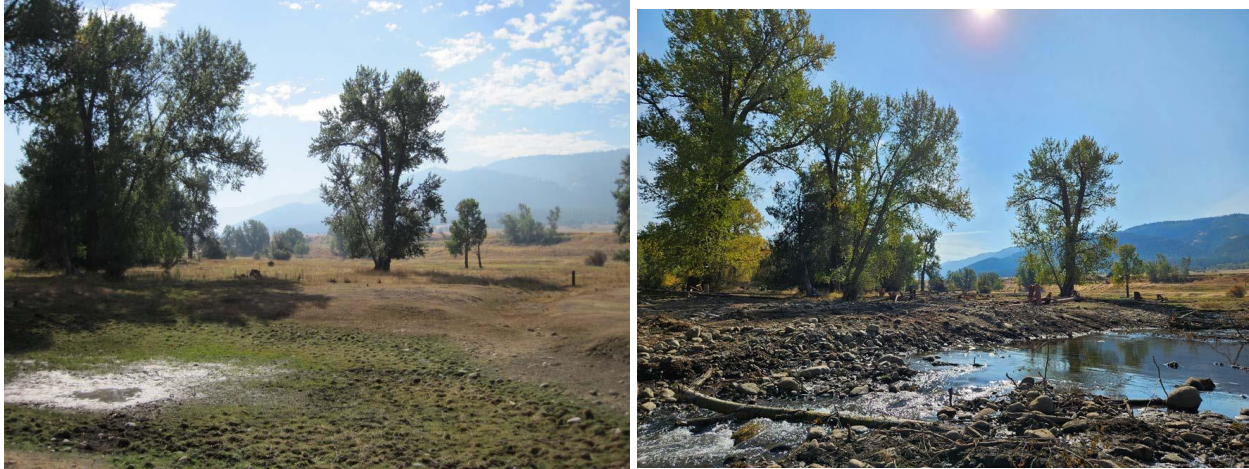
Figure 19. 2024012: Before (left) and after (right) photos looking upstream toward side channel confluence

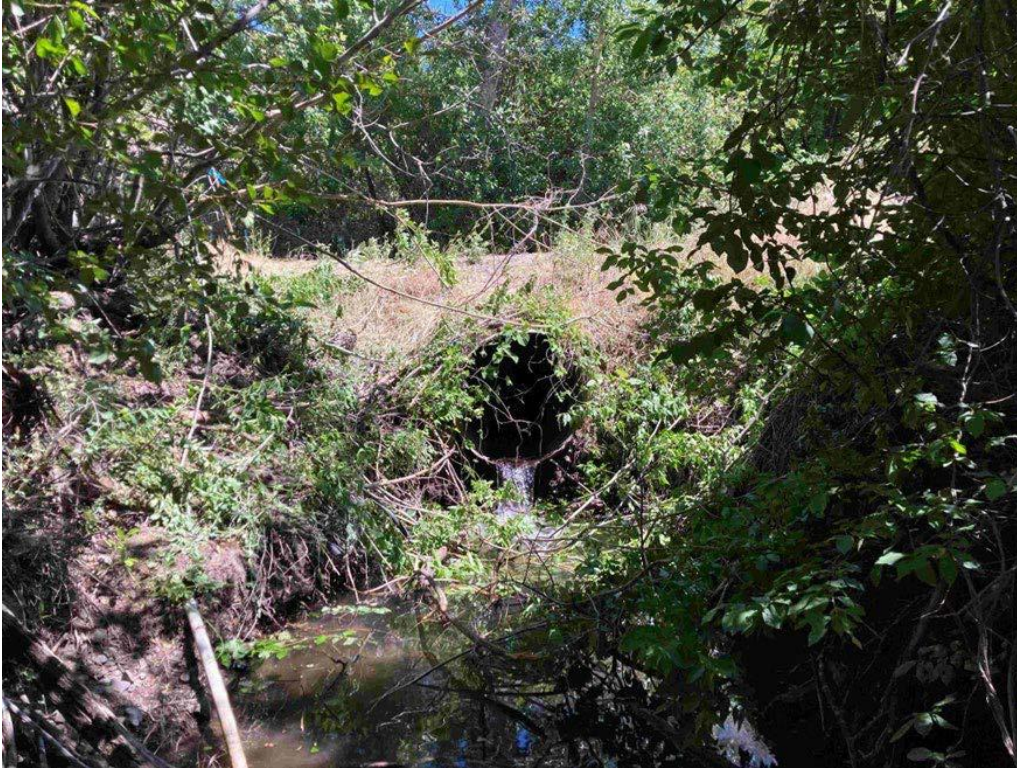
Figure 20. 2024039: Culvert to be removed prior to construction

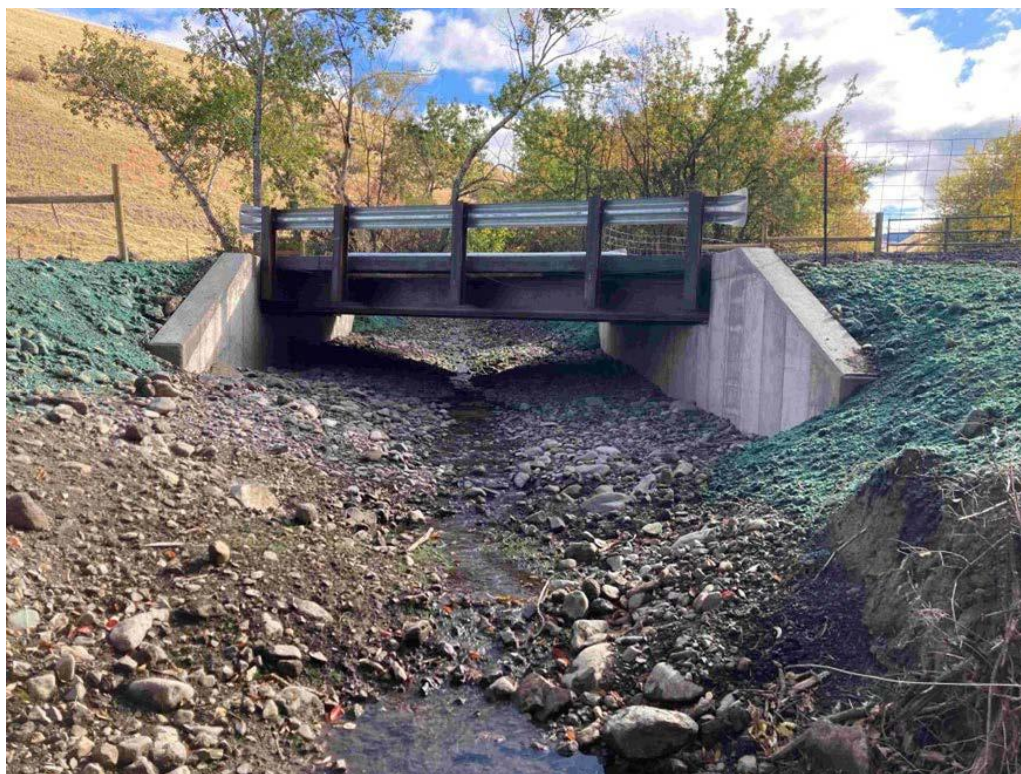
Figure 21. 2024039: New bridge after construction

- Re-grading of the channel bed and installation of habitat boulders in Stanley Creek\
- Installation of a pre-fabricated modular bridge at Stanley Creek
- Seeding and planting of native grasses, shrubs, and trees

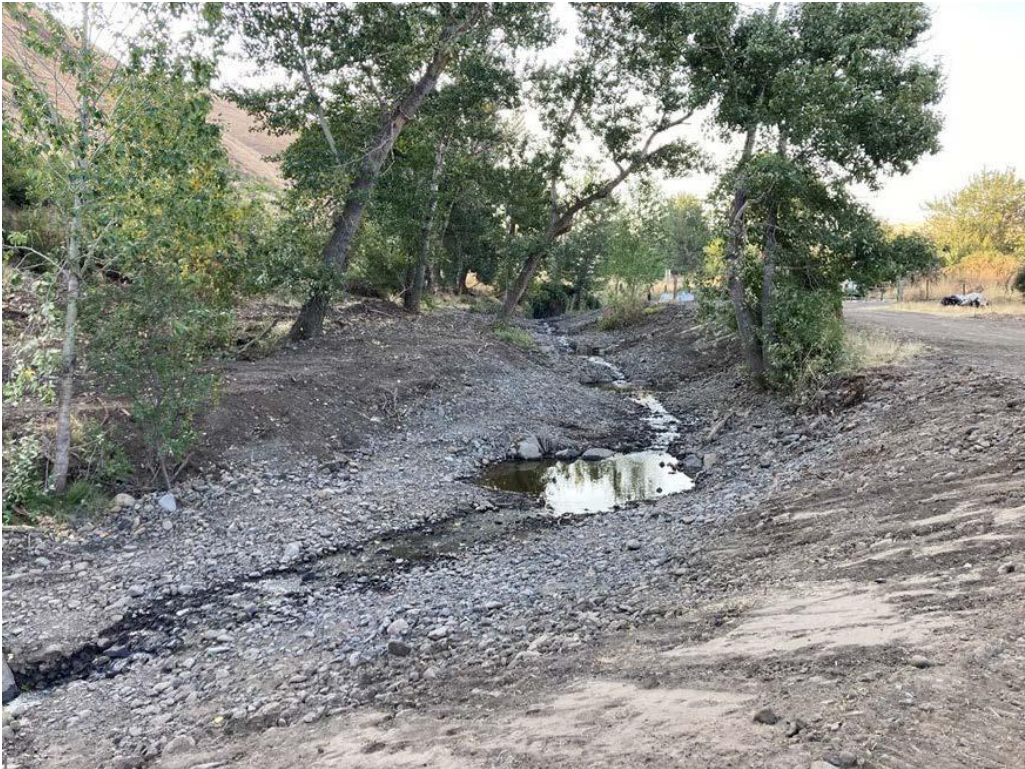
Figure 23. 2024039: Dam removal area after construction

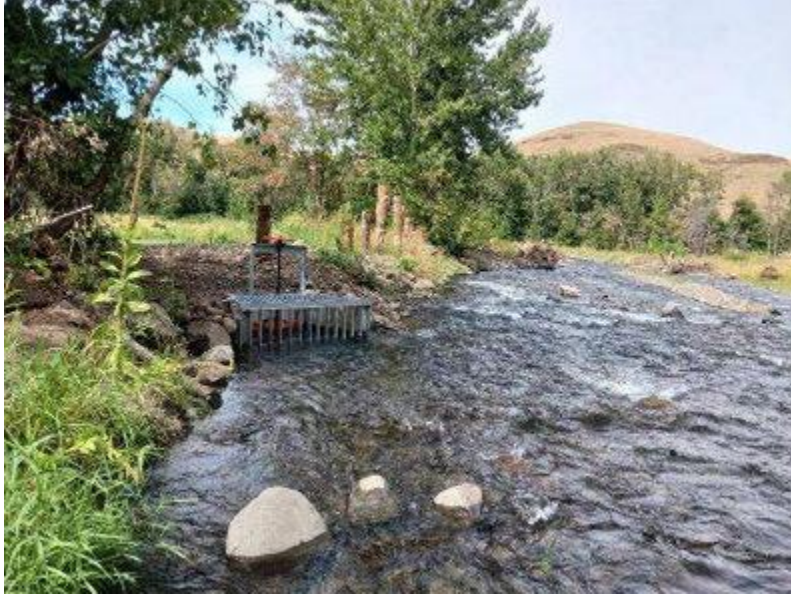
Figure 23. 2024049: South Fork Walla Walla diversion and roughened riffle

During the 2023 in-water work window, a new headgate was installed on the South Fork Walla Walla River immediately upstream of a roughened riffle that was constructed in 2022. During the winter of 2023-2024, irrigation piping and a new fish screen were installed to connect the new head gate to the existing irrigation conveyance system. The new headgate, fish screen, and irrigation pipe replaced the point of diversion (POD) located on the mainstem Walla Walla River, which was damaged in a February 2020 flood event.

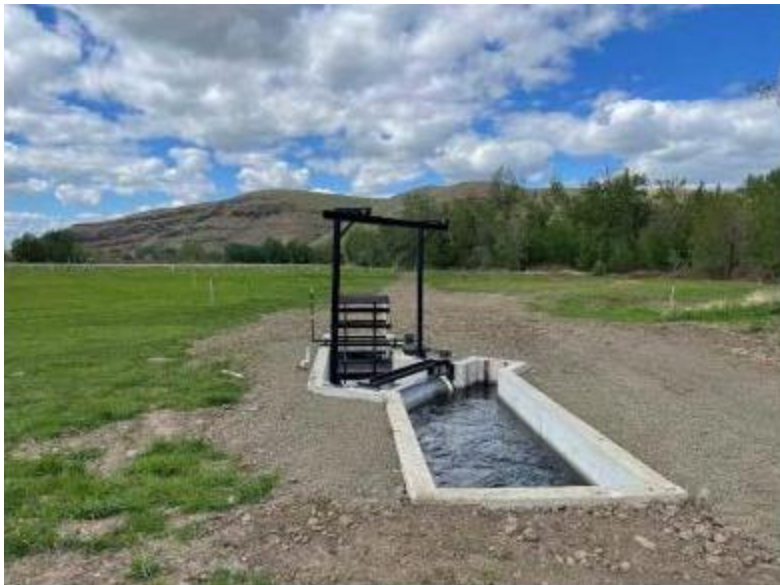
Figure 24. 2024049: New fish screen for the South Fork Walla Walla River POD

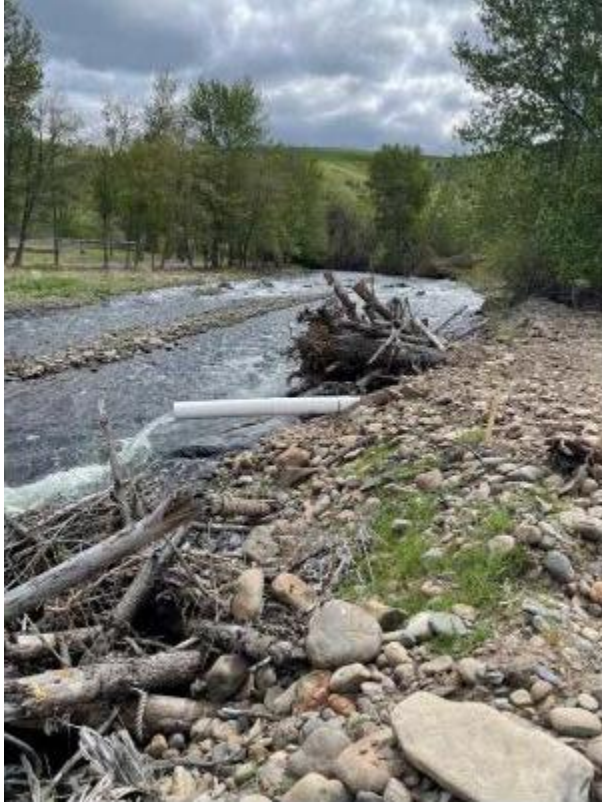
Figure 25. 2024049: New fish bypass pipe discharging to pool near large wood structure

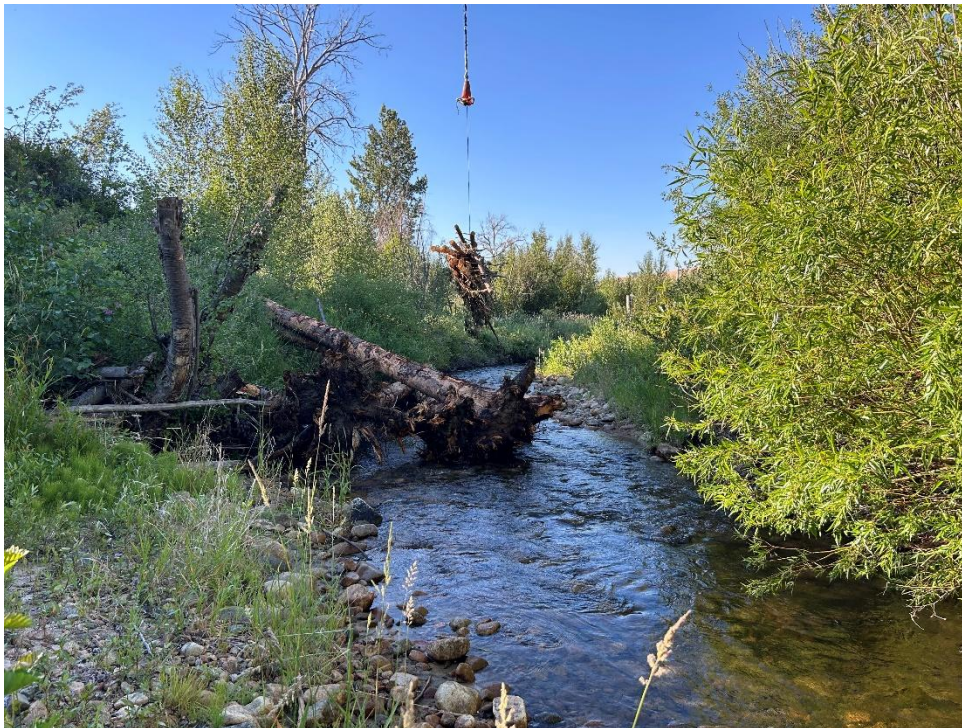
Figure 29. 2024077: Logs and slash bundles being dropped in Beaver creek site 3, slash bundles positioned in creek perpendicular to flow for ease of PAL construction.

The project was highly successful and resulted in the creation of 45 new log jams and approximately the same number of PALS built within the 1.25 miles of Beaver Creek stream that encompassed the three project sites. Using a helicopter to transport logs and boulders resulted in minimal damage to the riparian and rangeland habitat adjacent to Beaver Creek.

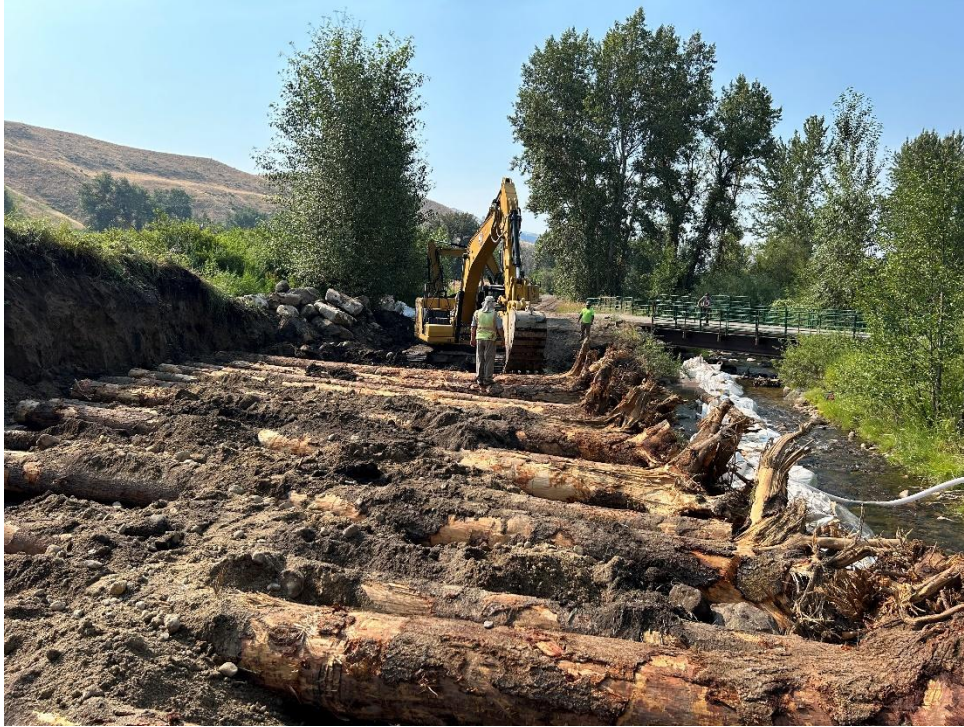
Figure 30. 2024077: Bank attached jam under construction with bridge in background.

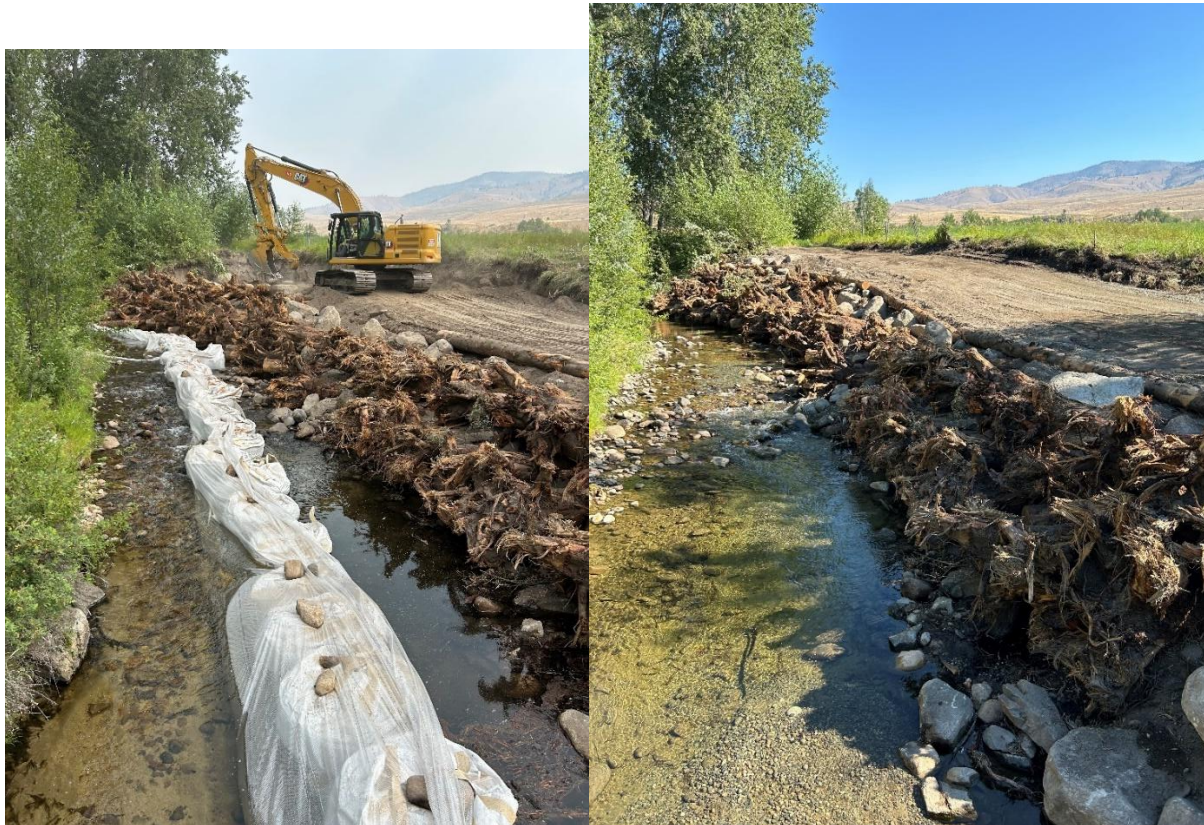
Figure 31: 2024077: Cofferdam positioned to exclude fish from the jam.

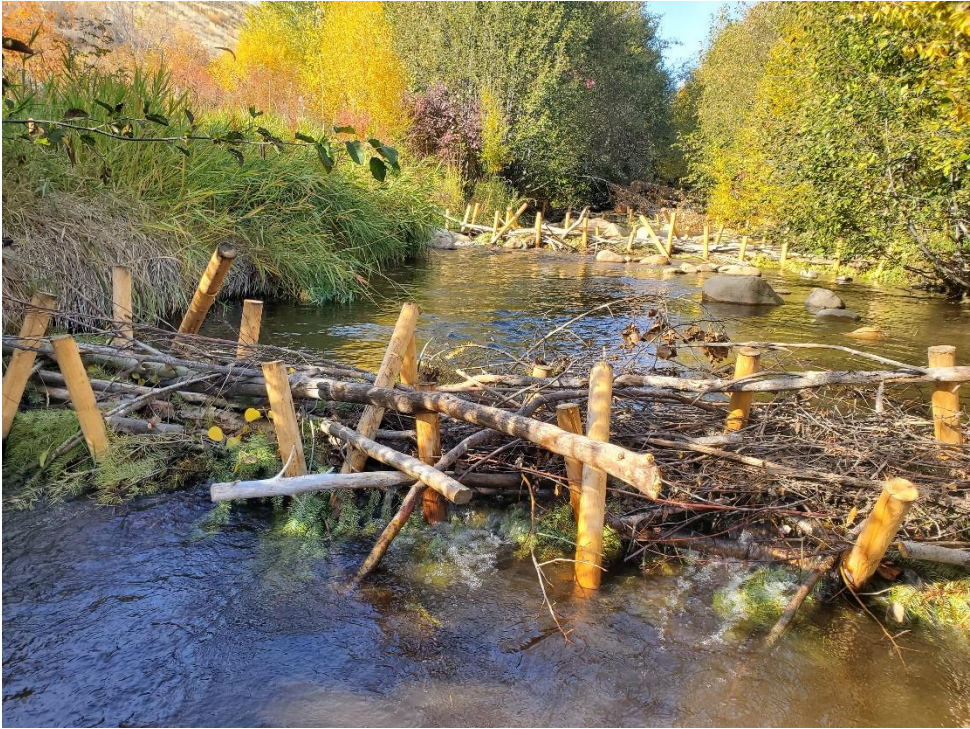
Figure 32: 2024077: Beaver Dam Analogues

Several PALS were utilized by Beavers as dams and modified within only weeks of the project's completion and increased floodplain access and ground water retained is expected to improve the riparian habitat further. Future plans for the project site are to continue monitoring log jam and PAL structures annually, and to return and reconstruct PALS in areas where they may fail following high flow events.

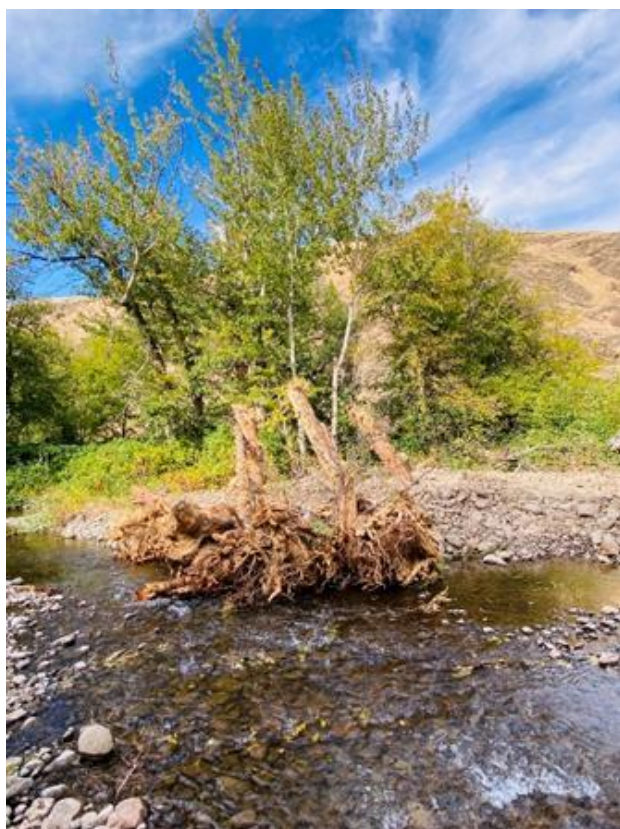
Figure 34. ELJ structure near RM 5.2 provides fish habitat uplift

Phase 3 of the project was constructed in 2024 and involved restoring a section of the river between RM 4.3 and 5.2. Deficiencies in the project reach were addressed as the anthropogenic, flumed channel was converted to a network of braided channels with the creation of 0.3 miles of complex side channels. Pools were created to provide holding cover for several age classes of salmonids. Hundreds of 3-foot diameter boulders and 35' long whole trees with root wads were added to improve physical habitat complexity. Phase 3 restored 17 acres of floodplain, reduced dominant substrate size by reducing stream slope, and significantly improved habitat complexity.

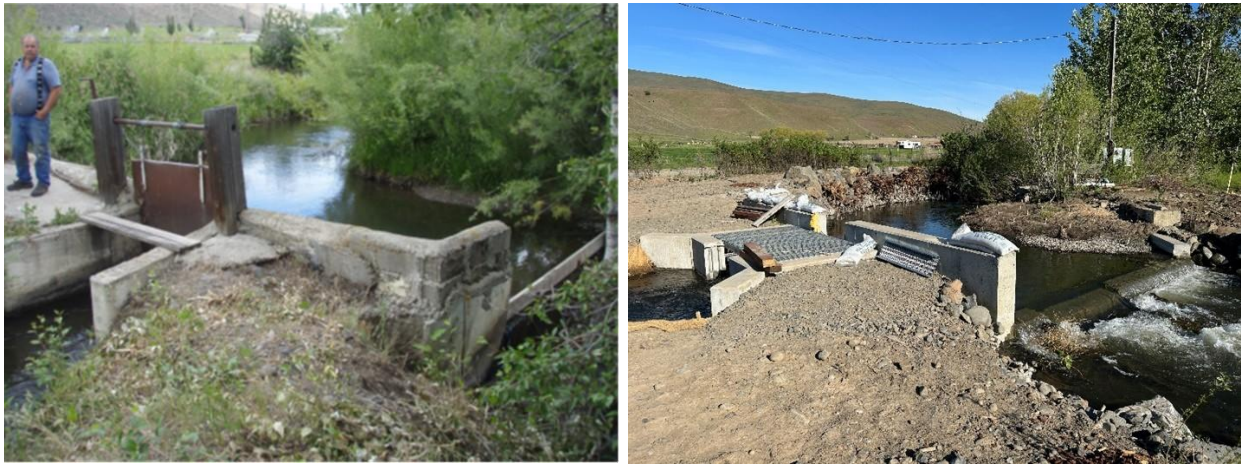
Figure 35. 2024086: Before (top) and after (bottom) photos of the diversion

In late February 2025 (after construction), snowmelt from the surrounding drainages caused the stream level to rise and engage large woody debris that had been installed near the new diversion structure's wingwalls. It was identified that water was seeping along one rootwad and log via uncompacted soil, around the wingwall of the new structure, and emerging downstream on the banks of the roughened channel. This put the structure and the banks of the channel at risk of failure. Adaptive management measures were implemented to remove the rootwad and replace it with ecology blocks, effectively extending the wingwall of the structure. When the reservoir upstream of the site filled, water levels rose again, and the same issue was identified on the opposite bank. In early March the trunk portion of one piece of large woody debris was removed and replaced with ecology blocks, leaving the rootwad in place.

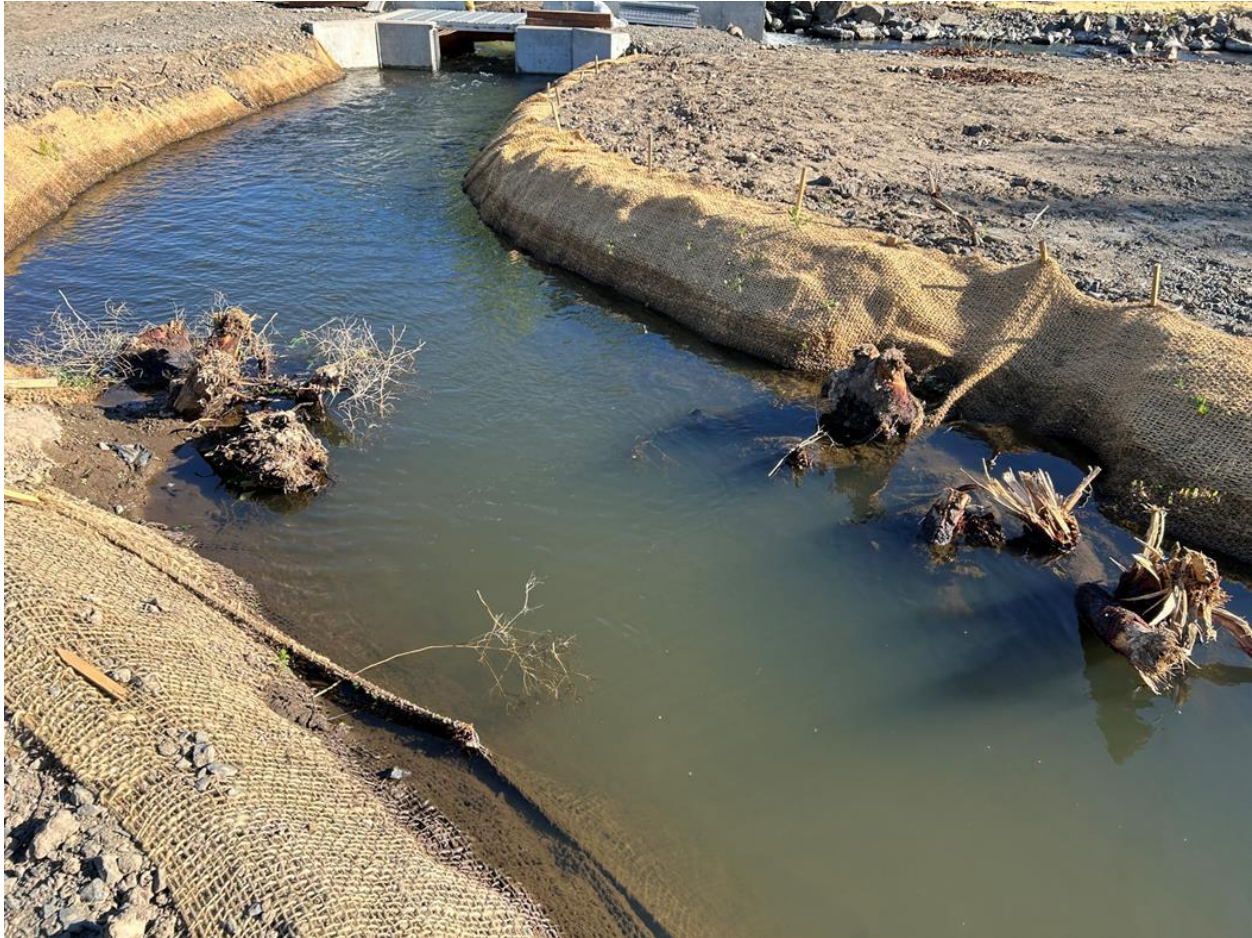
Figure 36. 2024086: Channel with rootwads between point of diversion and fish screen

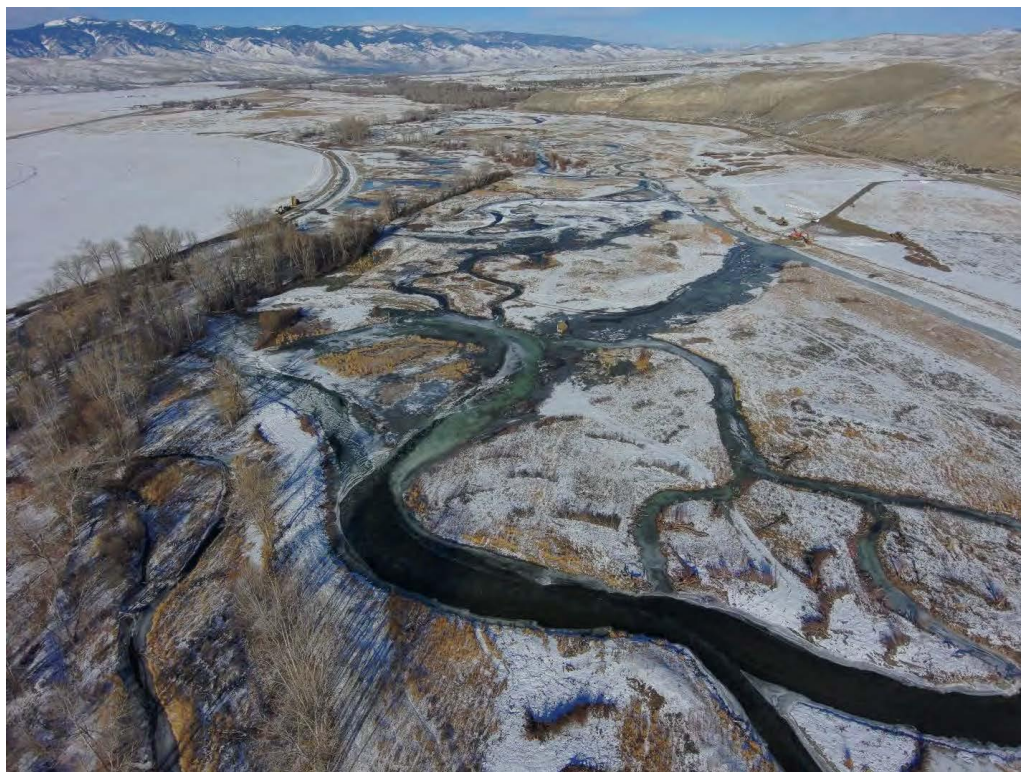
Figure 38. 2024101: Frazil ice floes visible in the Lemhi River during extreme cold weather in January 2025

A key lesson learned from observations of previously completed project phases, and from research on frazil ice, is that surface ice tends to form when water velocities fall below 2 feet per second (fps). When surface ice forms, it provides a substrate for frazil flocs to bind, and an ice jam builds from the surface ice down into the water column, eventually reaching the bottom of the river. The design team used this information to inform the design of the adaptive management phases.

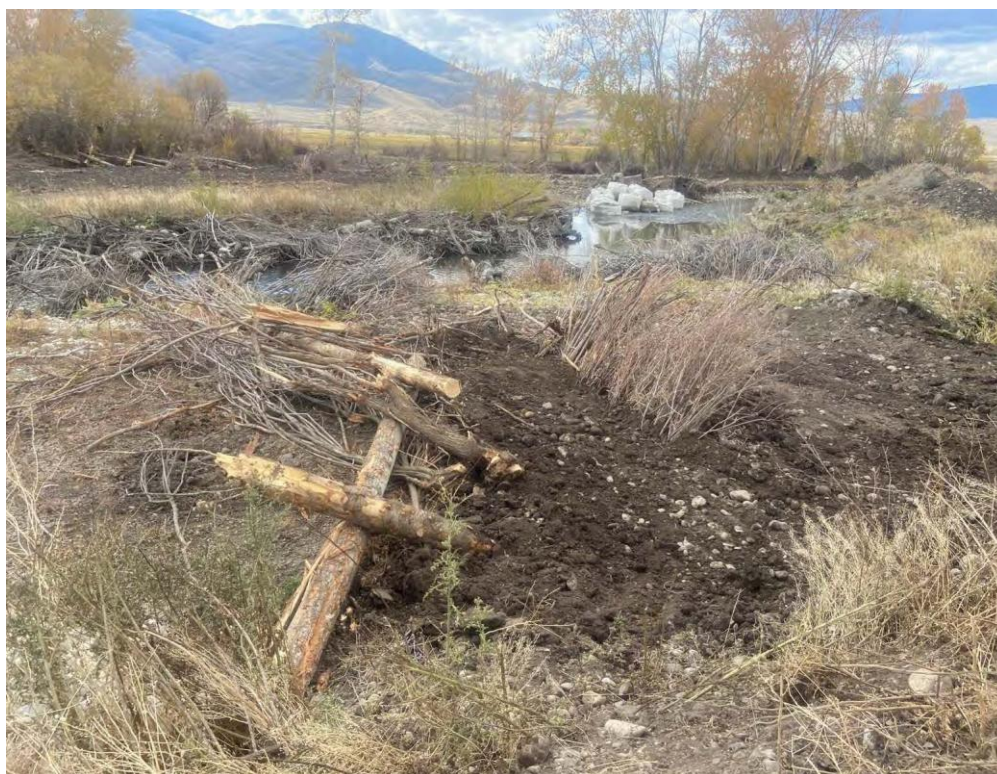
Figure 39. 2024101: Looking towards the main Lemhi River channel with newly installed habitat structure in Phase 3 area

Two main design approaches were used in the adaptive management to keep water velocities above the 2-fps threshold. The first was to reduce the channel length, and the second was to maintain a more consistent slope through the reach. The existing project slope was built with a pool-riffle-pool sequencing. The new design applied a continuous run type sequence while still maintaining some pools and riffles. Post-construction, the severity of the ice dams and the increase in flood stage during the winter of 2024/2025 was significantly less than in previous years, indicating that the adaptive management actions had positive results.
