# HABITAT IMPROVEMENT PROGRAM

## HIP4

### 2024 ANNUAL MONITORING REPORT

Bonneville  
POWER ADMINISTRATION

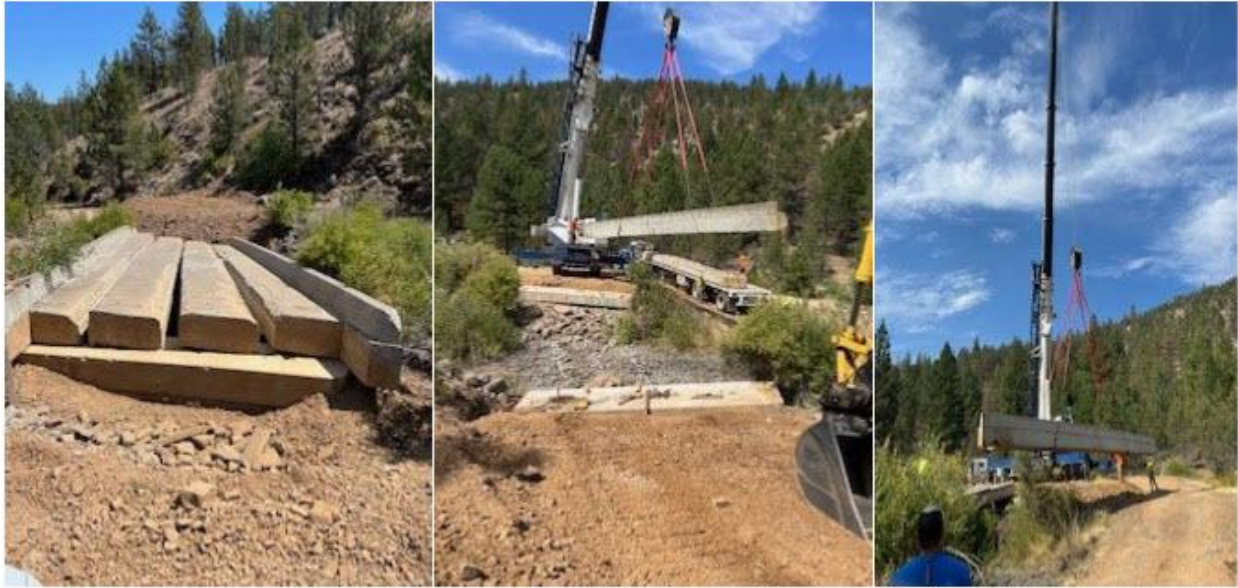
Moving the bridge to the new location over Dutchman Creek.

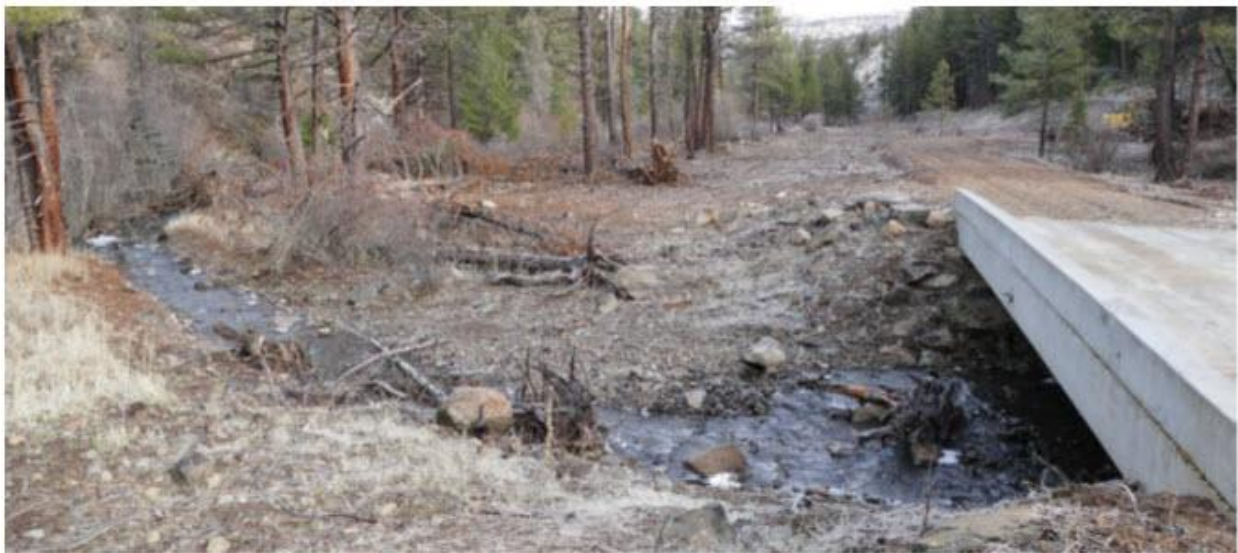
Bridge installed at the Dutchman Creek crossing.
