Figure 3-18a
Viewpoint 8: View to the west along Kootenai River Road through the Pipe Creek residential area.

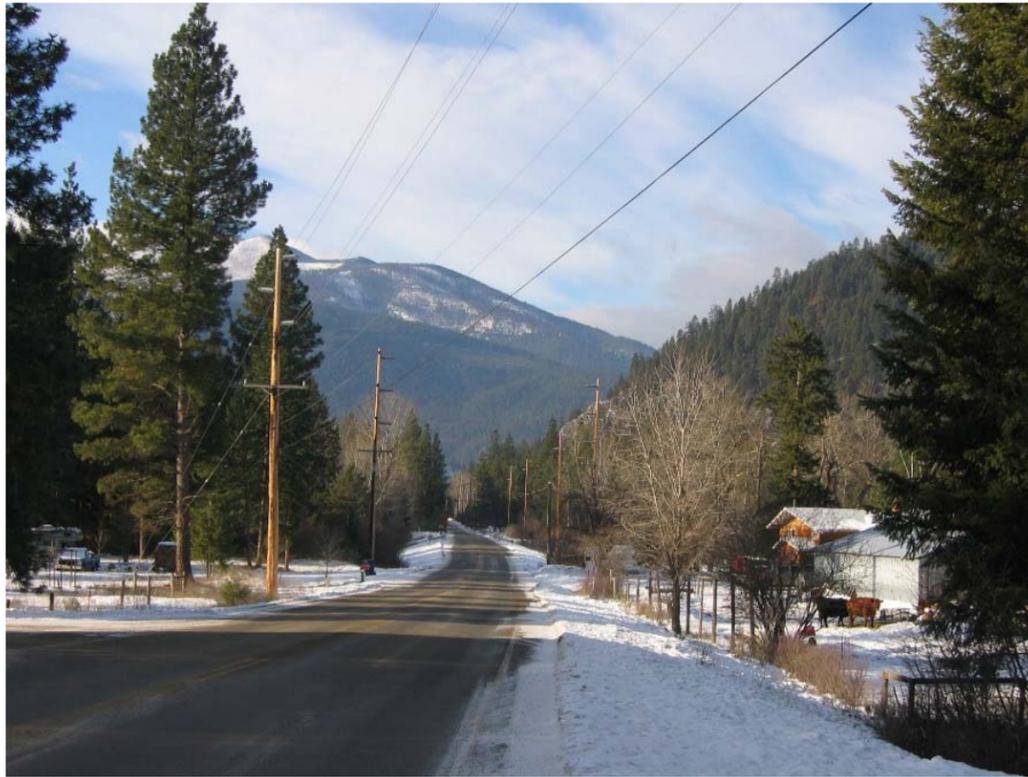
Existing
Condition

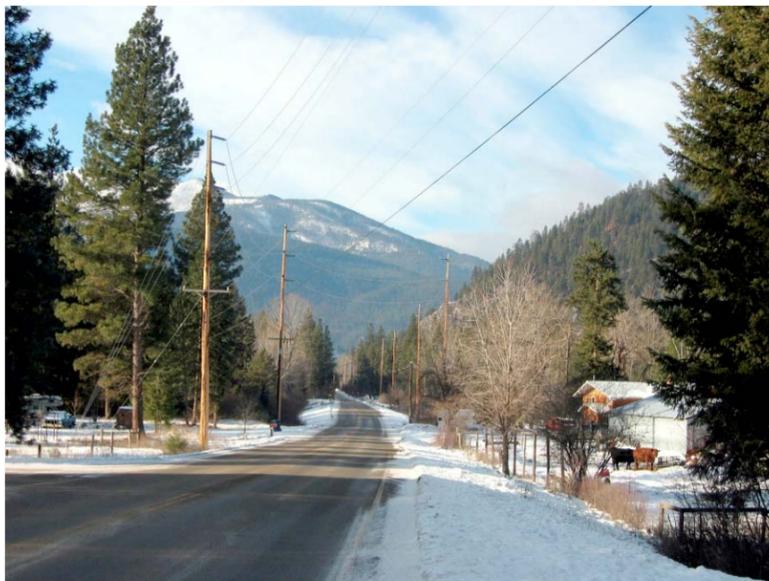
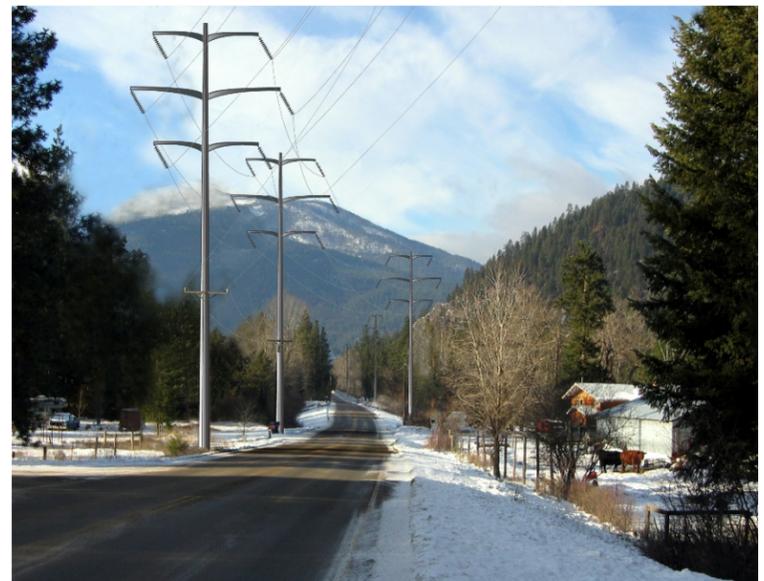
With photo simulations along Kootenai River Road with the line in the existing location at 115 kV (wood poles) and 230 kV (steel poles).

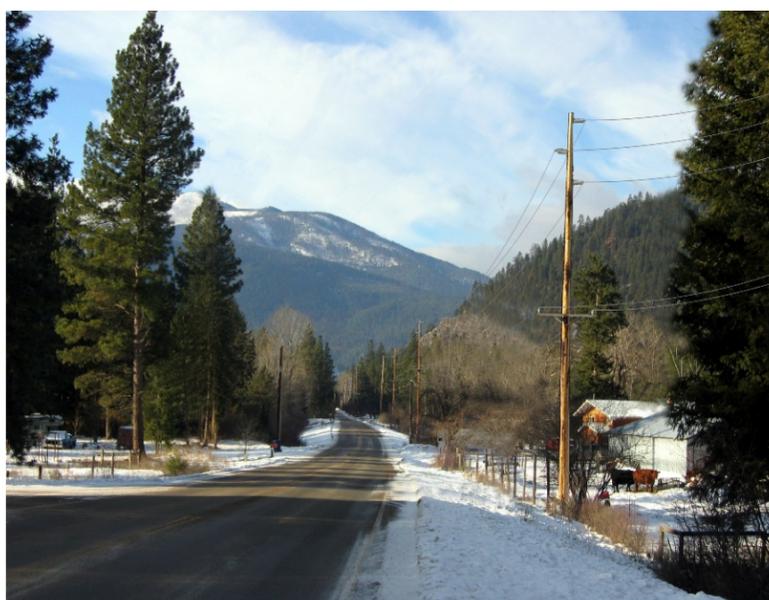
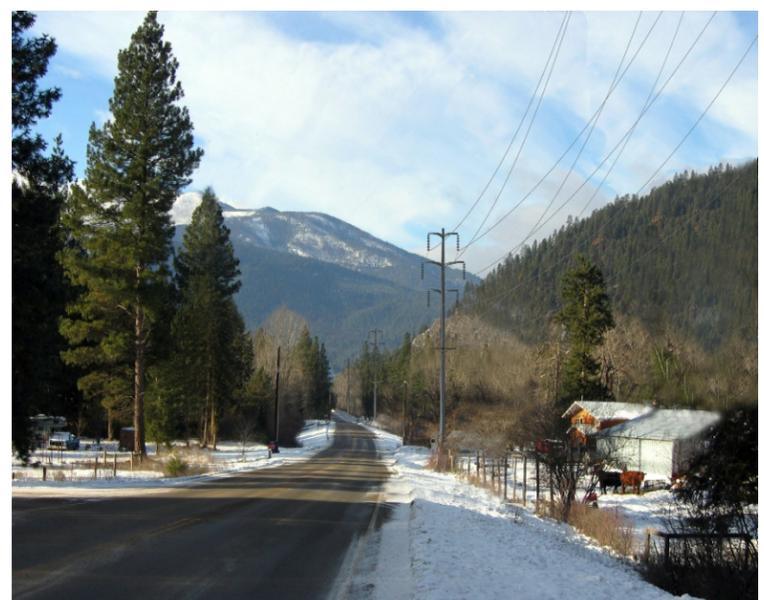
With photo simulations along Kootenai River Road with the line straightened at 115 kV (wood poles) and 230 kV (steel poles).
