# UPGRADES AT MOSSYROCK POWERHOUSE

MARK HAMMER  
TACOMA POWER

# MOSSYROCK DAM

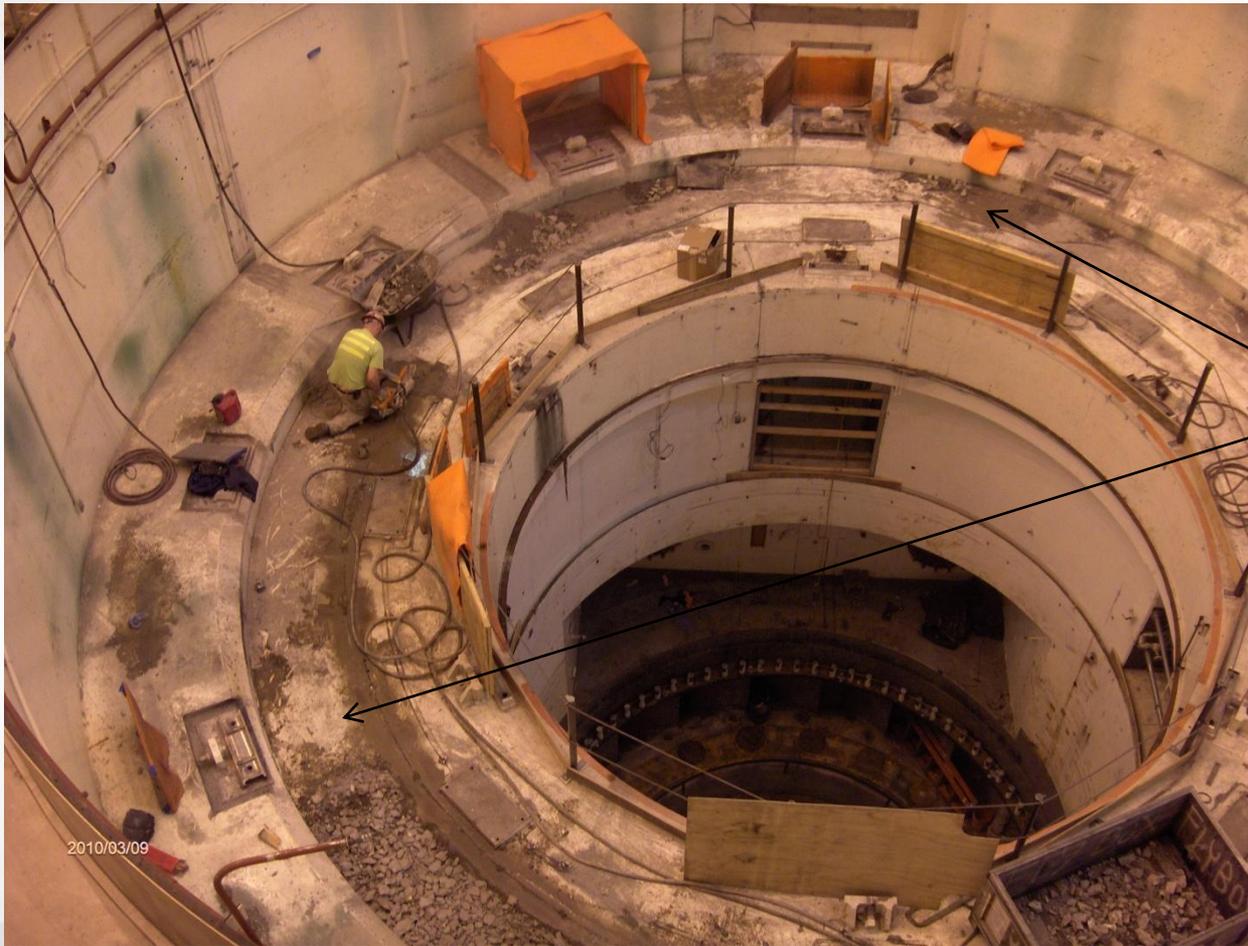
# GENERATOR PIT DEMOLITION

WINDING  
TRENCH

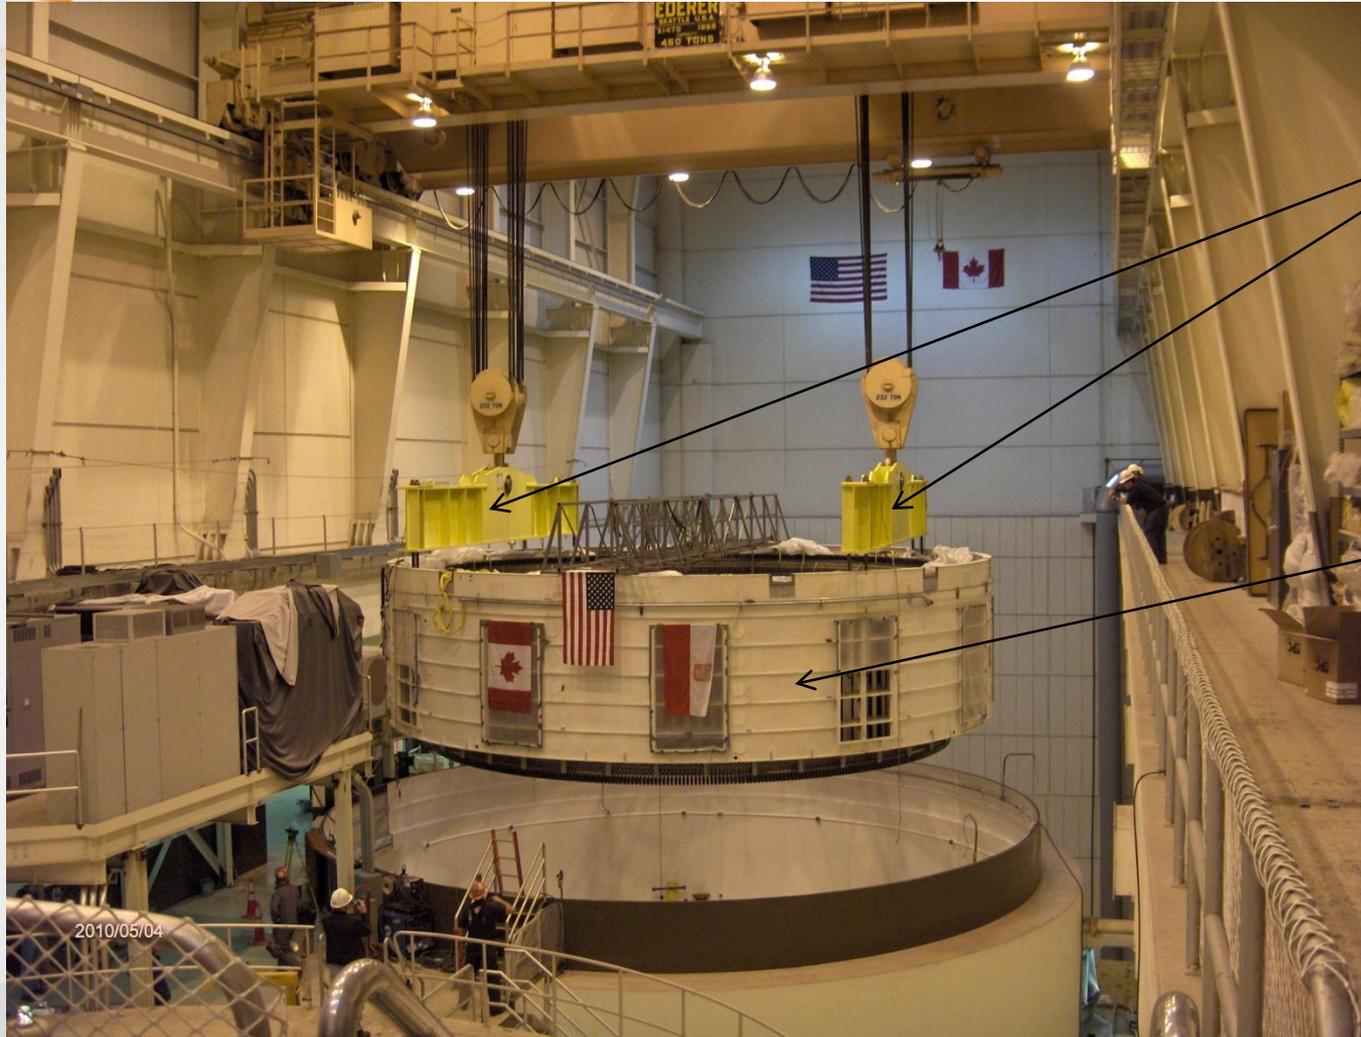
# STATOR LIFT

LIFTING  
BEAMS

STATOR  
ASSEMBLY

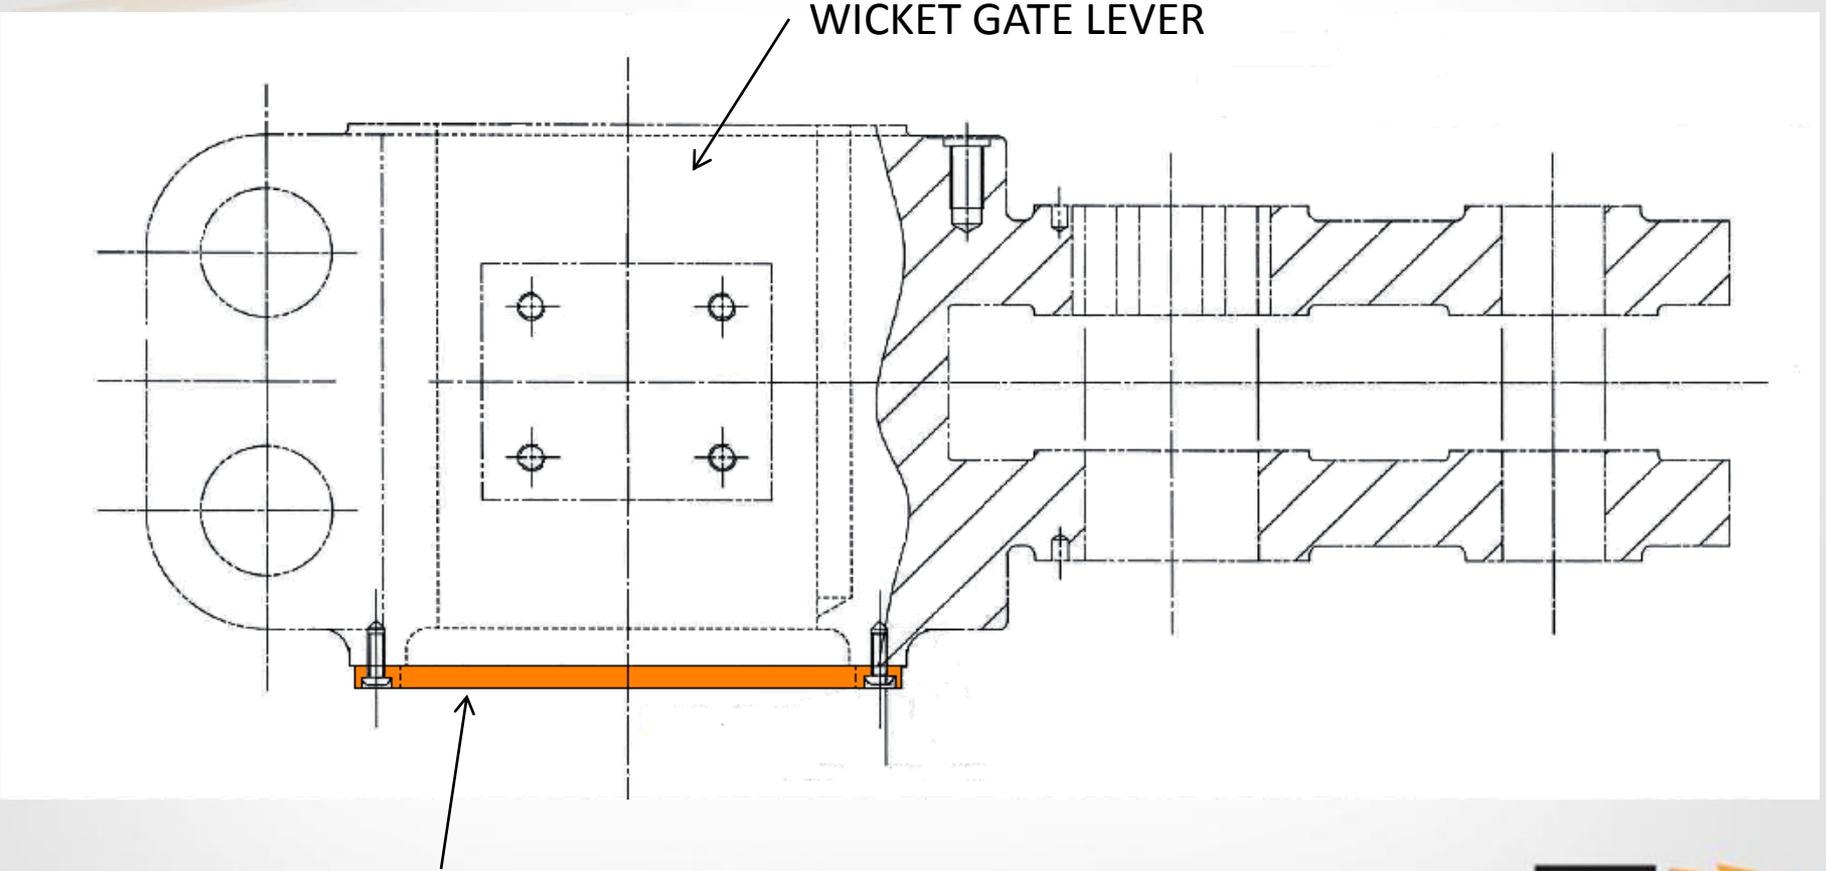
# WICKET GATE THRUST WASHER

WICKET GATE LEVER

ORKOT THRUST WASHER

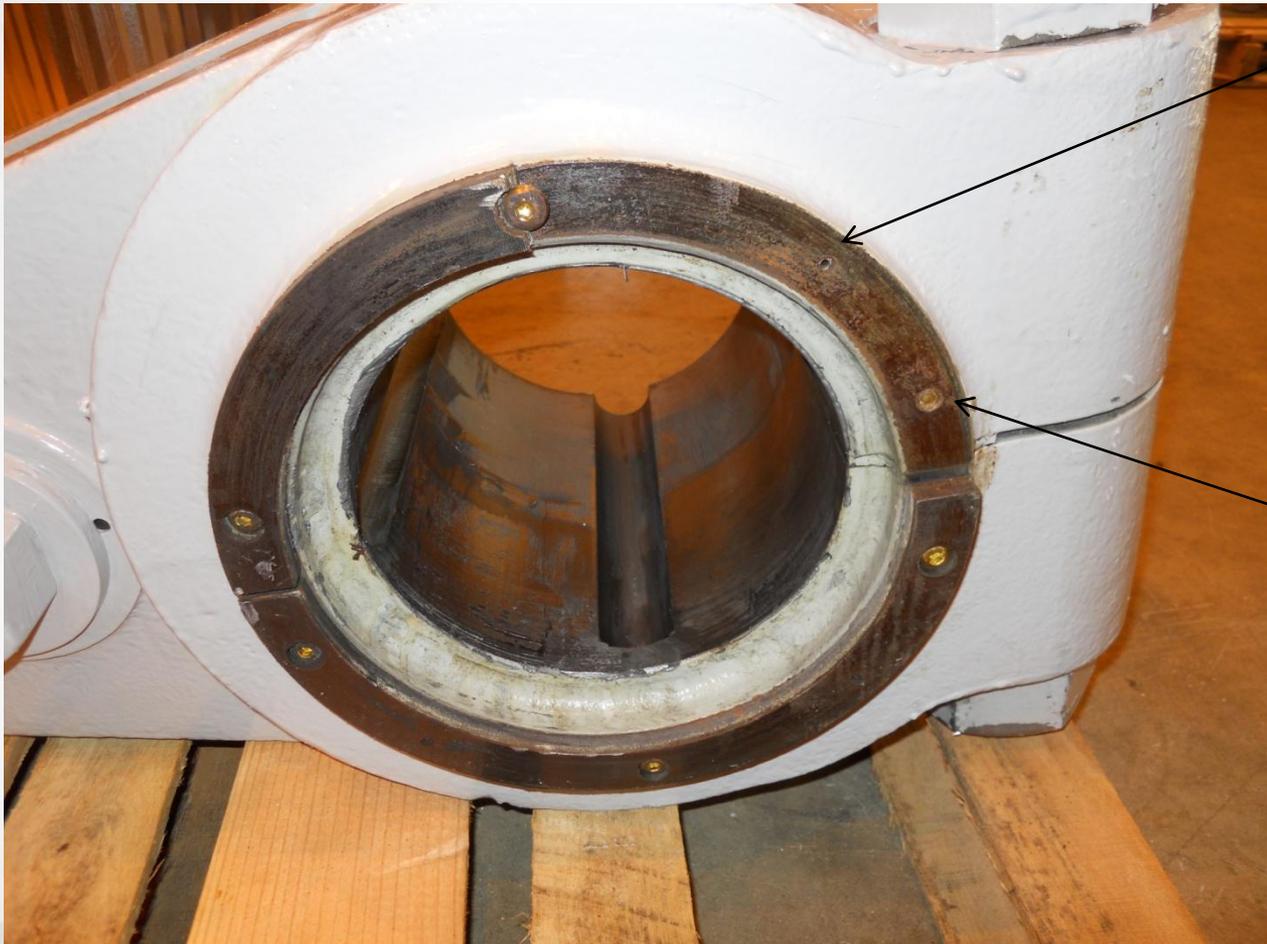
# THRUST WASHER FAILURE

SHEARED  
SPRING  
PIN

SHEARED  
BRASS  
SCREWS

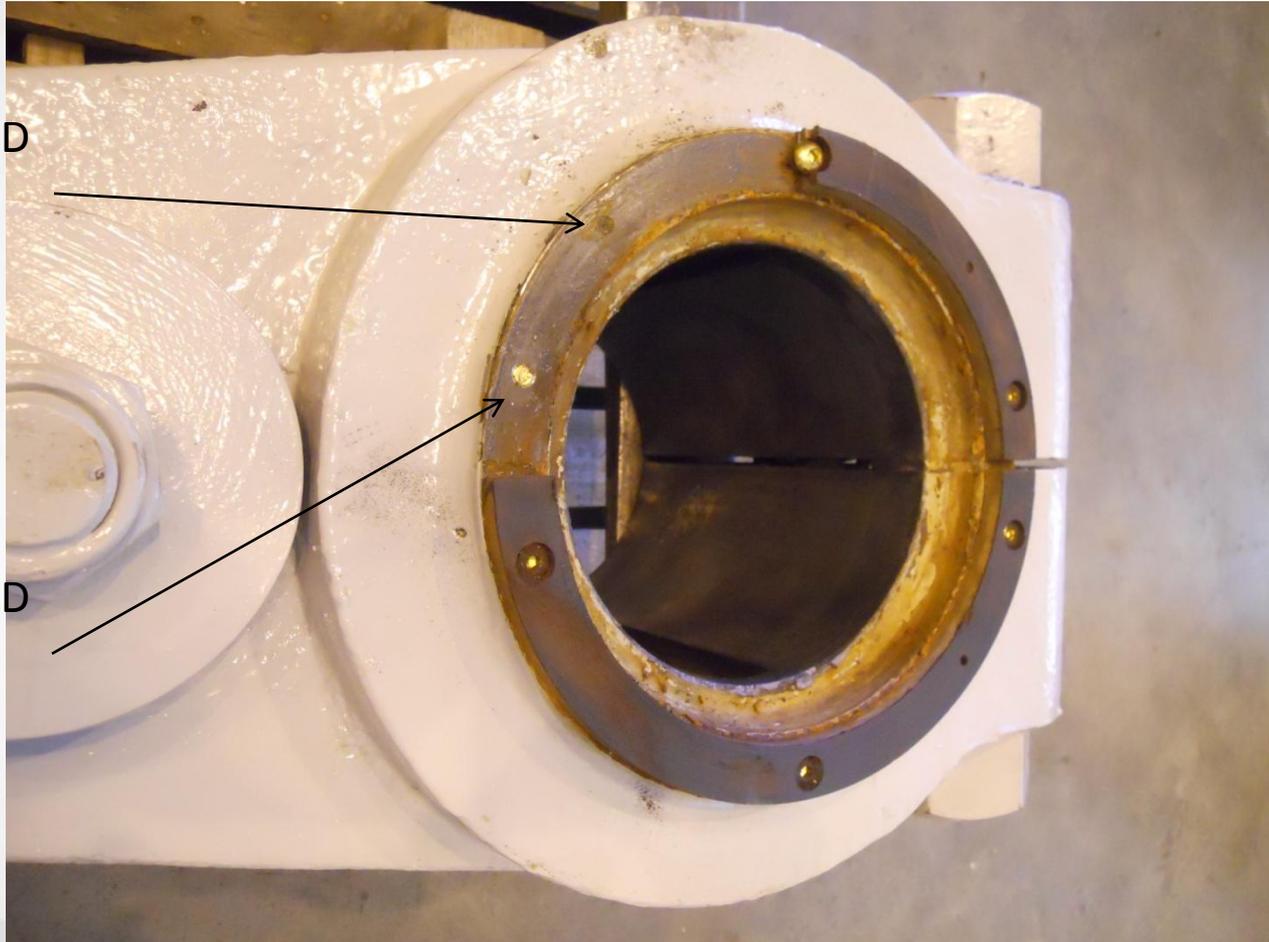
# THRUST WASHER FAILURE

SHEARED  
SPRING  
PIN

SHEARED  
BRASS  
SCREW

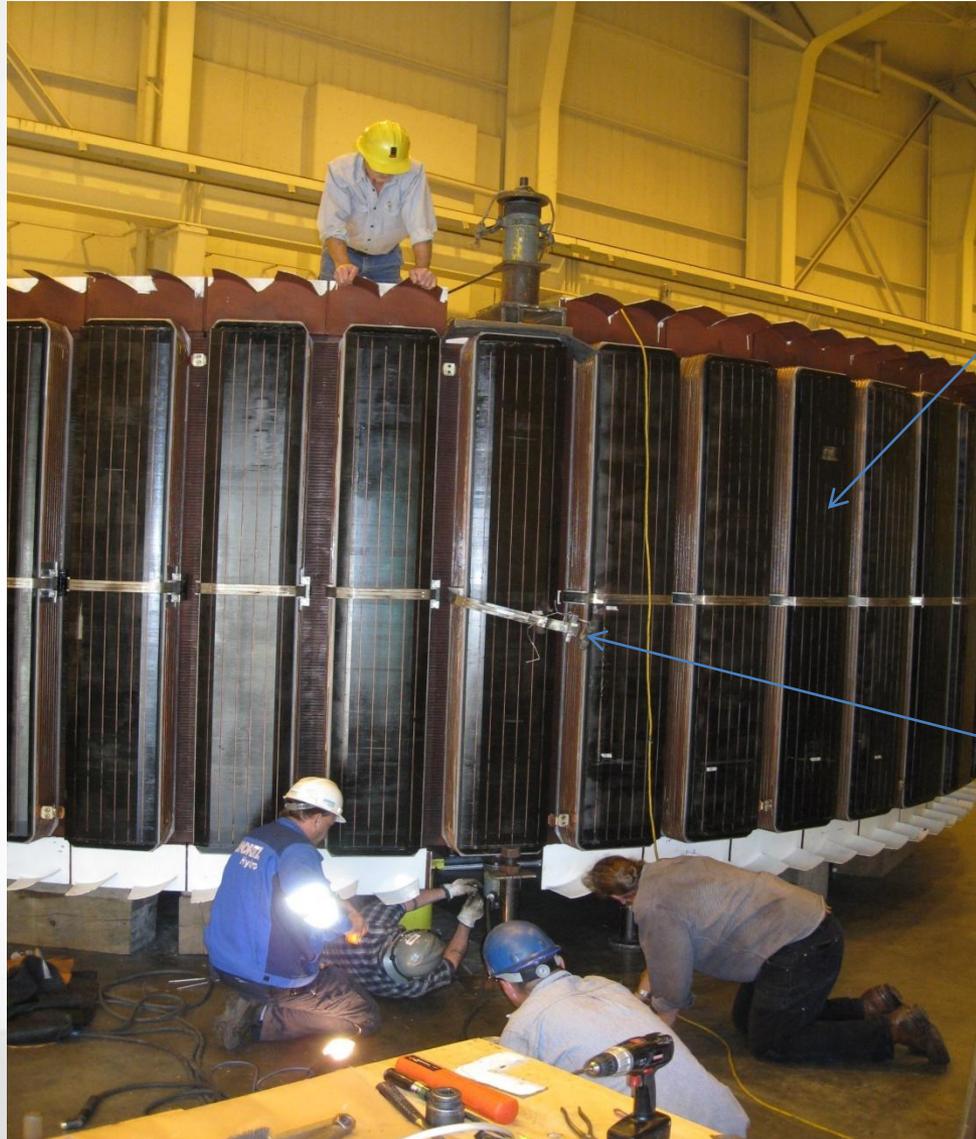
# BELLYBAND FAILURE

ROTOR  
FIELD POLES  
56 TOTAL

BROKEN  
BELLYBAND  
Pole #32

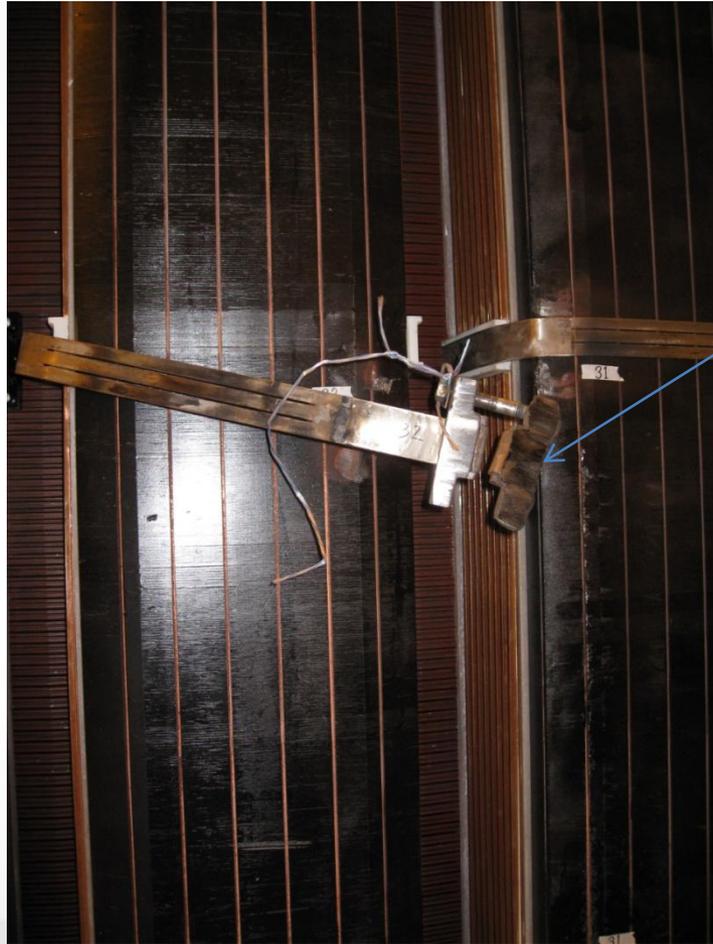
# BELLYBAND FAILURE

POINT OF  
BELLYBAND  
FAILURE

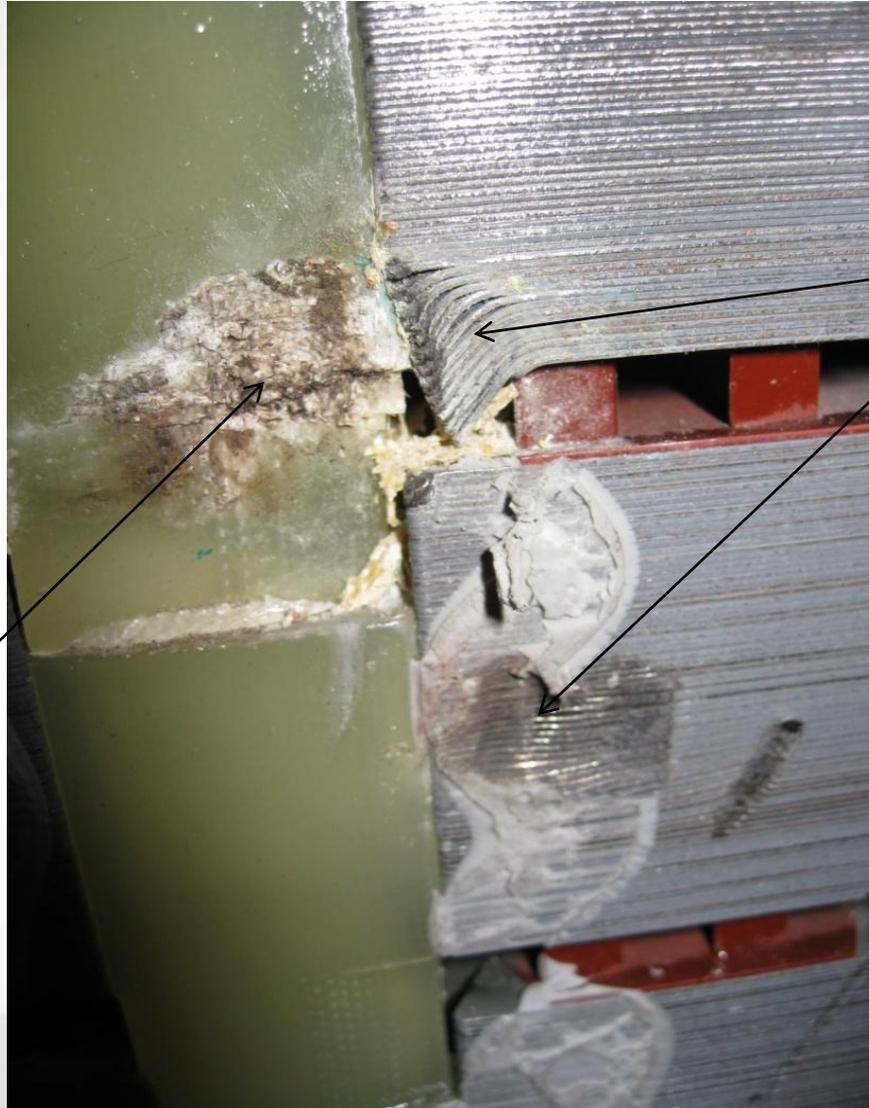
# STATOR CORE DAMAGE

DAMAGED  
WEDGES

DAMAGED  
LAMINATIONS

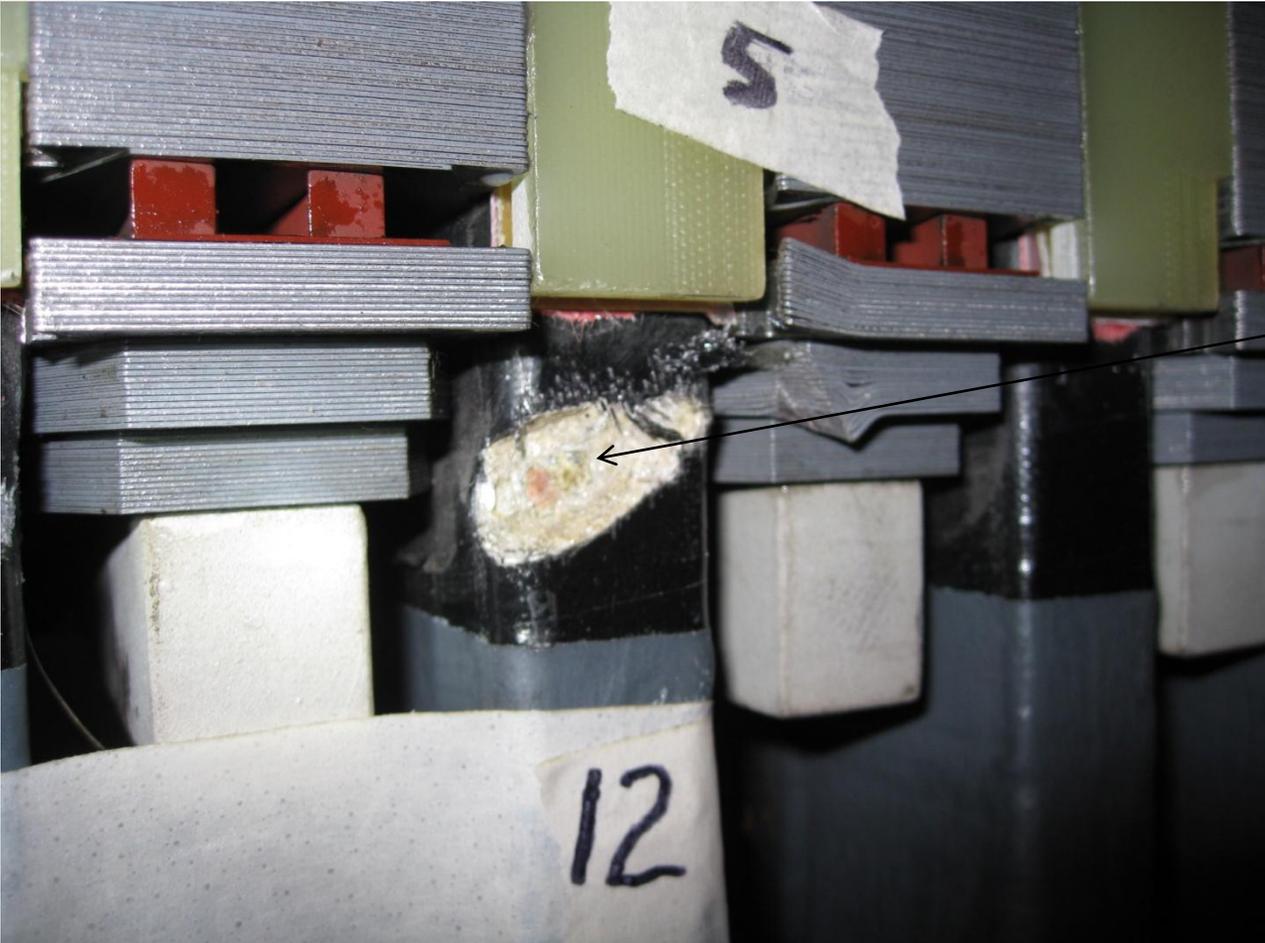
# WINDING DAMAGE

DAMAGED  
WINDING

REPLACED\*\*  
15 BARS

3% OF 480  
SLOTS
