WANAPUM DAM Spillway Incident

Update on Monolith 4 Repairs

*Dale Campbell, PE
Operation's Supervisor
May 19, 2015*

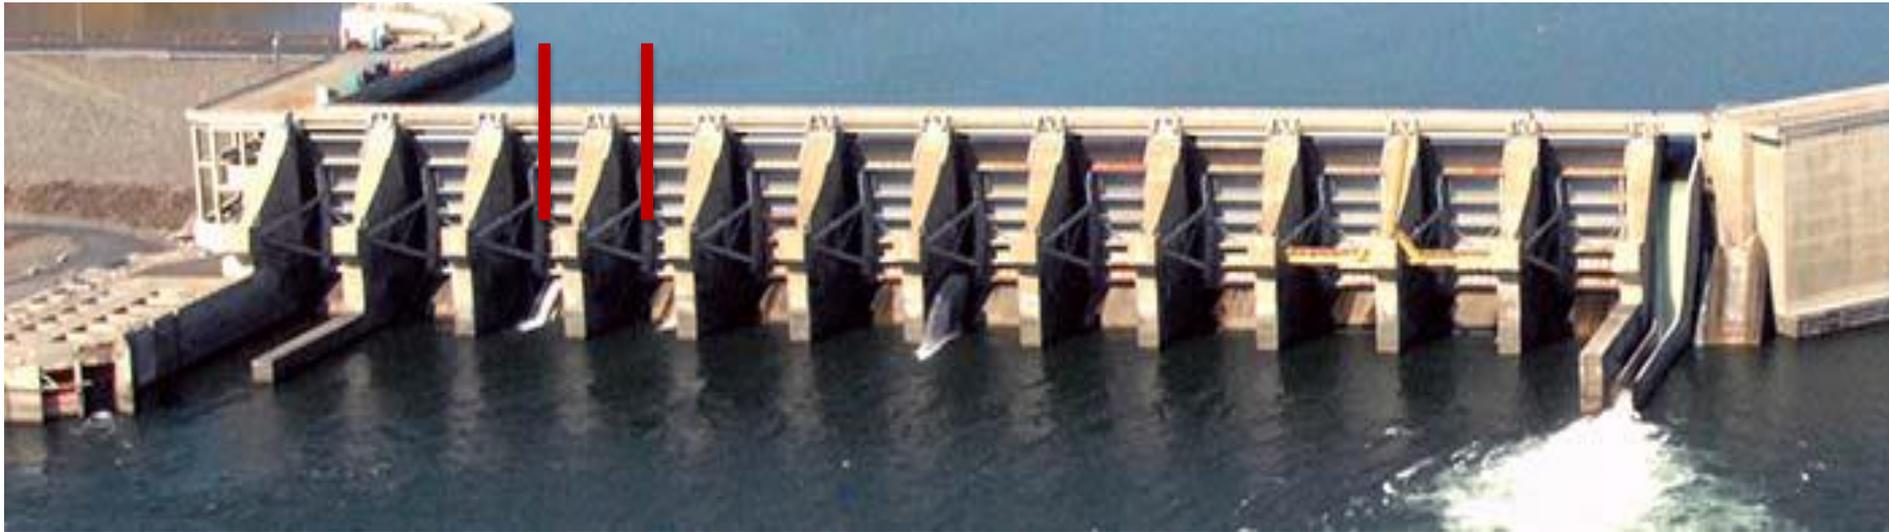
Monolith 4

- 13 monoliths
 - Each monolith approximately 65 feet
- 12 spillway gates
- Approximately 820 feet in total length
- Maximum flow capacity: 1.4 million cfs (normal operations)

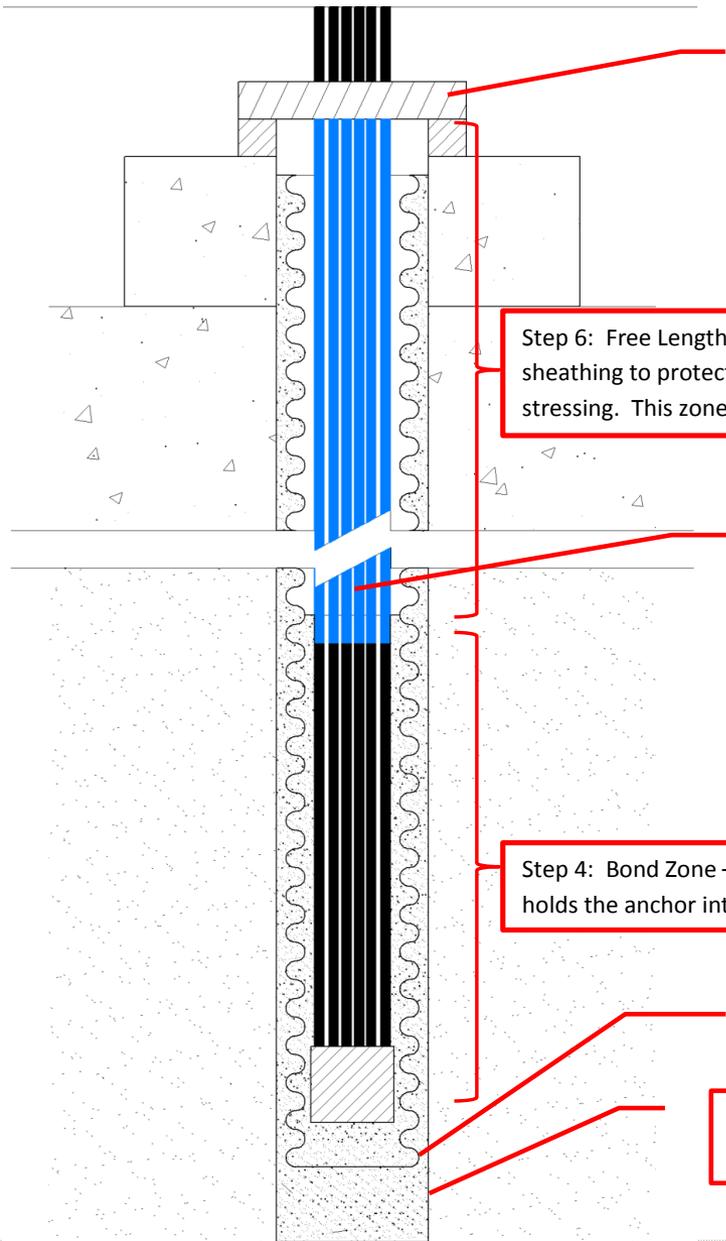
Step 5: Anchor Head and Wedge Plate – Tendon is stressed/tensioned and strands are clamped/wedge to hold tension (see photos)

Step 6: Free Length – Wire strands are encapsulated with plastic sheathing to protect from corrosion and allow for stretching during stressing. This zone is grouted after tendon is stressed.

Step 3: 61-Strand Tendon Anchor – Install 250 foot long (approximate) tendon into corrugated sheath (see photo)

Step 4: Bond Zone – Bare wires grouted into sheath prior to stressing. This holds the anchor into the rock formation.

Step 2: 10" Diameter Corrugated Sheath – Grouted into hole

Step 1: 16" Diameter Bore Hole – Drilled through spillway structure and into bedrock (see photo)

- Approximately 400 drilled holes in the Wanapum spillway to complete the project
 - 35 pier tendons
 - Remaining holes:
 - Post tensioned bar anchors
 - Lift joint drains
 - Lift joint drain efficiency holes
 - Grout holes
 - Piezometers
 - Crack exploratory holes
 - Geotechnical exploratory holes
 - Temporary post tensioned bar anchors

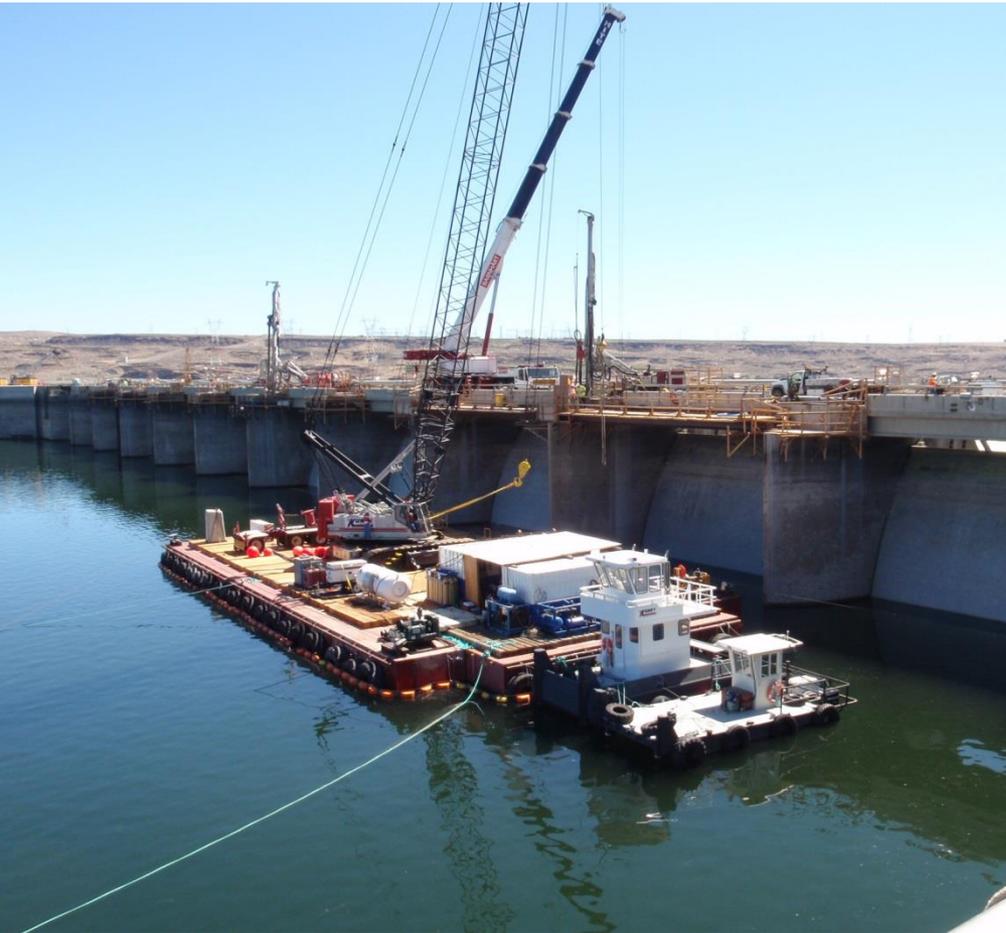
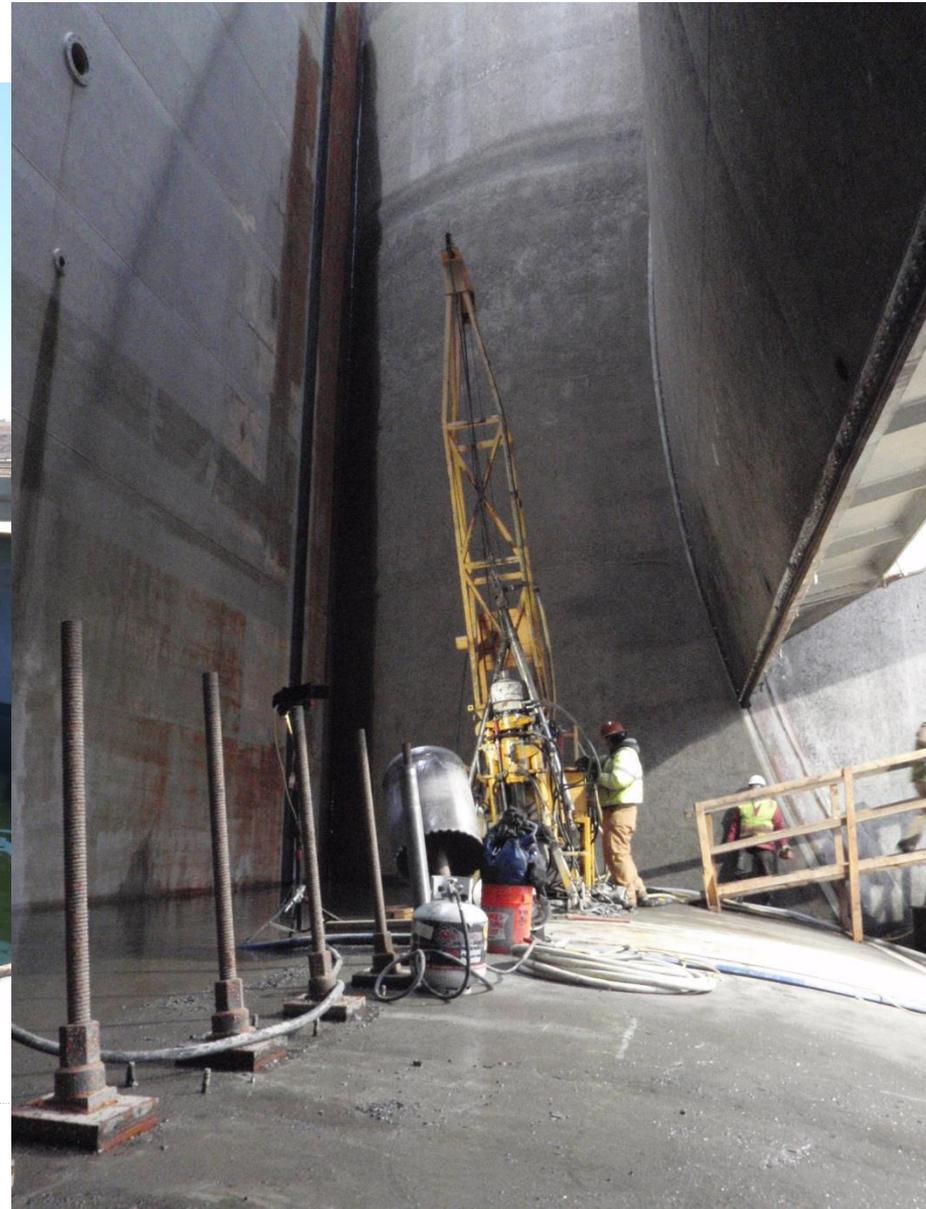
- Limited Access

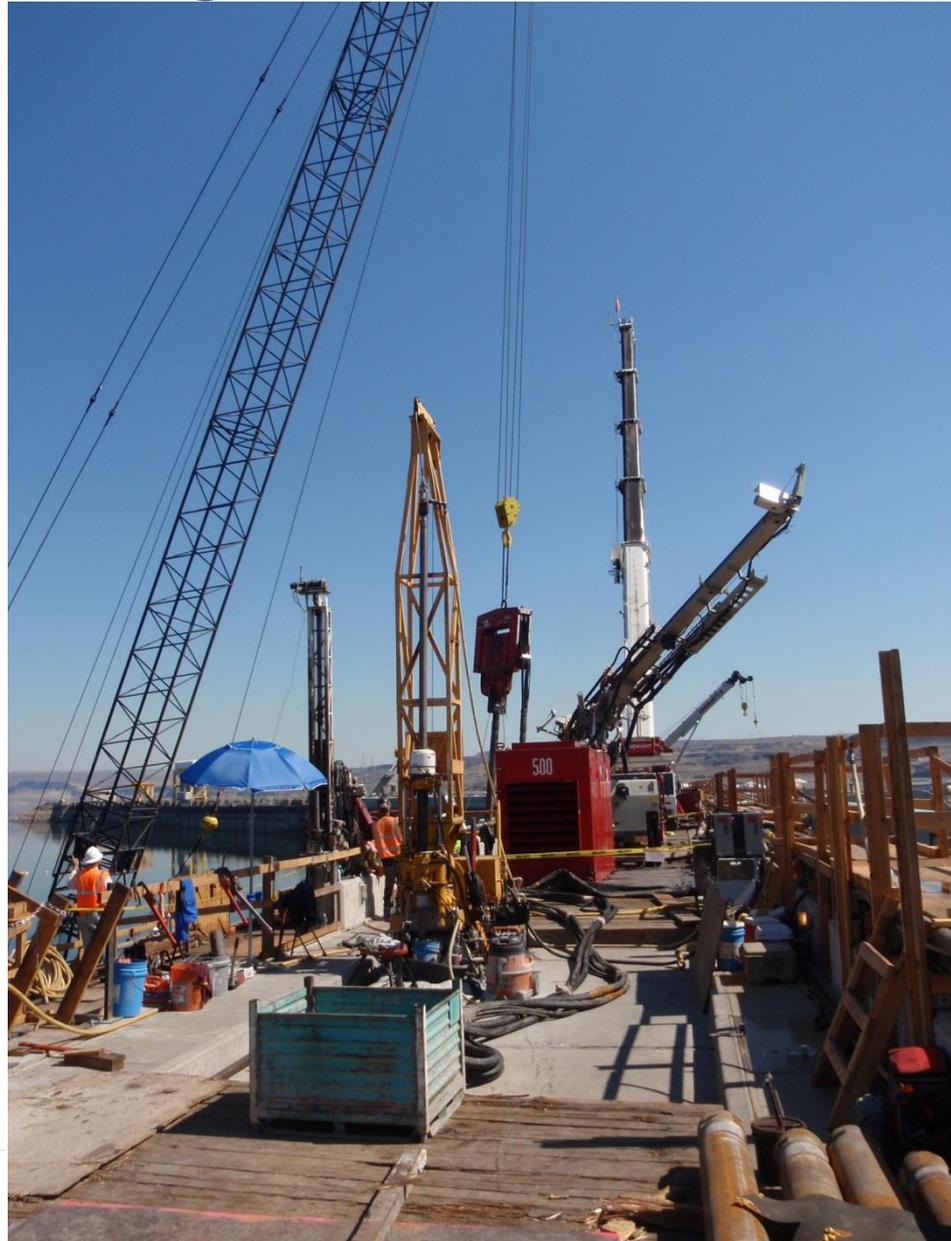
- Stuck drill bit

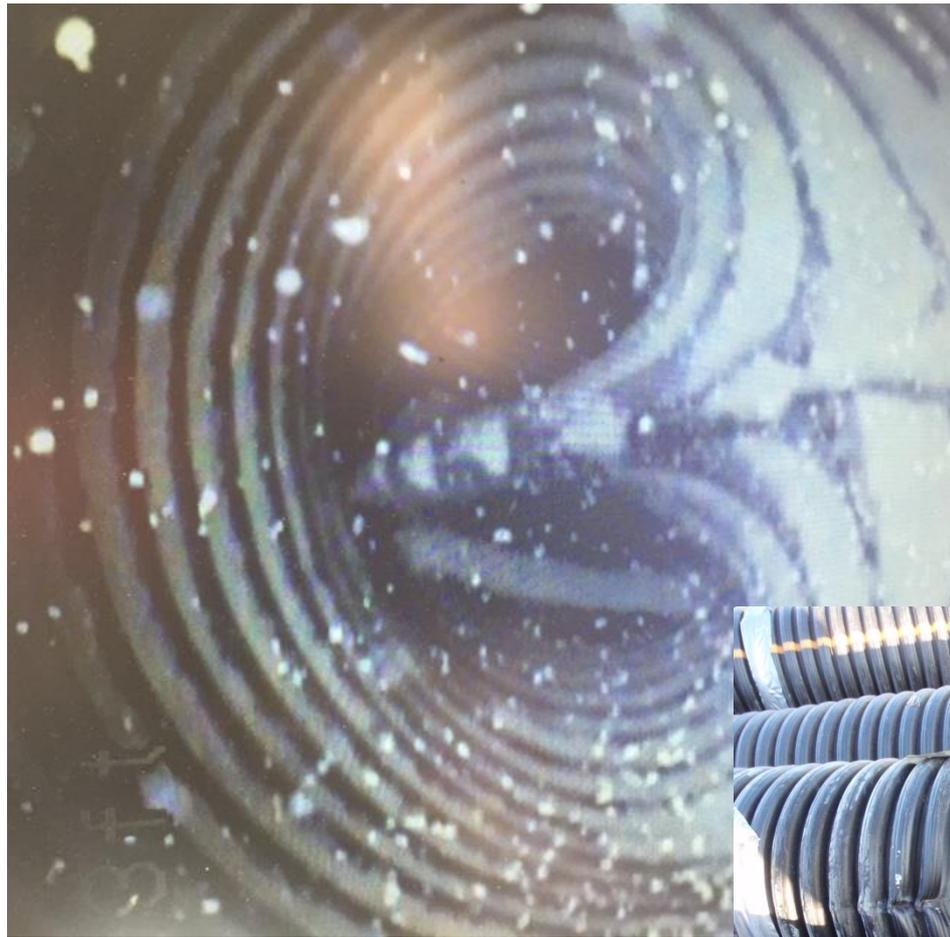
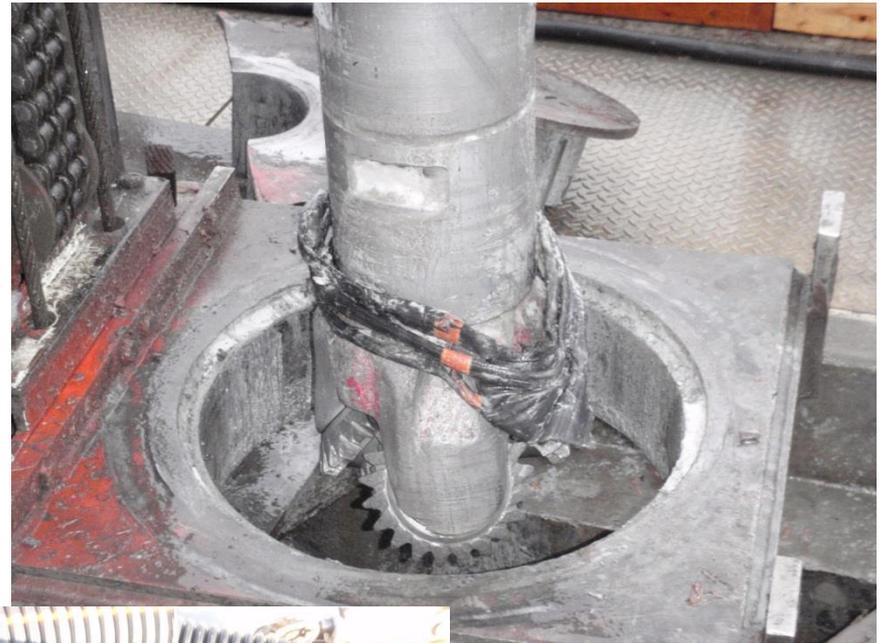
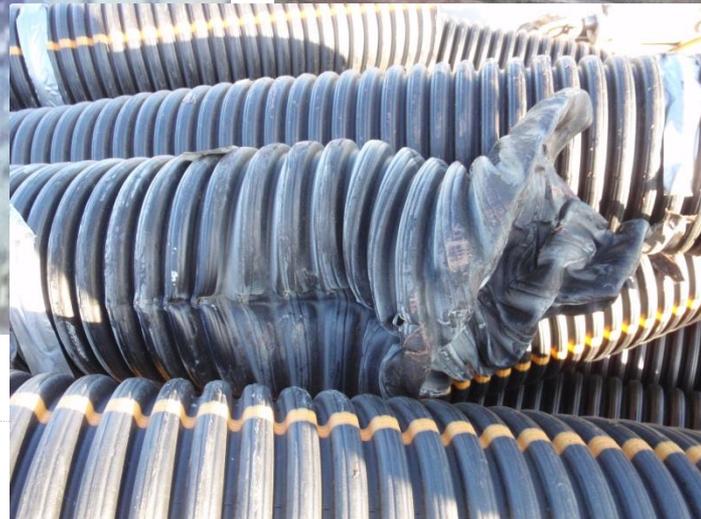
- Collapsed Sheath

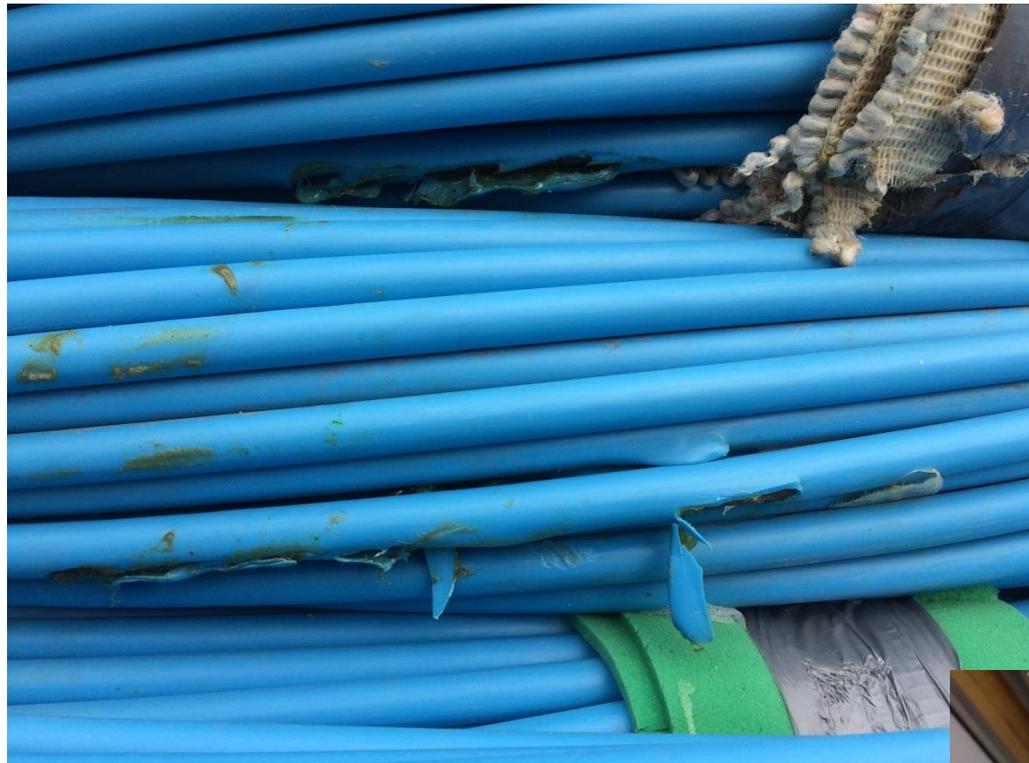
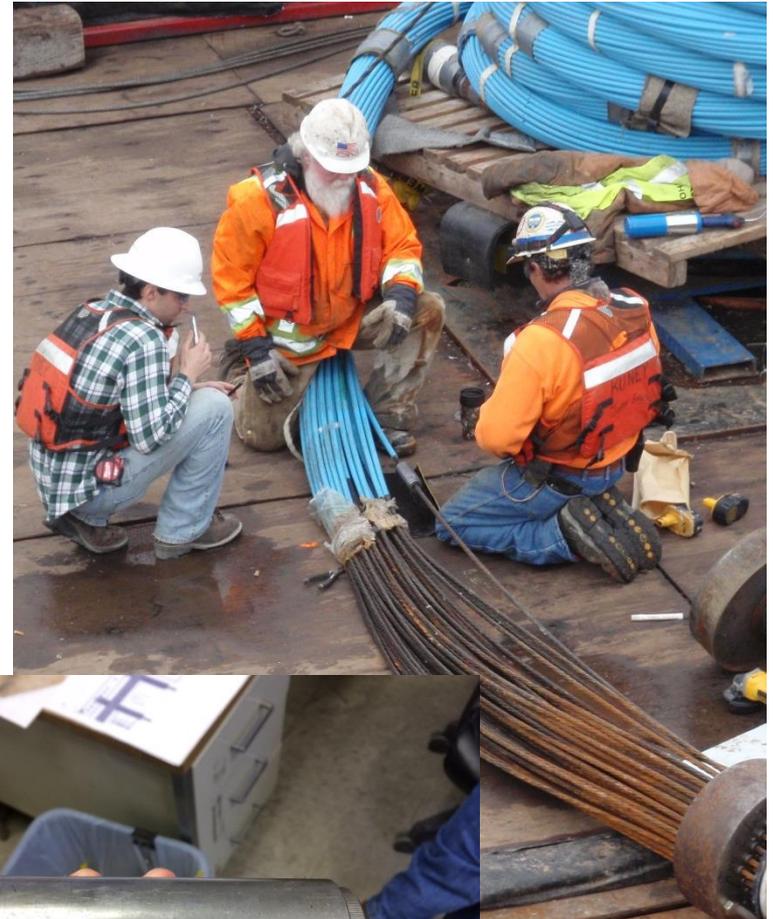
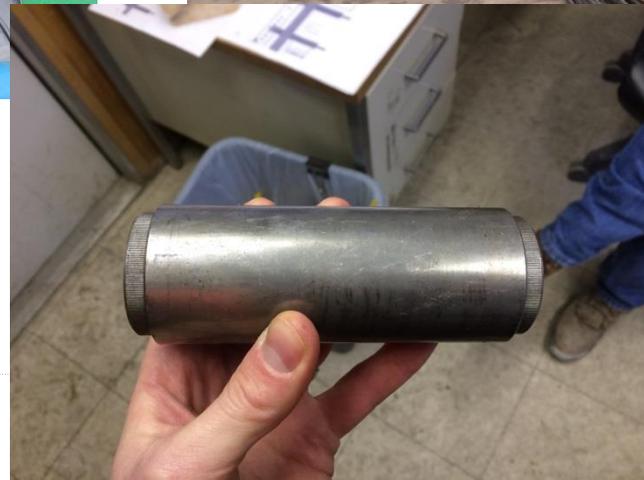
- Strand Repairs
