Field Evaluation of Trunnion Friction Using Strain Gages

Trunnion Friction Evaluation Agenda

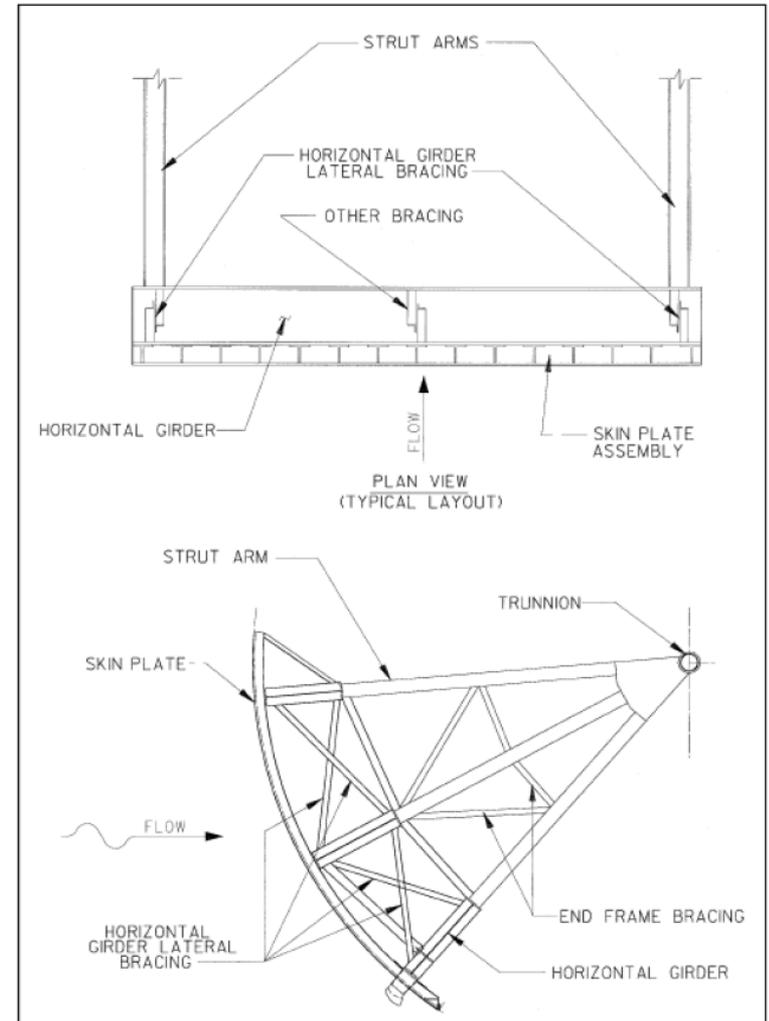
- Most common type of gate for a spillway crest
- Favorable hydraulic discharge characteristics from curved shape
- Economical
 - Simplicity
 - Light Weight
 - Low Hoist Capacity
- Hydrostatic loads transferred through the trunnion
- Terminology

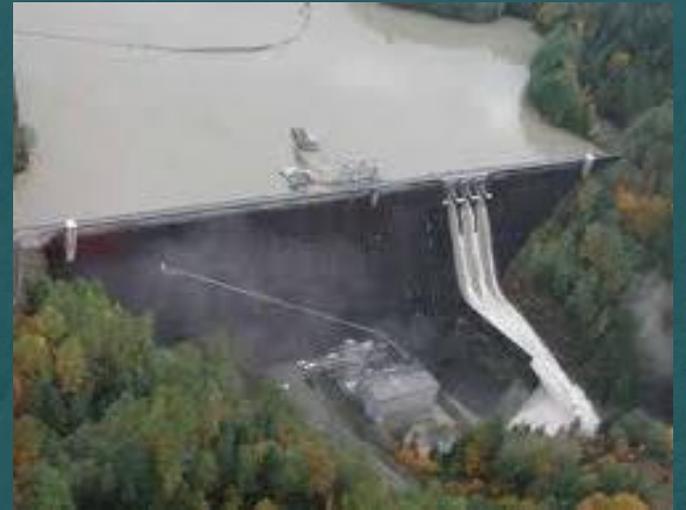
Upper Baker Dam

- Puget Sound Energy
- 3 Spillway Gates
- Self Lubricating - Lubrite
- 1999 Hands-on Inspection by HDR
- 2009 Hands-on Inspection & Laser Deflection Testing by MWH/Extreme Access
 - 5-Year Trunnion Friction Monitoring

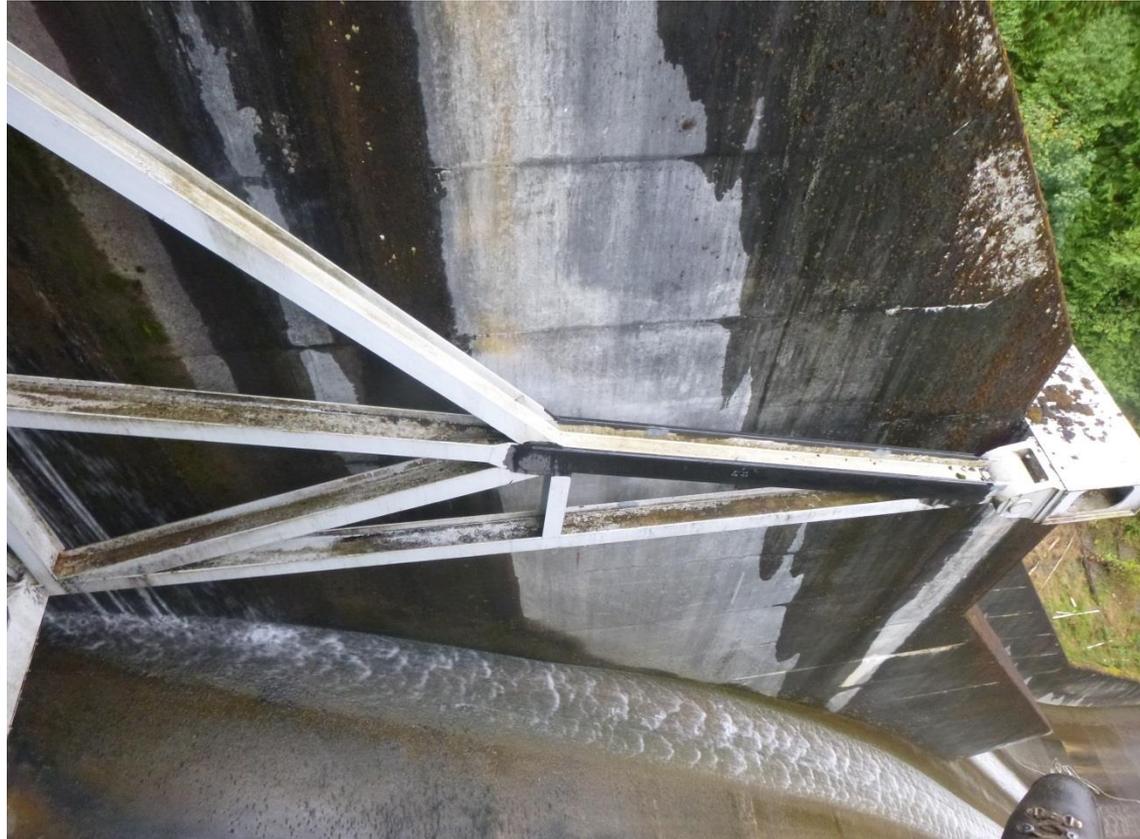
- Strengthened following 2009 Inspection & Analysis for Maximum Credible Earthquake
- No Maintenance (Self-Lubricating)
- Routine Exercise - Weekly
- 2014 Strain Gage Testing by BDI, Inc
 - 16 strain transducers
 - 2 rotation sensors
 - 2 torque sensors
 - Amp sensor

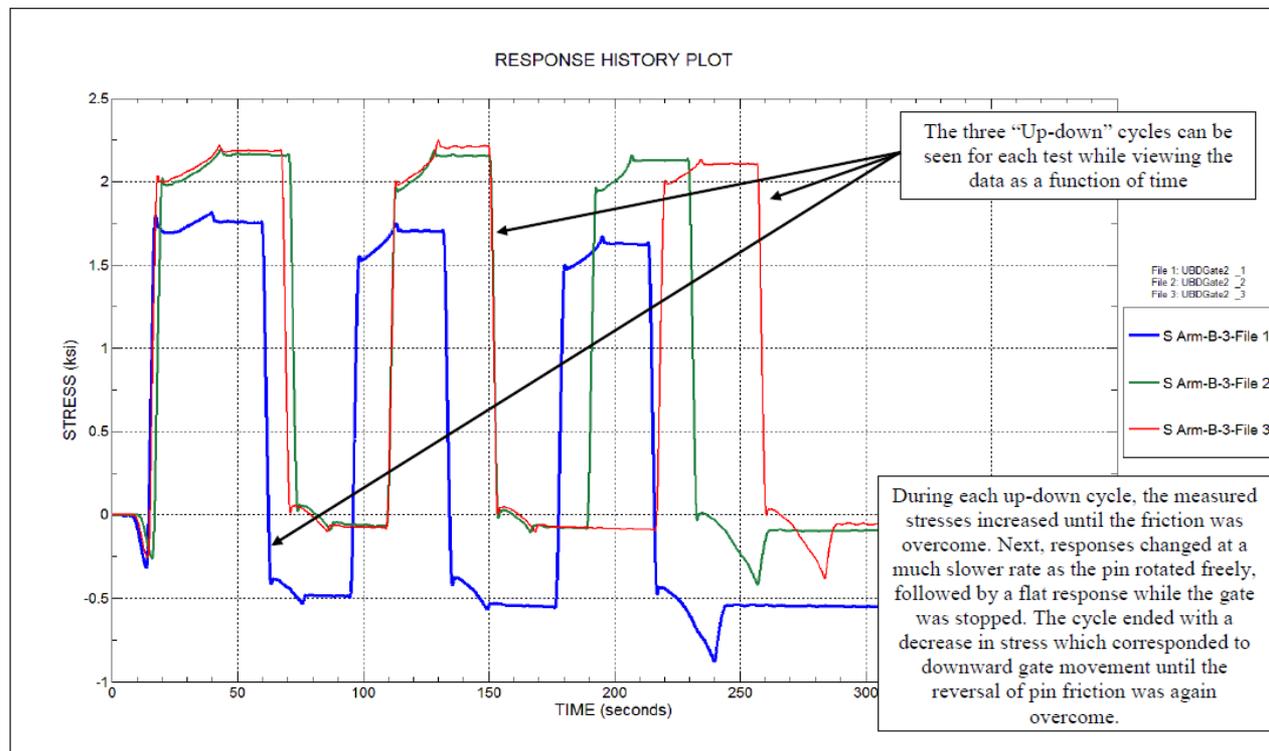
- 3 series of “Up-Down” spill tests
- Each test included 3 sets of direction reversal
- Direction reversal consisted of lifting the gate until friction was broken, pausing, then lowering until friction was broken again

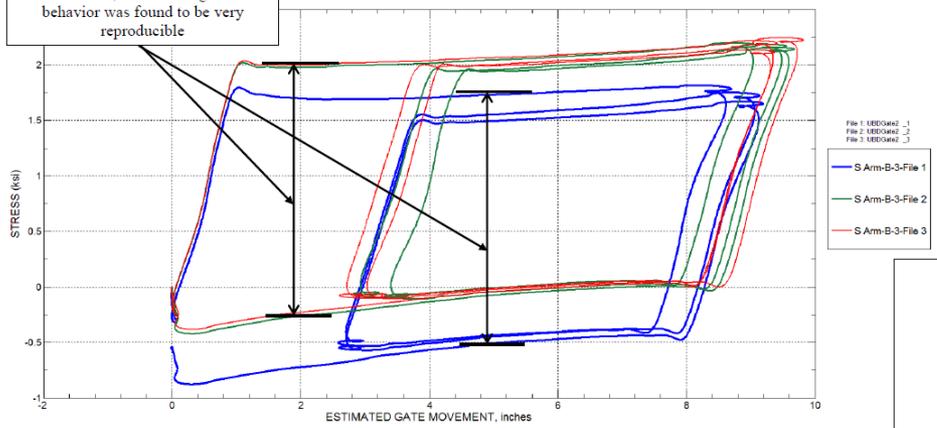
RESPONSE HISTORY PLOT

Although tests varied in gate movements, the data ranges and behavior was found to be very reproducible

The difference in response between the upward and downward gate movement is related to the reversal of friction at the pins

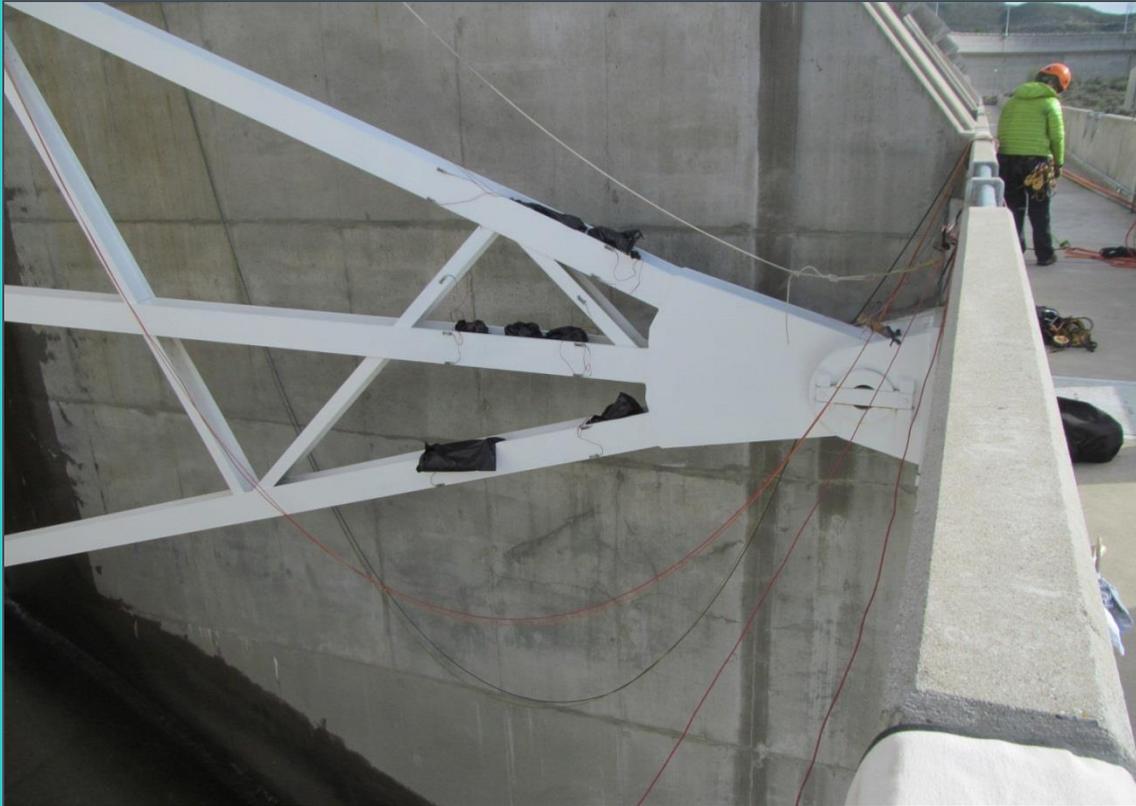
Chief Joseph Dam

- US. Army Corps of Engineers – Seattle District
- 19 spillway gates
- Lubrite “or equivalent”
- 3 gates instrumented in 2012 by HDR & BDI, Inc.
- Additional instrumentation required due to gate arm design:
 - 28 strain transducers
 - 2 displacement sensors
 - 1 rotation sensor
 - 1 Torque sensor @ pinion gear
