NHA's Operational Excellence Program Operations & Maintenance Case Study – Best Practices

2016 Northwest Hydro Forum

Broken Rotor Fin

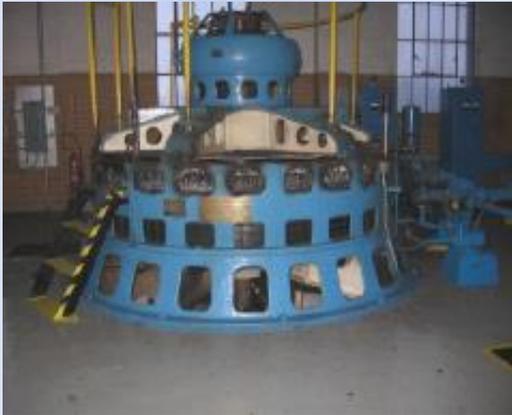
A cooling fin broke off of the rotor of unit #2 generator at the Beta Hydro Plant while the unit was in operation. This is a vertical shaft, 1.2MVA unit connected to a Francis runner operating normally at a speed of 257 Rpm. The steel fin struck the stator windings at a velocity sufficient to destroy the insulation, creating a phase to phase fault. It's very likely that the broken fin bounced around, contacting the stator in several places before ultimately being thrown out of the generator and onto the powerhouse floor. A junction box containing instrumentation transformers and overcurrent protective relays was mounted on the side of the generator. The resulting flashover destroyed the equipment inside the junction box, disrupting the DC control power to the switchgear. With the control power lost, the generator main breaker was unable to trip and the machine remained energized, sustaining very high fault currents until the power utility's recloser ultimately cleared the circuit. The powerhouse was unattended at the time of the incident; the damage was discovered when the operator was called out and arrived finding the building filled with smoke.

General View

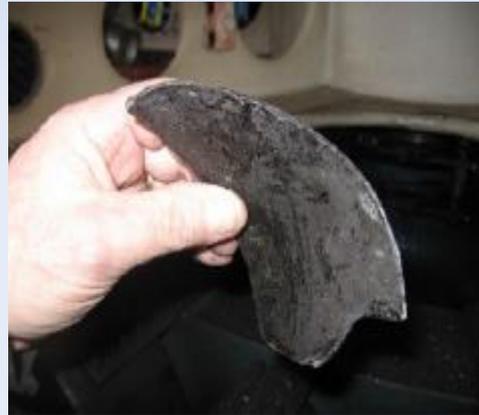
Broken Cooling Fin

Broken fin was examined and failed due to metal fatigue

- Stator winding was completely replaced
- Instrument transformers and over current relays were replaced and relocated
- Cooling fins were replaced
- Repairs required 90 days to complete

- Include inspection of cooling fins for cracks in standard outage inspection tasks
- Locate instrumentation and relays in different location away from generator housing

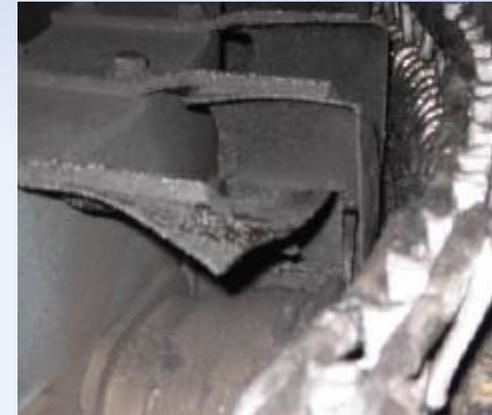
Rotor Cooling Fins

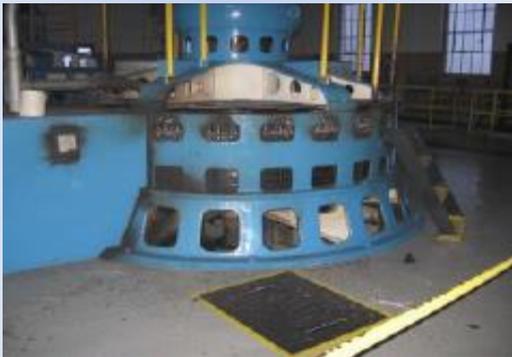
- Generator – 1.2 MVA, 257 RPM was in normal operation
- Cooling fin broke off
- Fin struck stator winding in several locations resulting in a phase-to-phase fault
- Electrical arc flash burned the instrument transformers and over current relays which were mounted on the side of the generator housing. The DC circuit power to the generator circuit breaker was interrupted.

Instrumentation Cabinet

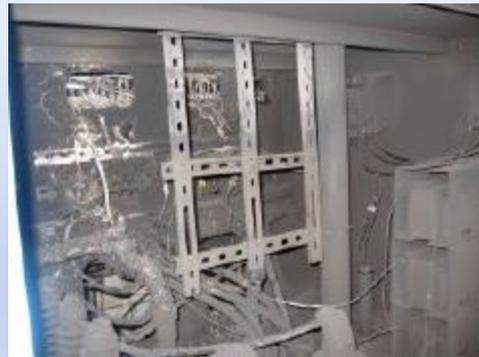
Interior View of Cabinet
