Bear Creek Dam Seismic Stability

2016 NW Hydro Forum

May 2016

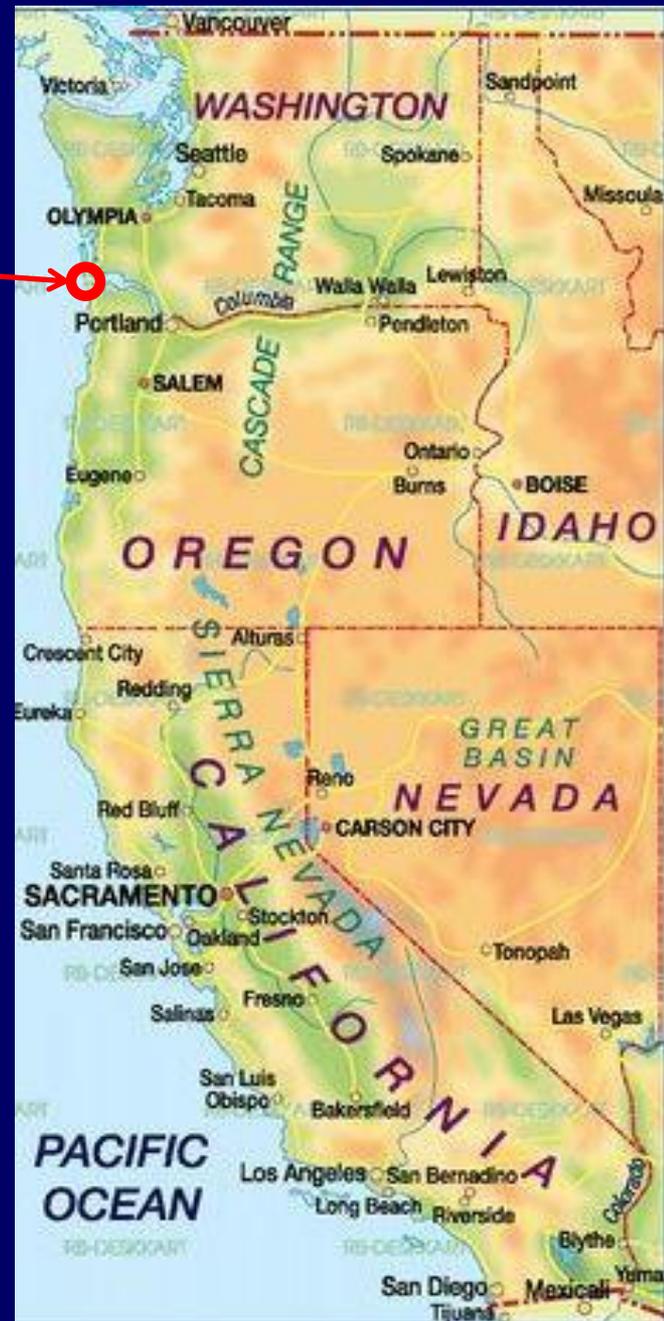
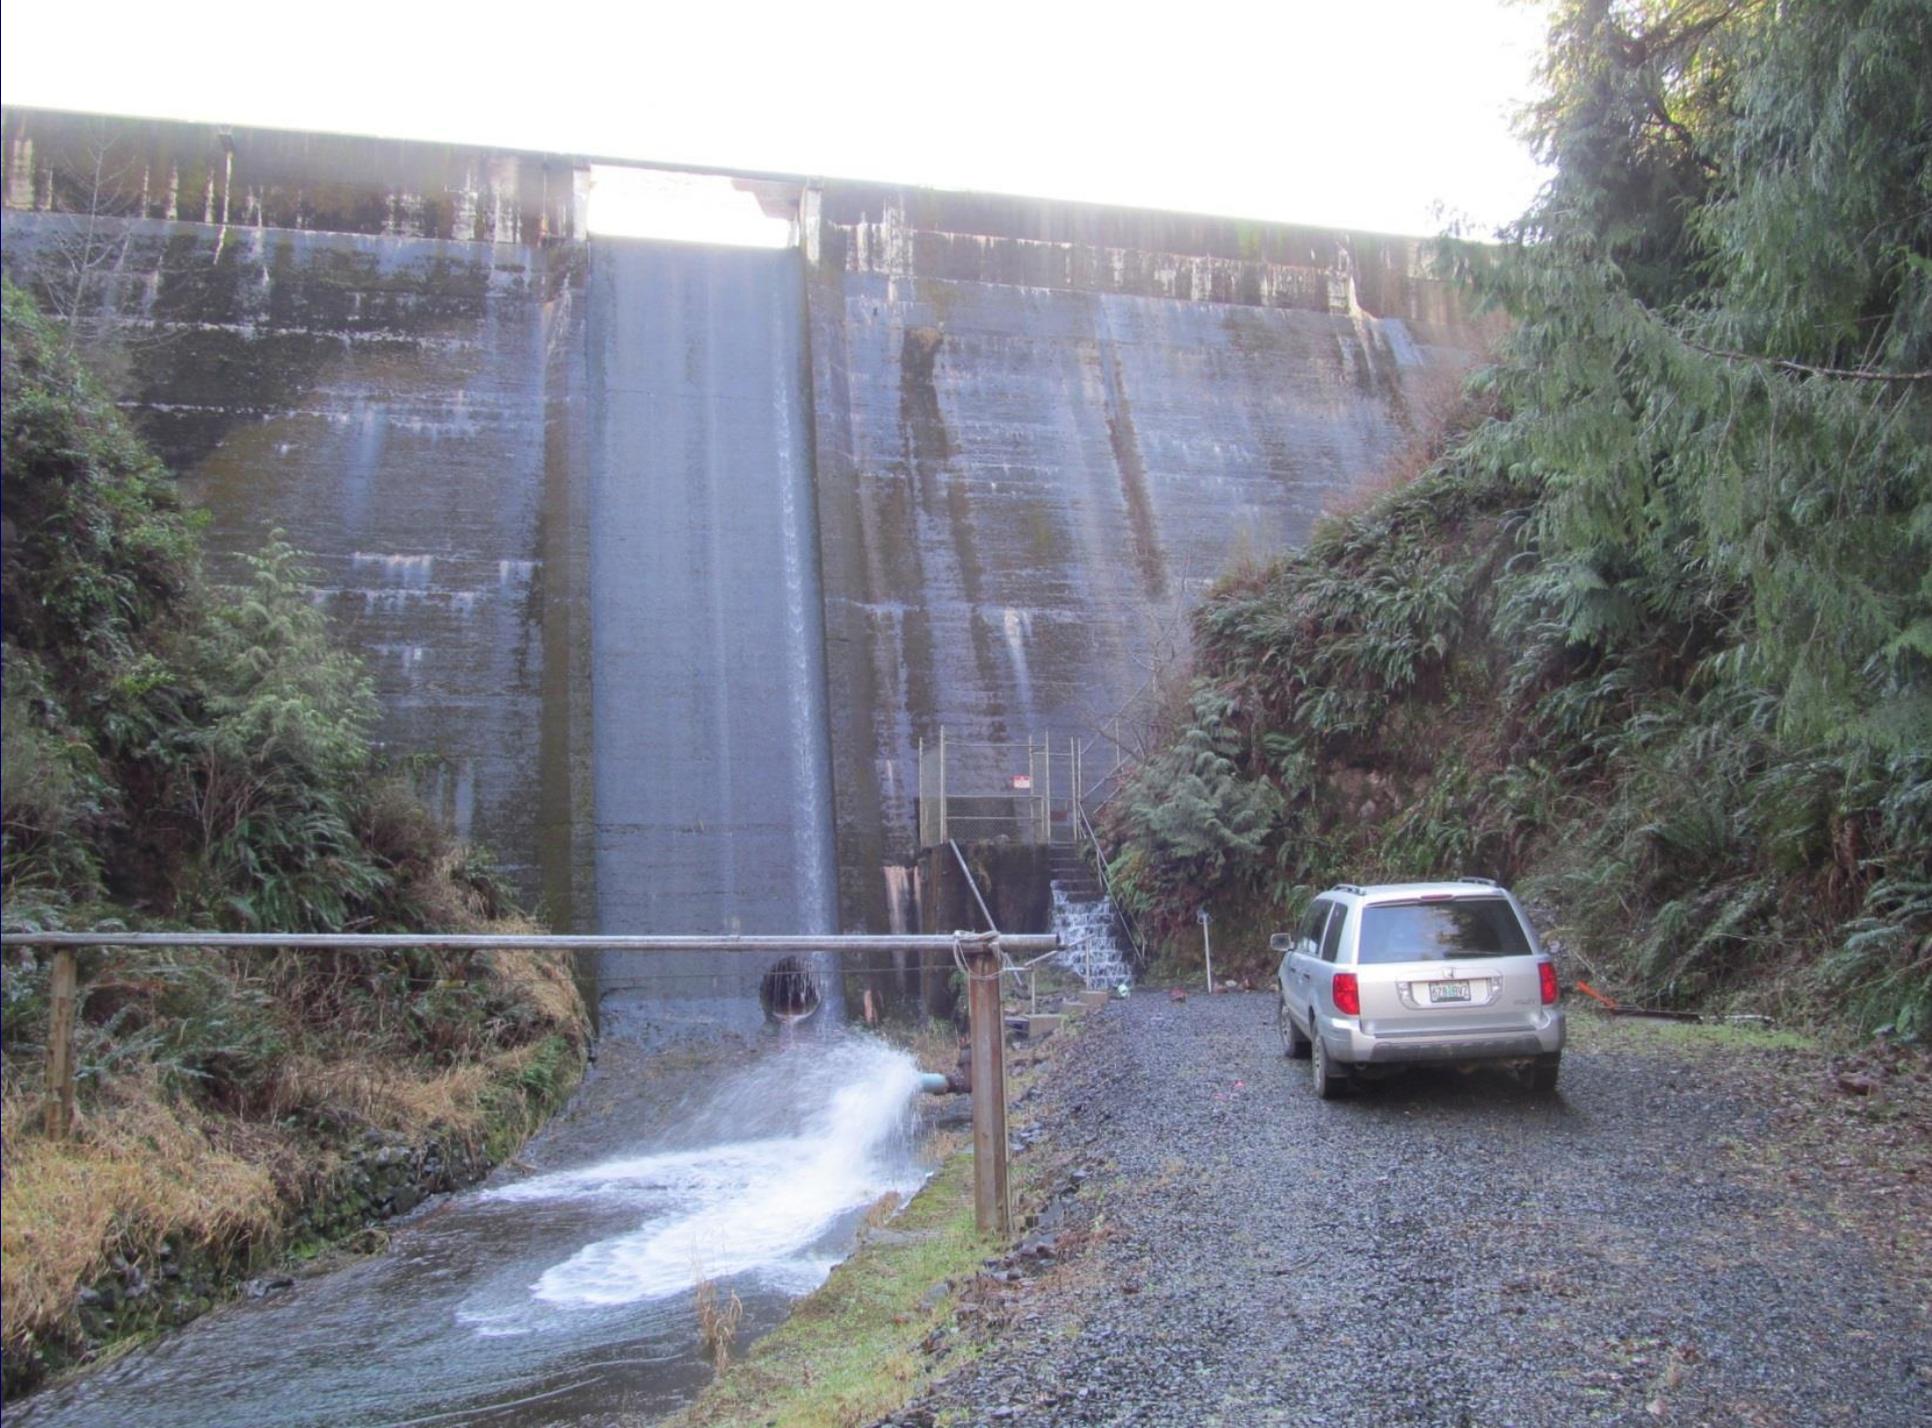
Bear Creek Dam

- Near Astoria, Oregon
- Constructed 1911
- Domestic water
- 90' concrete gravity
- 280' long
 - Only 180' is over 20'

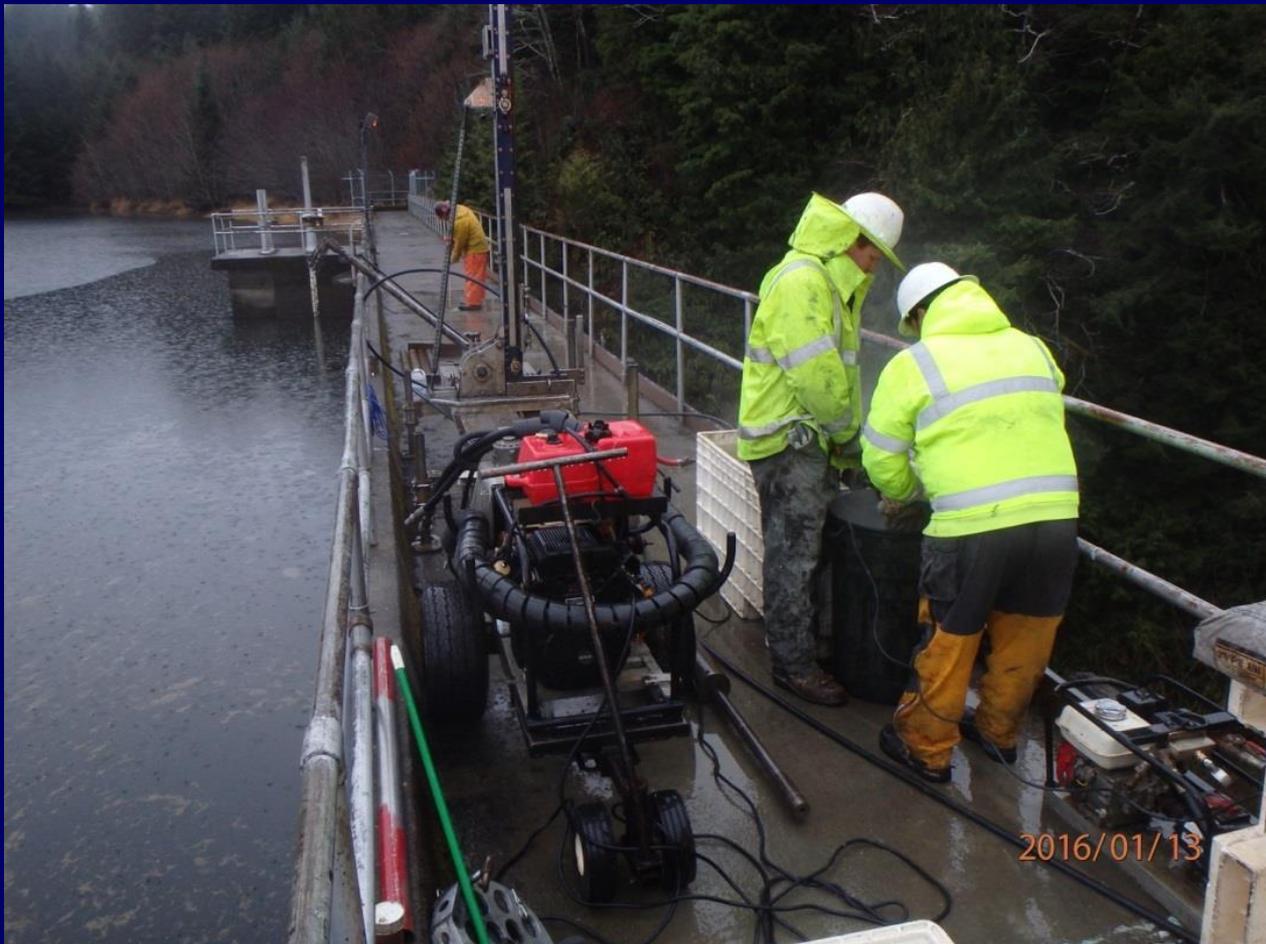
Additional Borings

- Refine right abutment geology
 - borings from crest
- Shear strength testing
- Reanalyze stability
