Summary Background Document for New Capital Hydropower Improvement Project

Project Title: Lower Monumental Powerhouse Bridge Crane Wheel and Drive System Upgrade

Dam and Reservoir Project: Lower Monumental

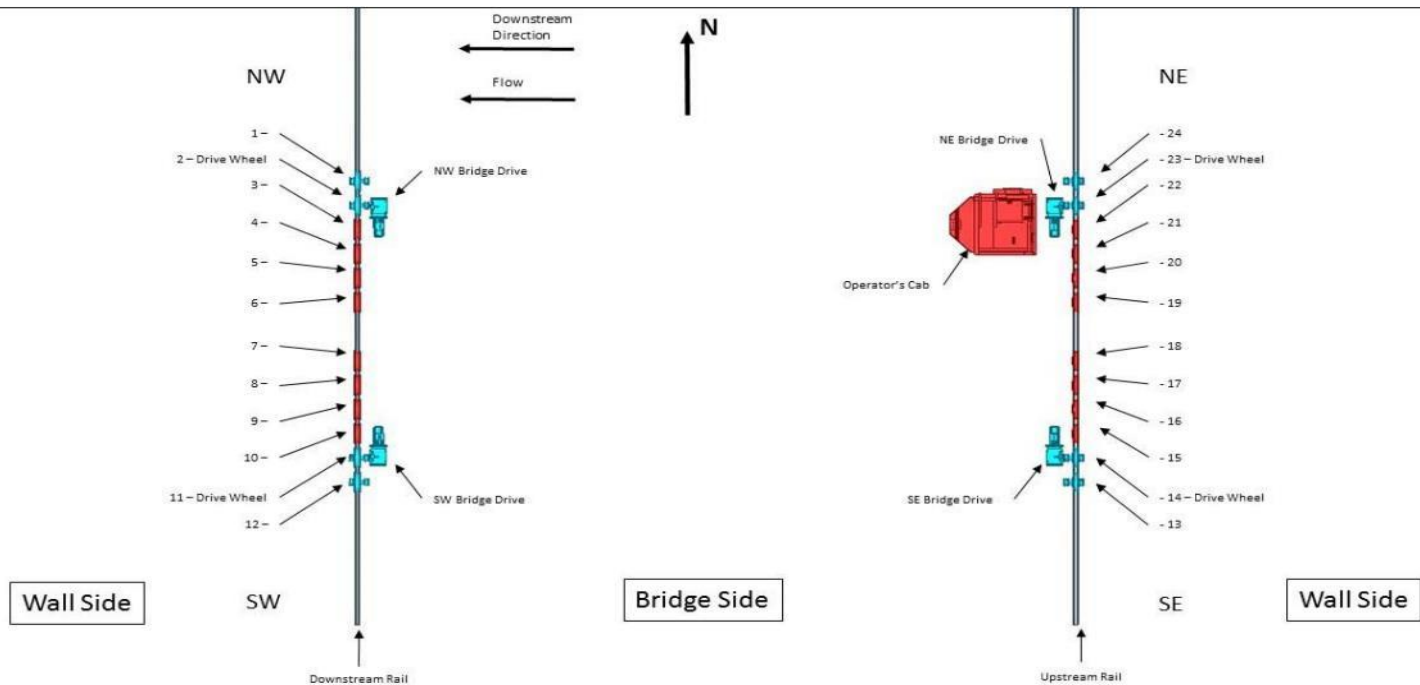
Diagram of Bridge Crane Wheel with Identification Numbers

In the diagram and table below, all 24 of the bridge crane wheels are shown and listed. Wheels 2, 11, 14, and 23 are the drive wheels. The other wheels are referred as idler wheels.
