Detroit Dam Electrical Failure and Fire

*Some Protective System
Lessons Learned – NW
Hydro Operators Regional
Forum May 22, 2008*

**US Army Corps
of Engineers.**

Detroit Dam

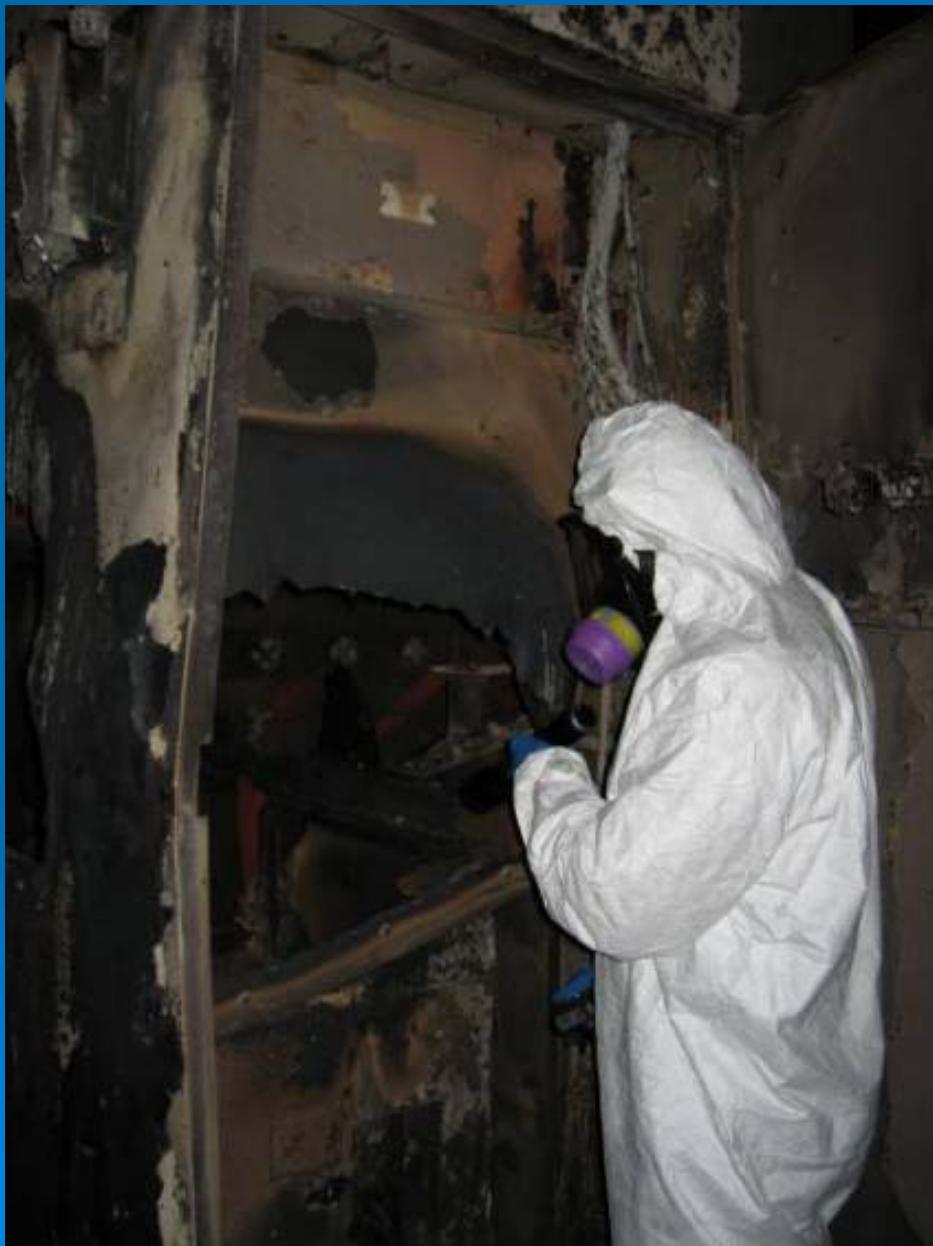
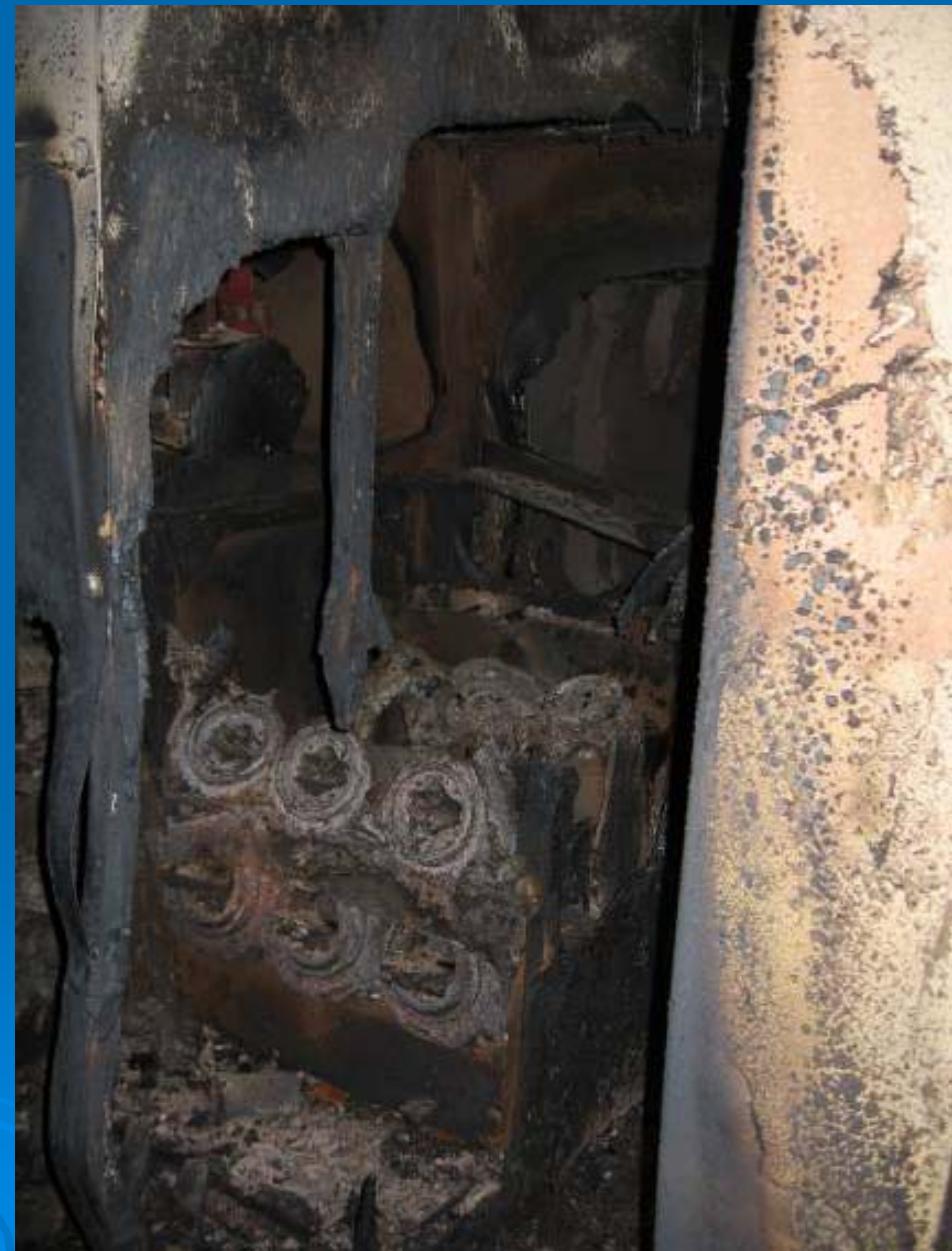
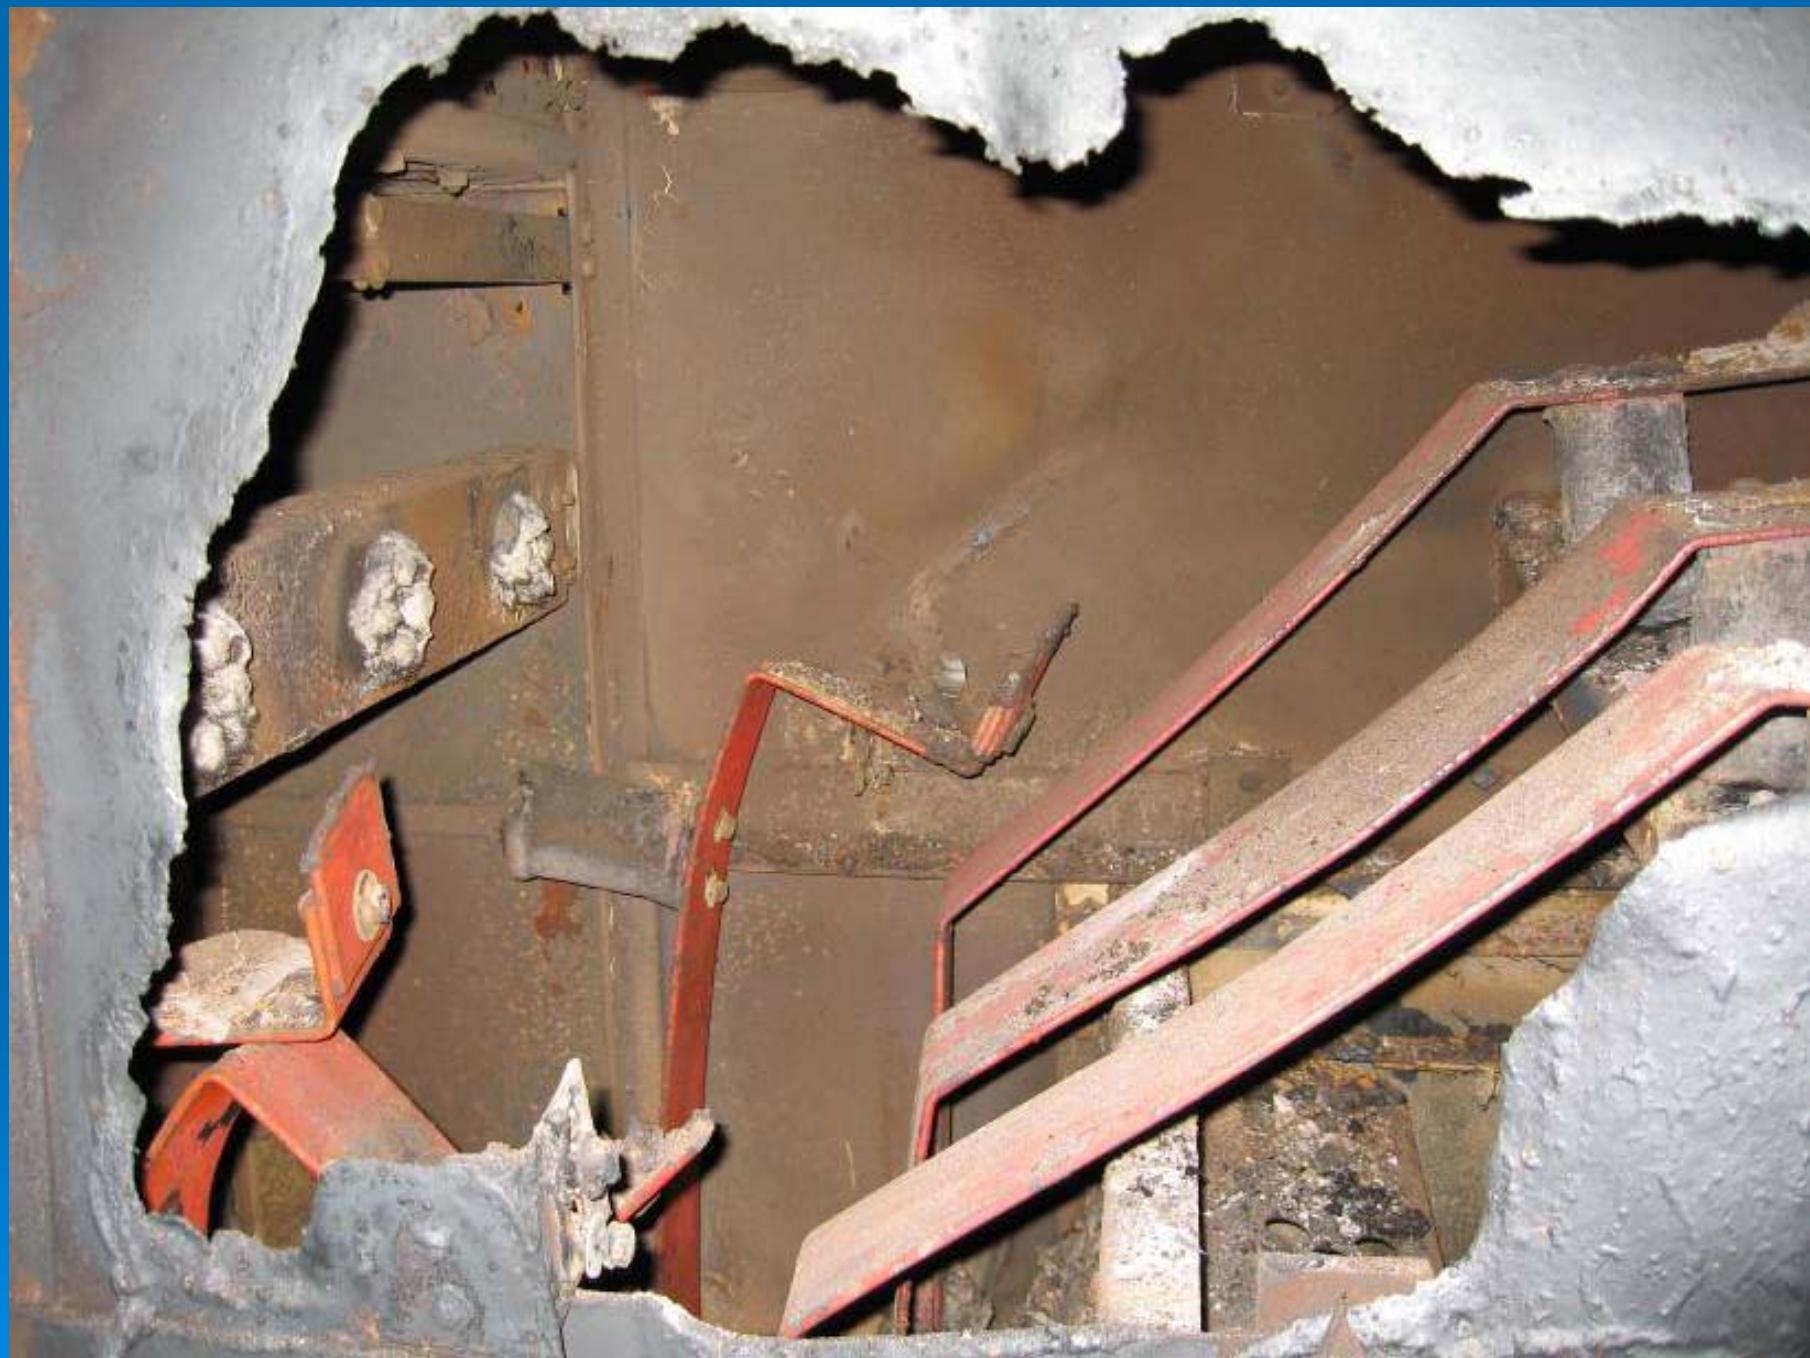
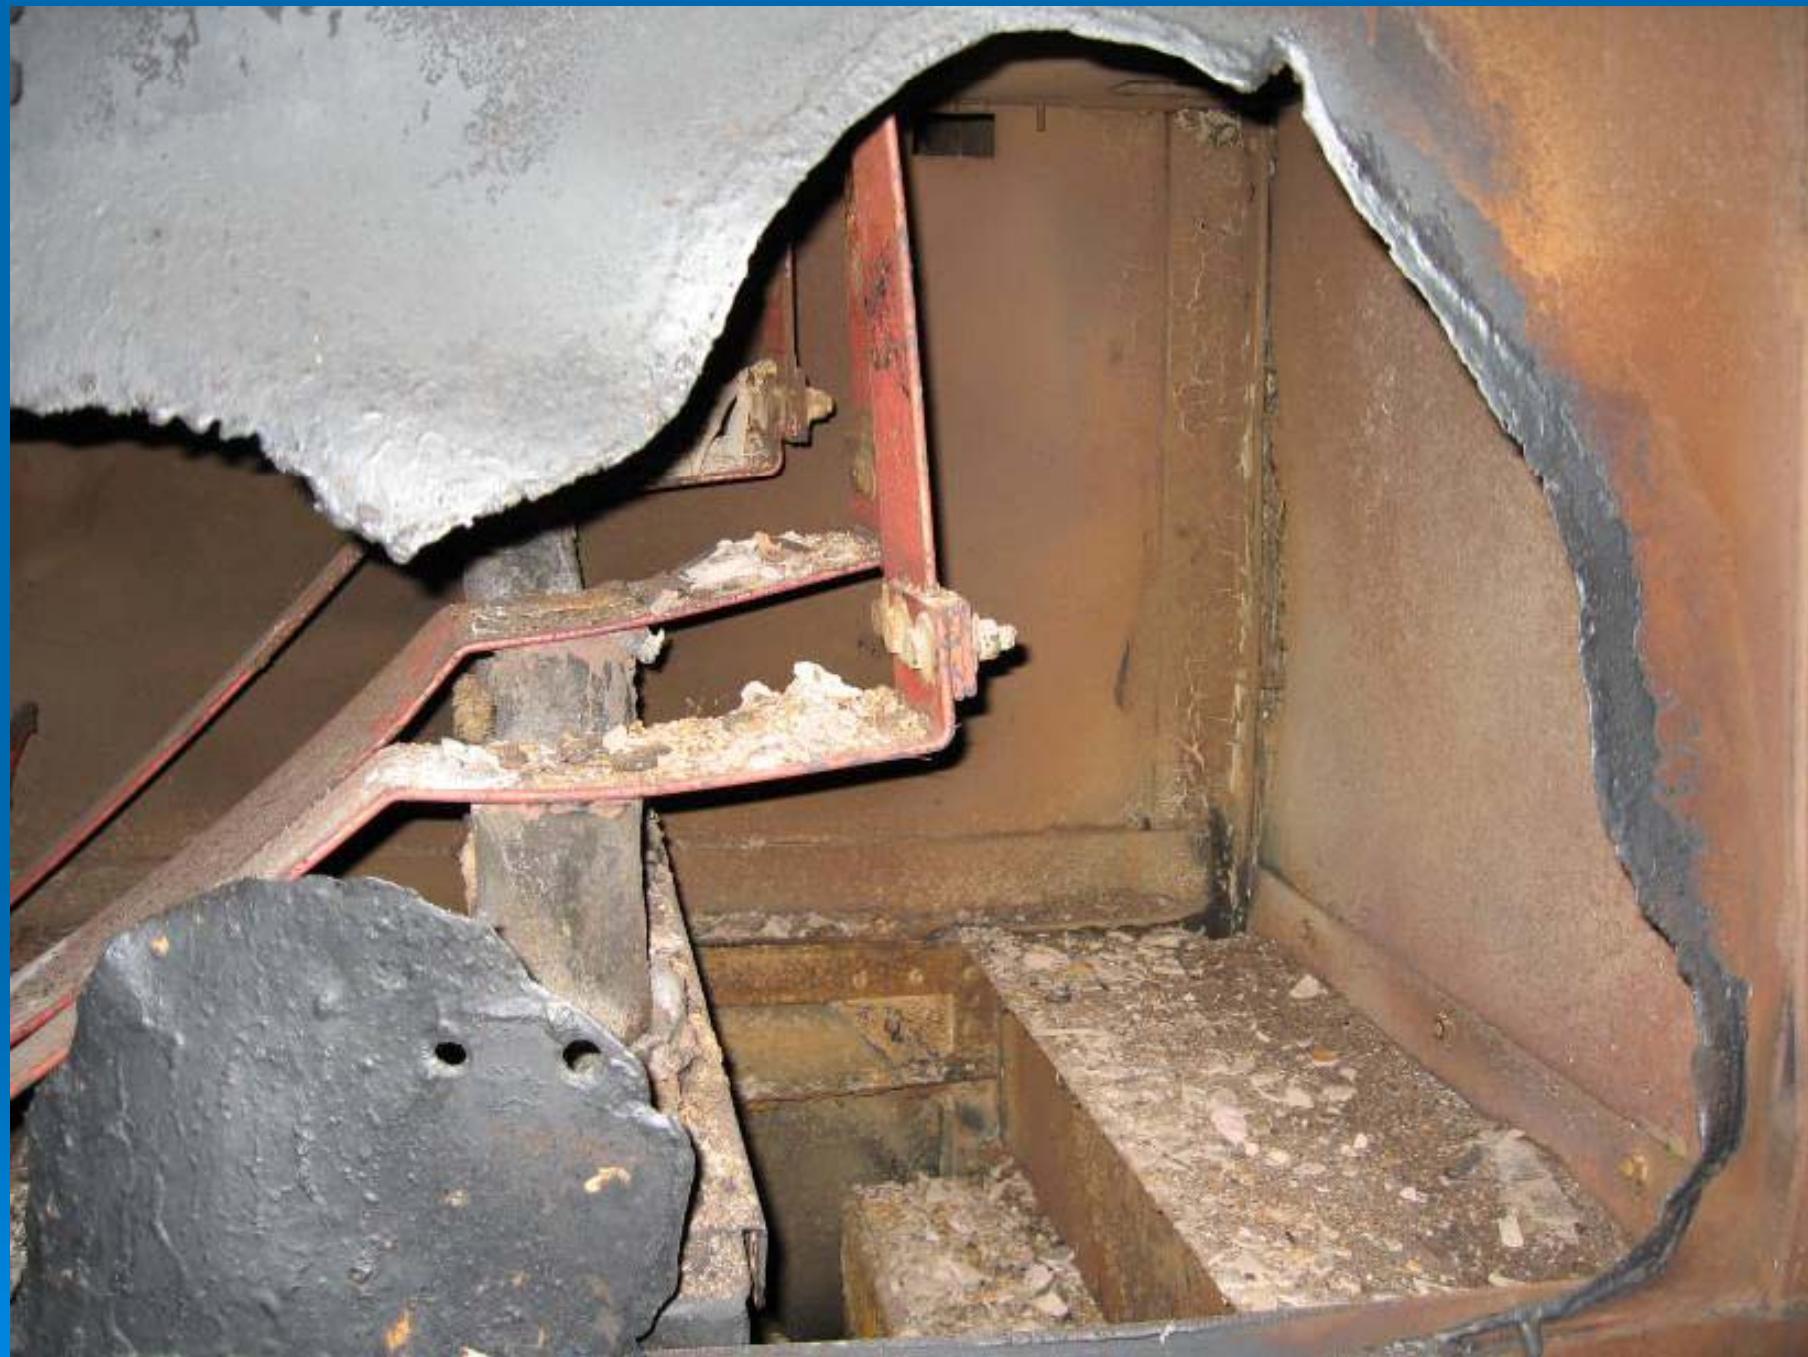
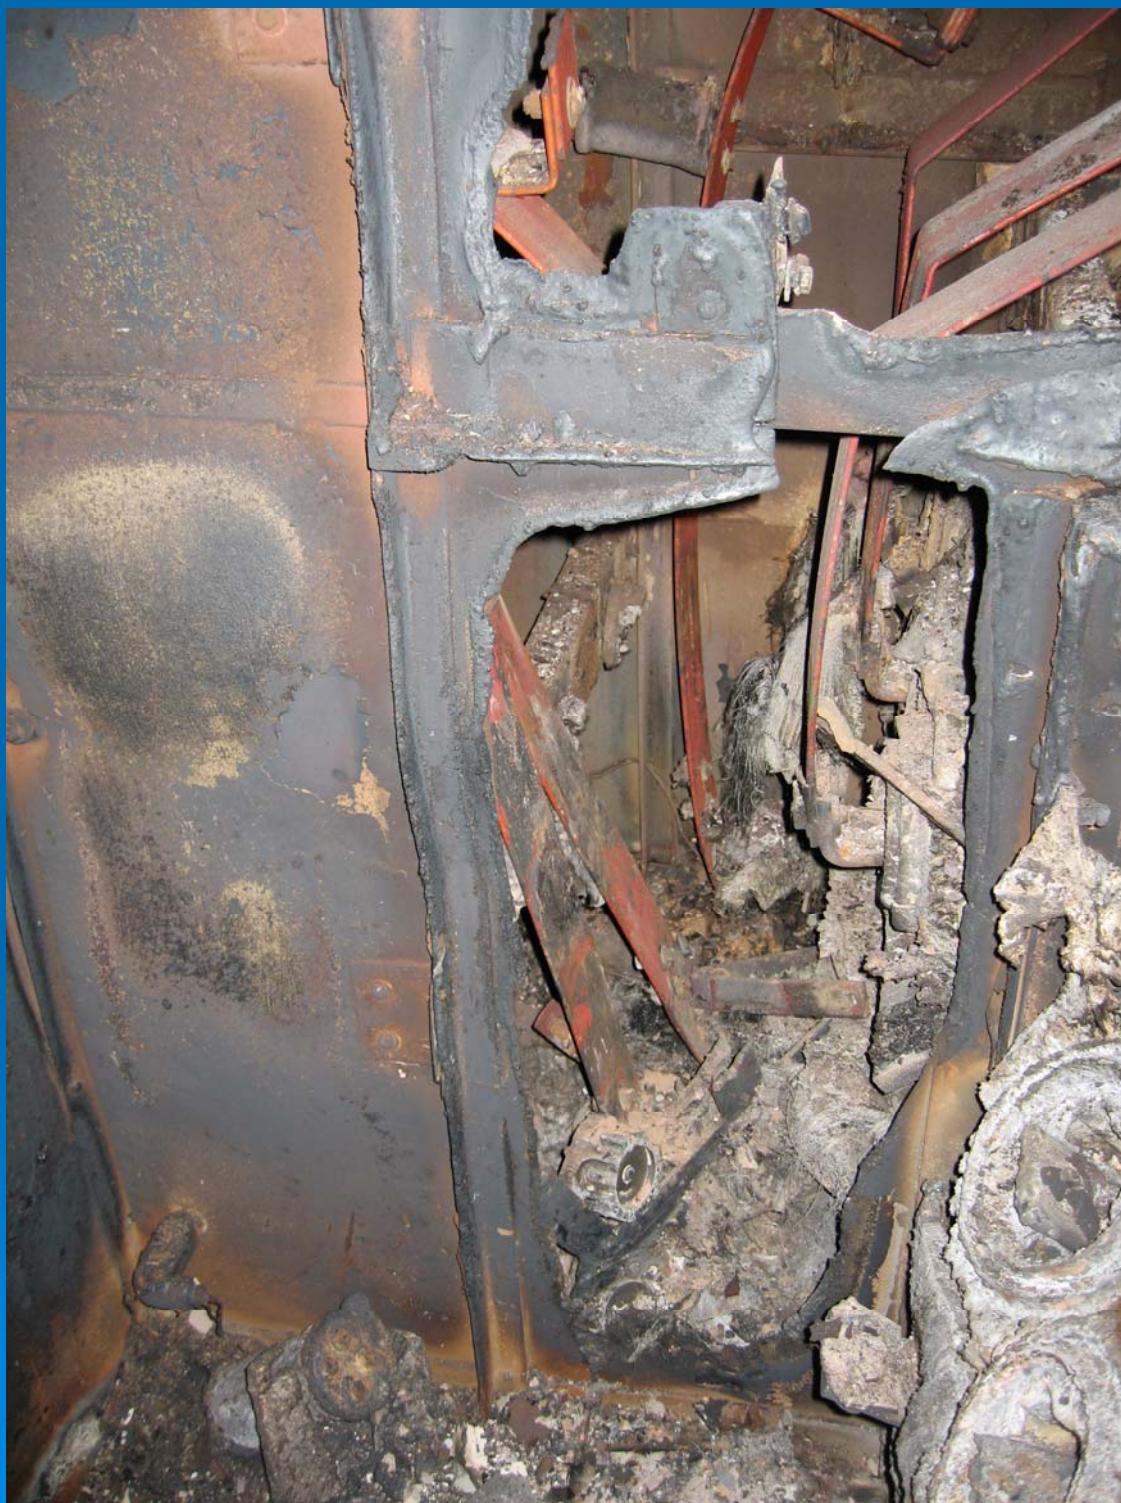
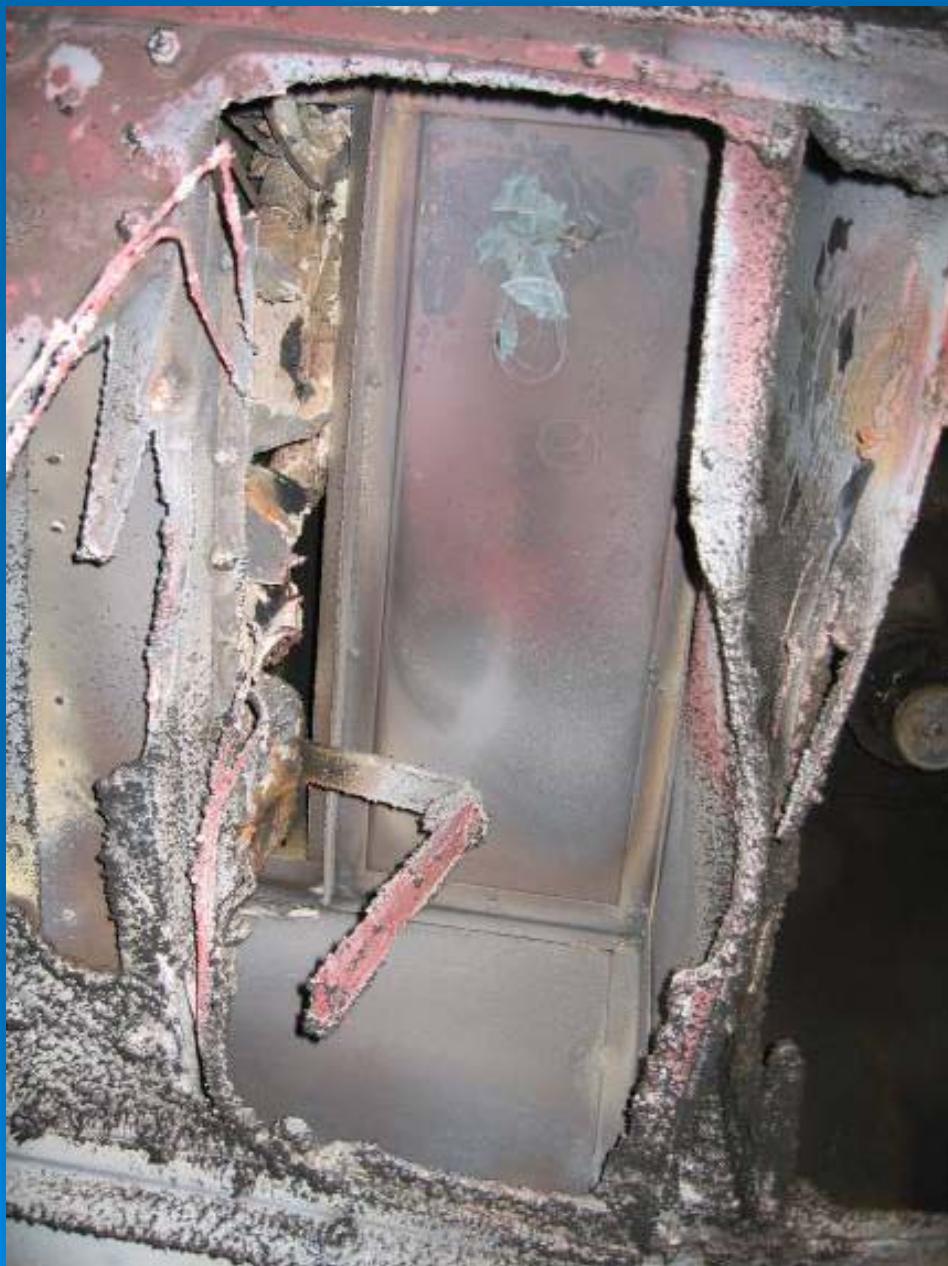
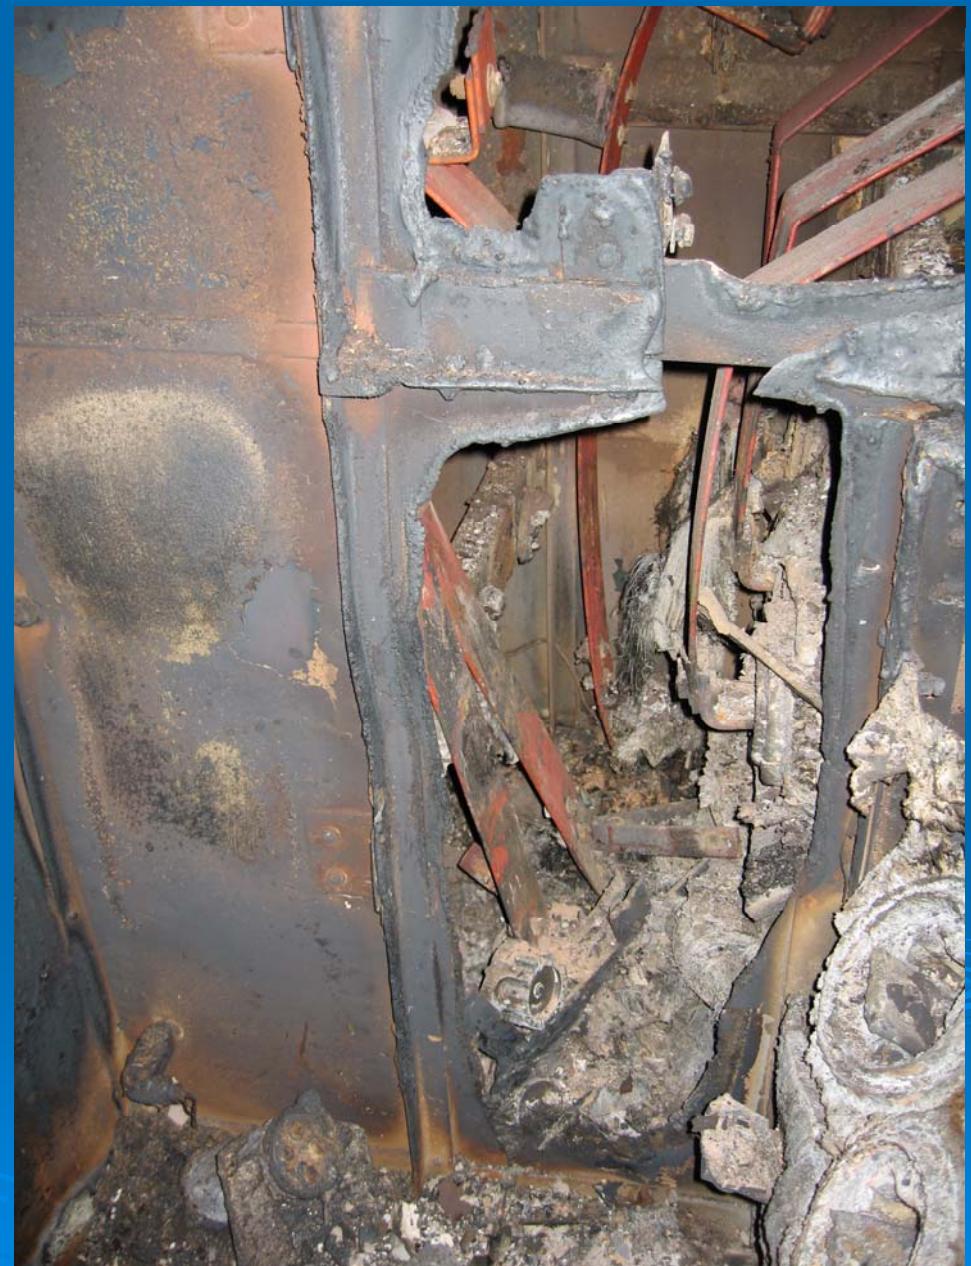
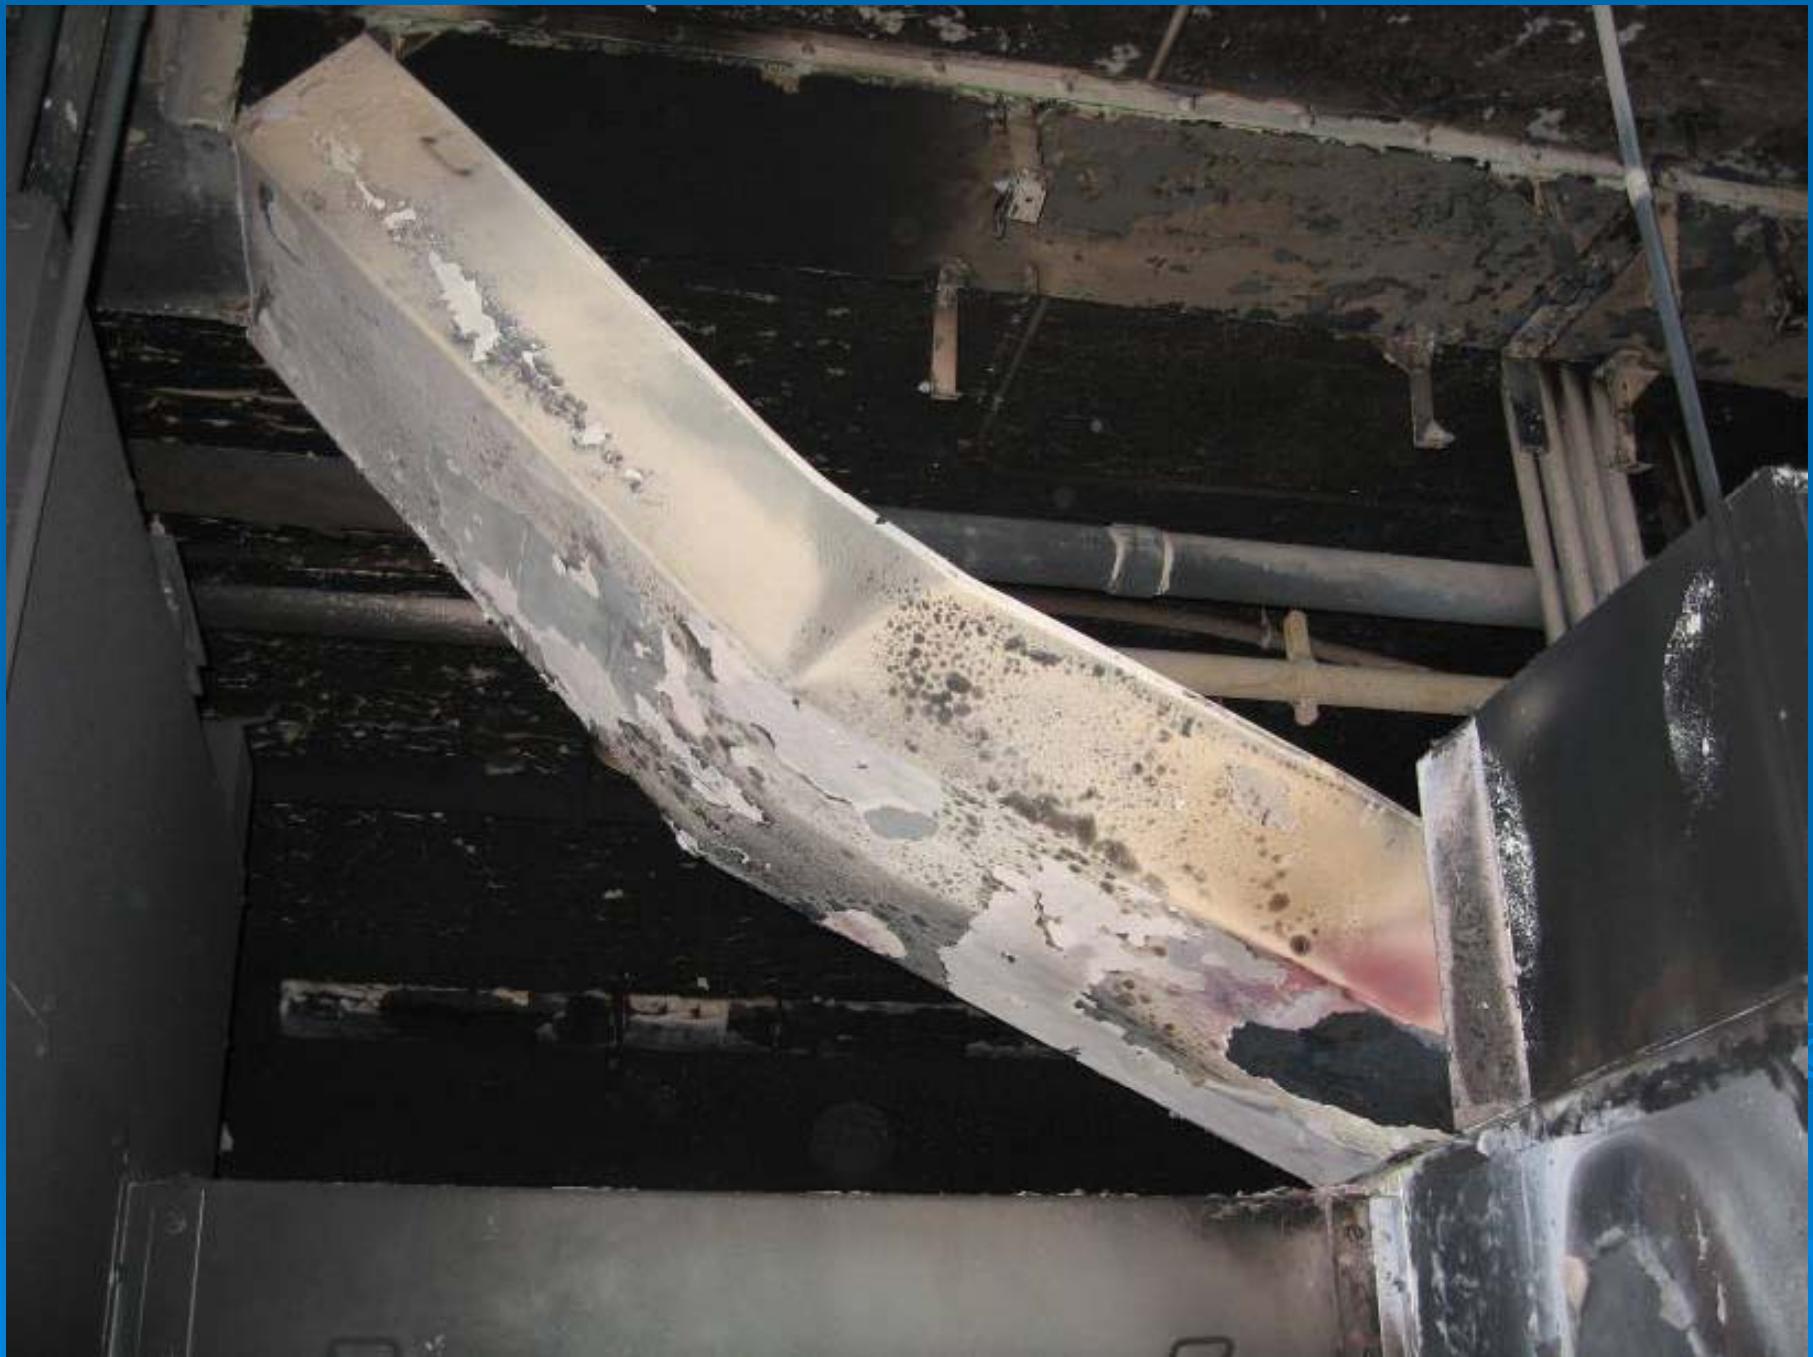
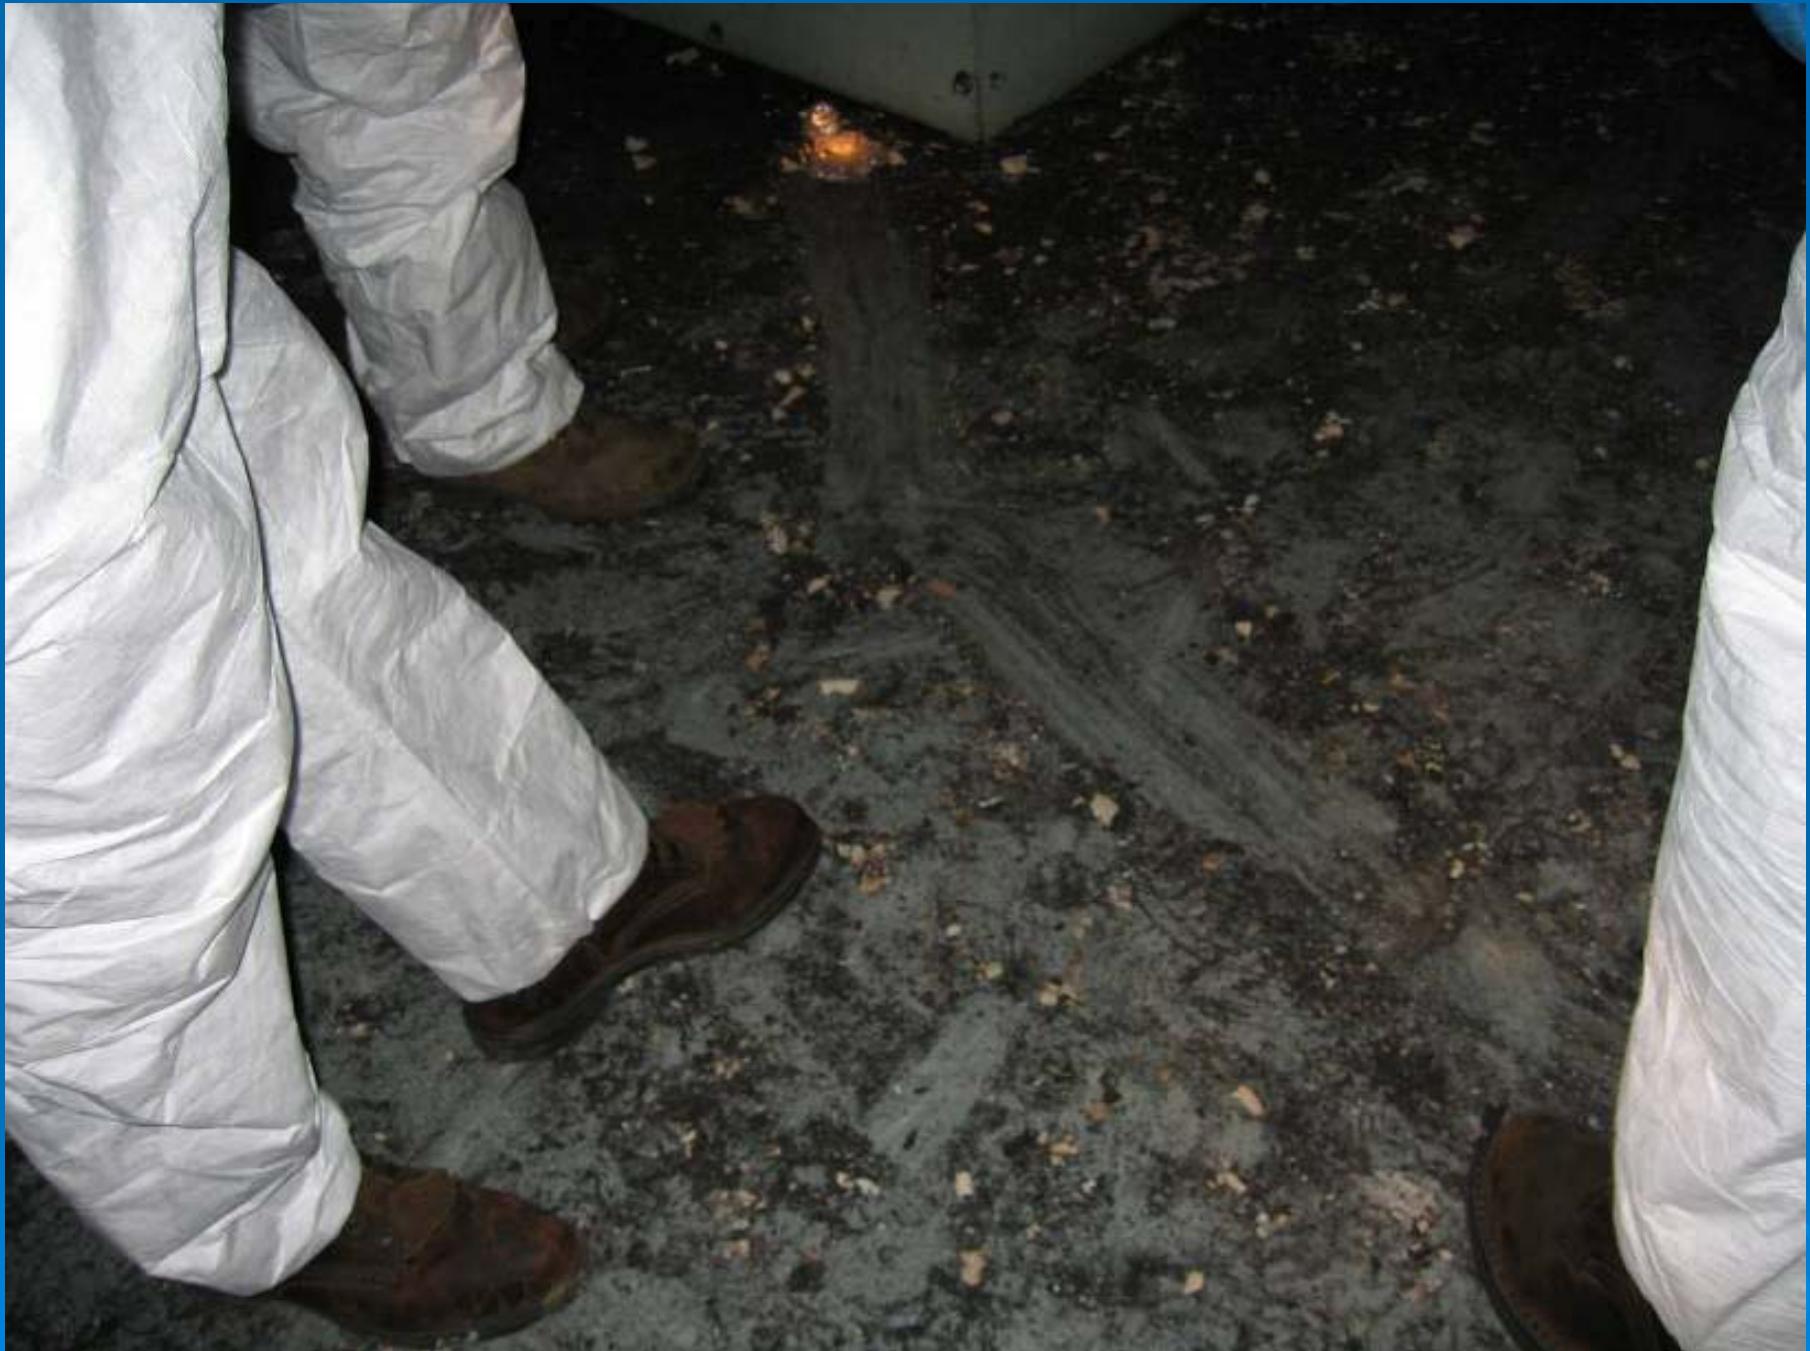
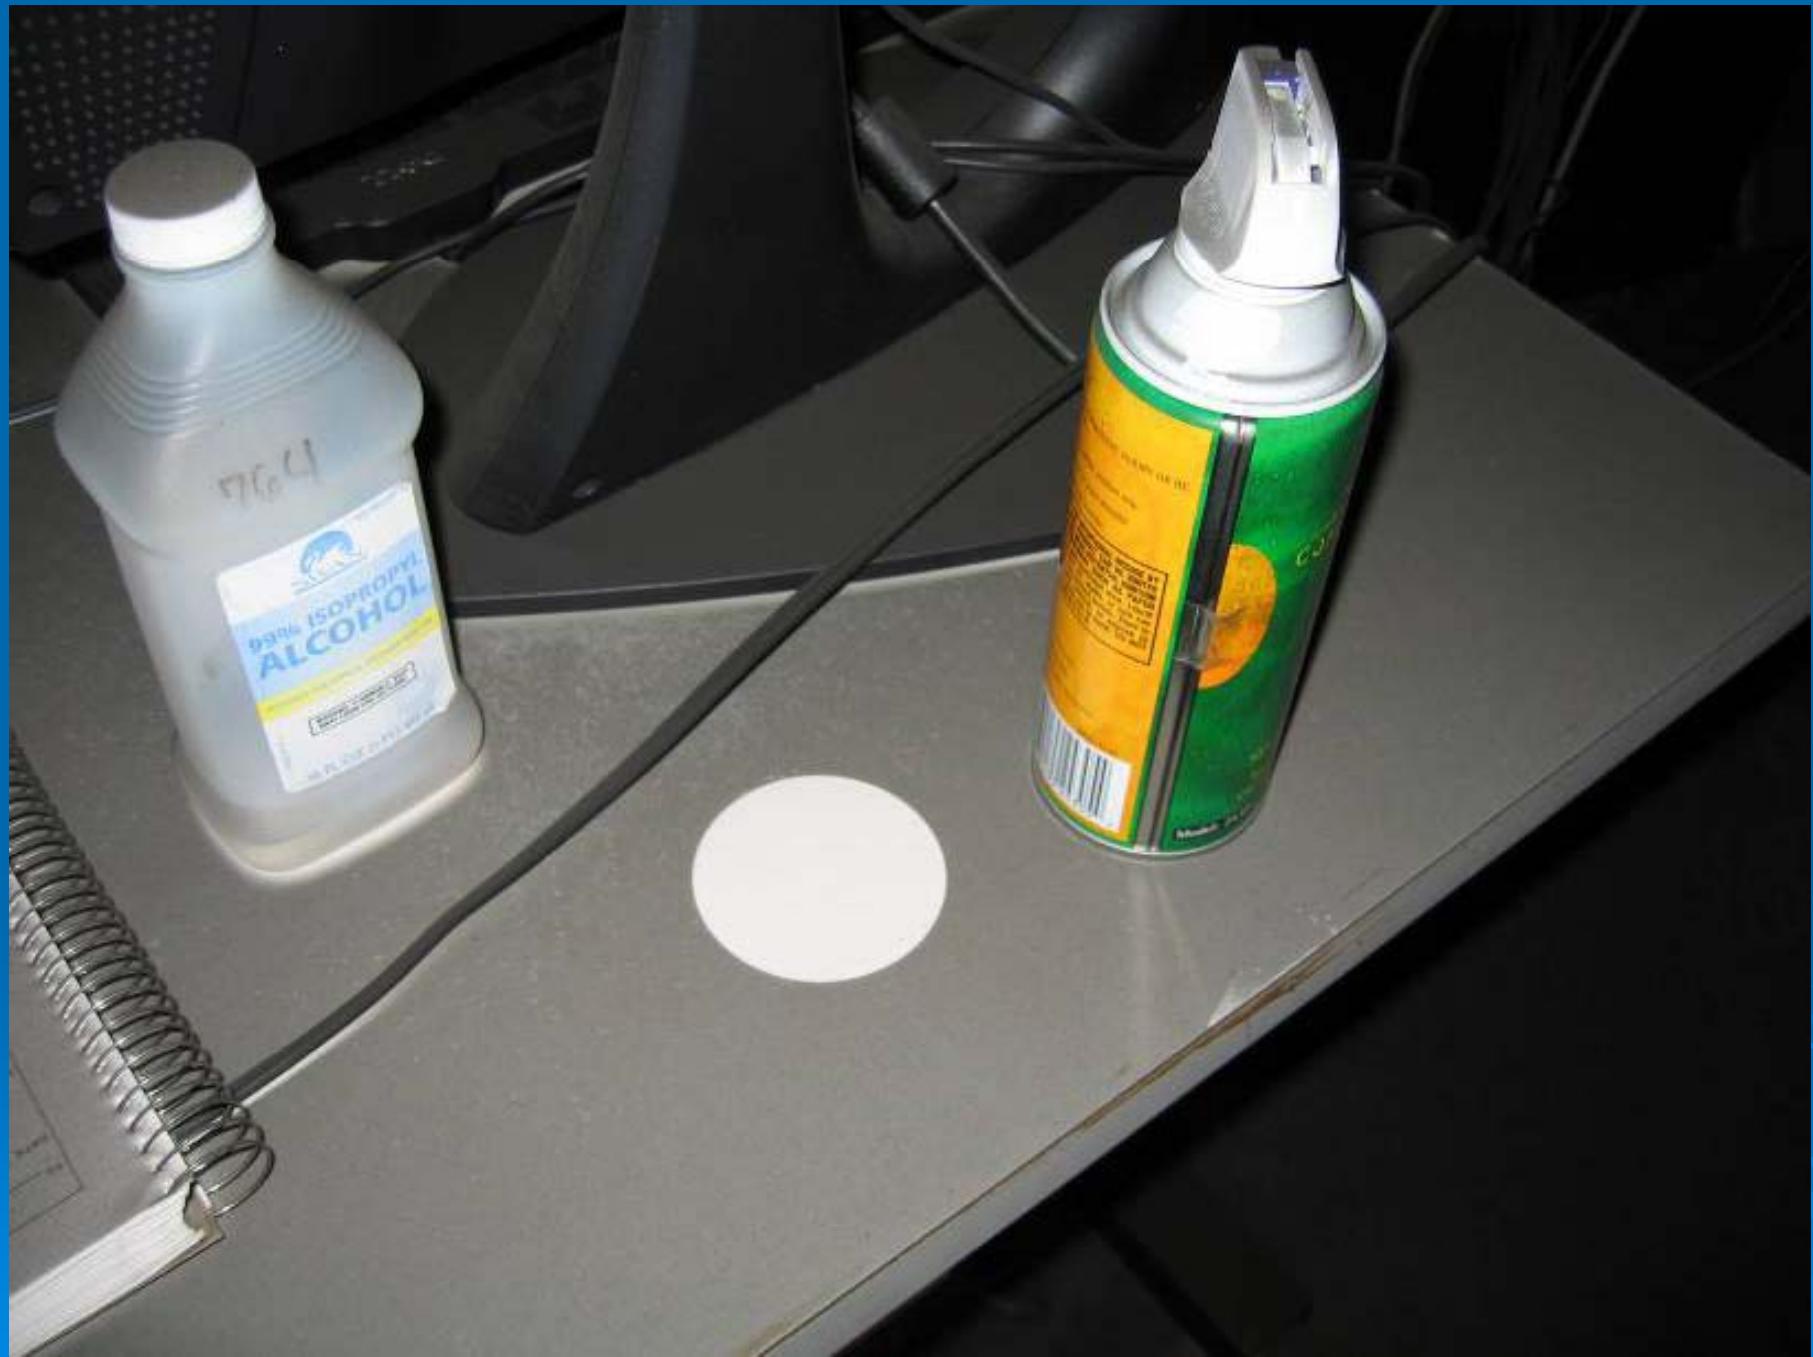
Damage Assessment

- BPA ground fault
- New under-rated surge arresters burn
- 2 circuit breakers burn
- BCL bus melted
- Fault bypasses reactor
- Substation breaker clears the fault
- Soot and smoke everywhere

- XJ5, XJ9 circuit breakers
- Surge arresters & capacitors
- Metering PTs, CTs
- Switchgear enclosures
- Portions of the isolated phase bus work
- Soot everywhere (environmental clean up \$2+M)
- Current estimate - \$6.5m
