Summary Background Document for New Capital and Non-Routine Expense Hydropower Project

Project Title: Main Units 1-6 Discharge Ring Upgrade and Turbine Blade Cavitation Repair

Dam and Reservoir Project: Little Goose Lock and Dam

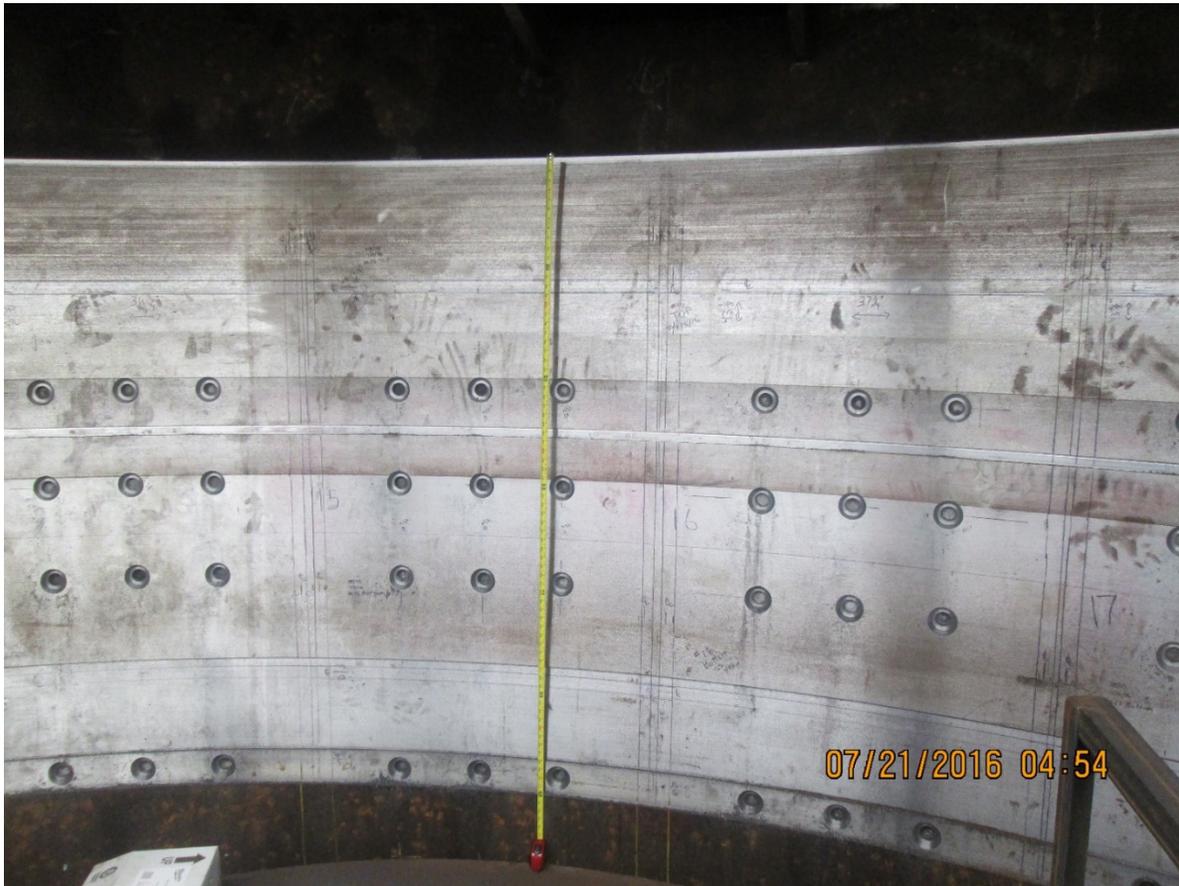
Picture 8: Discharge Ring Stainless Steel Liner Upgrade – Final Stage of Installation
Replaces Portion of the Discharge Ring with a Stainless Steel Band
Typical of Work Performed at Lower Monumental 2016

- Upgrade the discharge ring such that the MUs operate as originally designed.
- Repair turbine blade cavitation such that the MUs operate as originally designed to minimize or eliminate rough operation zones (or both).
- Replace turbine blade seals after the discharge ring and turbine blade cavitation work is complete.

(Recommended): This alternative would upgrade the discharge rings, by installing the stainless steel liner, restore the turbine blades to original dimensions for optimum operations, and replace the turbine blade seals.
