Sayano-Shushenkaya Hydro Power Project

Pat Regan

- On August 17, 2009 the Sayano-Shushenkaya Power Plant in Siberia suffered a catastrophic failure in a turbine-generator unit
- 75 people lost their lives in the accident

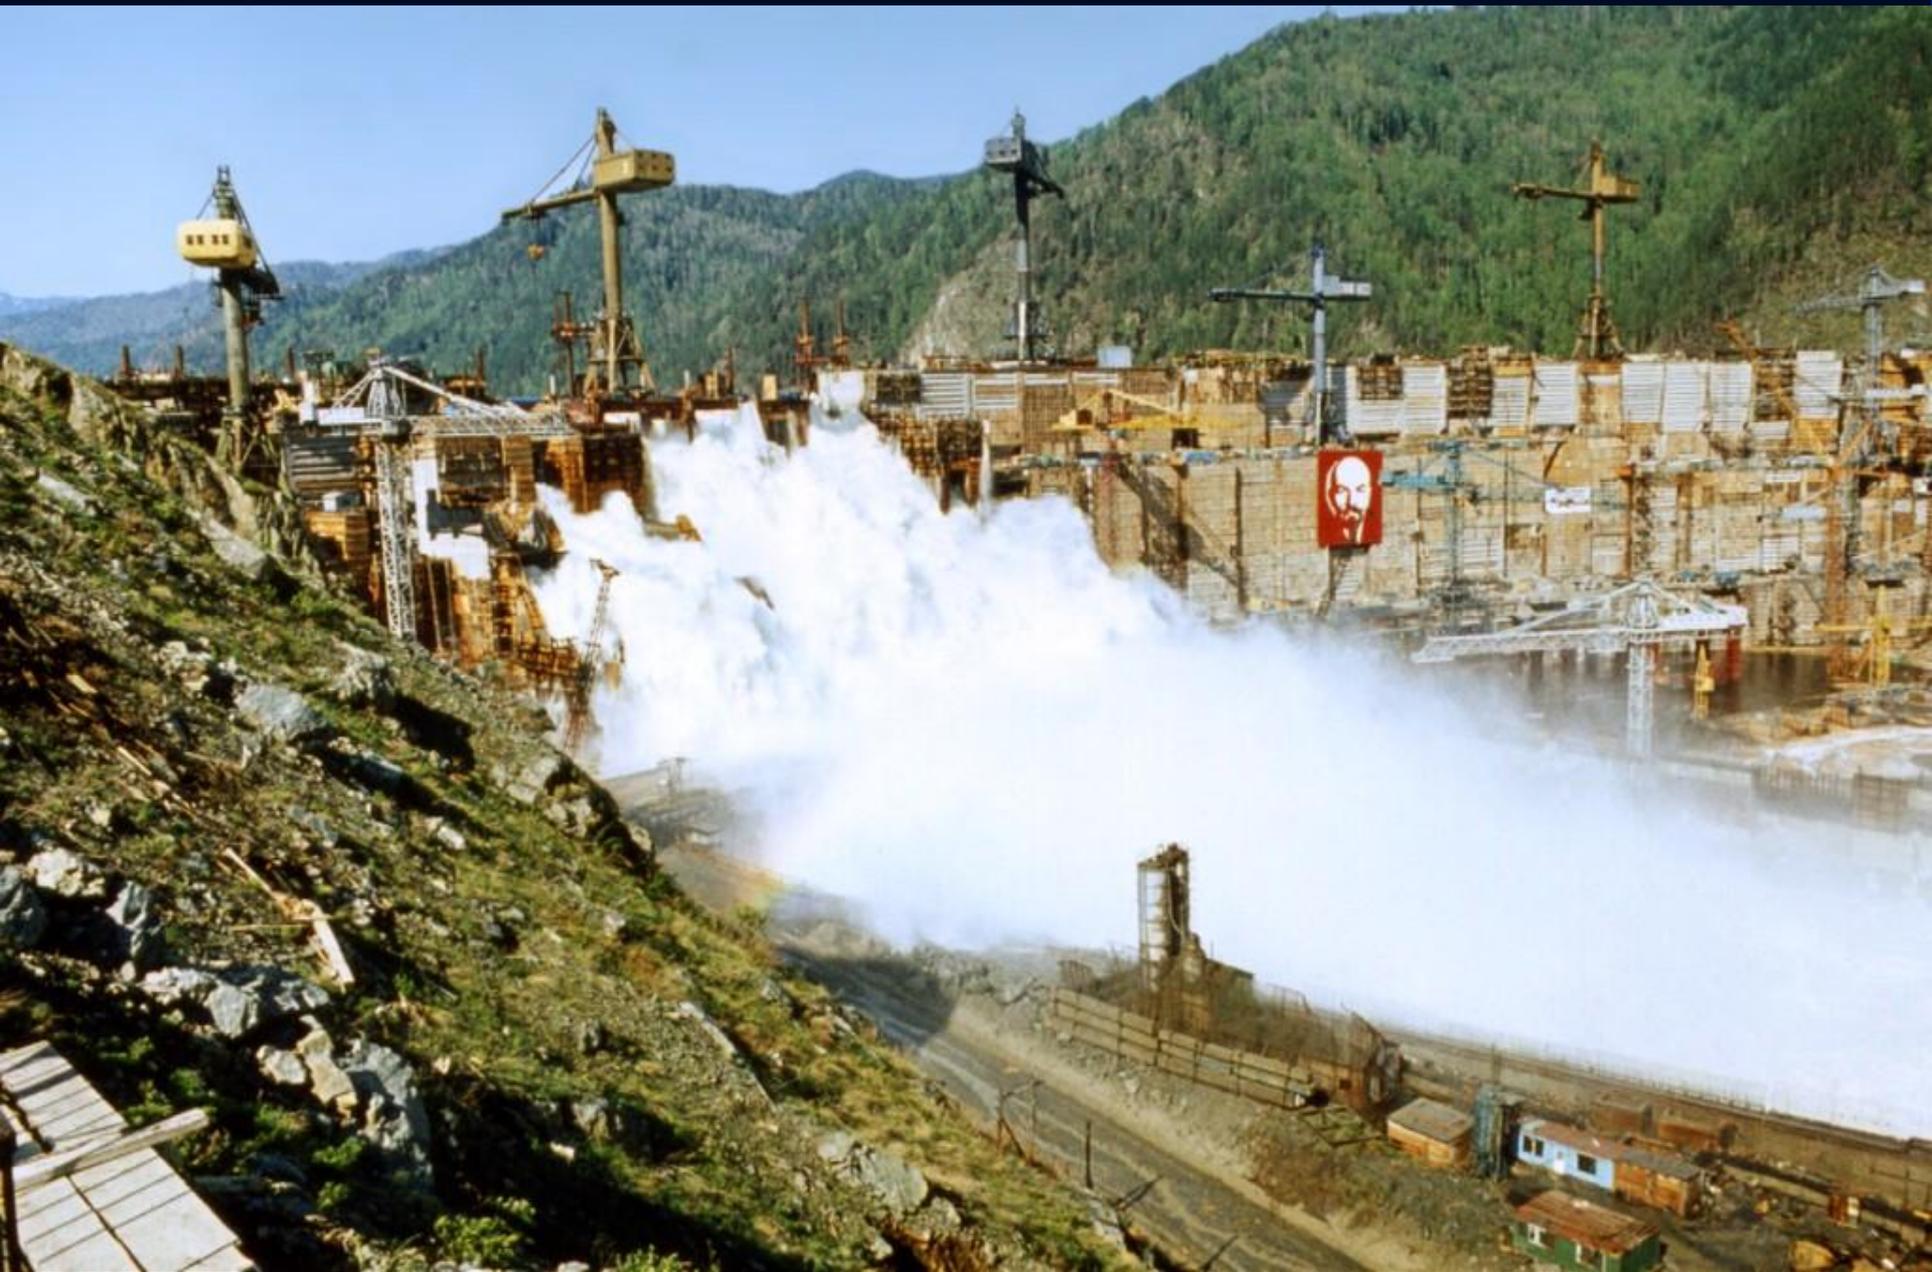
- Construction began in 1963 and the first unit was commissioned in 1978.
- In 1979, while the dam was still under construction, the seasonal flood could not be passed through the spillways and operating units and therefore overtopped the dam. The powerhouse was flooded.

- The overtopping resulted in:
 - Cracking of the concrete in the upstream monoliths
 - Cracking at the dam-foundation interface
- Seepage through the dam was 18.4 cms and through the foundation 19.4 cms
- In response to these problems the cracking was grouted and a decision was made to reduce the normal water level 1 meter.

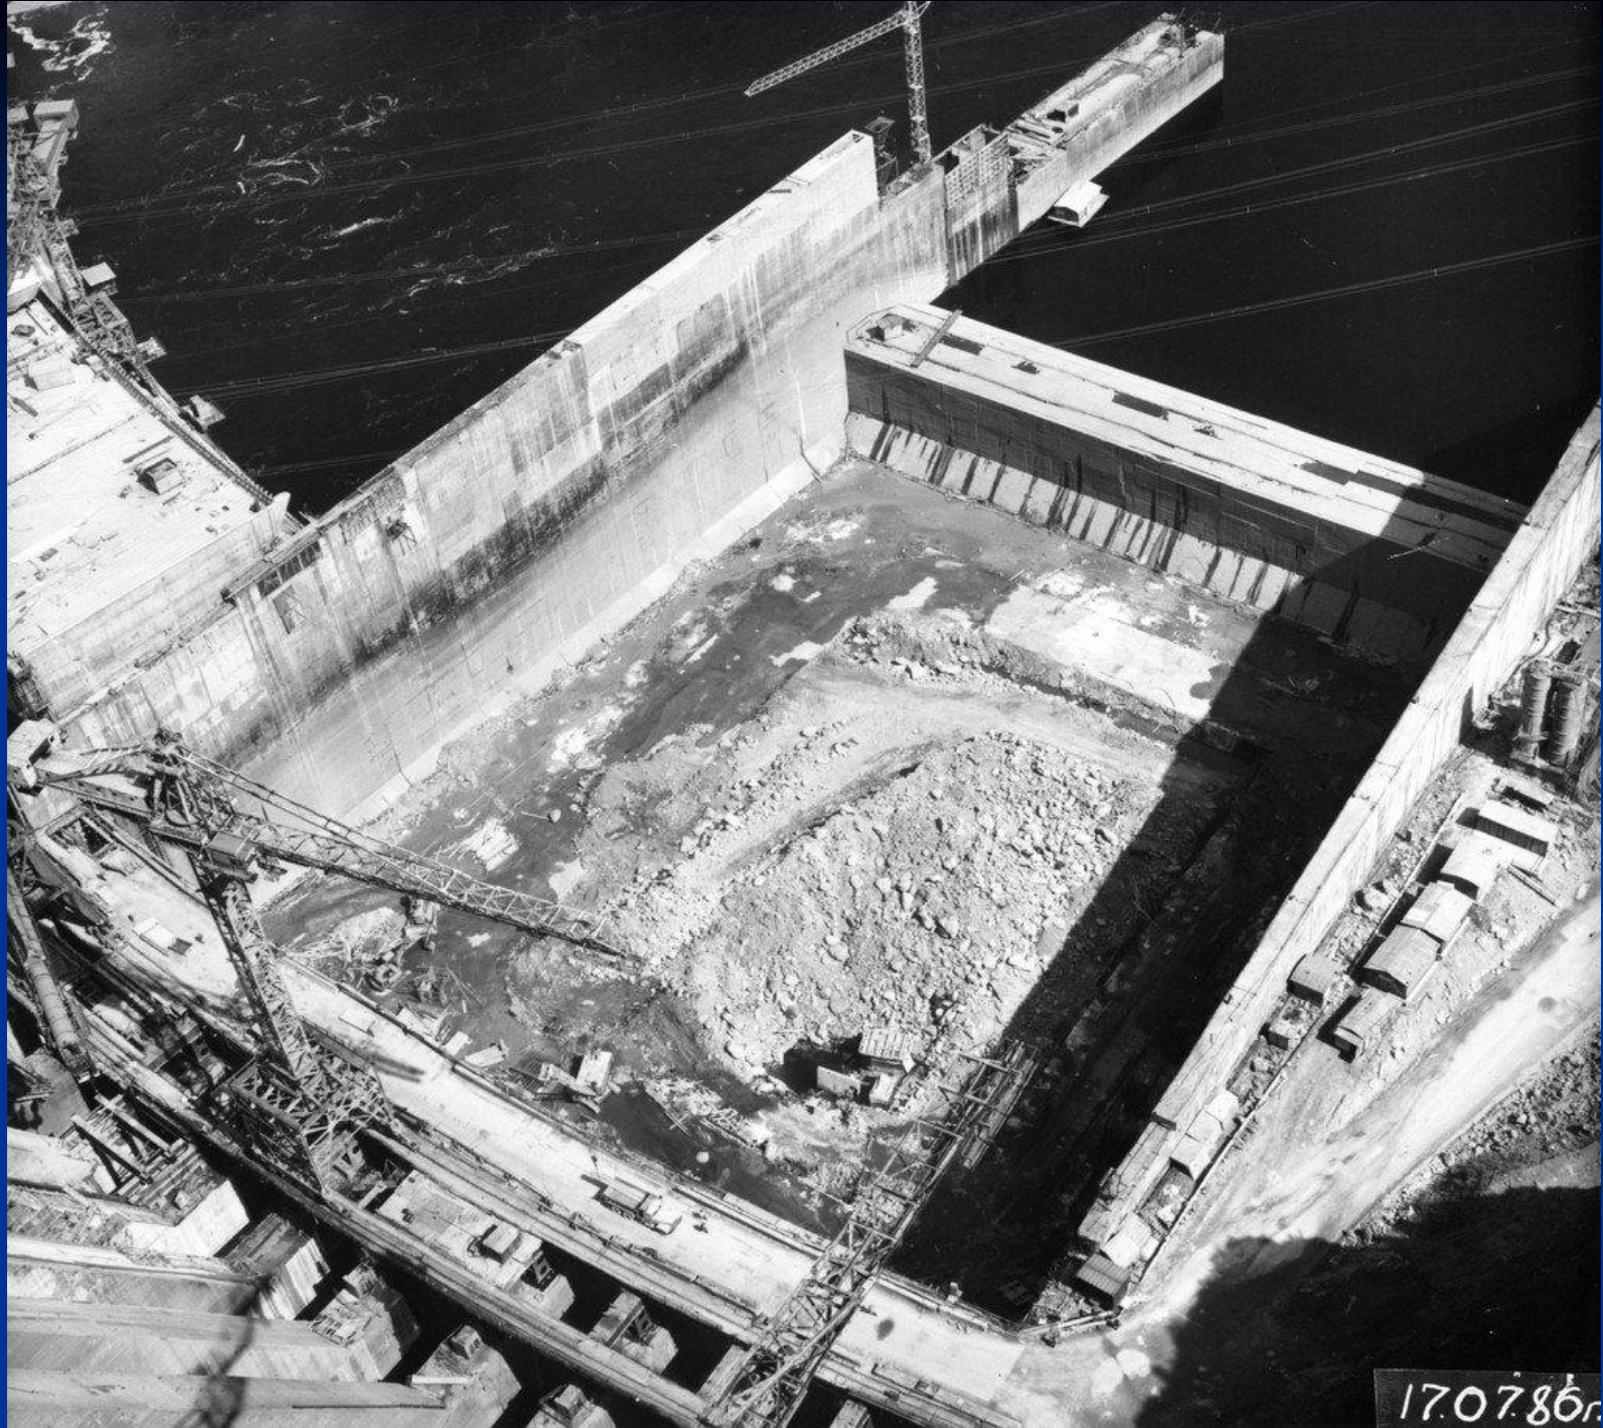
170786r

- A flood in 1985 resulted in a discharge of 4500 m³/s through the spillway
- The discharge resulted in destruction of the stilling basin bottom concrete
- Reportedly (from a source other than the official report) the spillway stilling basin also sustained damage in 1998
- An additional tunnel spillway was contemplated as early as 2000. The tunnel had been started but was not complete.
