Wanapum Dam Spillway Gate Trunnion Bearings

Nathan Manning
Grant County PUD

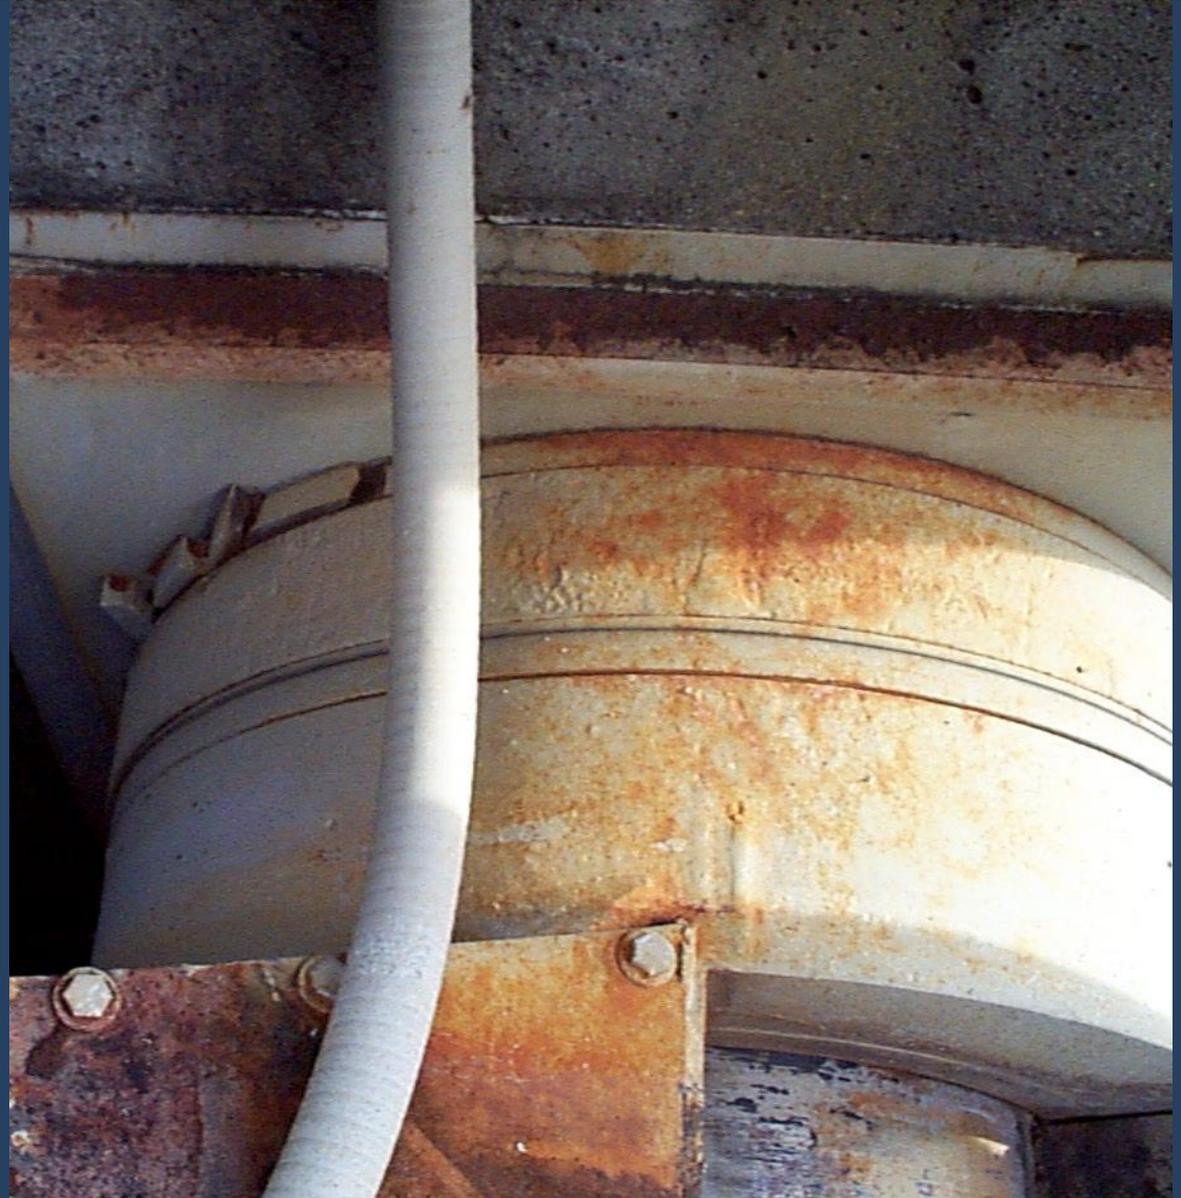
- 1999 FERC Part 12 Inspection
- Cracked / Crumbling Thrust Washers Observed at Priest Rapids
- Cracked Thrust Washer Observed at Wanapum
- Lab Analysis Determined Type C86100 Manganese Bronze
- Ammonia Induced Stress Corrosion Cracking

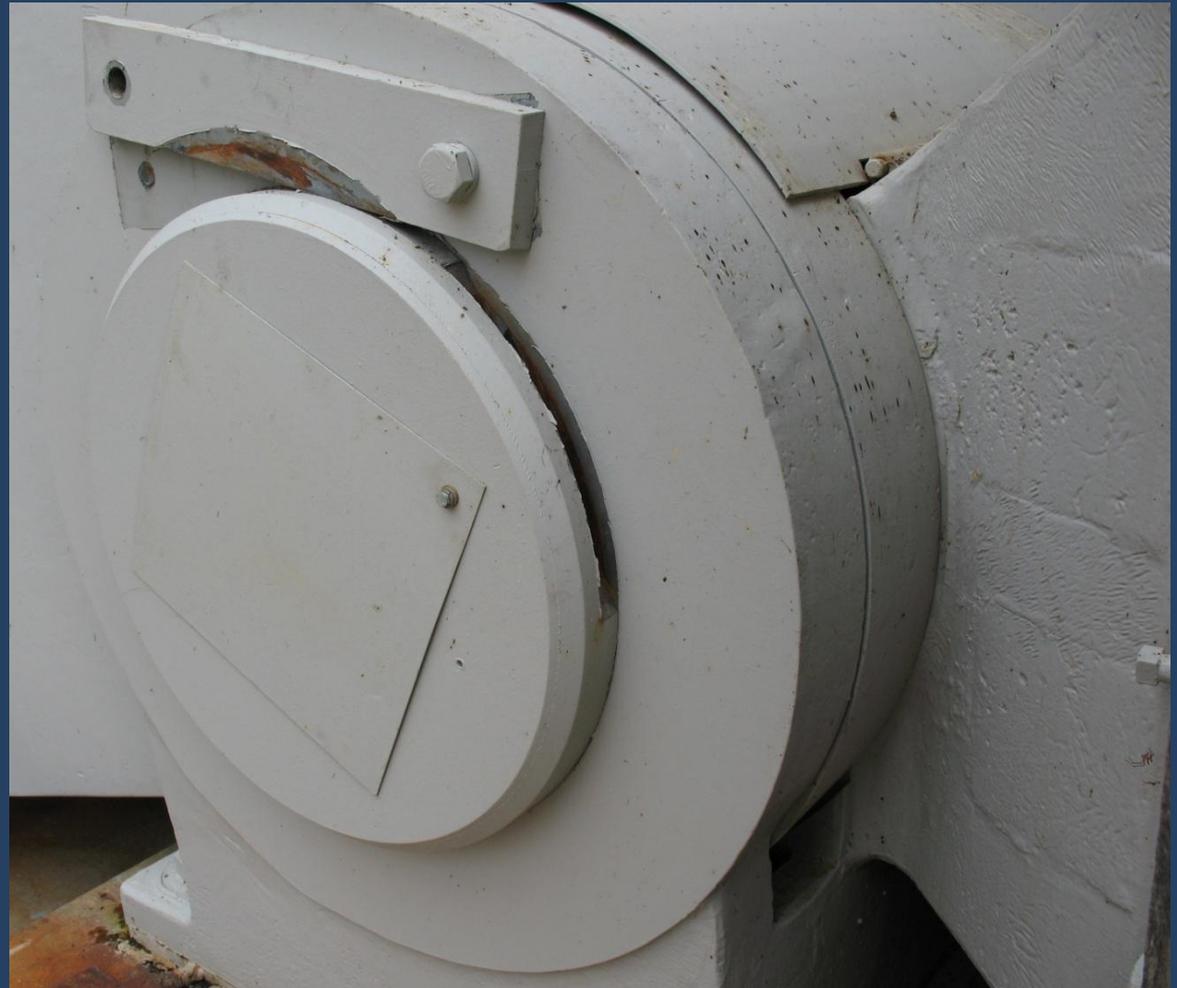
- Rotated Pins at Priest Rapids – Remedied with Stronger Keeper Plate Bolts
- Rotated Pins at Wanapum (11 of 24) – Doweled Pin to Prevent Future Rotation
- One Bearing Rotated Inside Housing
- Loose Tubular Support Bolts Possibly Due to Stretch
- Burn Type Wear Marks Observed on Some Pins

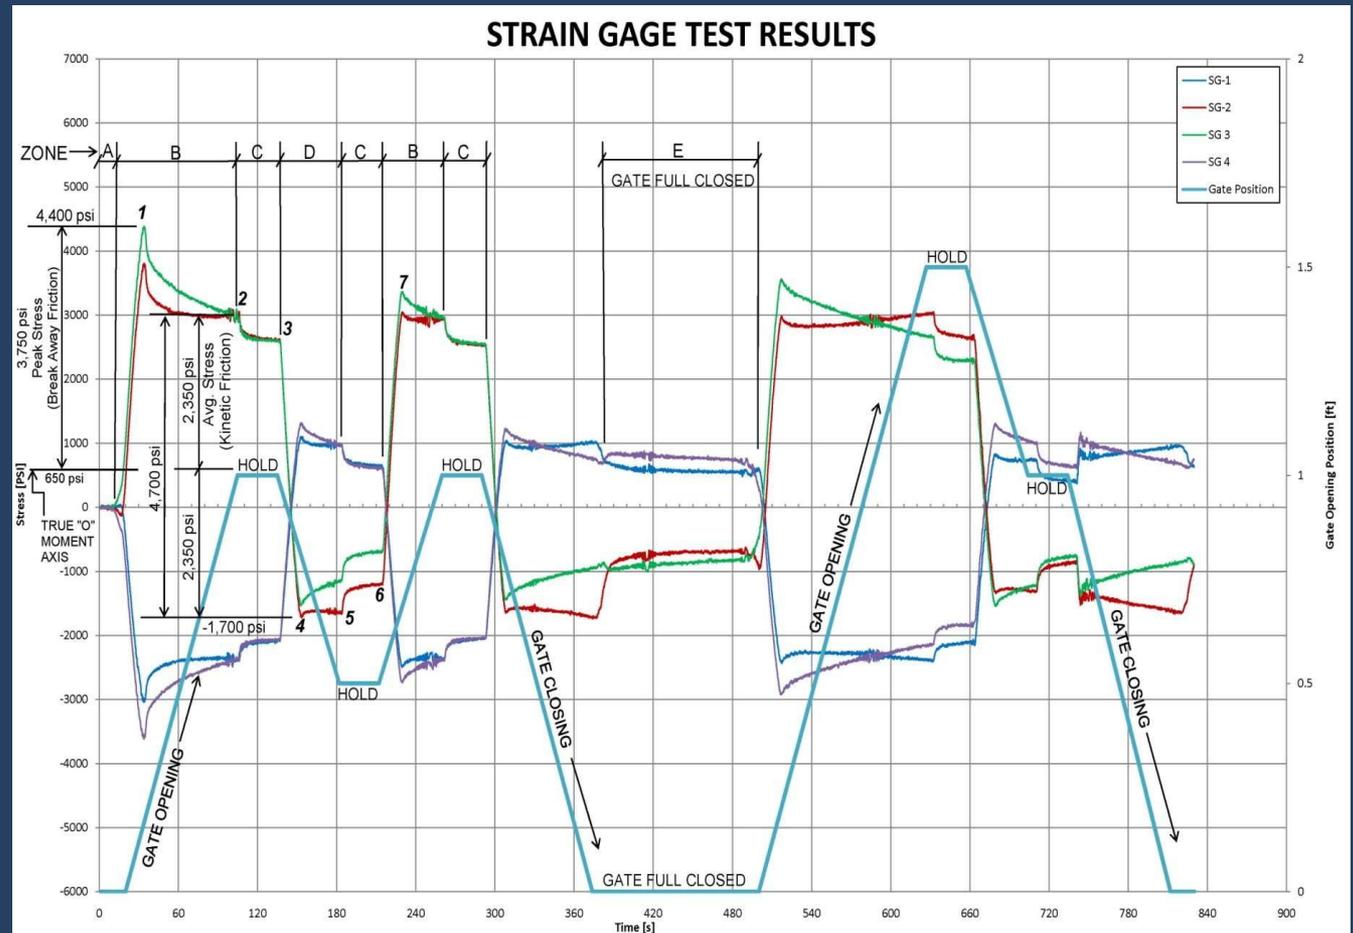
- TG-8 and TG-9, 2009 – 2011, Various Times of the Year, Various Trunnion Temperatures:
COF = 0.09 – 0.12
- TG-7, 2010 – 2012, First Set Installed, Chrome Plated Pin vs. Stainless Steel Sleeve: COF > 0.3
- TG-11, 2011 and 2012, Last Set Installed, Increased Clearance to Make up for Material Compression:
COF = 0.2

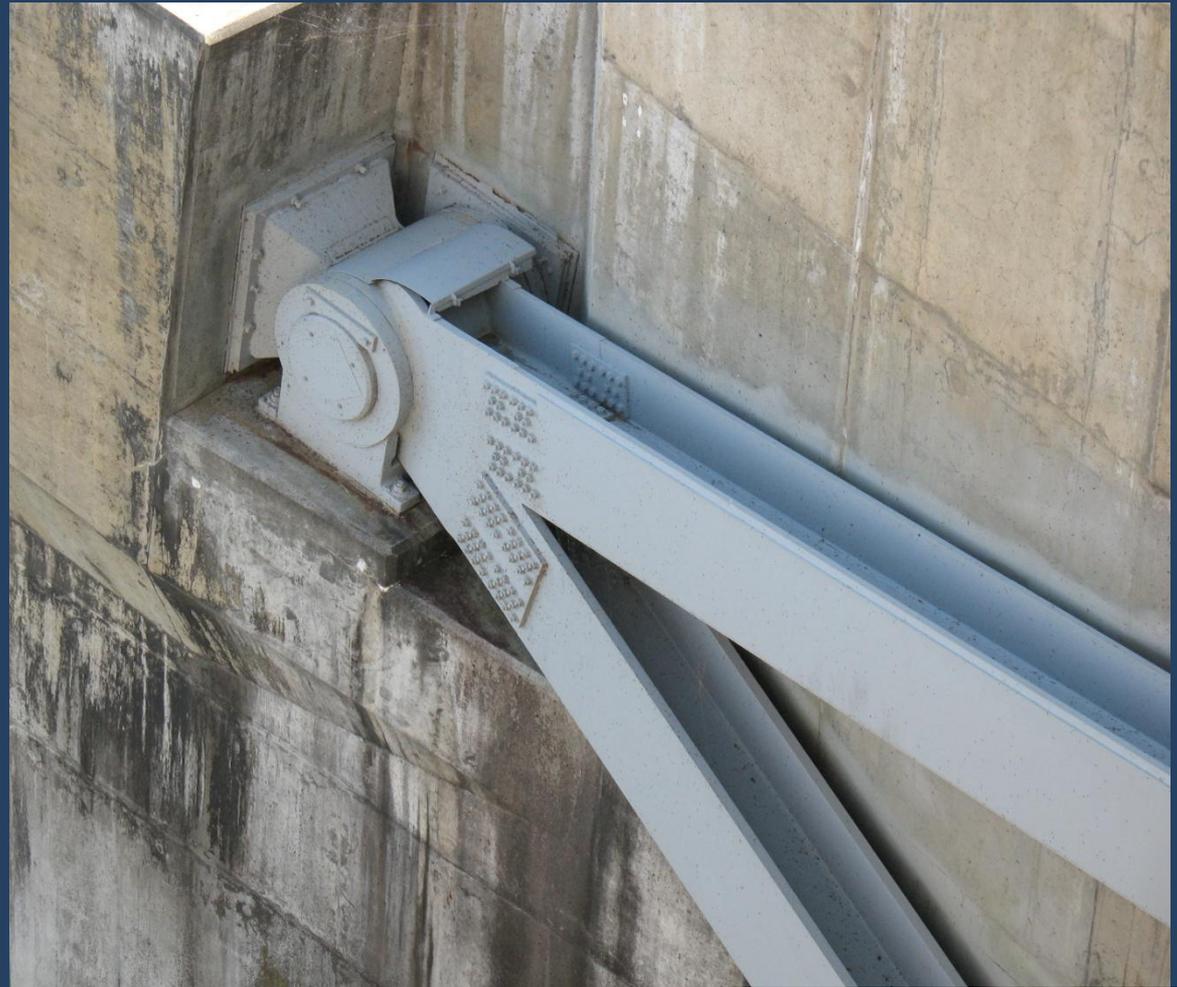
- Creep
- Temperature Related Material Expansion
- Material Compression - Increased Bearing Contact Angle
- Lack of Lubricant Transfer – No “Break in Period”
- Bearing Shape – Lack of Full Circle Support
- Speed of Rotation – Near Static vs. Dynamic
- Possible Increased Sensitivity to Trunnion Alignment
