# Howard A. Hanson Dam Seepage Issues, Risk Assessment and Repairs

Richard Smith, PG  
Seattle District  
U.S. Army Corps of Engineers  
May 2012

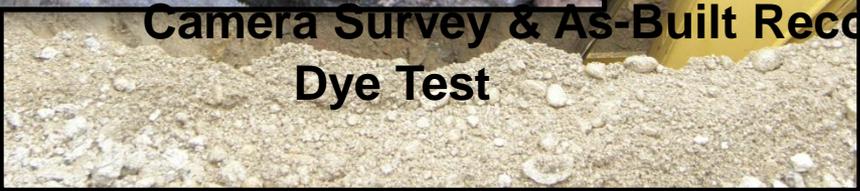
Camera Survey & As-Built Records  
Dye Test

No Hydraulic Connection  
Between Turbid Drain  
and Depression

Depression Caused by Collapse  
of 1950's Era Exploration Tunnel.

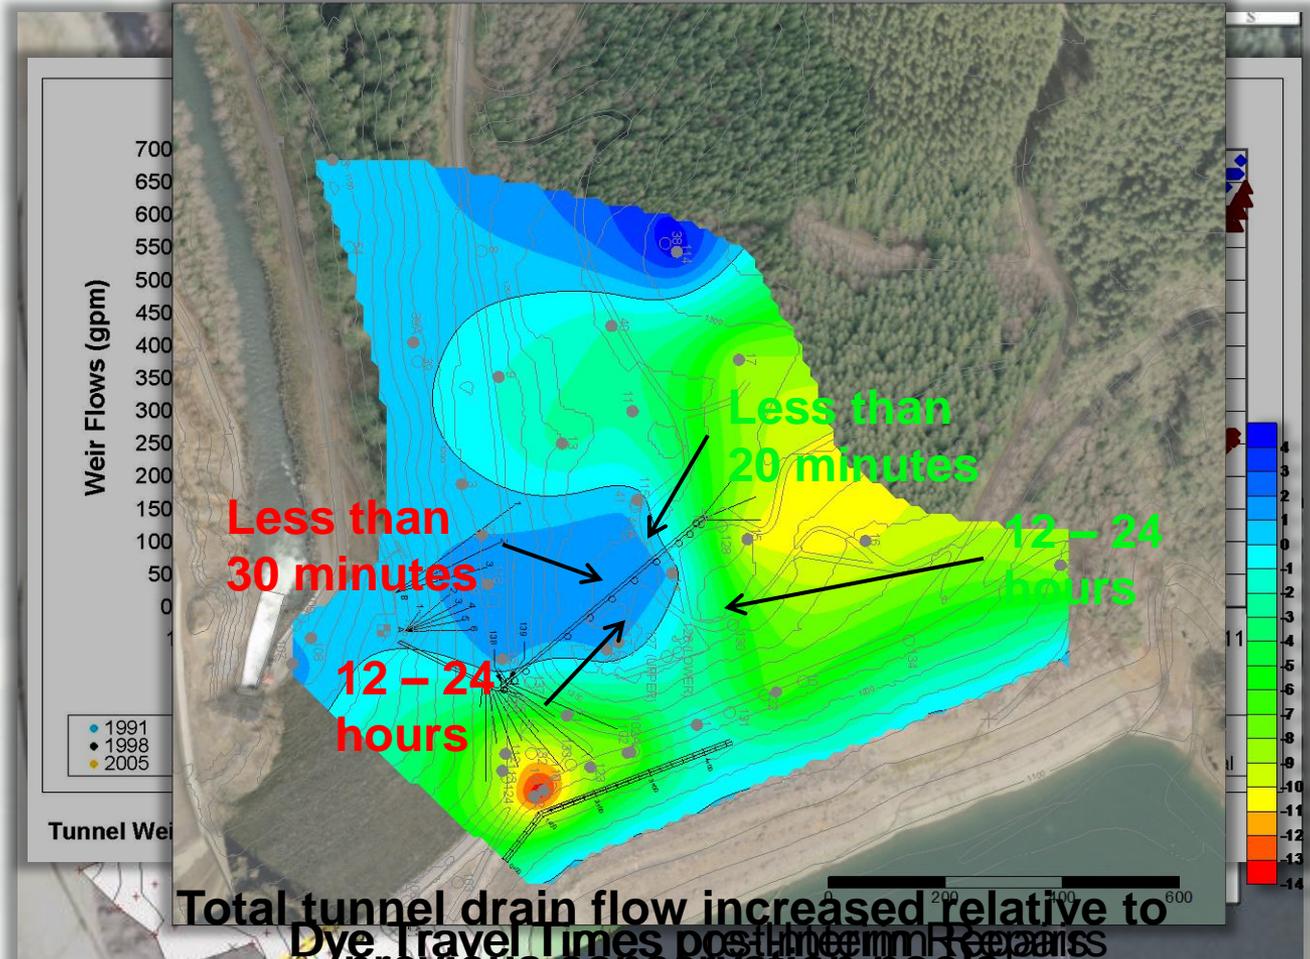
Reduced groundwater travel times

Preferential pathways lengthened

Increased tunnel drainage efficiency

Total tunnel drain flow increased relative to previous conservation pools.  
 Dye travel times positioned in areas  
 Water level regions (conservation pools).  
 Geophysical results indicate no preferential  
 conservation pool and 2010 conservation pool  
 pathways through new grout curtain.

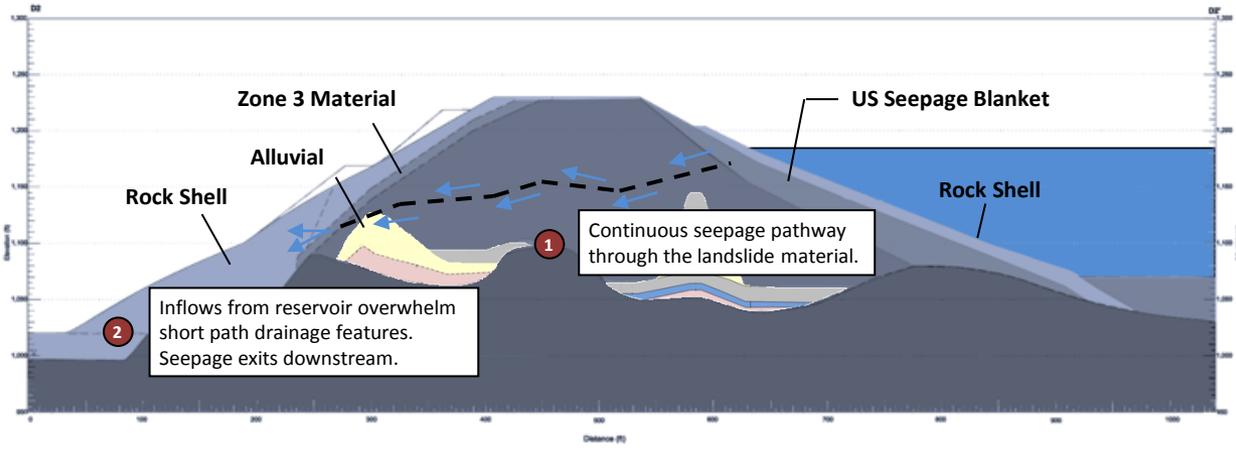
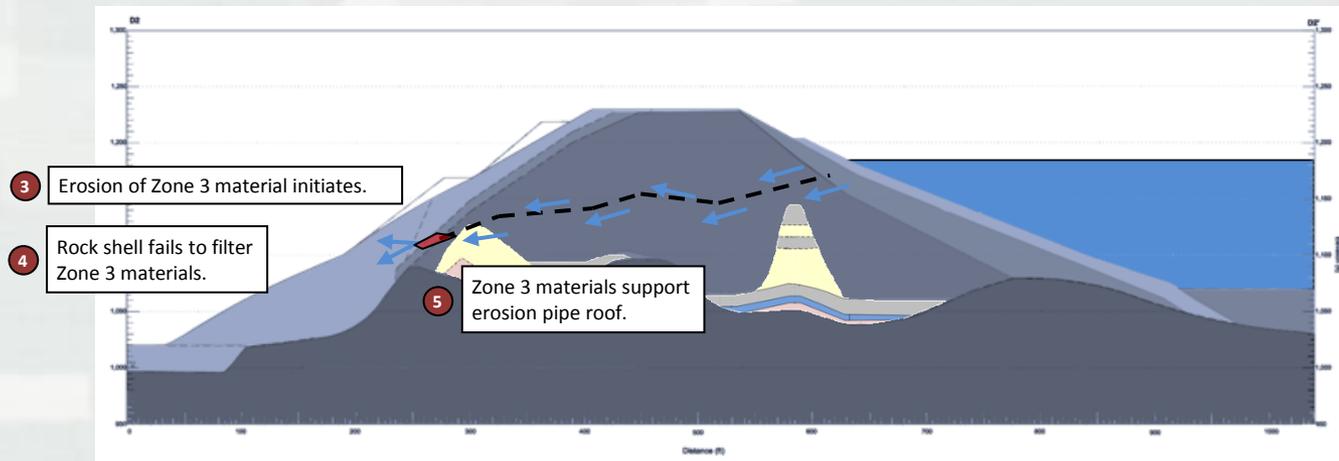
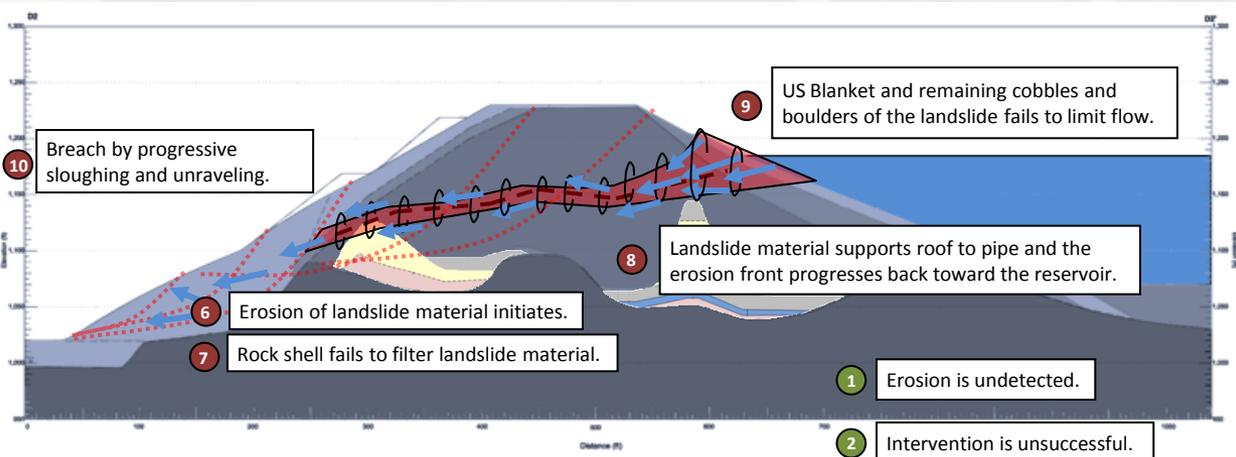
## Short Path Seepage

zone 3 material could erode into and through the rock shell. Seepage modeling suggests saturation of filter material. Gravel drain ends at edge of rolled rock fill then incompatible material under greater than design flood pool conditions. rock shell and rock toe in contact with zone 3 filter.
