Prepared By: AECOM

FINAL REPORT – October 2020

Bonneville Power Administration Marys Peak BPA Communications Site Project Scenic Resource Assessment

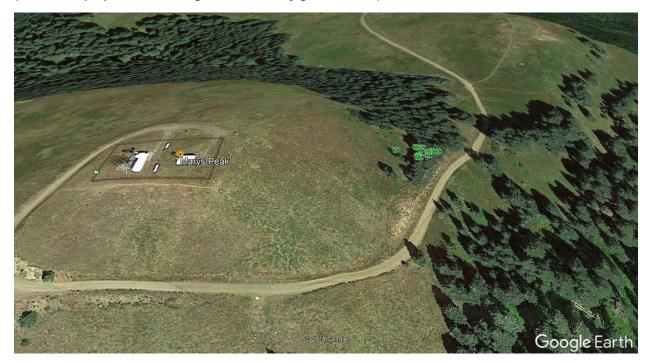
Figure 7-1. Proposed Tree Cutting Areas at Marys Peak, Alternatives 2A and 3C (Note: trees proposed for cutting are indicated by green circles.)

KVA 7 is located along the access road immediately west of the existing Marys Peak communications site at the top of Marys Peak. Views from this location are directed west across the West Point Spur communications site to the Pacific Ocean. Visual contrast of the proposed BPA lattice structure, associated components, and access road improvements on Marys Peak is expected to be Strong for views to the east. Viewer position is subordinate, contributing to the expected scale dominance of the structure. New surfacing on Marys Peak Road would appear bold, with the new gravel surface introducing Strong visual contrast against the soft texture of adjacent meadow grasses. This level of visual contrast is expected to be reduced over time as the new gravel weathers and surrounding vegetation along the road edge encroaches into the graveled areas. However, because the view to the west is focal, viewer attention is expected be directed west, away from Marys Peak. The tree cutting area would be visible from KVA 7, as tree cutting would occur adjacent to the roadway (Figure 7-1). Depending on how this action is performed, ground scarring could be apparent, with potential impacts to the integrity of the rock garden. Impacts from tree cutting are expected to be short term, as potential visual contrast from this action would decrease over time due to natural revegetation. Scenic integrity at Marys Peak would remain Very Low (for Marys Peak summit) and Low-Moderate for views directed west. There would be no deviation from the existing landscape character, and there would be no overall change.

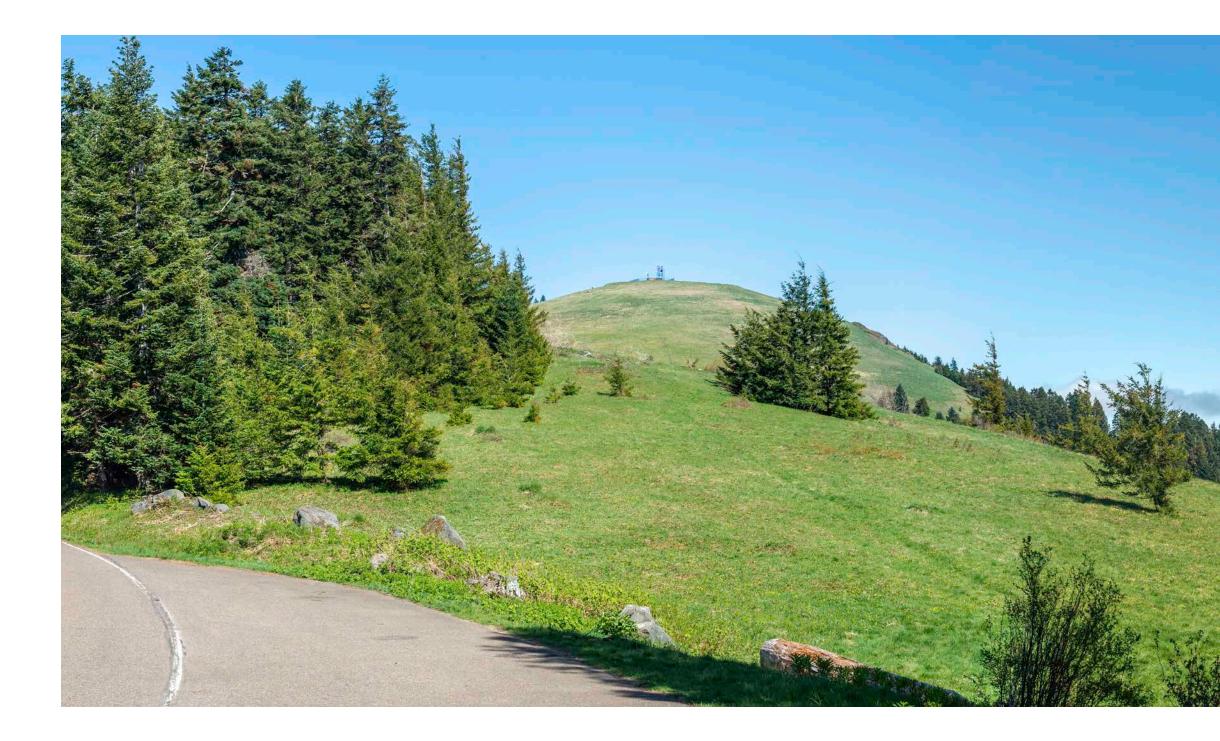
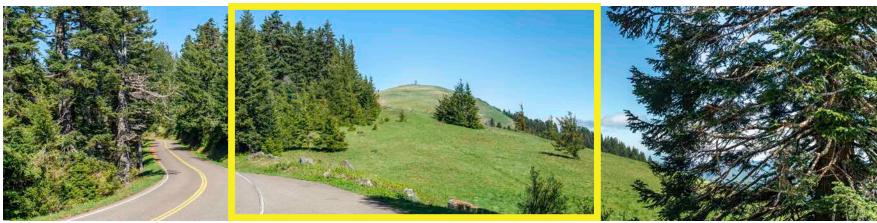
Time of photograph:	3:04 PM
Date of photograph:	5-17-18
Weather condition:	Clear
Viewing direction:	East
Latitude:	44°30'25.30"N
Longitude:	123°34'8.32"W

Alternative 2A Simulation Key Viewing Area 1 Marys Peak Road at Saddle Meadow Pullout

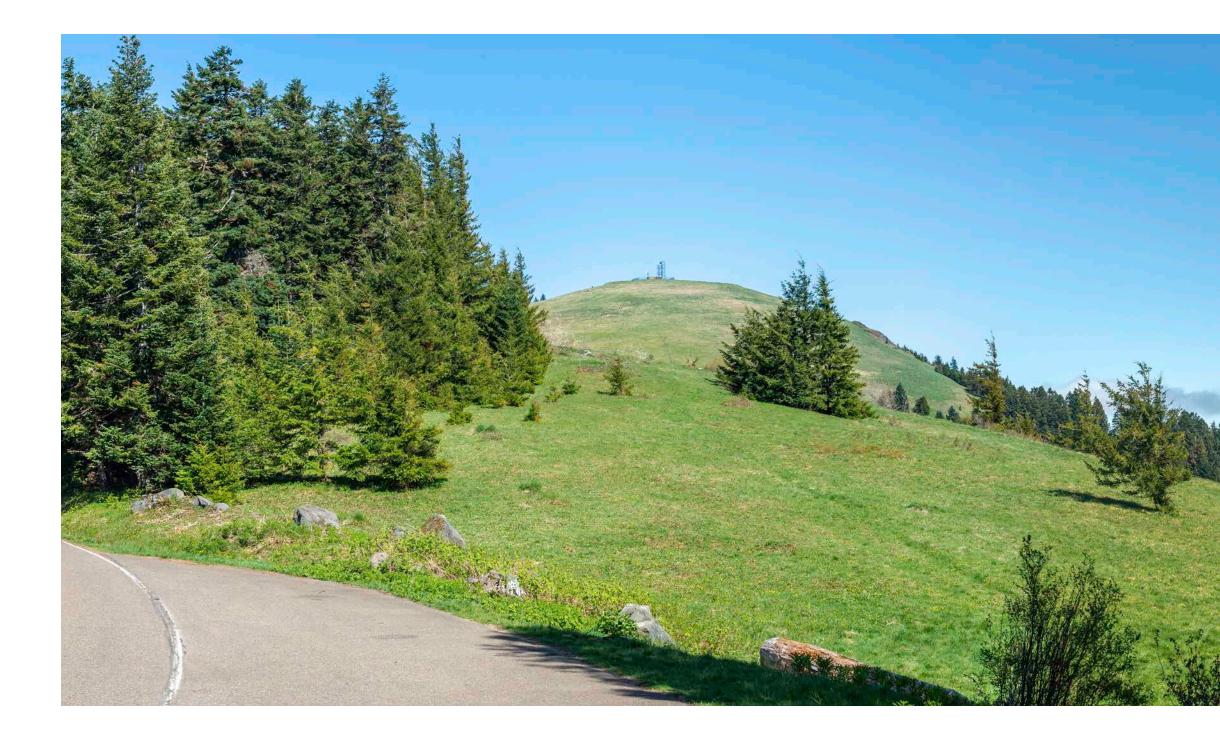
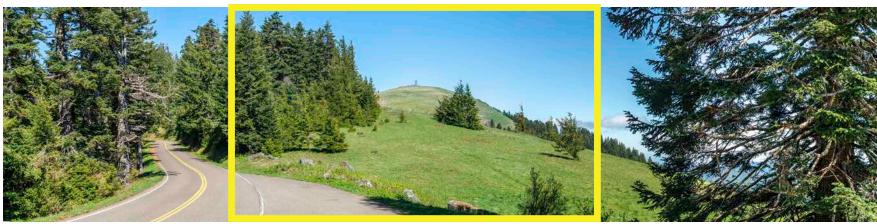
Time of photograph:	3:04 PM
Date of photograph:	5-17-18
Weather condition:	Clear
Viewing direction:	East
Latitude:	44°30'25.30"N
Longitude:	123°34'8.32"W

Alternative 3C Simulation Key Viewing Area 1 Marys Peak Road at Saddle Meadow Pullout

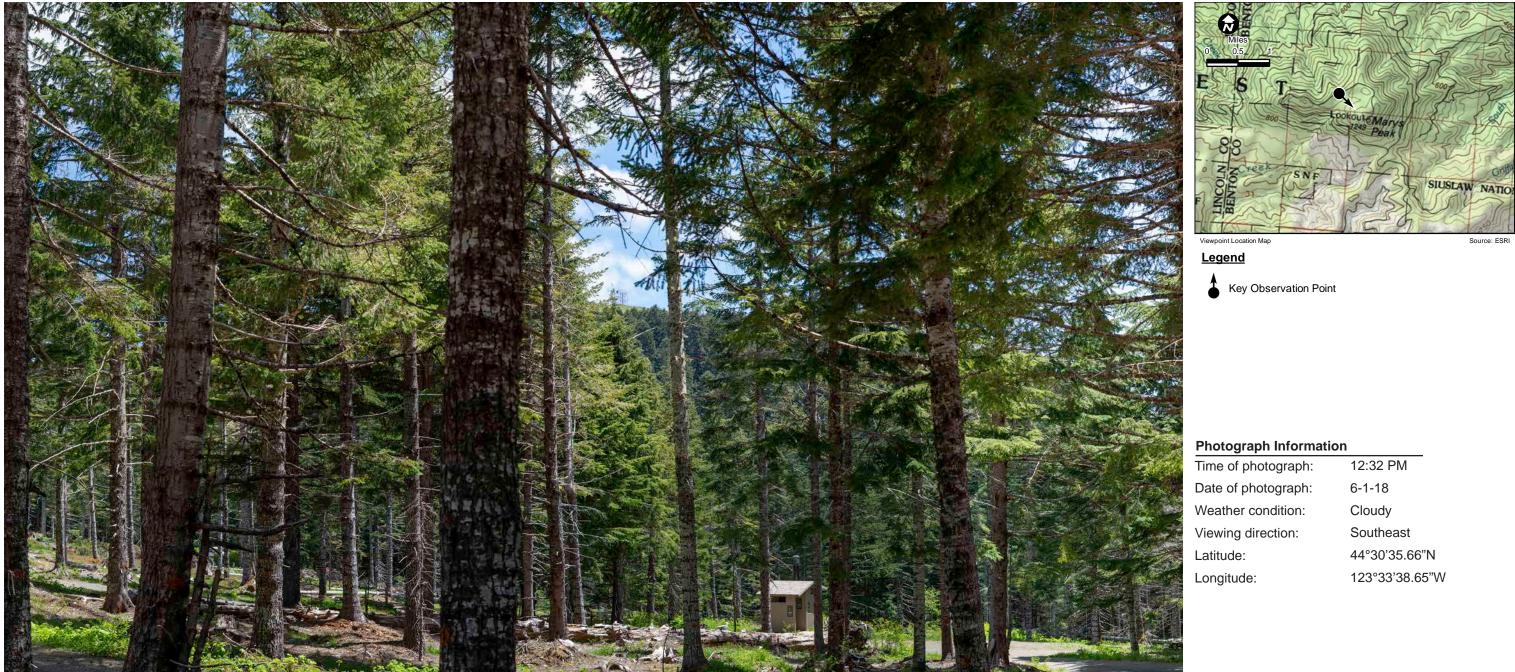
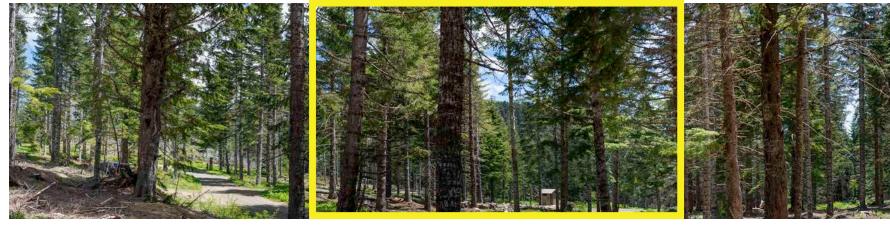
Time of photograph:	12:32 PM
Date of photograph:	6-1-18
Weather condition:	Cloudy
Viewing direction:	Southeast
Latitude:	44°30'35.6
Longitude:	123°33'38.

Alternative 3C Simulation Key Viewing Area 2 Marys Peak Campground (Site Number 2)

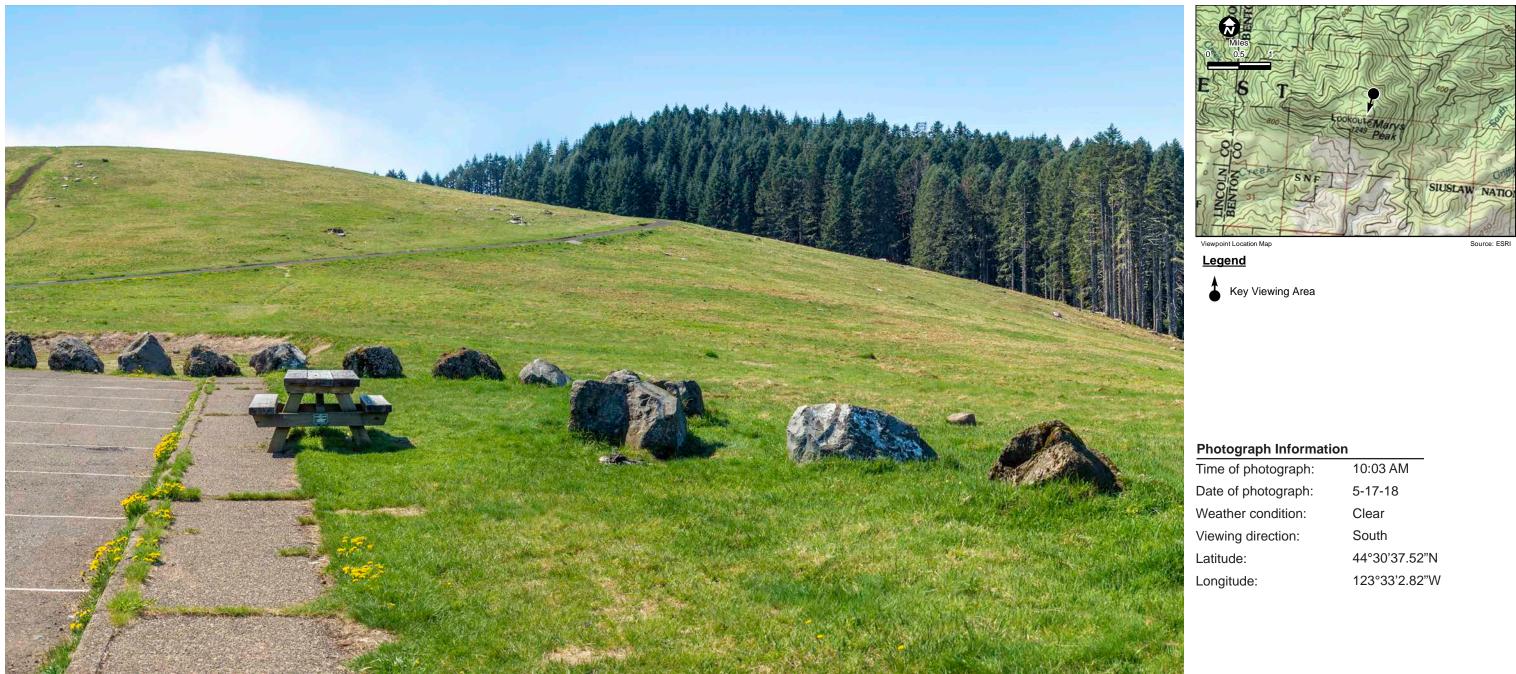
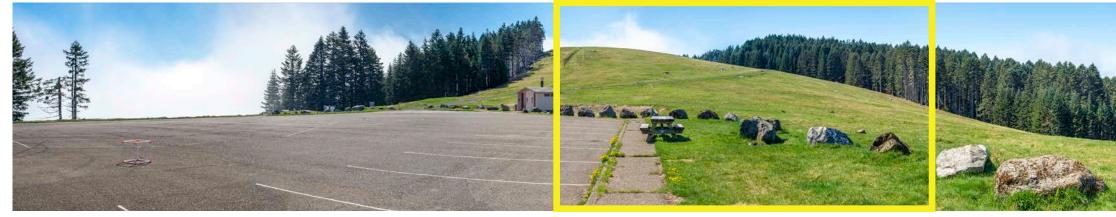
Time of photograph:	10:03 AM
Date of photograph:	5-17-18
Weather condition:	Clear
Viewing direction:	South
Latitude:	44°30'37.52"N
Longitude:	123°33'2.82"W

Alternative 2A Simulation Key Viewing Area 3 Parking Area at Marys Peak Road

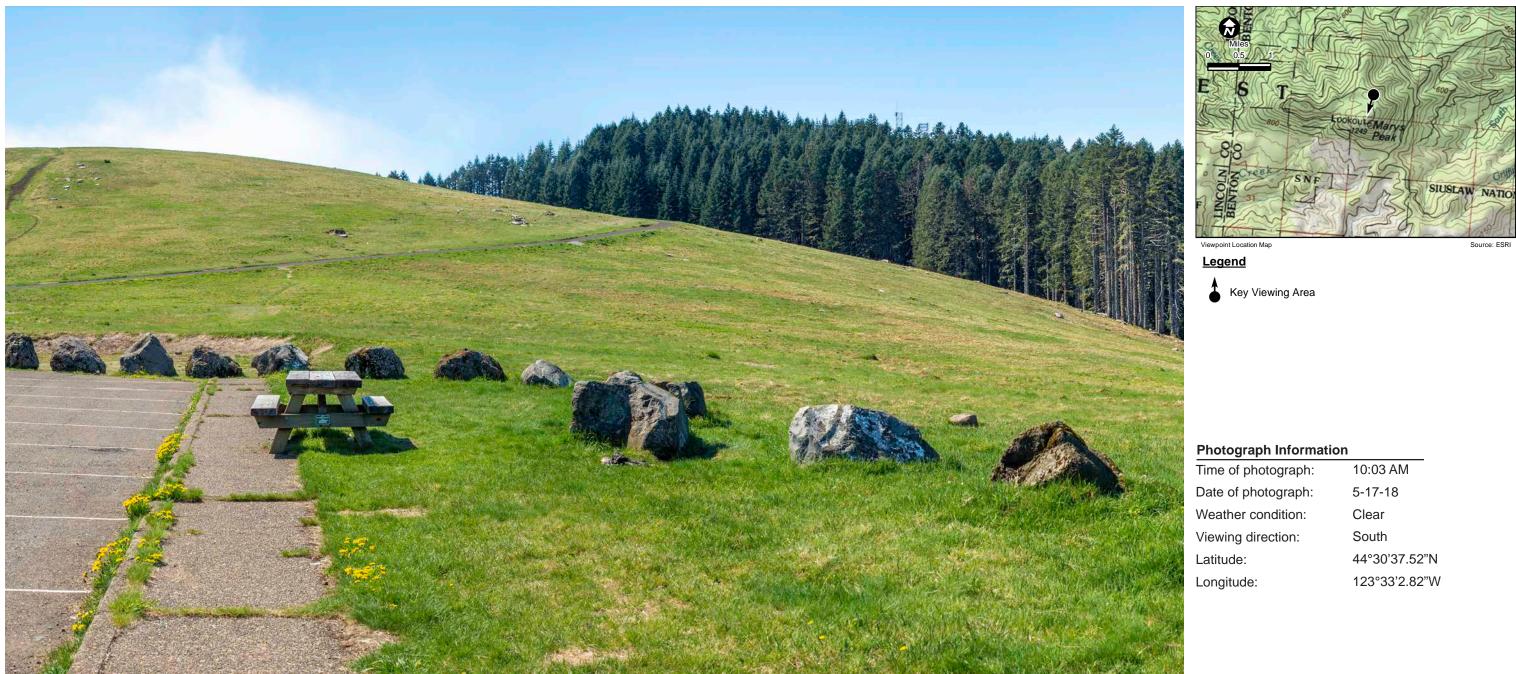
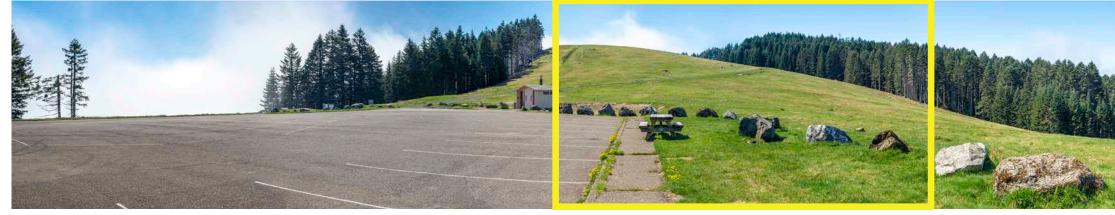
Time of photograph:	10:03 AM
Date of photograph:	5-17-18
Weather condition:	Clear
Viewing direction:	South
Latitude:	44°30'37.52"N
Longitude:	123°33'2.82"W

Alternative 3C Simulation Key Viewing Area 3 Parking Area at Marys Peak Road

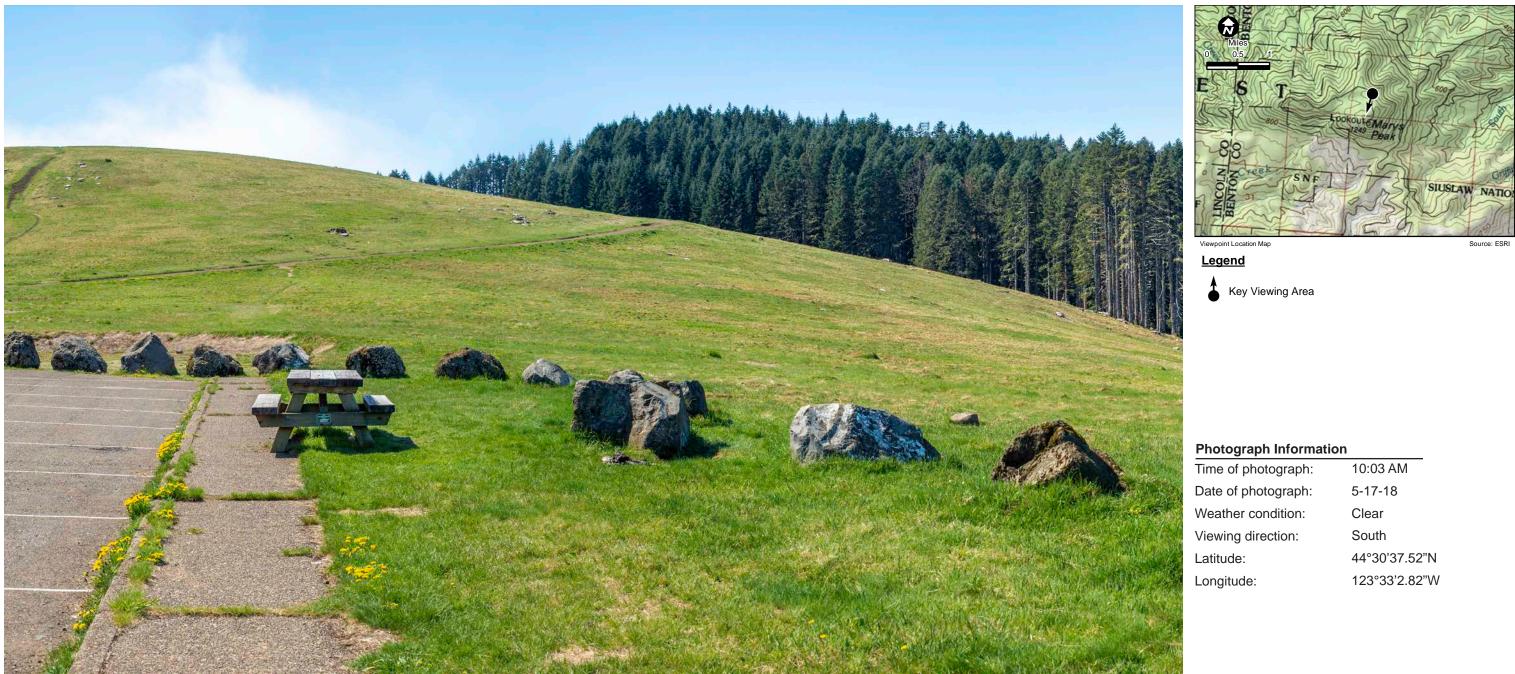
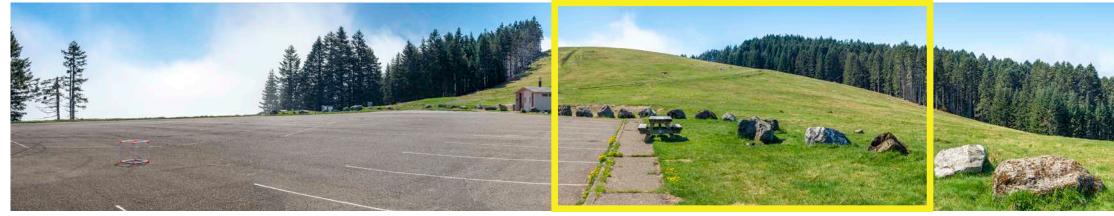
Time of photograph:	10:03 AM
Date of photograph:	5-17-18
Weather condition:	Clear
Viewing direction:	South
Latitude:	44°30'37.52"N
Longitude:	123°33'2.82"W

Alternative 4 Simulaton Key Viewing Area 3 Parking Area at Marys Peak Road

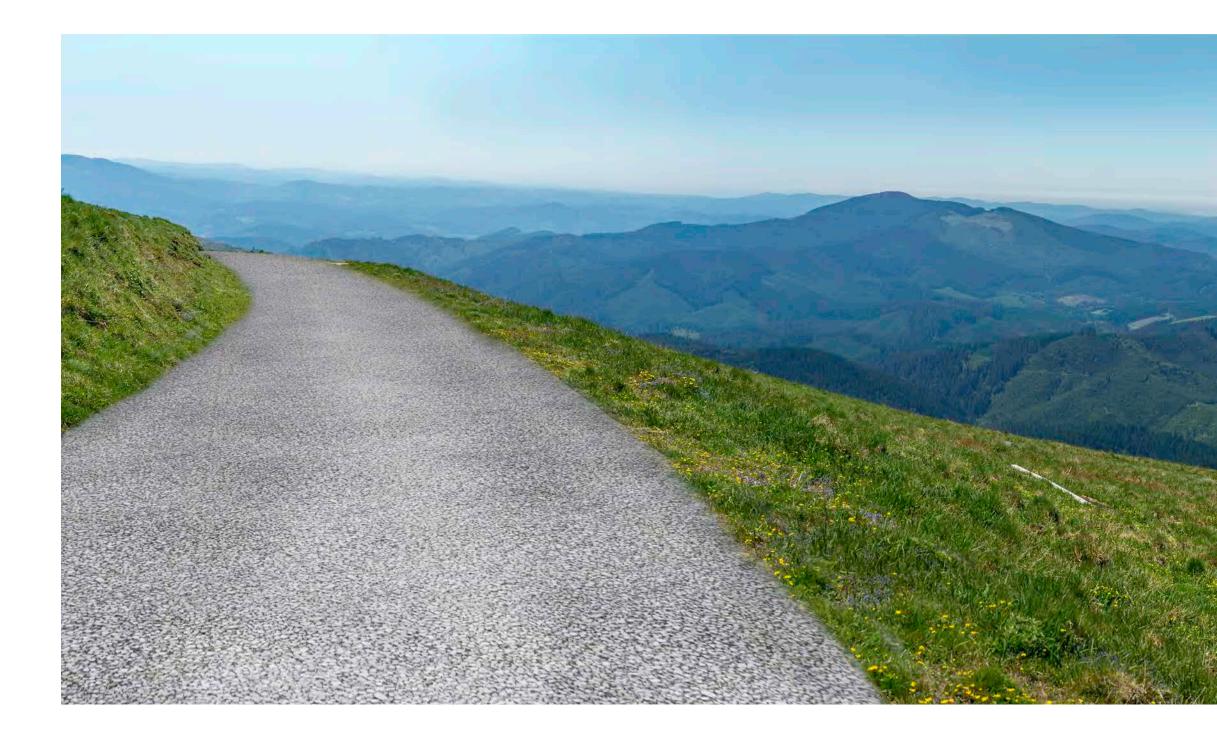
Alternative 4 Simulaton Key Viewing Area 7 Marys Peak Access Road (View Directed West)

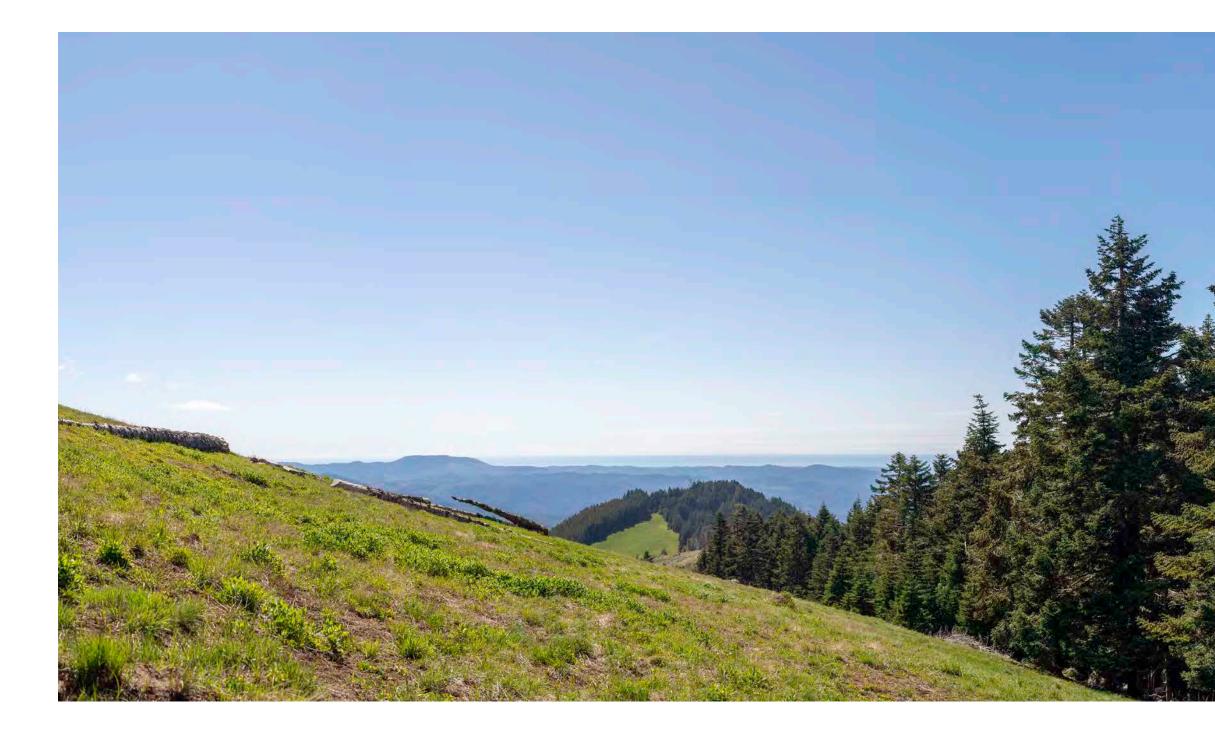
Simulation of Road Key Viewing Area 7 Marys Peak Access Road (View Directed South)

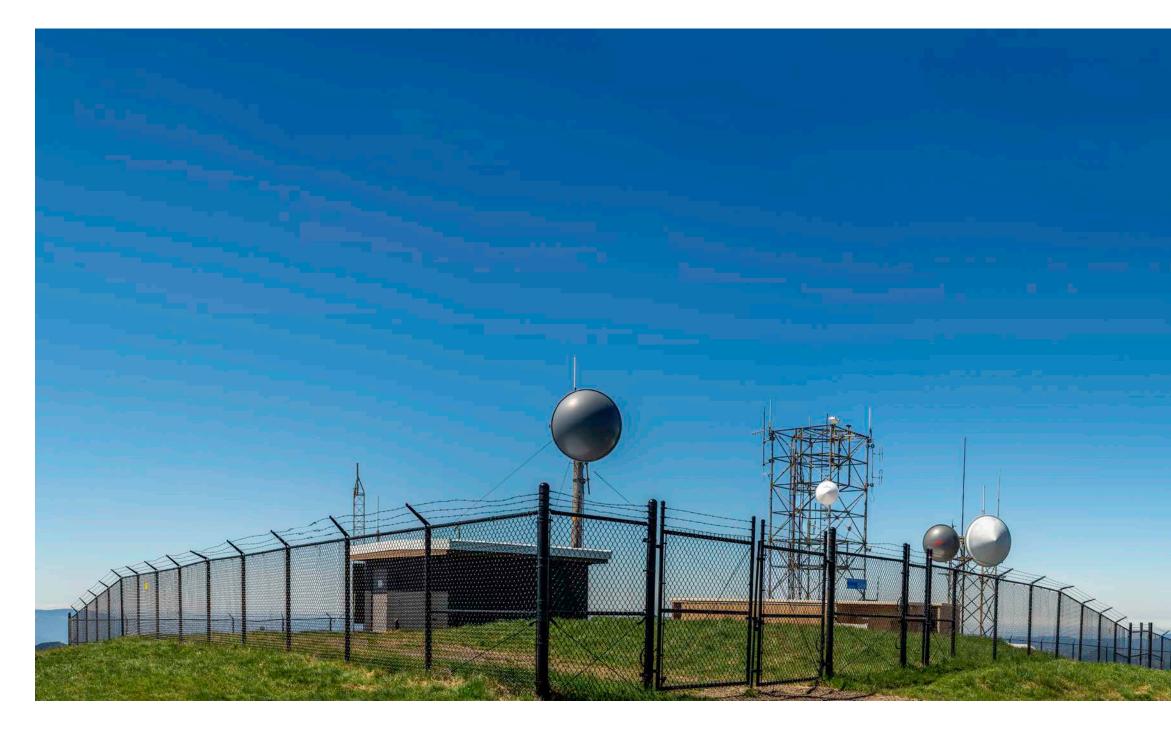
Alternative 4 Simulation Key Viewing Area 8 Meadowedge Trail (Lower Portion)

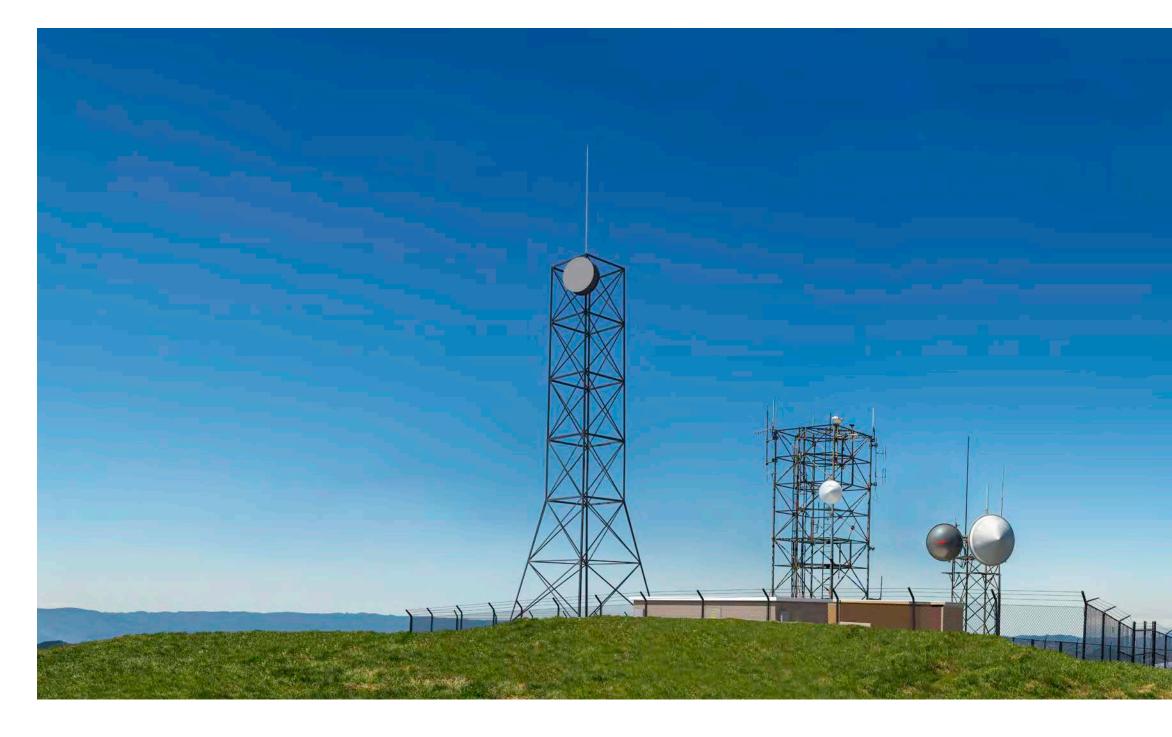
Alternative 2A Simulation Key Viewing Area 9 Marys Peak Summit (Picnic Table)

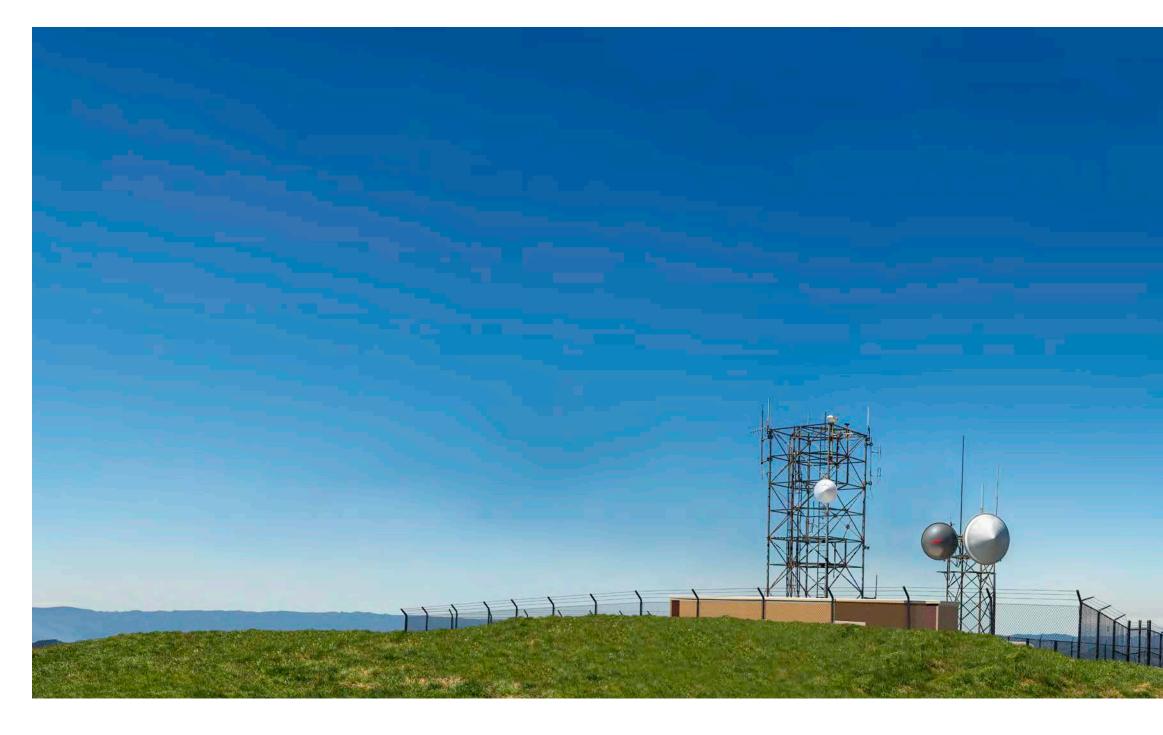
Alternative 3C Simulation Key Viewing Area 9 Marys Peak Summit (Picnic Table)

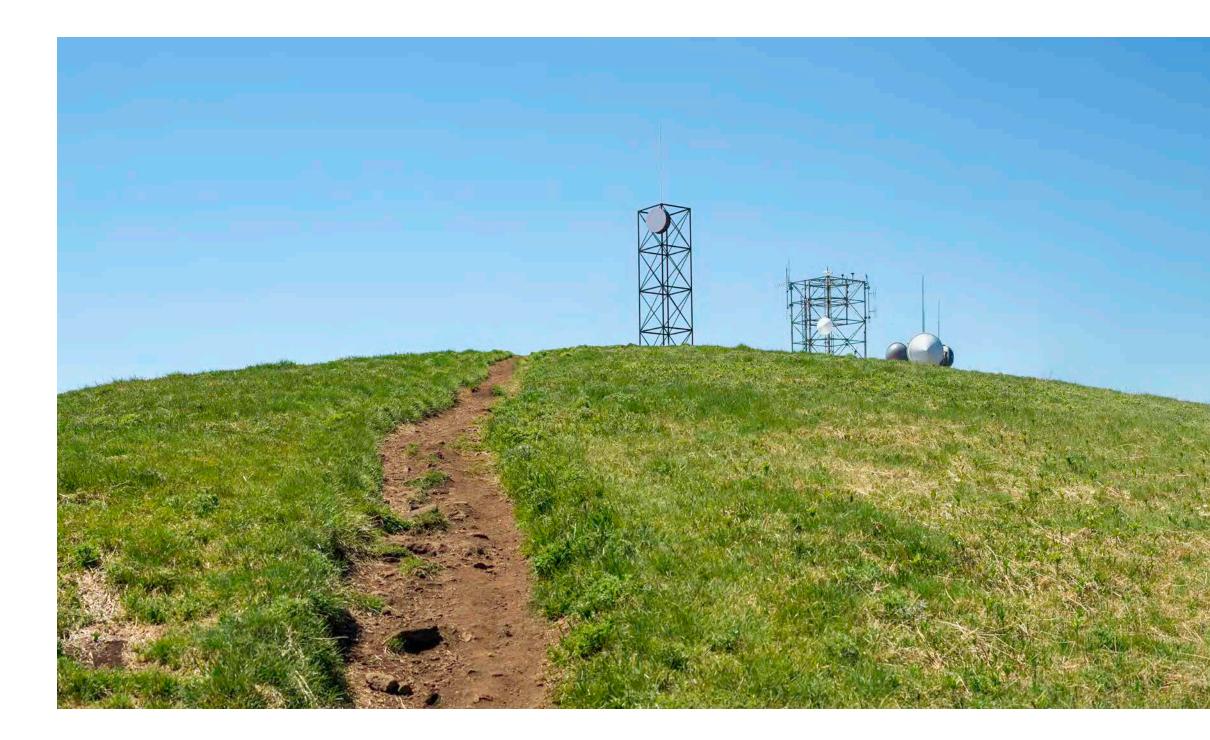
Alternative 2A Simulation Key Viewing Area 12 Marys Peak Summit and Meadowedge Trail Intersection

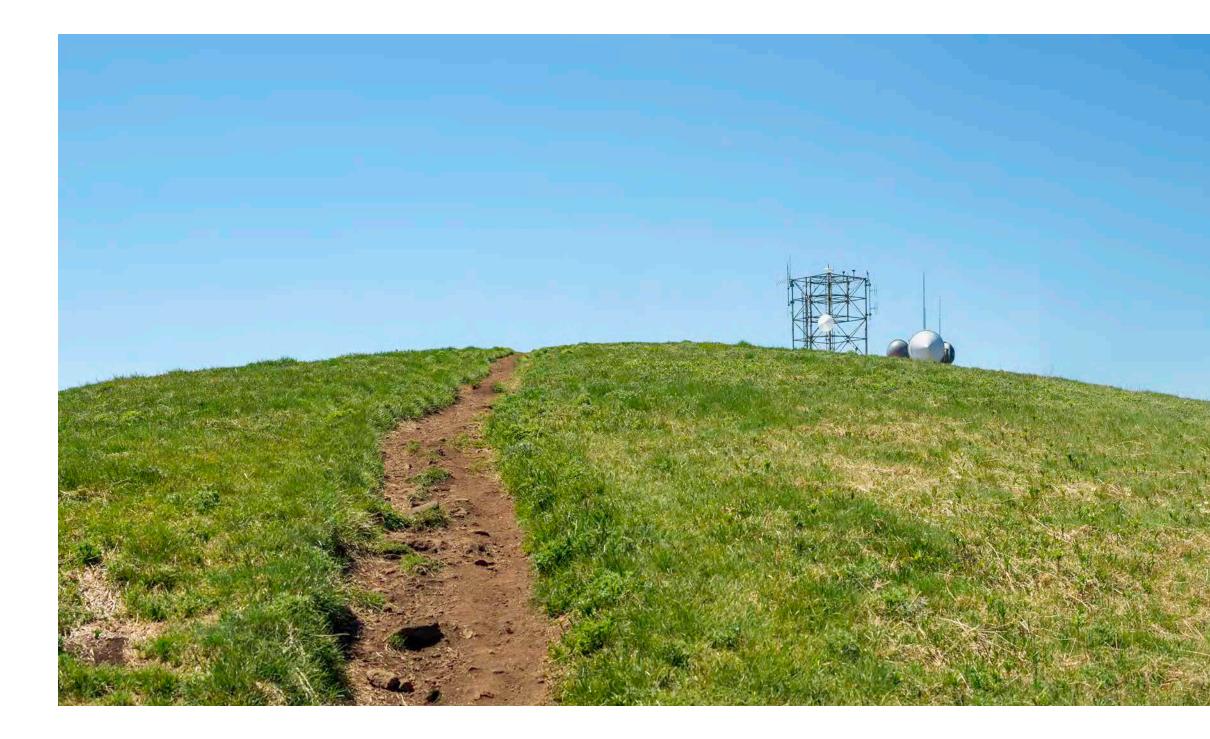
Alternative 3C Simulation Key Viewing Area 12 Marys Peak Summit and Meadowedge Trail Intersection

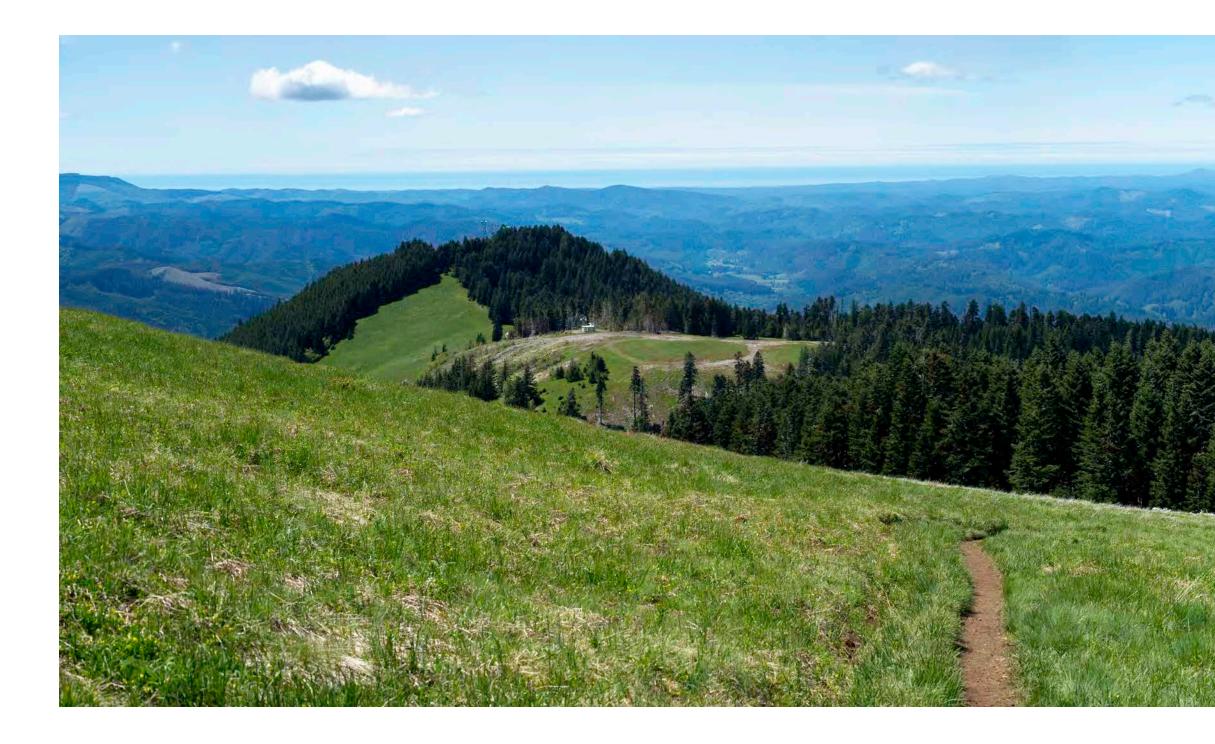
Alternative 4 Simulation Key Viewing Area 12 Marys Peak Summit and Meadowedge Trail Intersection
