Transmission Asset Management Strategy

Sustain Program: Lines – Wood Pole

Rob Ochs, Program Manager
April 19, 2010

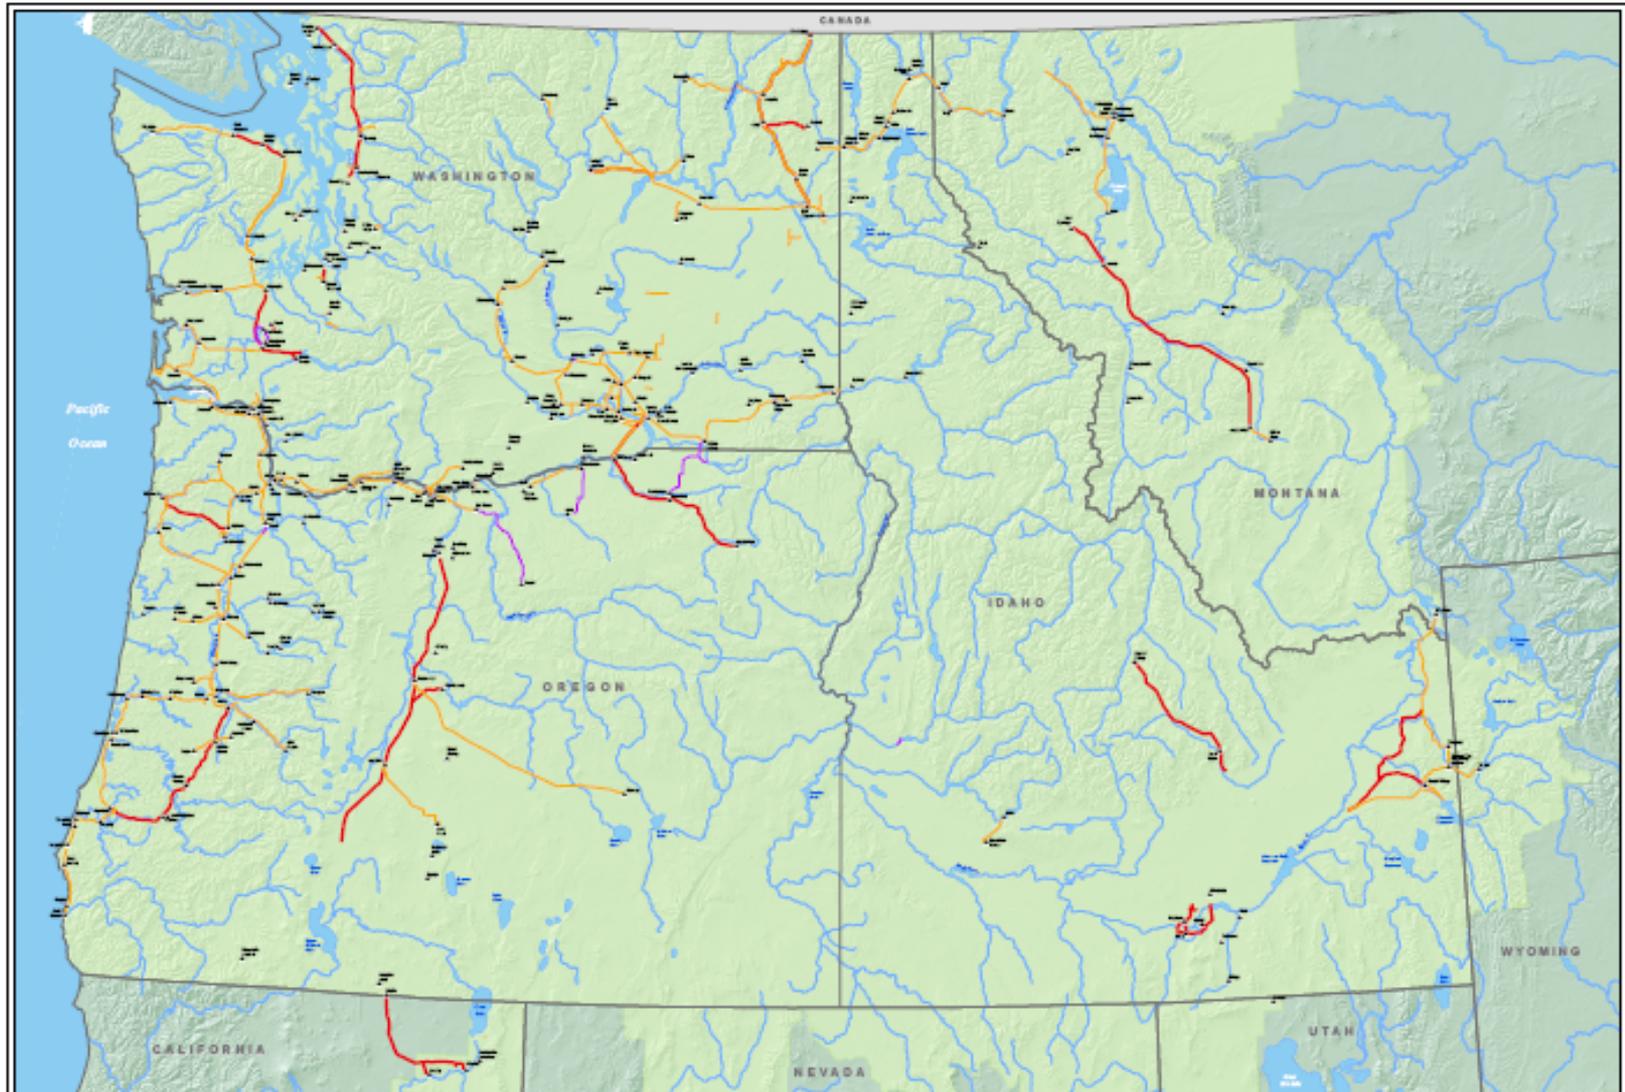
BPA Wood Pole Transmission Lines

- Wood Pole Lines by Voltage
- 12.5 - 69 kV
 - 115 to less than 230 kV
 - 230 kV
- ▲ BPA Substation
■ BPA Service Area Boundary

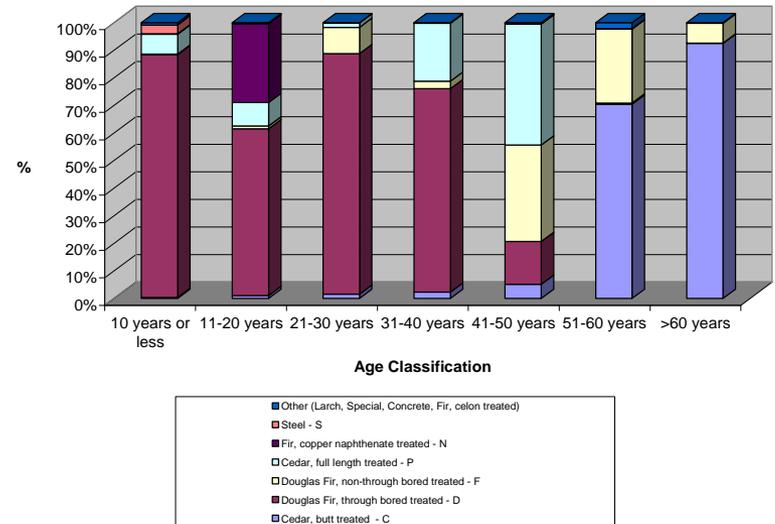
% Pole Type by Age Classification

- Approximately 75,000 wood poles on 4,775 miles of wood pole transmission lines
- Expected service life of 60 years
- 8% of wood poles exceed 60 years of age (over 6,000 poles)
- Older poles tend to be butt treated cedar
- Pole strength and capability declines with age
- Loss of 1/3 of original strength = need to replace pole-no longer meets standards

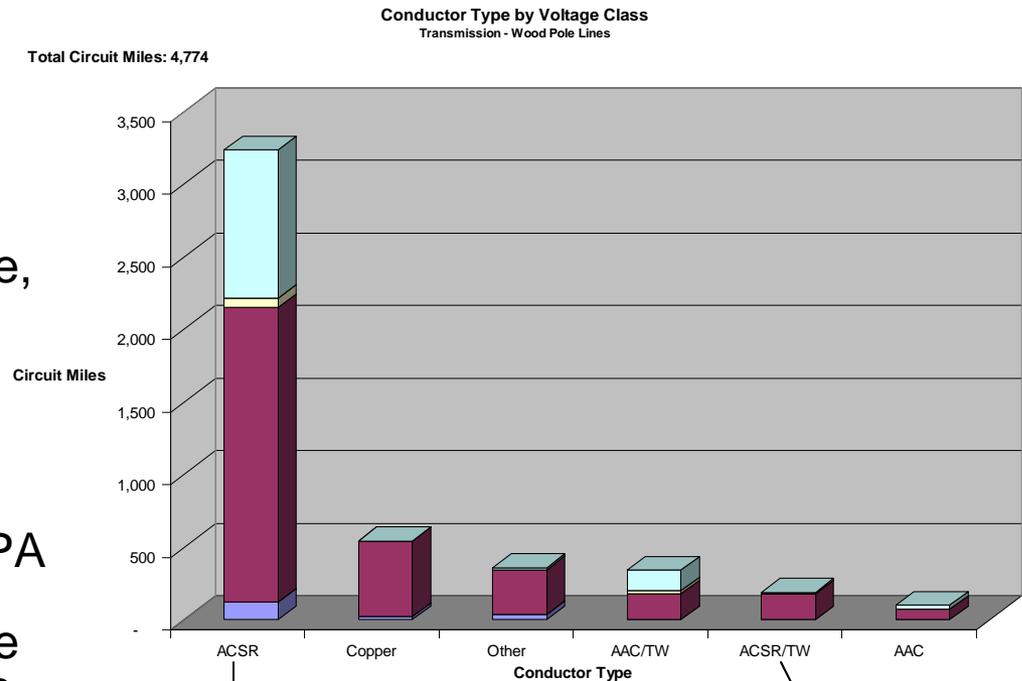
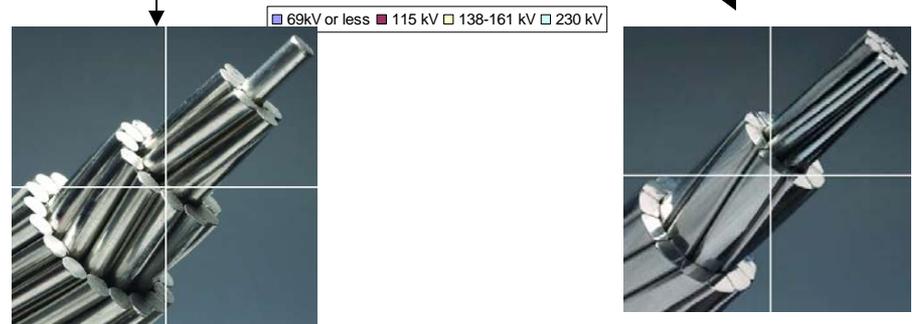
Conductor condition assessment

- For all transmission lines, we know the type and vintage of conductor, but lack adequate condition assessments.
- Information on other line equipment including hardware, insulators, guying and counterpoise is also lacking and antidotal at best.
- Various retired line components need to be collected and tested in the BPA lab to identify component issues and establish base-line and benchmarking data. This data will be made available through TAS for easy access for adjusting the future pace and priority of line rebuild activity.

Note: Aging Overhead Transmission Asset: Condition and Risk Assessment study completed in December 2007 provides a preliminary health assessment of conductor on pages 58-64.

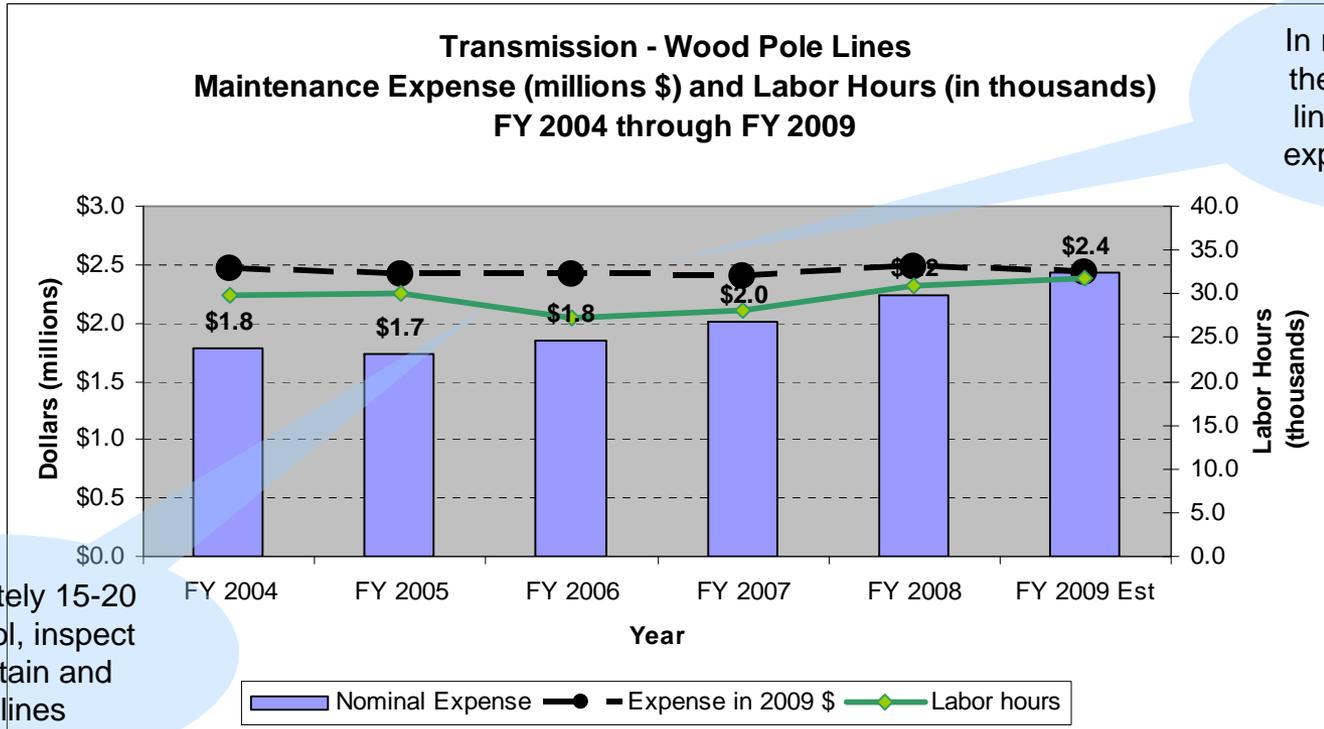
Historic Inspection and Maintenance Expense

- Annual maintenance costs for 4775 miles of transmission line – FY 2004 through FY 2009

In real terms, over the past six years line maintenance expense has been relatively flat

Approximately 15-20 BFTE patrol, inspect and maintain and these lines

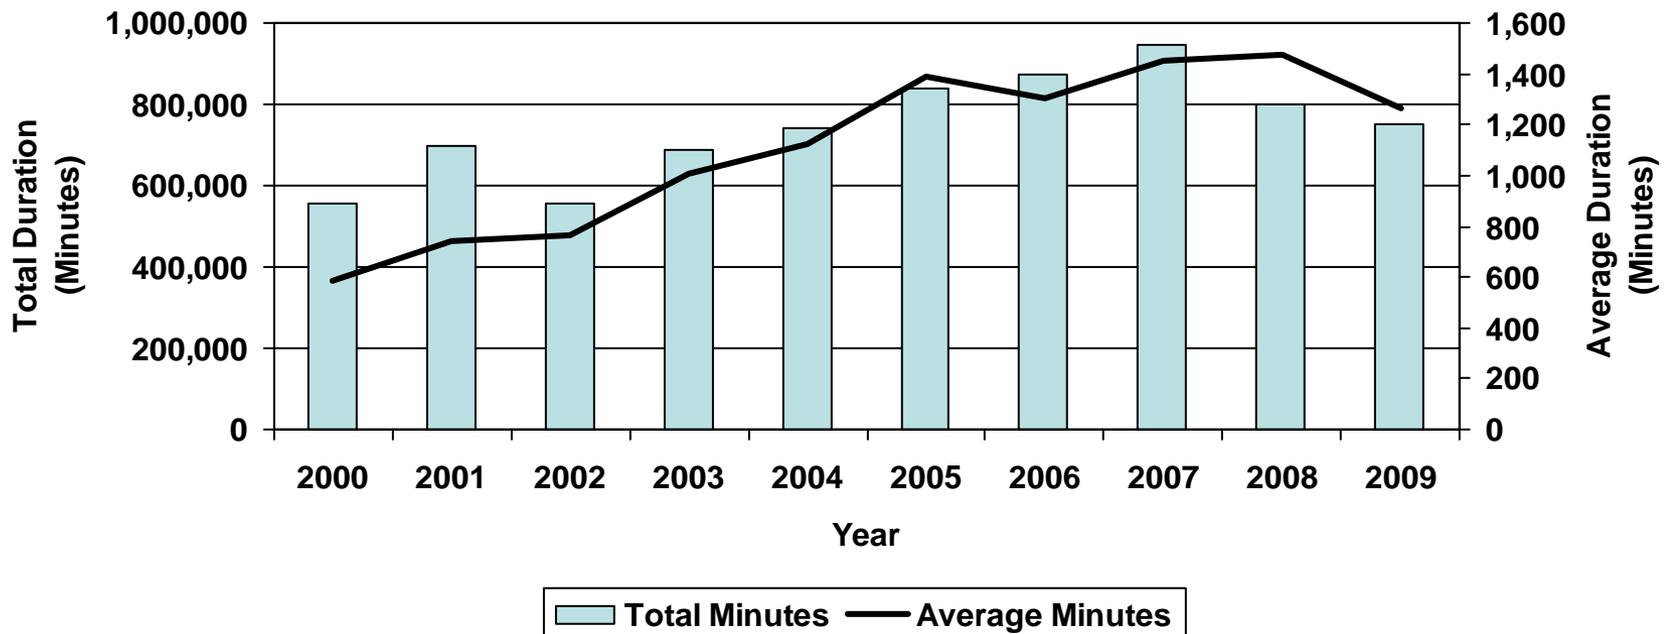
Planned Maintenance Outage Trends

- Aging wood pole lines have required increasing total planned outage minutes and an increase in the average duration of planned outages to complete necessary repair and replacement work.
- In 2008 and 2009, vegetation management issues diverted resources that would normally be doing capital replacement and maintenance work.

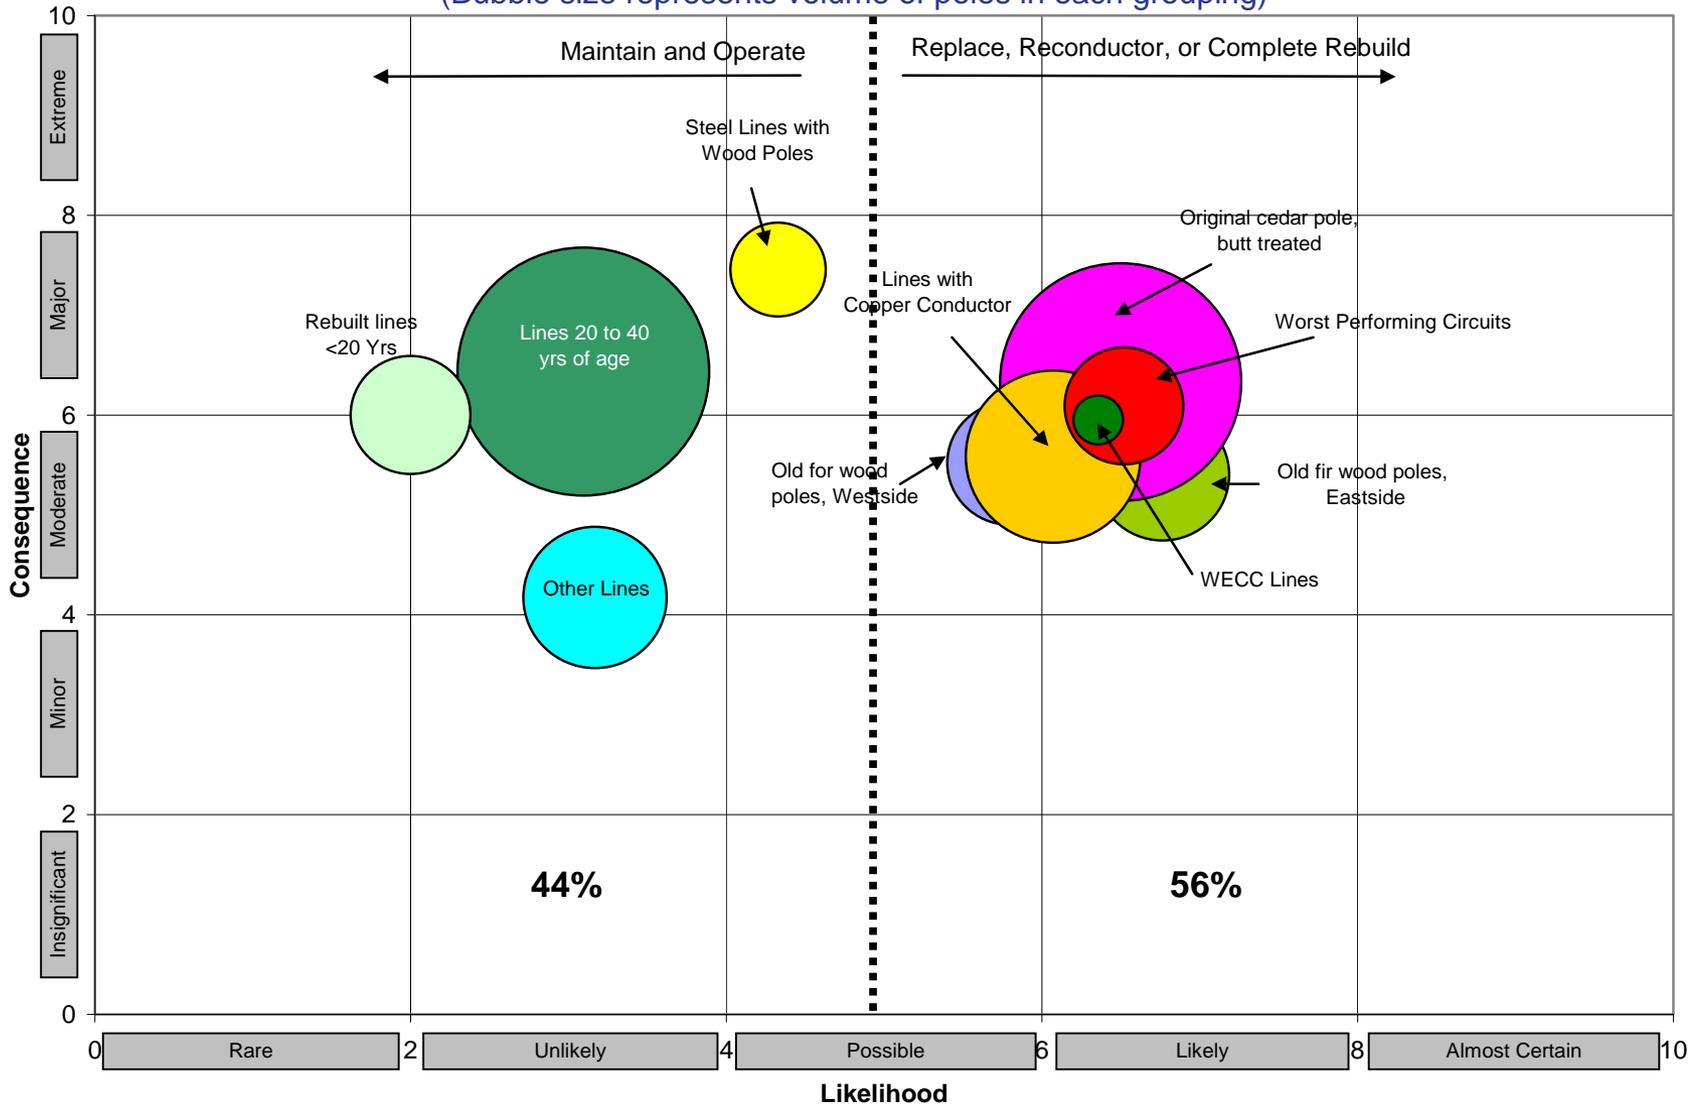
Risk Map – Current State (FY 2010)

(Bubble size represents volume of poles in each grouping)

- Likelihood of failure depends on asset condition and historical performance (ratings are a scale of 1 to 10, with 1 being in excellent condition to 10 being in poor condition)

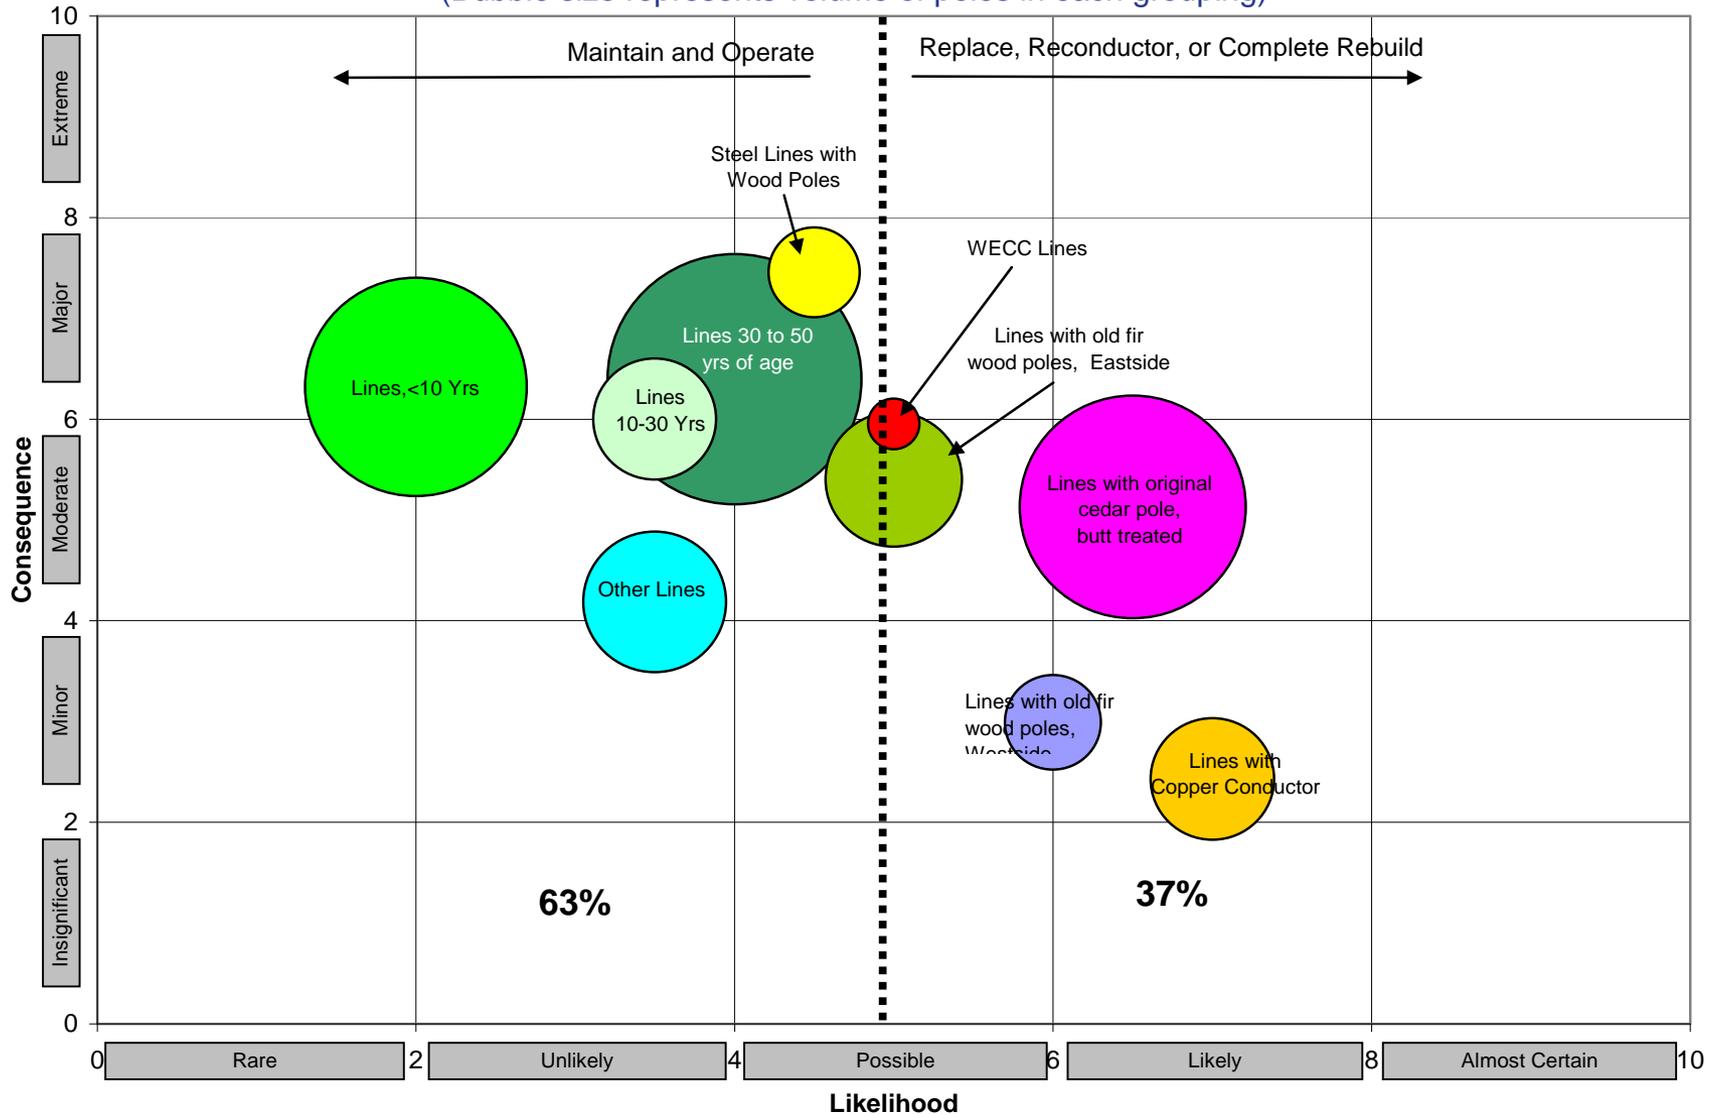
Risk Map — Future State (FY 2020)

(Bubble size represents volume of poles in each grouping)
