3.2 Geology, Soil, and Seismicity

The information presented in this section is based on the studies and analysis conducted for the SCA as amended by Amendments No. 1 and No. 2, filed with EFSC on July 25, 2003, and October 15, 2003, respectively.

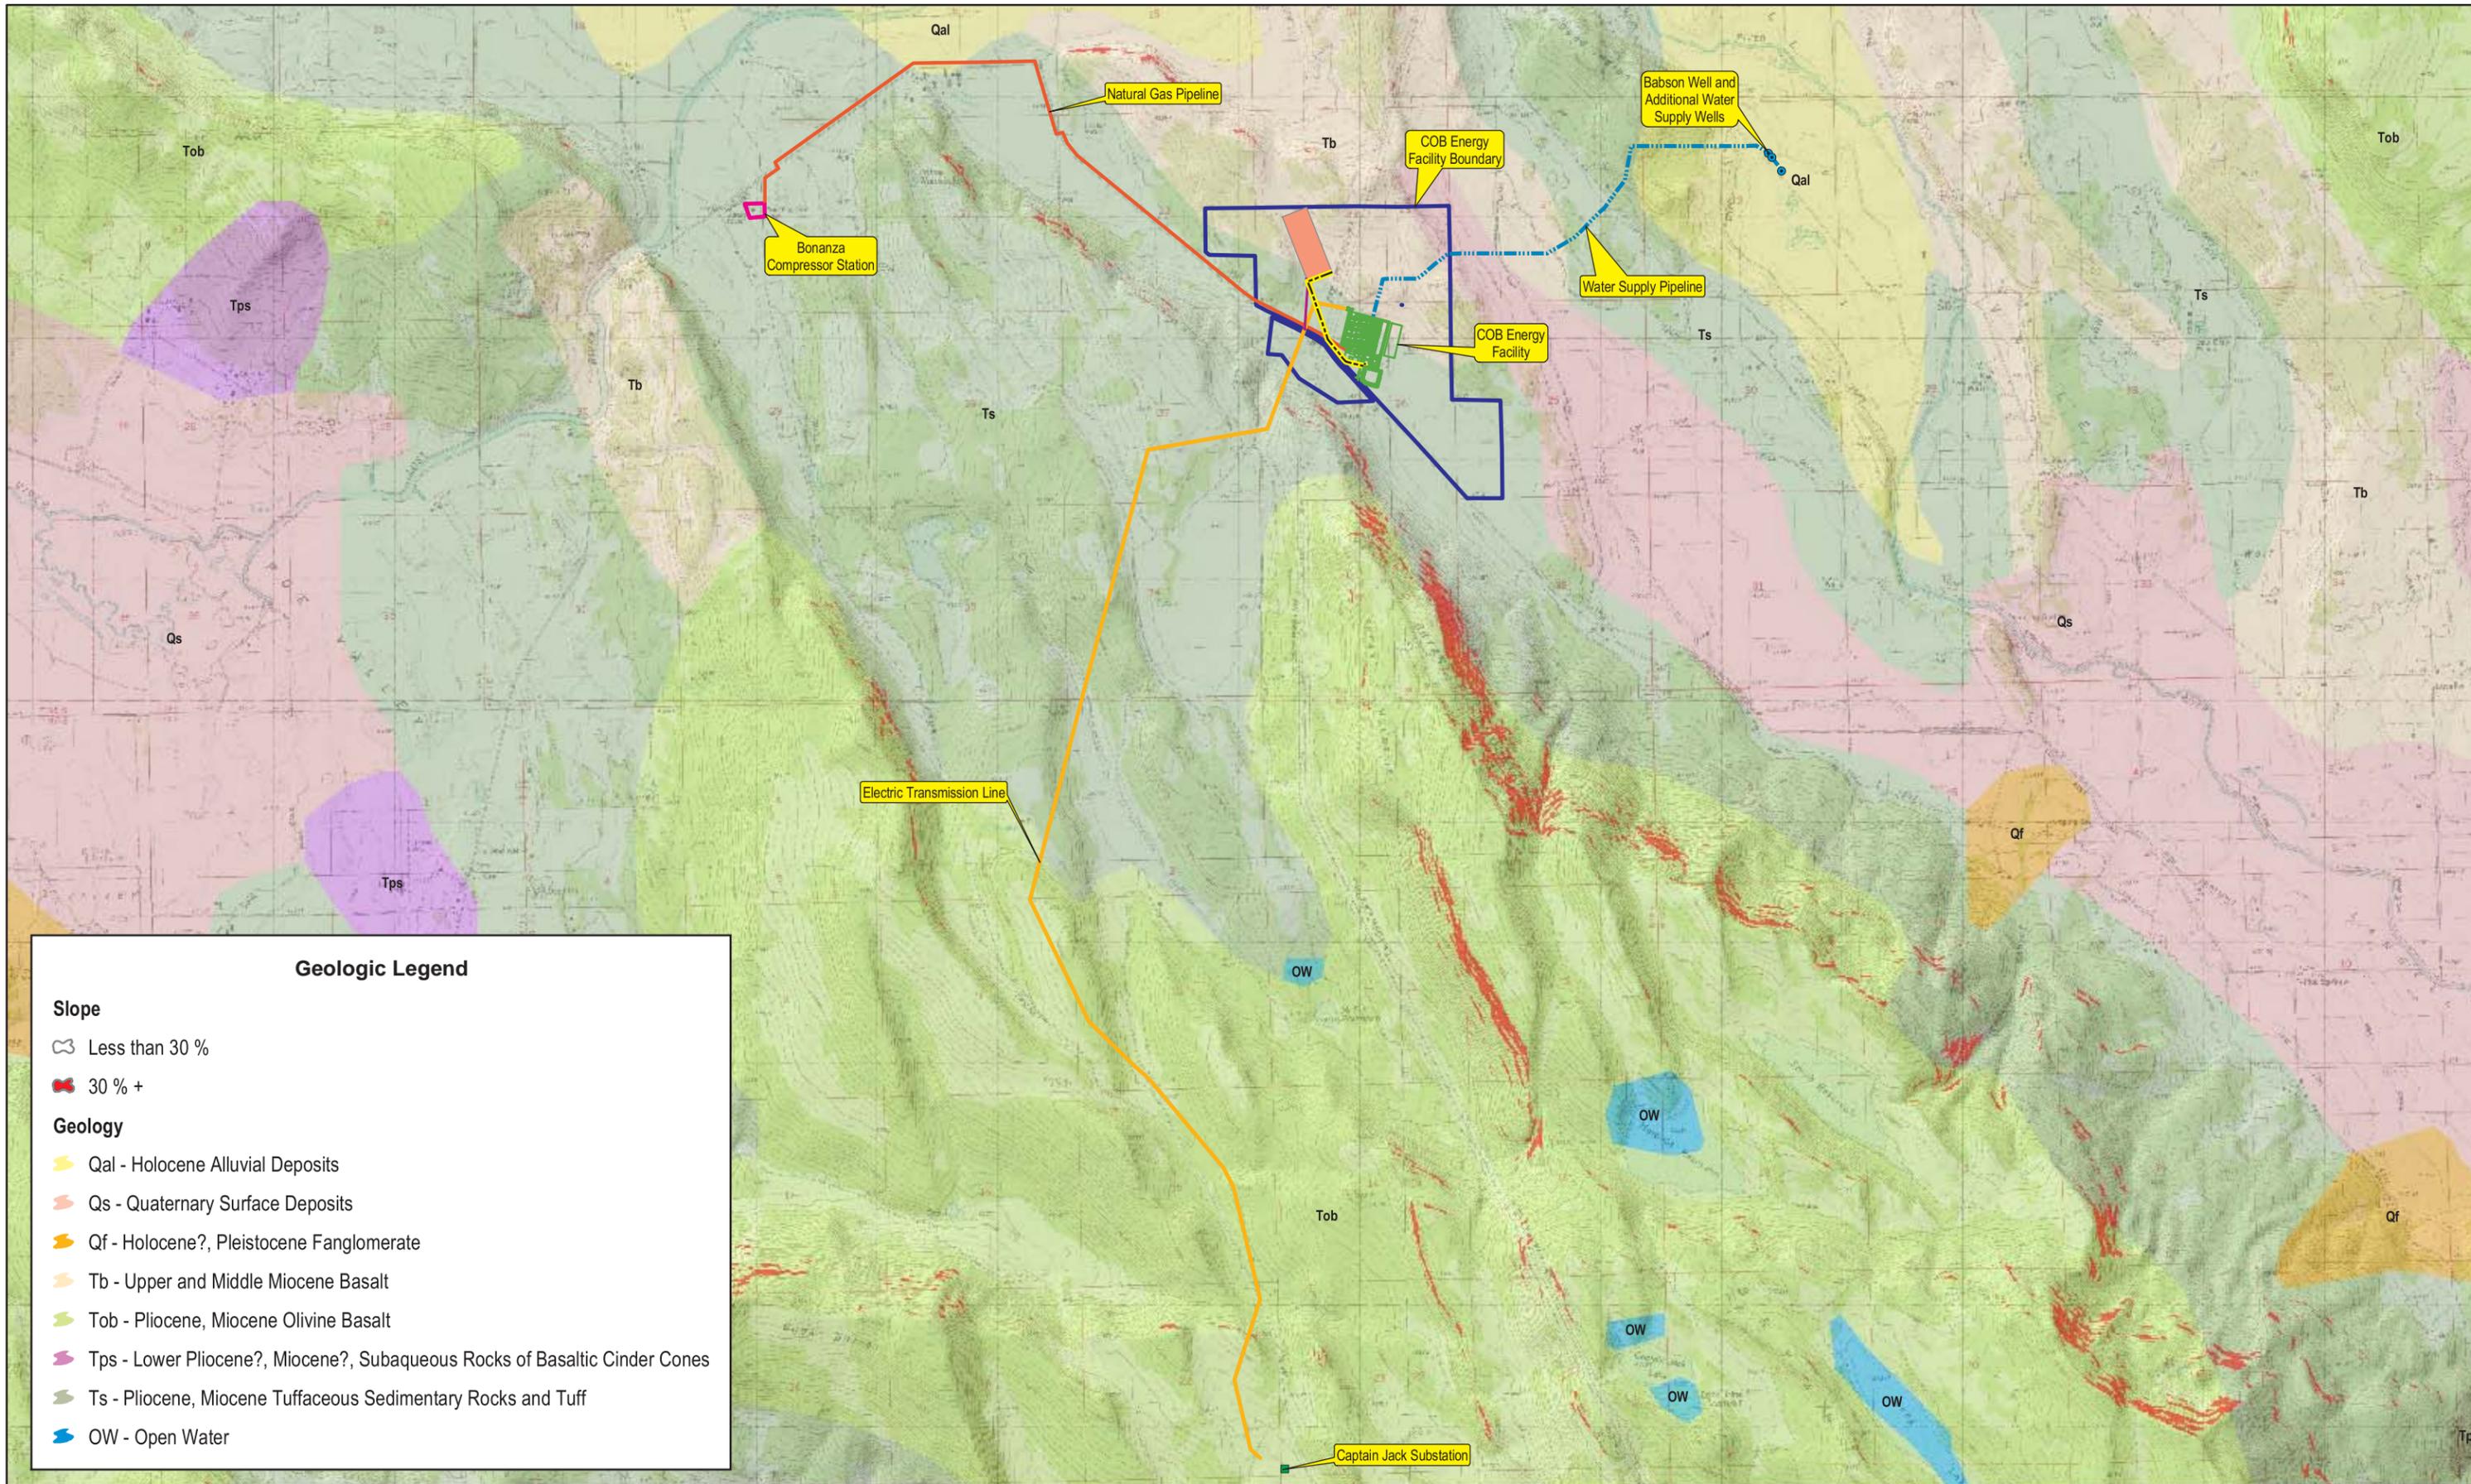
Figure 3.2-1
Geologic Hazards
COB Energy Facility
Bonanza, OR

The Energy Facility site is located in a subbasin of the larger Klamath Basin in south-central Oregon. The Klamath Basin is a composite graben that forms the westernmost structural trough of the Basin and Range physiographic province. The Klamath graben is bounded by predominantly north- to northwest-striking normal faults. The geology and topography of the Facility site are summarized below and shown in Figure 3.2-1.

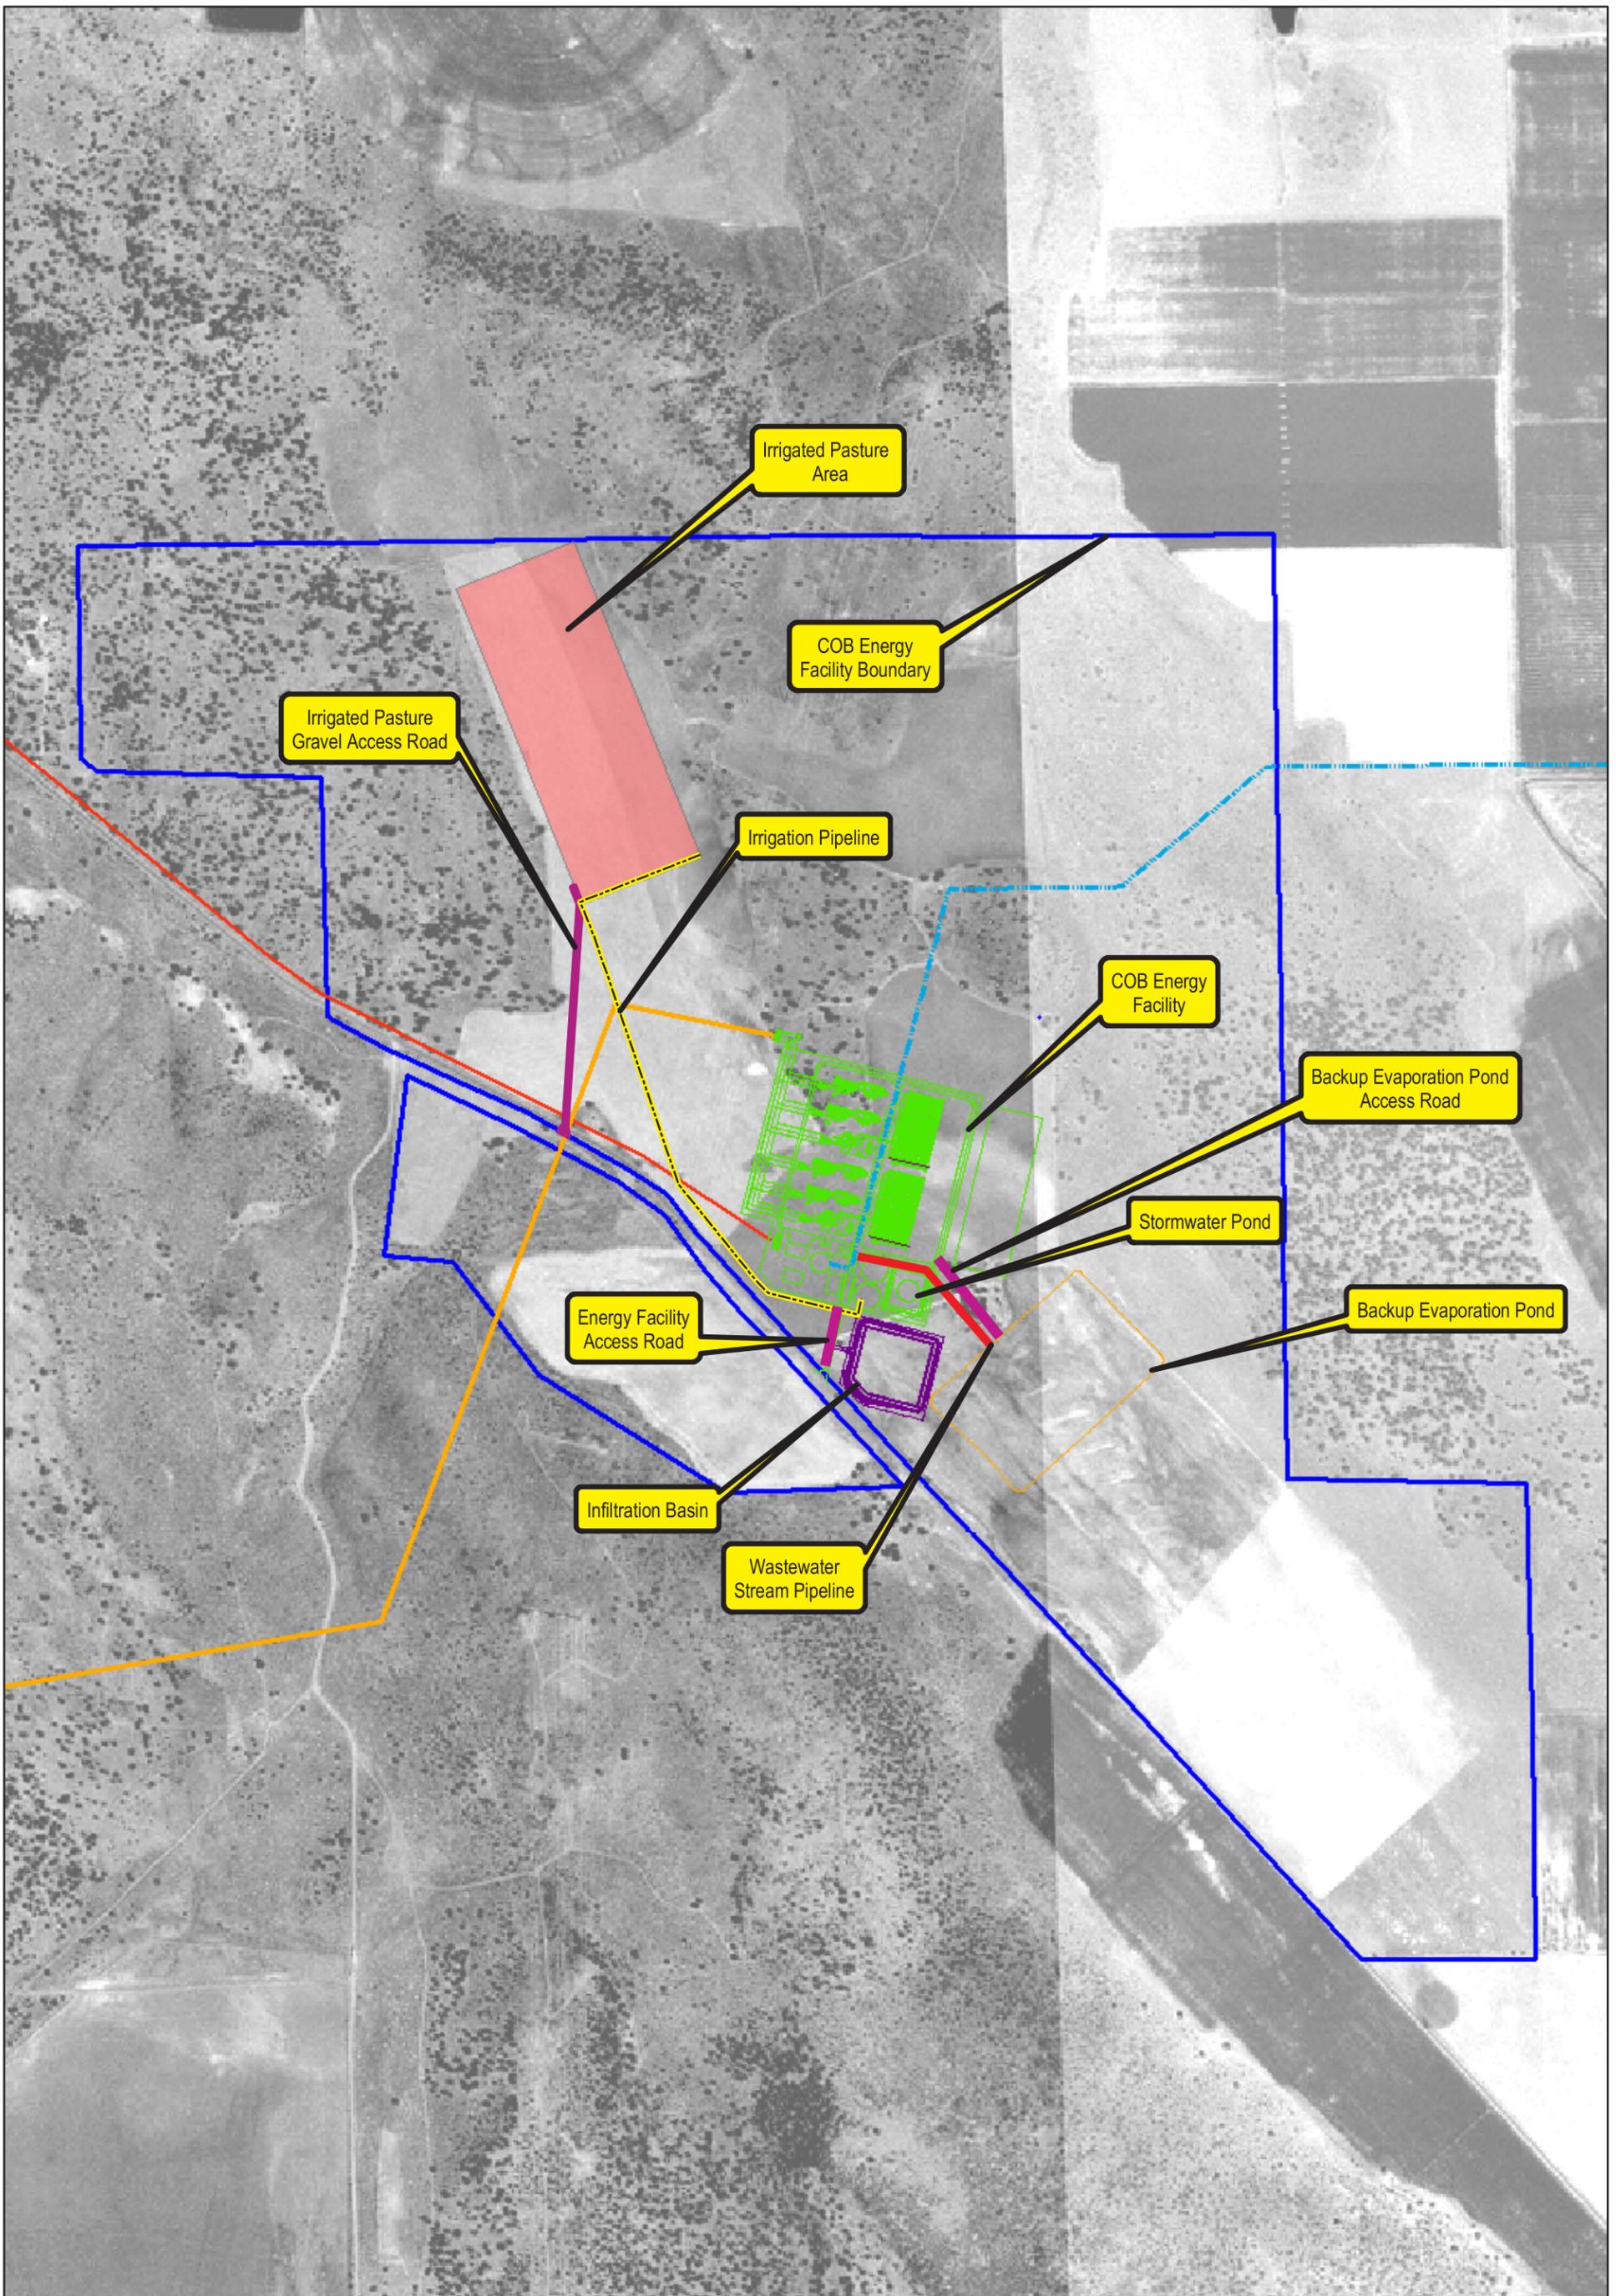
Figure 3.2-4
11 x 17
Back

<p>Legend</p> <ul style="list-style-type: none"> — COB Energy Facility — Irrigation Pipeline — Natural Gas Pipeline — Backup Evaporation Pond — Water Supply Pipeline — Infiltration Basin — Wastewater Stream Pipeline — Access Roads — Electric Transmission Line 		<ul style="list-style-type: none"> COB Energy Facility Boundary Irrigated Pasture Area 	<p>N</p> <p>1 inch equals 850 feet</p> <p>0 250 500 1,000 1,500 Feet</p>	<p>Figure 3.2-4 Energy Facility Site Layout COB Energy Facility Bonanza, OR</p>
--	--	--	--	--
